# US Army Centrifuge: Progressive Collapse Testing of a 4-Story Reinforced Concrete Structure at 1/18-Scale

W. Vanadit-Ellis, ERDC, Vicksburg, MSJ. K. Gran, SRI International, Menlo Park, CAD. Vaughan, Weildlinger Associates, Mountain View, CA

**Abstract:** A 1/18-scale model of a 4-story reinforced concrete structure was tested at 18 g in the US Army Centrifuge to support the development of computational modeling of progressive collapse of multi-story buildings. The model structure was 4 bays long and 3 bays wide with column spacing about 33 cm in each directions and story height of 20.3 cm. Three columns around one corner at the 1st story were explosively removed while the model was spinning in the centrifuge at 18 g. The column removal resulted in complete collapse the bays above those columns but collapse did not progress to the rest of the structure.

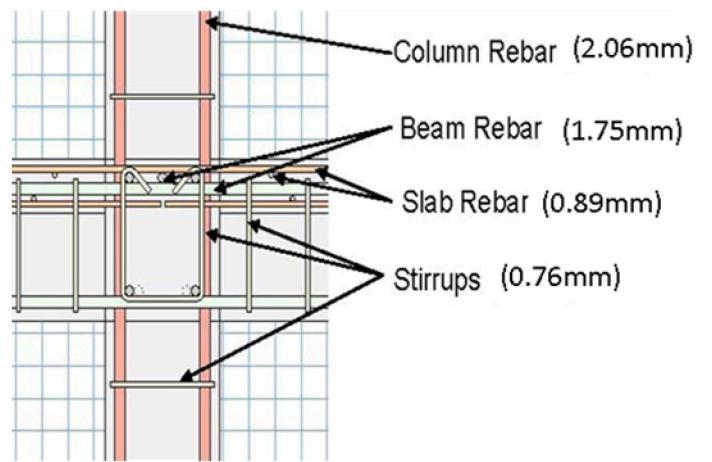
Figure 1. Beam-column rebar detail of the 1/18-scale model.

The main steel reinforcing bars in the beams and columns were modeled with steel threaded rods. Previous investigations showed that the threads provide a reasonably good match to the bond between full-scale rebar and concrete [1, 4]. The nearest matches of standard thread sizes to the desired rod diameters are 1-64 threads for 1/18-scale #9 bars and 2-56 threads for 1/18-scale #11 bars. The pitch diameter of the 1-64 thread is about 1.5 mm and the pitch diameter of the 2-56 thread is about 1.7 mm. For comparison, 1/18-scale diameters of #9 and #11 bars are 1.6 mm and 1.9 mm, respectively.

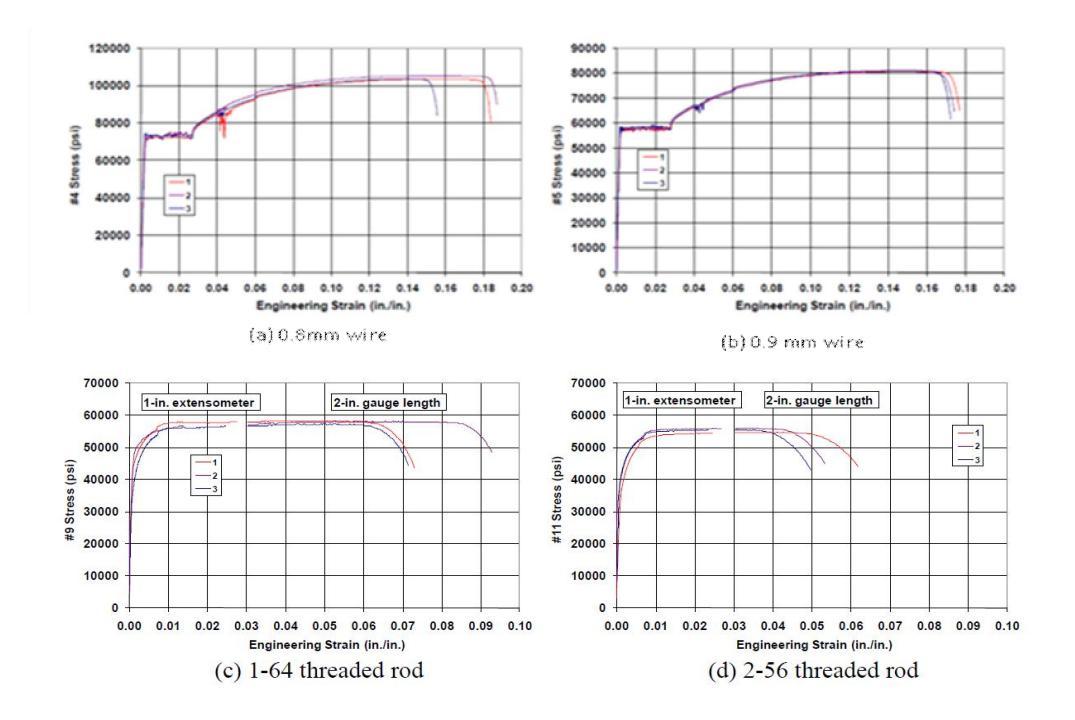
Typical tension test results are plotted in Figure 2. In these plots, the measured force vs. strain was converted to effective stress vs. strain using areas computed by scaling #4, #5, #9 and #11 rebar by  $1/18^2$ . In the first portion of each curve, the strain was measured with a 2.54 cm extensometer attached to the rod. In the second portion, the strain was computed from the cross-head displacement and the 5.08 cm gauge length between the grips. Because the threaded rods exhibited essentially no hardening beyond about 2% strain, the ultimate strains are highly dependent on the gauge length. For all rod sizes, the strengths were very uniform but generally a little lower than desired to match Grade 60 properties.

Figure 2. Properties of steel rods used to model rebar at 1/18 scale.

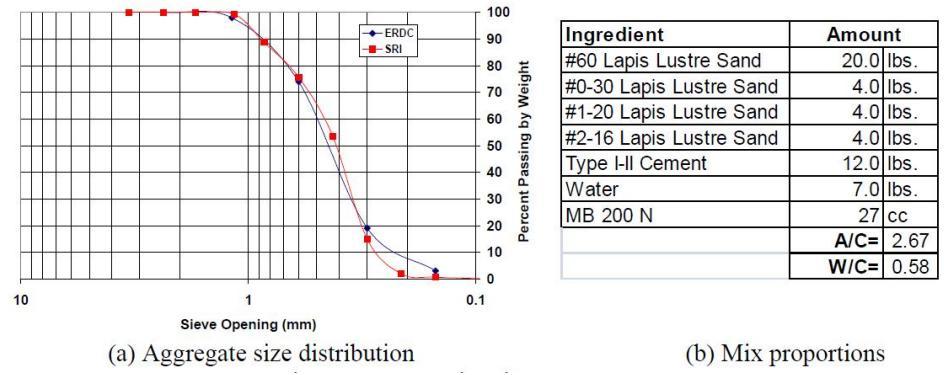
The batch mix design for the model concrete is given in Figure 3(b). Mixing was done in a pan mixer in 23.15 kg batches. The proportions of the mix vary slightly from ERDC FACM because the fluidity had to be increased to place the SRI FACM in the column forms. In consultation with ERDC, trial batches were made at SRI with adjustments to increase the fluidity. The aggregate-to-cement ratio (A/C) was reduced slightly and the amount of fluidizing add mixture was

Figure 3. Approximation to ERDC FACM.

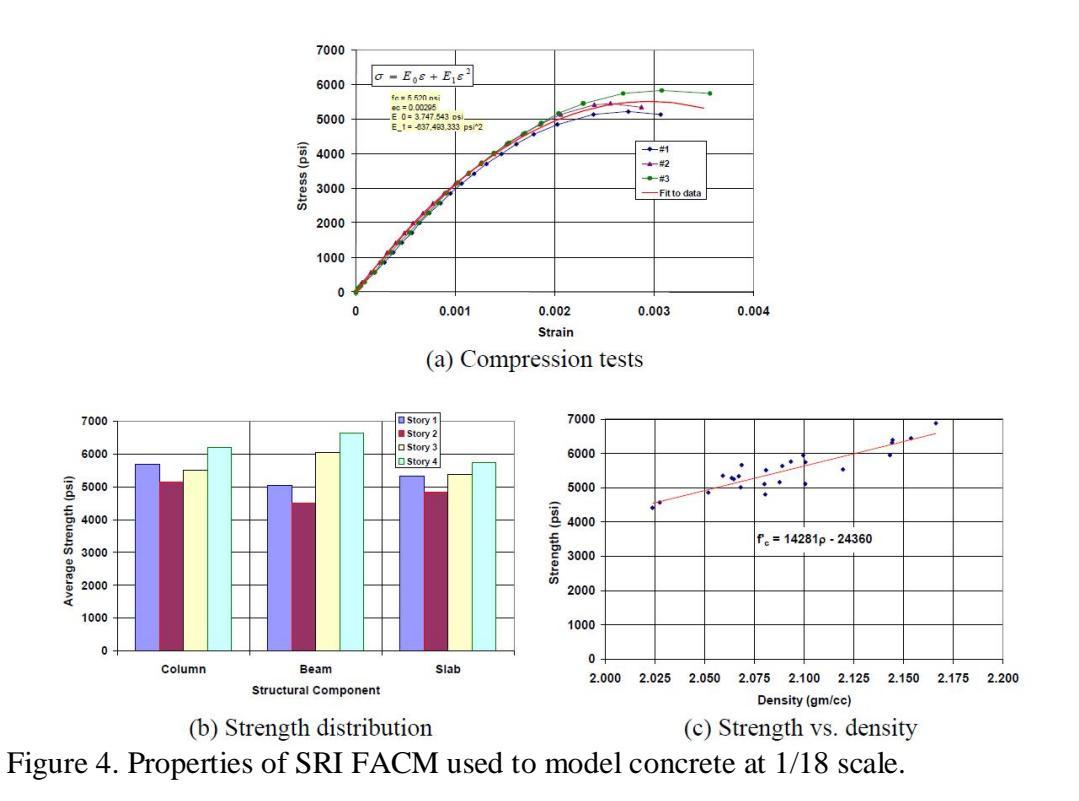
Static compression tests on 7.62 cm diameter cylinders of SRI FACM at age 40 days were performed by Dynamic Consultants (DCI), Mountain View, CA. Axial deformation was measured with a compressometer. The results are plotted in Figure 4(a). The average unconfined strength is about 37.0 MPa. The initial modulus and the strain at peak stress are reasonably good matches to full-scale concrete of that strength. Additional test specimens were made to measure

During fabrication of the structural model, 3 to 5 test cylinders were made with each batch of model concrete. Some of these cylinders were tested in unconfined compression at the time of the centrifuge tests. The age of the cylinders ranged from 251 to 364 days at that time. Figure 4(b) shows how the strength data correlate with structural component and story. As has been our experience in other concrete structures modeling programs, variations in the strength of the model concrete are caused by variations in placement and vibration, especially as they affect the consolidation of the fresh concrete. Figure 4(c) illustrates the correlation between strength and density for this set of samples. The fact that some column sections were cut out of the structure for the centrifuge tests allowed a rare opportunity to estimate the density of the model concrete in the structure from measurements. Based on measured masses and volumes of the column sections from the 1st story averaged 2.089 gram/cm3 and the section from the 4th story was 2.055 gram/cm3. Using the relation shown in 4(c), these densities indicate that the model concrete in the structure was in the range 34.5 to 37.9 MPa.

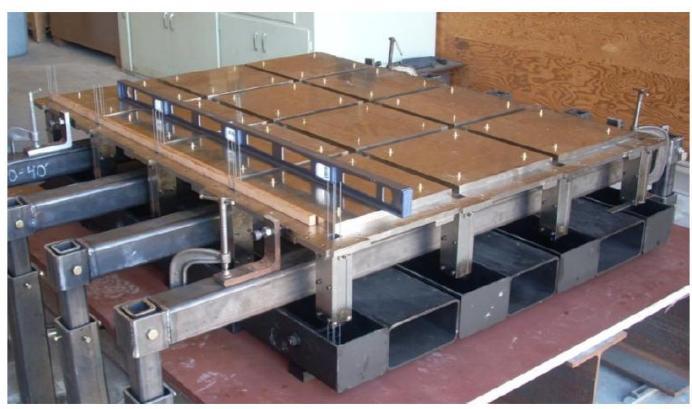
The basic approach for construction was to build the structural model from the ground up, one story at time. For each story, the formwork for all the columns, beams, and floor slabs was first assembled into a single unit and positioned accurately and supported firmly. Then the steel reinforcement for the columns was emplaced, followed by the steel reinforcement for the beams and, finally, the steel reinforcement for the floor slabs. Figure 5 shows the formwork assembled during emplacement of the 1st story column steel—the outer beam side forms are not in place. The assembled formwork was supported with adjustable screw jacks under each slab plate, which in turn rested on customized steel scaffolding that spanned the aluminum table. The formwork was made of aluminum bars and plates that were nickel coated to prevent corrosion and reaction with the cement.

Figure 5. 1st story formwork assembled and supported on scaffolding over the foundation unit.

Two vertical laser beams mounted above the assembly area were used to accurately locate each floor in the horizontal plane. These shone on small countersink divots at the center of two slab plates. By aligning each story with the lasers, leaning and twist of the structure was prohibited. Level and vertical position were controlled by the jacking screws under the slab plates. Once the form assembly was in the correct position, it was secured with camping screws on the scaffolding.

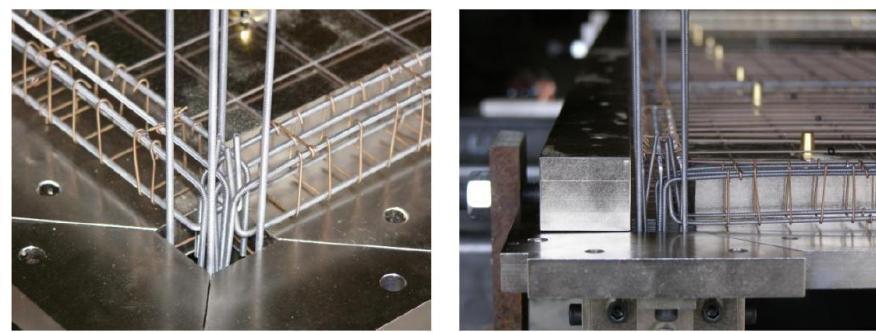
both assist in handling and to space them in the form. These upper bar units were placed into the opening of the stirrups, then the stirrups were bent around the outer two bars. Figure 6 shows some of the column and beam rebar during fabrication of the 1st story.

Figure 6. Beam and column rebar.

After all the column cages were in place, the beam steel was installed. Partial assemblies of beam steel were also prefabricated with special tooling. The lower bars were attached to stirrups that were open at the top. The upper bars were attached together with similar horizontal wires to

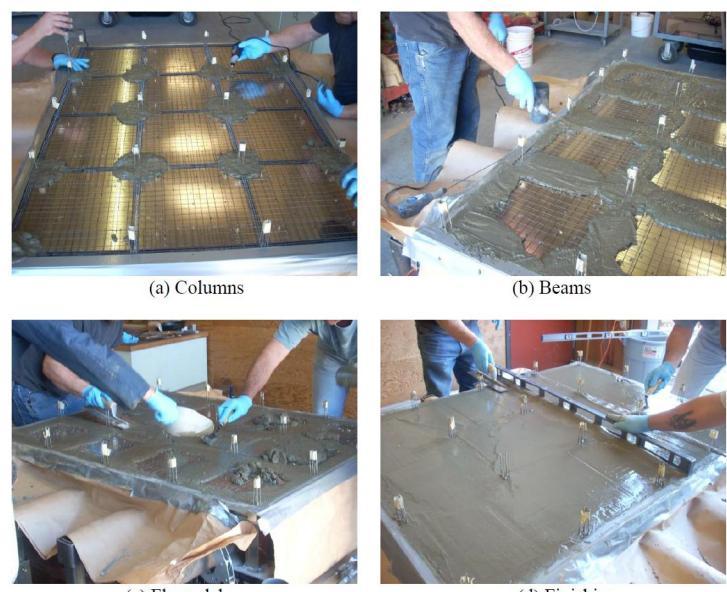
The lower rebar mats for the floor slabs were prefabricated with special tooling. They were spot welded at each intersection. A few glass beads were slipped onto some of the wires to provide the proper spacing of the mat from the bottom form. The mat dropped into the forms after the lower beam steel was placed but before the upper beam steel was placed. The upper slab rebar was also spot welded lightly to a crossing wire near each end. The ends of the upper bars were bent downward at 90 degrees to space themselves up from the form. These prefabricated units were then dropped over the upper beam steel. Figure 7 shows photographs of the concrete placement in the 1st story. The concrete was left to harden for about a week before the forms were removed, cleaned, and reassembled for the next story.

(c) Floor slabs (d) Finishing Figure 7. Model concrete placement in the 1st story.

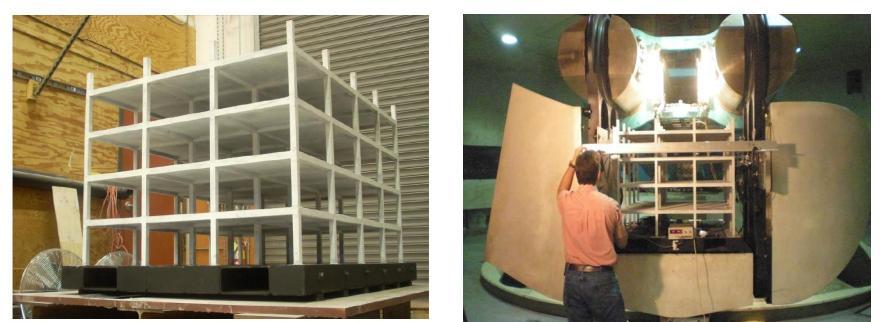
After construction, the structure aged for about 6 months. Prior to shipping to the centrifuge facility for testing, surface flaws in the concrete were patched and many measurements were made to document the precision of the structural dimensions. Finally, the structure was spraypainted white to enhance the visibility of cracks that would occur in the tests. The finished structure and test set-up are illustrated in Figure 8.

(a) Four-story reinforced concrete structure (b) Bracket mount for high speed camera Figure 8. 1/18-scale structure on the centrifuge platform.

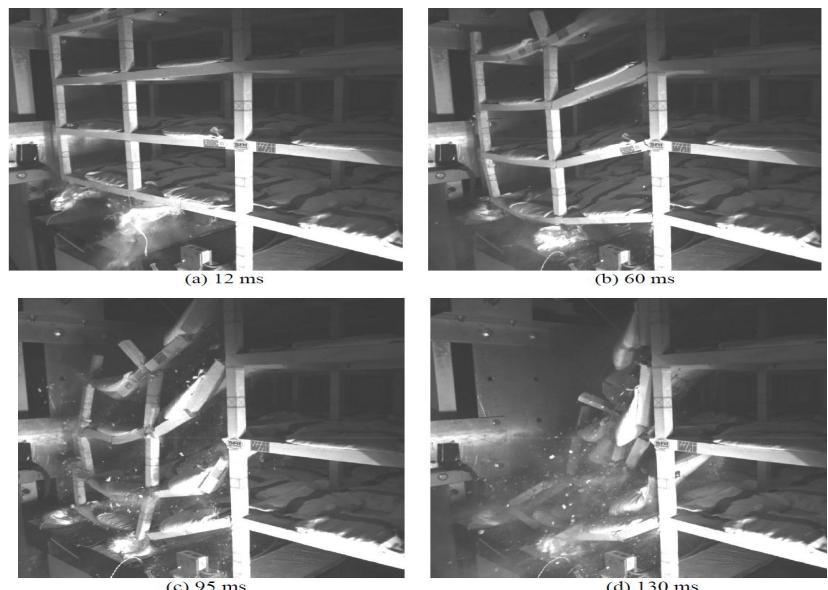
Figure 10. All stories of the corner bay initially fell straight down and hinges formed at both ends of the beams in the middle bay of the east end. The corner column stub bottomed out first, at which time the outer beams in the 1st and 4th stories cracked in the middle of the span, followed shortly by cracking in the middle of the 2nd and 3rd story beams in the middle bay. Then the penultimate column stub bottomed out, causing the concrete in the beam-column connections above it to fail in compression. All the outer beams except the 1st-story middle bay cracked in the middle, but the hinges at the right end of the middle bay did not immediately separate from the rest of the structure so each story of the collapsing section rotated about those hinges, eventually bottoming out and/or impacting the side of the third bay. The 1st-story beam of the middle bay eventually gave way when the stories above it collapsed onto it, cracking in the middle like the others. Meanwhile, the stable portion of the structure swayed, first toward the collapsing corner, then away from it.

Figure 10. High-speed video frames from Test 3.

Test 3 resulted in the collapse of the south east corner of the structure. The high-speed video viewing the east end of the structure captured the event quite well. Selected frames are shown in

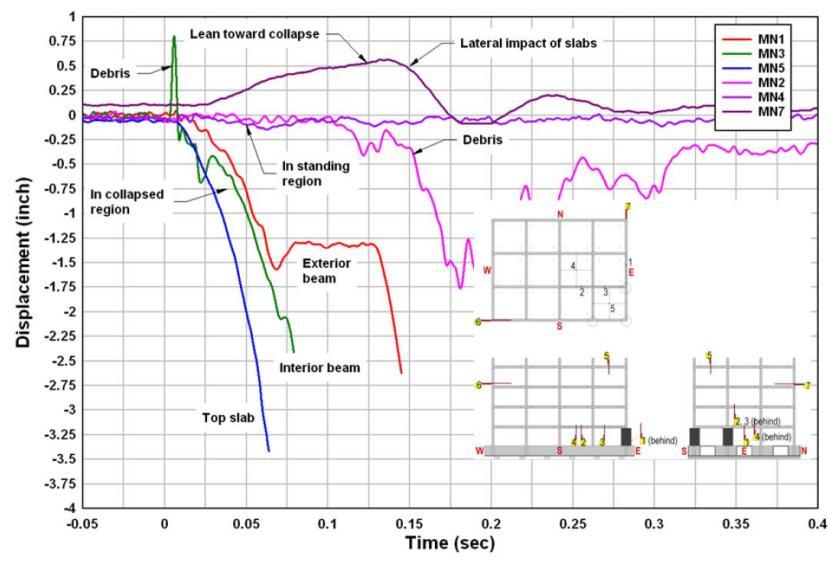
The deflection measurements are plotted in Figure 11. The 4th-story corner floor slab (MN5) and two of the beams that were monitored (MN1 and MN3) fell at about the same rate. The exterior beam (MN3) arrested briefly when the columns bottomed out but then deflected further when the beam broke. The gauge under the beam in the standing region of the structure (MN2) showed no significant deflection until shortly after the time that the column bottomed out, and the signal after that is almost surely due to debris crossing the path of the laser (that beam was not deflected posttest and floor slab debris was leaning against it). The interior floor slab (MN4) did not deflect. The lateral motion of the north east corner (MN7) was initially toward the collapsing corner, by about 12.7 mm, 25.4 mm, then and began to return at about the time the rotating slabs banged into the standing structure.

Figure 11. Test 3 deflections.

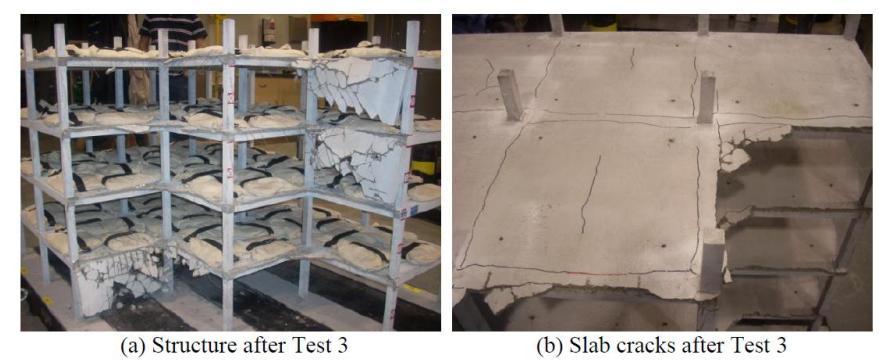
The half-slabs hanging to the structure were also cut away. Subsequently, all the shot-filled bags were removed so that the slabs could be inspected for cracks. Typical cracks on the top slab surface are shown in Figure 12. Rough measurements of slab center deflections were made with a 0.25 mm grid scale and a straight edge set along diagonals. These measurements ranged from 0 to 1.78 mm with a slight bias of lower deflections toward the top of the structure and away from the collapsed portion.

Figure 12. Status of structure after Test 3.

The collapsed portion of the structure was removed, story by story. The threaded steel rods in the beams adjoining the penultimate columns were fractured at the columns, but steel rods through many interior beam-column joints were still continuous. Some of the beam and floor slab steel was unbroken at the edge connected to the remaining structure. Some of the lower rebar mat in the floor slabs pulled out at the beams but broke in tension in the middle of the slab. The upper rebar mats in the slabs generally peeled out at the beams but some broke at the beams. Some steel bars were cut in order to clear the debris.
