Renovation of the flour factory de Sleutels in Leiden

Master Thesis Marloes van Loenhout

Overview of the factory complex Meelfabriek 'de Sleutels' in Leiden Renovation of the flour factory 'de Sleutels' in Leiden

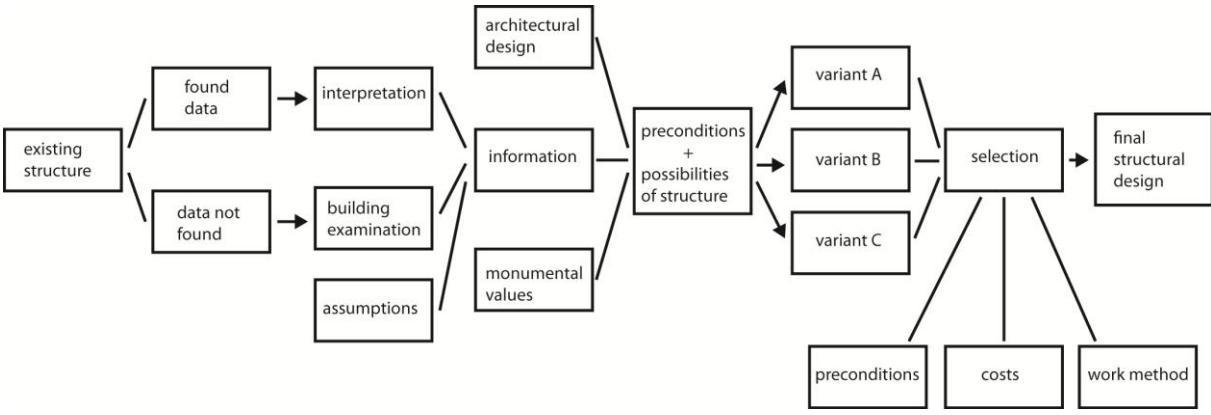
Figure 1-1 from seeking information towards a structural design

In the architectural analysis the buildings, the monumental values, the architectural redesign and the demands of the architects are examined. With this data a set of requirements for the structural interventions is created. In the structural analysis the failures of the buildings are examined. Based on the results of this analysis two buildings are selected for the first schematic designs. Based on the strengths and weaknesses of the buildings a study is made of structural variants on the redesign. A selection of the variants is made based on the set requirements. When the best solutions for the two buildings are chosen, they will be designed in detail and verified if they are sound structural interventions. This research method is summarised in a scheme (figure 1-1).

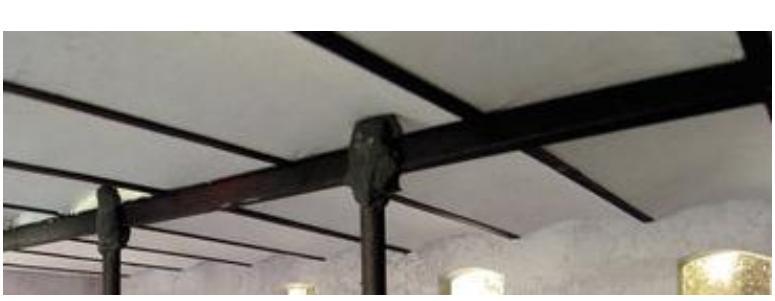
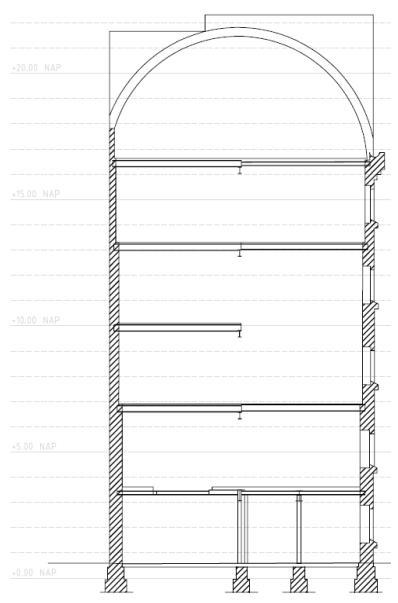
figure 2-3 section Boiler house

The brick façade and an iron skeleton, transport the loads to the foundation. The iron skeleton consists of beams of rolled I profiles and cast-iron columns (figure 2-3). The columns have an U-head, which consists of two bolted pieces and are decorated (figure 2-2). Those columns are standing on a grid of 3500 mm. The arch shape floors are made from concrete. The concrete roof has the shape of a half cylinder and every 3 meters an iron profile resists the tension forces. It has a 15m span and is built according to the Monier system.⁸

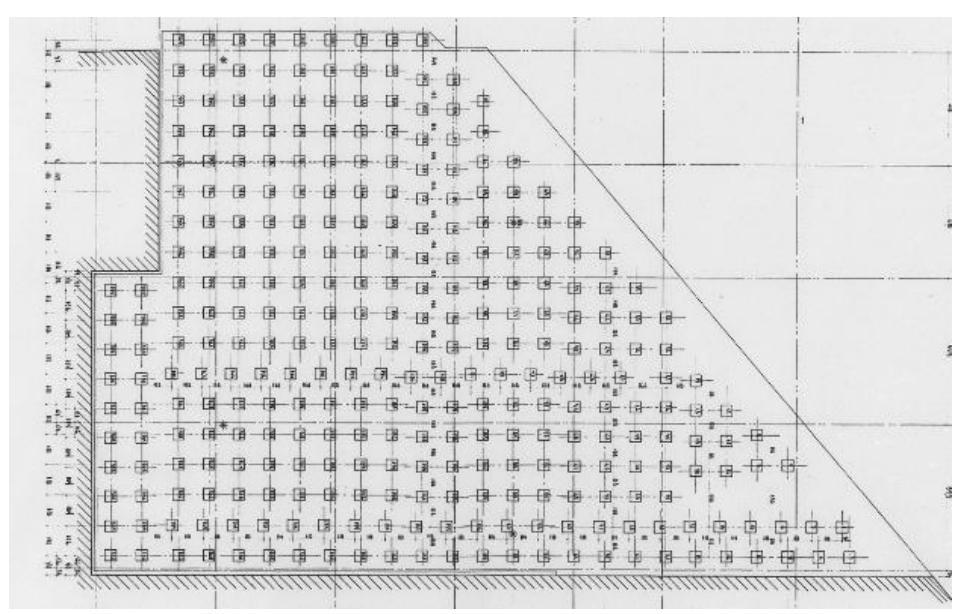
figure 2-39 Foundation – archive municipality Leiden

The foundation consists of a concrete sandwich-structure floor plate of concrete-sand-concrete, to transfer the load to the 306 concrete square piles. The piles have a length of 16m and a diameter of 300 x 300 mm². The piles have a capacity of 785 kN each, as is described in the drawings.

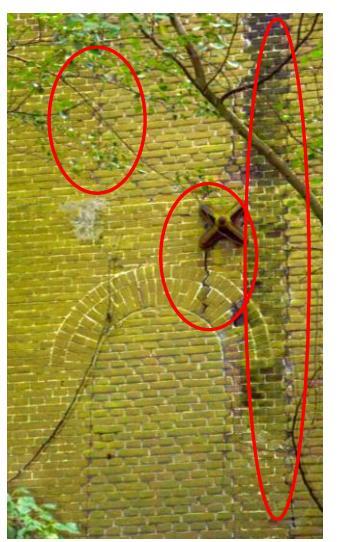
Figure 11-1 Visible cracks in North façade

During the visual inspection vertical cracks in the façade were noticed (figure 11-1 and 11-2). This implicates that on the locations where the steel beams rest on the brickwork, high stress occurs. Furthermore, the influence of corrosion can play a part. Vibrations and different expansion coefficients of steel and brick caused the cracks in the facade. 66

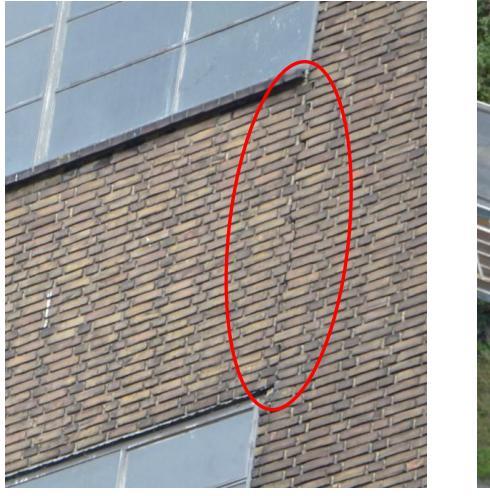
Figure 11-4 Cracks visible in the south façade

The visual inspection by ABT BV made clear that cracks appear in the façade. Vibrations and different expansion coefficients of the iron profile, which supports the façade and the brick façade, caused the cracks in the walls (figure 11-4 and 11-5). ⁶⁹

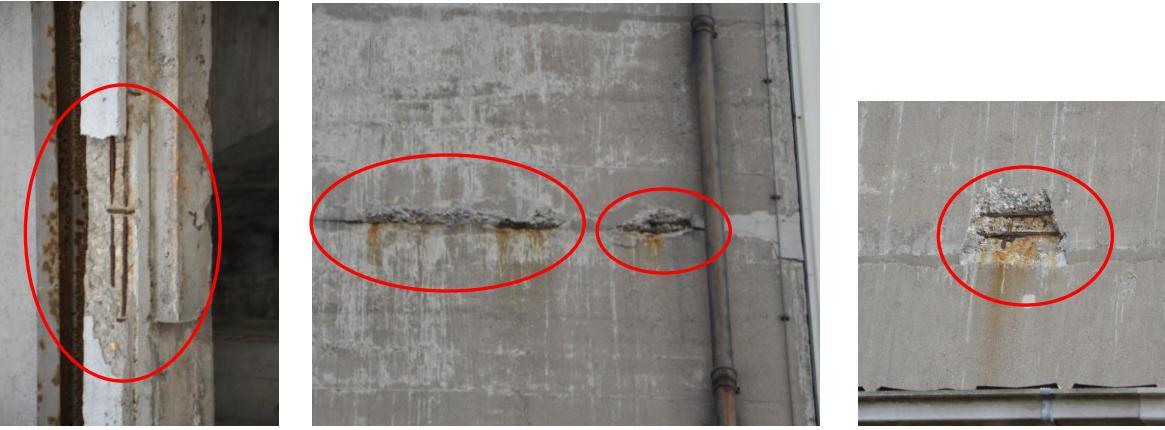
Figure 11-6 Reinforcement visible

The visual inspection made clear that at the seams of the pouring at the silos of 1937, concrete is spalling and reinforcement is visible (figure 11-7 and 11-8). Moreover, reinforcement is visible at the façade columns on the ground floor (figure 11-6).

To adapt the silos built in '37, '38 and '55 to a hotel the concrete has to be repaired where reinforcement is visible to prevent (further) carbonation and corroding of the steel.

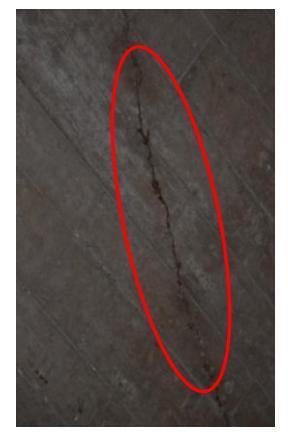
Figure 11-18 Cracks in the roof

The visual inspection by ABT BV made clear that the roof and façade are damaged (figure 11-18 and 11-20). Firstly, the rooftop shows cracks and leakages. Secondly, at the lower part of the stairs there is steel visible in the concrete. Thirdly, in the concrete walls on floor 4 till 8 horizontal concrete cracks are visible of max 1 mm. Furthermore, at the rooftop the concrete blocks on the inside have a bad condition. Moreover, the bitumen on the roof is cracked in several places.⁷⁴

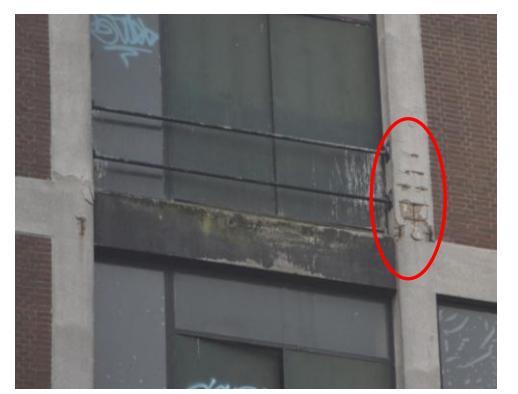
Figure 11-21 Reinforcement visible

The visual inspection made clear that in the concrete columns reinforcement steel is visible. Moreover, in the closed part of the façade there are horizontal cracks present on the locations where the floors are positioned.

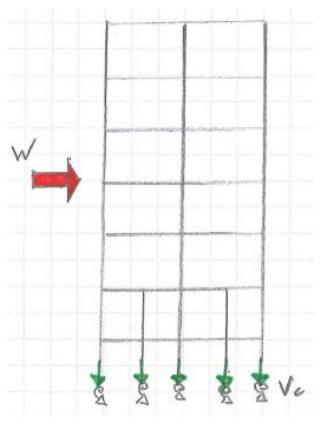
Figure 12-6 scheme mill

h = 31m p_W = 1,04 kN/m² q_W = 1,04 x 1,2 x 5m = 6,24 kN/m The reaction forces are all pressure forces on the foundation (appendix N).

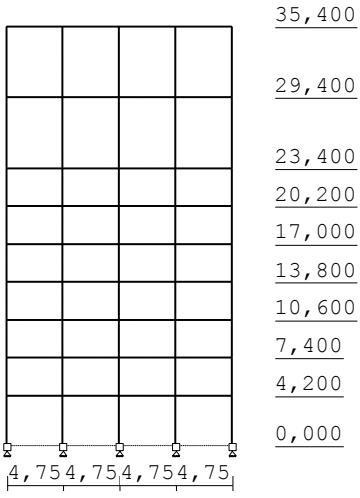
Figure 12-8

The flour warehouse is schematised (figure 12-8) and tested in a technosoft Raamwerken program as a portal system.

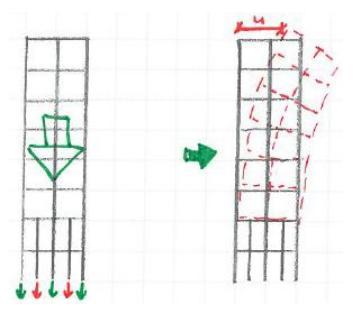
Figure 13-1 insufficient bearing capacity foundation and a large displacement

The bearing capacity of the foundation of the mill is insufficient to bear the load of the new functions. Furthermore, the maximum displacement due to lateral load is exceeded compared with the set requirements of $u_{max} = h/500 = 62 \text{ mm}$ (figure 13-1).

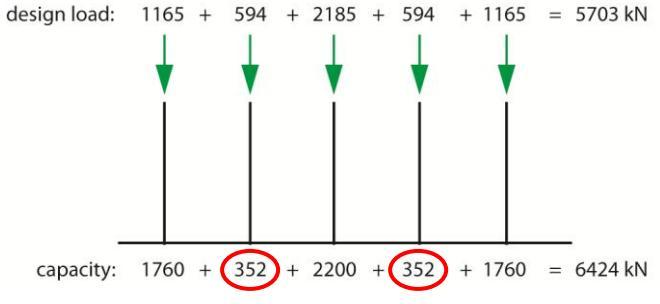
Figure 13-2 capacity and load on foundation

The capacity of the piles beneath the middle columns on the ground and first floor is insufficient to support these columns (figure 13-2).

The piles beneath the middle column have no capacity left to support the load of these middle columns on the ground and first floor (figure 13-2). However, the outer columns do have this capacity. The piles beneath the middle columns on the ground and first floor have a maximum foundation capacity to bear the ground floor solely (appendix V). A possibility to solve this problem would be to demolish the columns on ground floor and transfer the forces to the outer columns (figure 13-5). Another possibility, to solve the problem of insufficient bearing capacity, would be to add more piles to support the columns and ground floor.

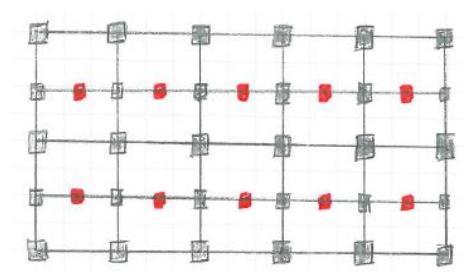
figure 13-13 dies and piles added to foundation

A part of the load of the building is transported to new added piles, dies and columns (figure 13-13). The new columns bear the load of floor 0 and 1 (figure 13-14). The new design load on the existing die is F = 367 kN (figure 13-15) and the capacity is exceeded with 4%, which will be allowed. The design load on the new column is F = 93 kN, profiles of HE100A are used as columns (appendix V).

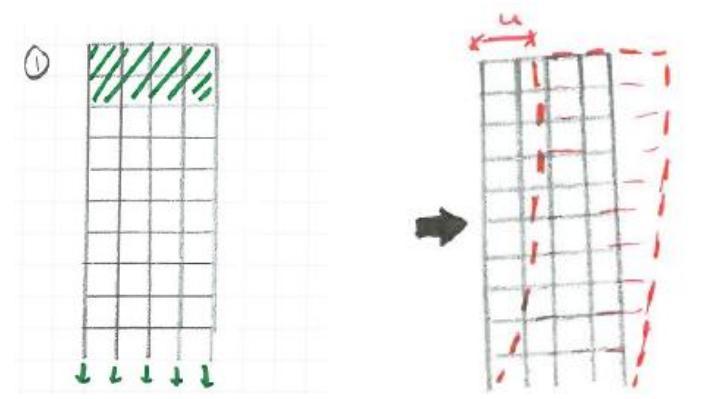
Figure 14-1 too high forces on the foundation and a large displacement of the flour warehouse

The bearing capacity of the foundation of the flour warehouse is insufficient to bear the load of the new functions. Moreover, the maximum displacement due to lateral load compared with set requirements of $u_{max} = h/500 = 71 \text{ mm}$ is exceeded (figure 14-1).

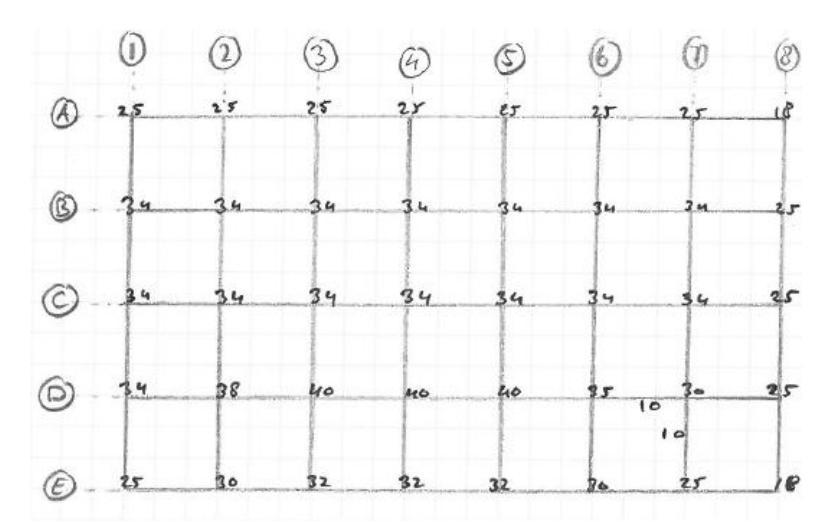
Figure 14-2 Amount of piles flour warehouse

The numbers of piles is different per each column (figure 14-2). In the structural analysis a capacity of 25 piles per column is assumed. To examine the possibilities of the foundation, the configuration of the different number of piles and therefore different capacity is considered thoroughly (table 14-1). Examination of bearing capacity left on these columns can lead to a solution for an economic configuration of the swimming pools on the floor plan. The amount of piles is determined and multiplied with the capacity of one pile, which is minimised from 100 kN til 88 kN (chapter 12.7).

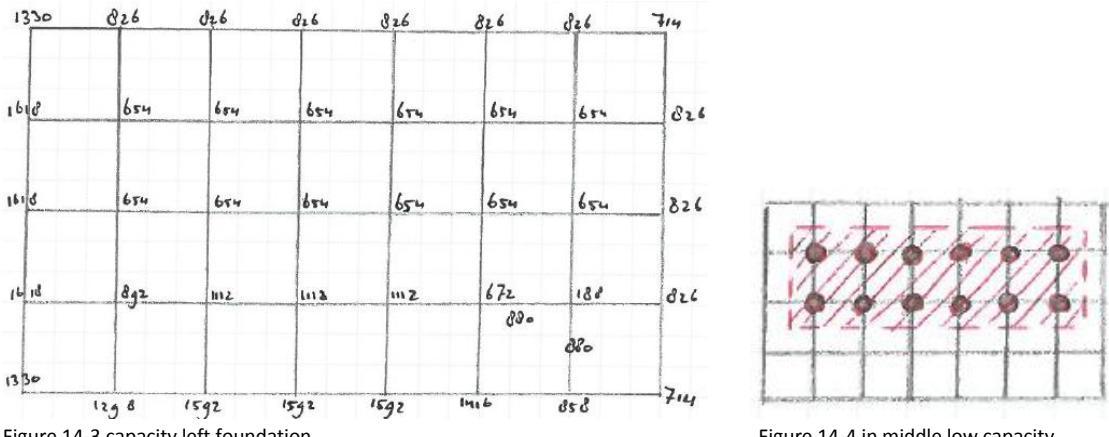
Figure 14-3 capacity left foundation

The existing structure consists of seven floors. These floors have the new functions of restaurant, café and fitness. When only the existing structure on permanent and imposable loads of the floors 1-6 (table 14-2) is considered there is still capacity left on the foundation (figure 14-3). Few capacity is in the middle columns (figure 14-4). Therefore the swimming pools should be located as much as possible on the outside of the building, where the capacity is left.

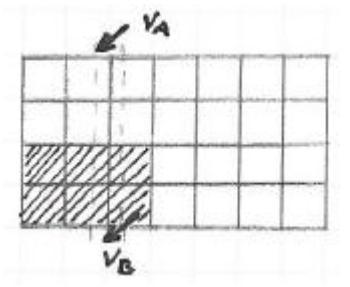
Figure 14-11 load on outside columns

4. In the fourth situation the possibility of transferring the load to the outer columns is examined (appendix W). But doing this creates high forces on the outside columns while the capacity of the foundation is not sufficient (figure 14-11). Not all the capacity of the foundation beneath the middle columns is used in this situation, this would mean more additional piles then situation 3 and therefore it is not a good solution.

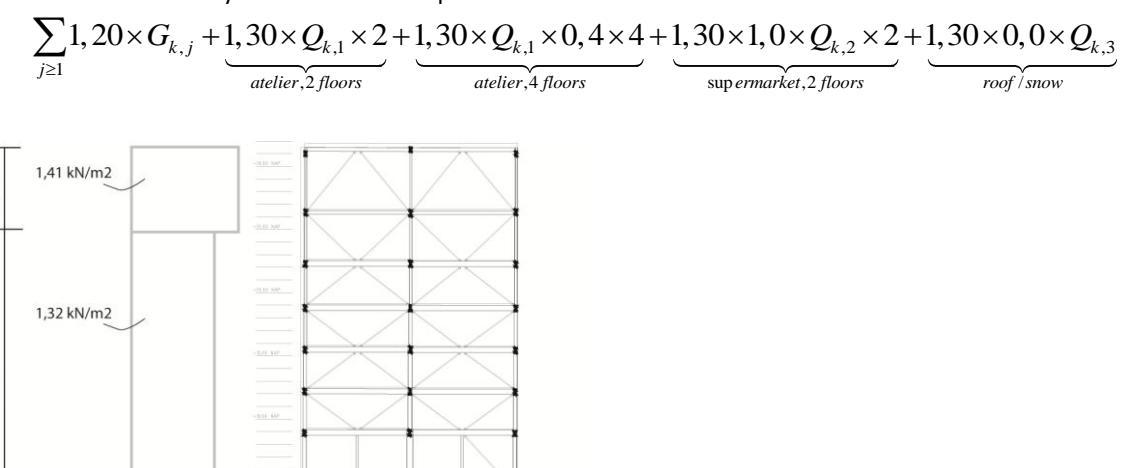
Figure 16-11 windload on mill transverse direction

i. wind-load fully loaded and the imposable load with an instantaneous factor
