Proceedings of the 17th European Conference on Composite Materials

# COMPARATIVE ANALYSIS OF IN-PLANE AND OUT-OF-PLANE MECHANICAL BEHAVIOUR OF SPOT-WELDED AND MECHANICALLY FASTENED JOINTS IN THERMOPLASTIC COMPOSITES

**Keywords:** Thermoplastic composites, spot-welded joint, mechanical behaviour, fracture analysis

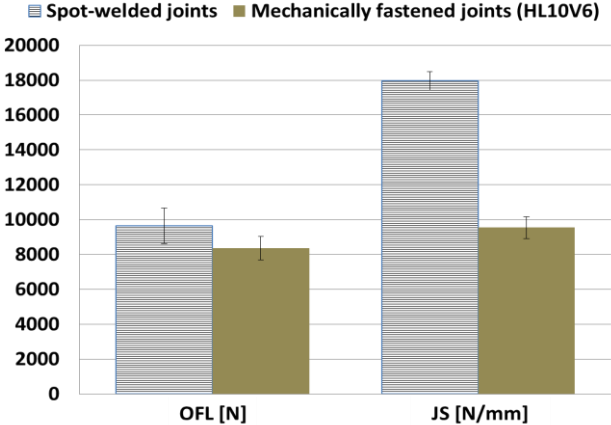
**Figure 4.** Comparison of mechanical performance between spot-welded and mechanically fastened joints in DLS tests. (OFL: onset failure load, JS: joint stiffness)

Fig. 4 shows the comparison of average onset failure load (OFL) and joint stiffness (JS) of both types of joints. Based on the indication in Fig. 3, the onset failure load for welded specimen is equal to the ultimate failure load. Therefore, it can be noted that the spot-welded joints have a comparable OFL compared to the mechanically fastened counterparts. However, the average JS of the mechanically fastened joints is approximately half of the welded joints, which is considered to be attributed to the presence of the bolted hole and thus leading to a stiffness reduction for the composite substrates.

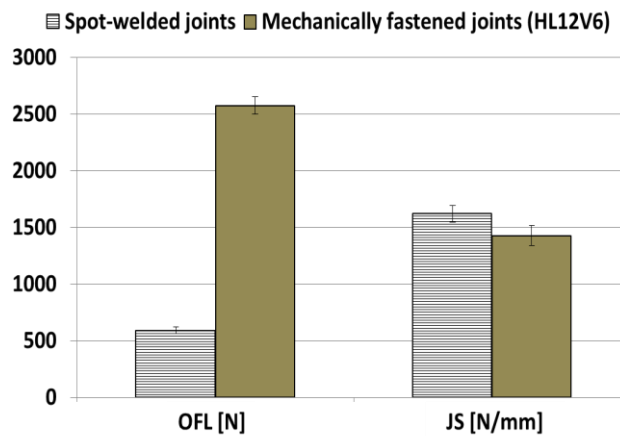
**Figure 8.** Comparison of mechanical performance between spot-welded and mechanically fastened joints in PT tests. (OFL: onset failure load, JS: joint stiffness)

Correspondingly, the comparison of the onset failure load and joint stiffness of both types of joints are shown in Fig. 8. Compared to spot-welded joints, the mechanically fastened specimens show significantly higher onset failure load for carrying the peel load due to the through-the-thickness reinforcement effectively provided by the mechanical fasteners. Nevertheless, due to the presence of the bolted hole, the joint stiffness of welded samples is slightly better than the mechanically fastened counterparts.

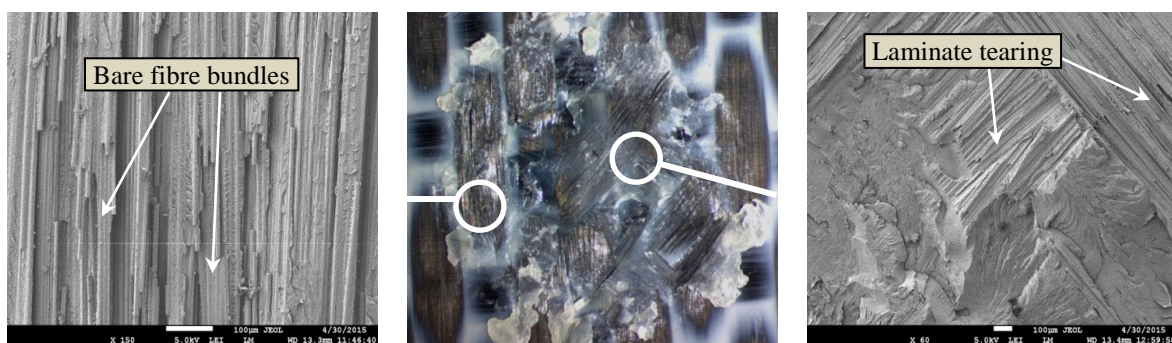
**Figure 9.** Fracture surface of the spot-welded joint after PT tests (middle). The left and right images show SEM details for the failure modes, indicated by the left and right white circles on the fracture

surface, respectively. Welding parameters: energy 600 J, welding force 1500 N, peak-to-peak amplitude 60.8  $\mu\text{m}$ .

Similar to the observation in DLS tests, the visual inspection on welded samples after PT tests reports that a circular welded joint (approximately 9 mm in diameter) presents on the central point of overlap (Fig. 9) and no further failure appears on the sample surface. Meanwhile, SEM analysis indicates that intralaminar failure, consisting of fibre-matrix debonding and laminate tearing, is still the major failure modes for welded joints. As a comparison, bending failure happens on the bottom substrate of mechanically fastened specimens due to the penetration of the Hi-Lok<sup>TM</sup> collar during tests (Fig. 10). Cracks are found radially propagating away from the bolted hole and thus leading to a significant size of damaged zone in the substrates [8].
