Measuring Plasticity with Orientation Contrast Microscopy in Aluminium 6061-T4

Sepideh Ghodrat ^{1,*}, Ton Riemsdag ¹ and Leo A. I. Kestens ^{1,2}

Abstract: Orientation contrast microscopy (i.e., electron backscattered diffraction, EBSD) was employed to monitor the plastic strain in loaded tensile samples of aluminium alloy Al6061 in T4 condition. The kernel average misorientation (KAM) is known to be an appropriate parameter in orientation contrast microscopy which has the potential to characterise the plastic strain by monitoring the local misorientations. This technique was applied here to gauge the extent of the plastic zone around a fatigue crack. To establish the magnitude of strain (which can be identified by the KAM parameter), a series of tensile samples were strained in the range of 1% to 25%. KAM maps were compared, and the average misorientations were related to the tensile strain values. The KAM distribution functions for all the strained samples were derived from a large scanned area. In addition, Vickers microhardness tests were conducted for these series of samples. This allowed the comparison of the mesoscopic plastic strain measured by Vickers microhardness with

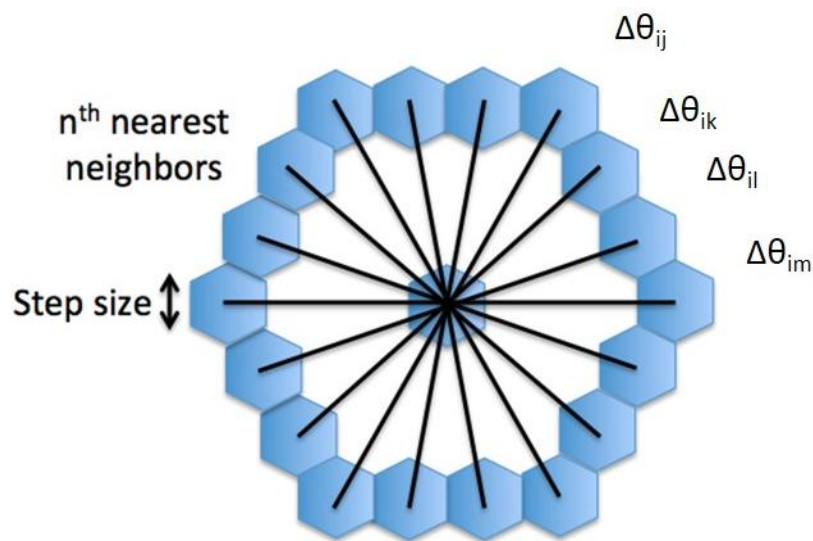
Figure 2. Kernel average misorientation (KAM) parameter used to characterize the accumulated plastic strain by monitoring the local orientation gradients [15].

For metallographic purposes, conventional mechanical polishing up to 0.25 μm was applied with OPS (oxide polishing suspension), followed by electropolishing with A2 Struers® electrolyte (Maassluis, The Netherlands, 2011) with a voltage of 39 V and a flow rate of 9 for 15 s. Orientation contrast scans were carried out in a selected region around the crack tip with an EDAX-TSL® EBSD tool (EDAX Inc., Draper, UT, USA, 2012) attached to an FEI Quanta 450™ field emission gun (FEG)-SEM. Several grids with step sizes ranging from 0.3 to 2.0 μm were applied. The kernel average misorientation (KAM) parameter was considered as a measure of local orientation gradient. This parameter is calculated by considering for each pixel the average misorientation with the Nth neighbouring pixels (neighbouring pixels for which the misorientation exceeds 5° are not included in the average). Only the perimeter points of the kernel are included in the procedure (cf. Figure 2). The misorientation cut-off θ_c was set to 5° , as it is assumed that misorientations of more than 5° originate from grain boundaries, and were not induced by (micro-)plasticity around the crack tip.

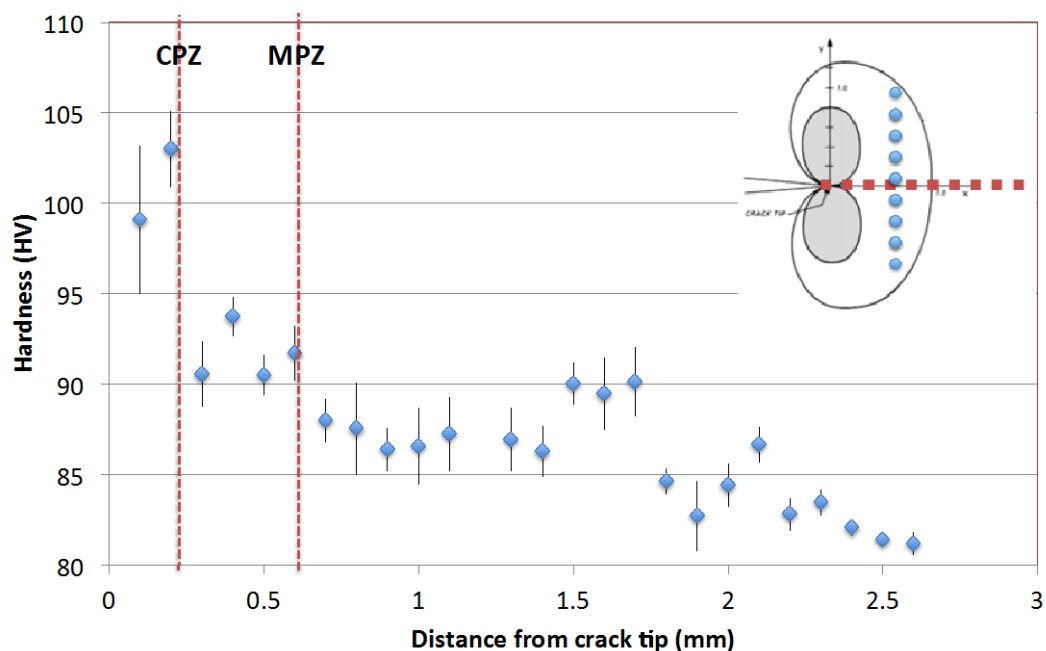
Figure 3. Vickers Hardness (Hv) values along a line in the extension of the crack tip. Each data point is the average of ten data points along a line that is perpendicular to the crack tip (cf. insert). CPZ: cyclic plastic zone; MPZ: monotonic plastic zone.

Figure 3 presents the hardness data along a line that extends along the crack tip. Each data point is the average of 10 data points along a line that is perpendicular to the crack tip (cf. insert in Figure 3). Based on these data, the plastic zone size was determined visually by two drops in Hv values, indicated by the vertical lines in Figure 3. It must be noted that $H_v = 85 \pm 2$ is the hardness of the unstrained or base material. Vickers microhardness measurements indicate an MPZ and CPZ size of ~ 0.6 mm and ~ 0.2 mm, respectively (cf. Figure 3).

Vickers microhardness measurements indicate the MPZ and CPZ size of ~ 0.6 mm and ~ 0.2 mm, respectively (cf. Figure 3). These values are in reasonable agreement with the theoretical estimated values of MPZ and CPZ size of 0.53 mm and 0.13 mm, respectively, as derived from Equation (1) with $K_{max} = 5.62 \text{ MPa } \sqrt{m}$ and $C = 1.17$ [3], whereby $CPZ = (1/4) * MPZ$ [4].

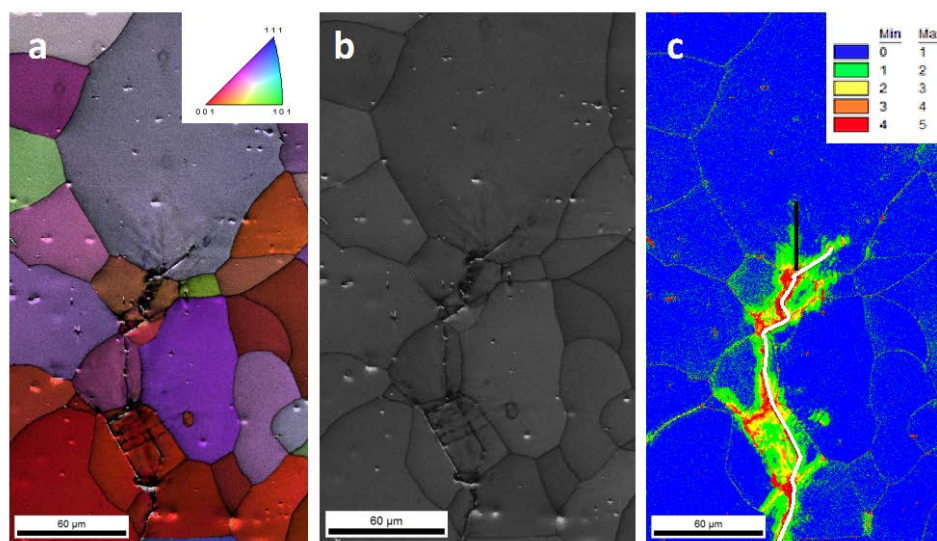
Figure 4. Electron backscattered diffraction (EBSD) scan of the crack tip region: (a) Inverse pole figure map; (b) Image quality map; and (c) KAM map (colour legend in degrees).

Figure 4 shows the orientation contrast scan of the crack tip area. In the inverse pole figure map of Figure 4a, it can be observed that the crack is predominantly of a transgranular nature. The scan also shows that there are many particles in the microstructure, which is normal for this type of aluminium grade alloyed with Si and Mg. It appears that the crack path morphology is affected by these particles. A similar phenomenon was observed in a previous study of cast iron with the graphite particles embedded in a pearlitic metal matrix during thermo-mechanical fatigue (TMF) testing [16]. Similar to the cast iron case, in the current material under investigation, the crack deviates towards the particles that exhibit a characteristic stress field. The tip of the crack splits in two branches; the one on the right-hand side (marked in white in Figure 4c) is more pronounced, whereas the one on the left-hand side (marked in black in Figure 4c) is less developed but appears to exhibit some deformation lines perpendicular to the crack path (cf. image quality (IQ) map of Figure 4b). However, it seems that this branch of the crack was stopped by a particle in its front.

The misorientation corresponding to the plastic zone at the crack tip—as revealed by the KAM parameter—is shown in Figure 4c. This map suggests a plastic wake size of less than $30\ \mu\text{m}$, which is much smaller than the size obtained from the hardness measurements and theoretical calculations as mentioned above. Therefore, this can suggest that the magnitude of strain in the plastic zone is not high enough to be gauged with EBSD. Hence, the following experiment was performed to determine if the noise dominates the misorientation maps for strain levels below a critical threshold.

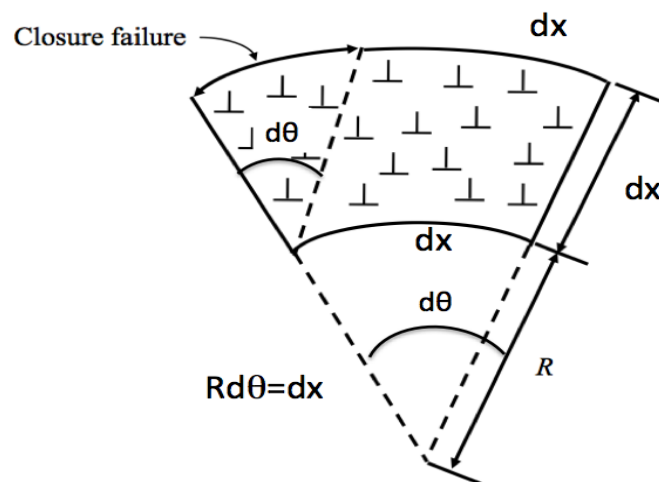
Figure 5. Schematic representation of a one-dimension lattice curvature, inducing a shear strain $d\theta$ [7].

The Nye tensor connects the density of GNDs to the lattice curvature tensor. In a simplified one-dimensional (scalar) representation assuming only parallel edge dislocations of the same sign, this tensor relation can be expressed as (cf. Figure 5) [7]:

whereby κ is the lattice curvature $d\theta/dx$, ρ the density of GNDs, and b the Burgers vector. On the simplified lattice geometry of Figure 5, it can be seen that the curvature $\kappa = 1/R = d\theta/dx$. In a discrete representation, the local $d\theta/dx$ value can be approximated as $\Delta\langle\theta\rangle/\Delta x$, whereby $\Delta\langle\theta\rangle$ is the local average misorientation as quantified by the KAM parameter in an EBSD measurement and Δx is the distance over which the misorientation is evaluated.

Figure 5 equally shows that the shear strain $\tan(d\theta) \approx d\theta$ is approximately equal to the local lattice misorientation $d\theta$ in the approximation of very small (shear) strains. If it is assumed that the angular resolution limit of EBSD is approximately equal to 1.0° (0.0174 rad), then this corresponds to a plastic shear detection limit of $\sim 1.7\%$.

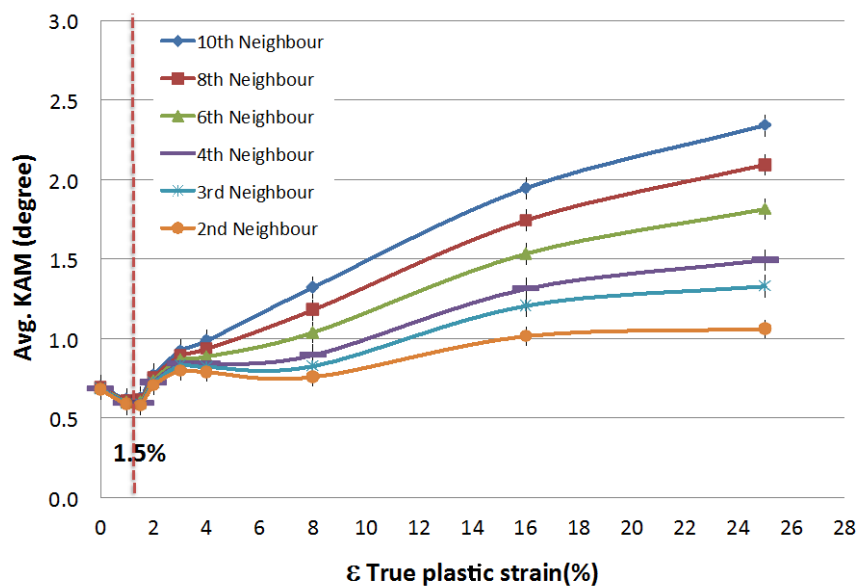
Figure 6. Average KAM parameter vs. true strain observed in tensile experiments. The KAM parameter was evaluated for different values of nearest neighbours.

A plastic strain was applied to a tensile test sample of the same aluminium alloy with tensile strains ranging from 1% to 25% at fracture. Orientation contrast maps were measured with a step size of $0.3\ \mu\text{m}$ on each of the tensile samples in four different locations (scanned area $200 \times 300\ \mu\text{m}^2$), and the scan average KAM value was extracted for each scan; thereafter, the average value and the standard deviation was determined for the set of four scans. The procedure was repeated for different values of nearest neighbours: 2nd, 3rd, 4th, 6th, 8th, and 10th nearest neighbours were considered. The dependence of the KAM value on the tensile plastic strain is shown in Figure 6.

According to the theoretical expectation, it was confirmed that no specific tendency could be observed up to a plastic strain level of $\sim 1.5\%$, indicating that the accumulated plastic strain at the crack tip is less than the detectable limit. For plastic strains exceeding the critical value of $\sim 1.5\%$, noise no longer determines the average KAM value, and there is an ascending correspondence between the KAM value and the plastic strain, which was also observed by Kamaya et al. [13].
