Structural glass: A new remedial tool for the consolidation of historic structures

Lida Barou ^a, Faidra Oikonomopoulou ^b, Telesilla Bristogianni ^a, Fred Veer ^b, Rob Nijse ^a

Keywords: Structural glass, restoration, consolidation, materiality, transparency, reversibility, compatibility, aesthetics

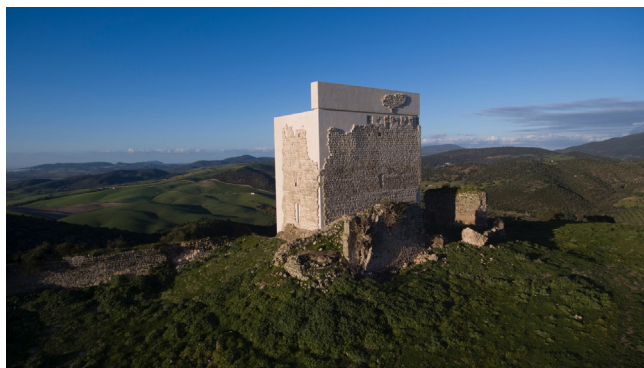
Figure 1a. The restoration of Martera Castle in Cádiz (Spain) has raised a big debate regarding the consolidation strategy, questioning whether the new limestone structure appears imposing on the remaining historic materials (Architizer 2015)

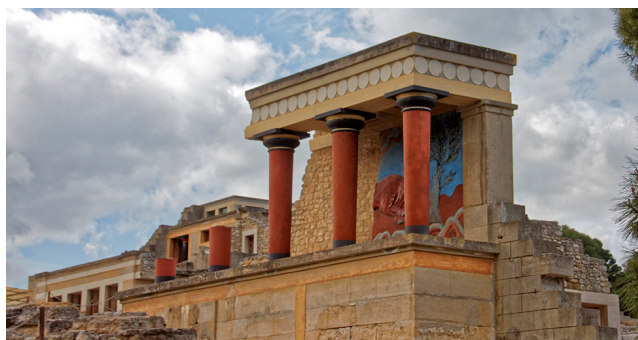
Figure 1b. The restoration of Knossos Palace in Crete (Greece) is debatable as a lot of assumptions were made misinterpreting the original composition, which was recreated in the archaeologist's (Sir Arthur Evans) own modernist vision (Dewaele 2015).

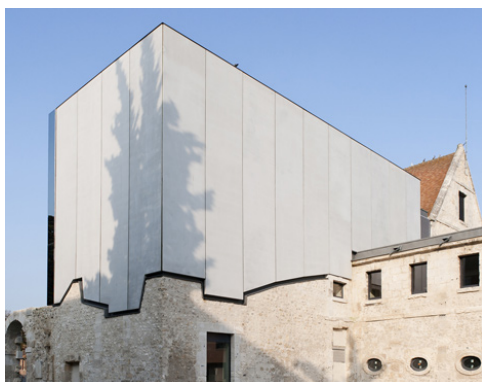
Figure 2a. The new façade of Louvoiers Music School (France) was restored using prefabricated reinforced concrete panels, cut out to follow the surface of the historic masonry showing the distinct boundary between the old and the new (Dent 2012).

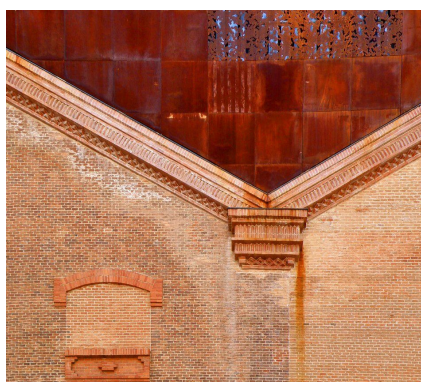
Figure 2b. The restoration of Caixaforum in Madrid (Spain) uses cast iron façade tiles to match the brick walls (CIRCARQ 2013).

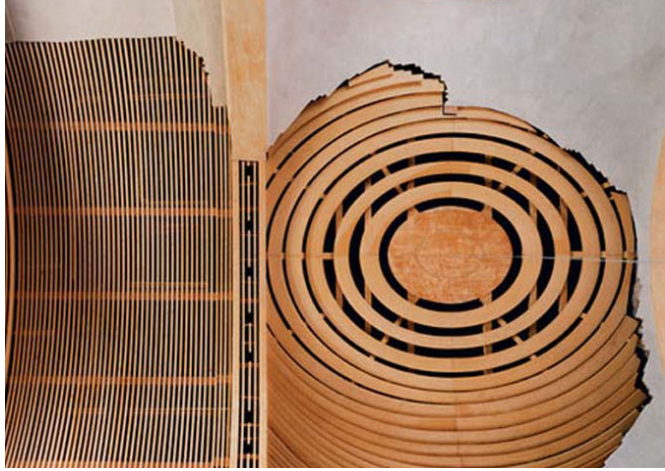
Figure 2c. The new roof of San Filippo Neri in Bologna (Italy) uses wood, a traditional material, in a rather contemporary way to preserve the outline of the collapsed part due to Second World War bombings (wegstudio 2018).

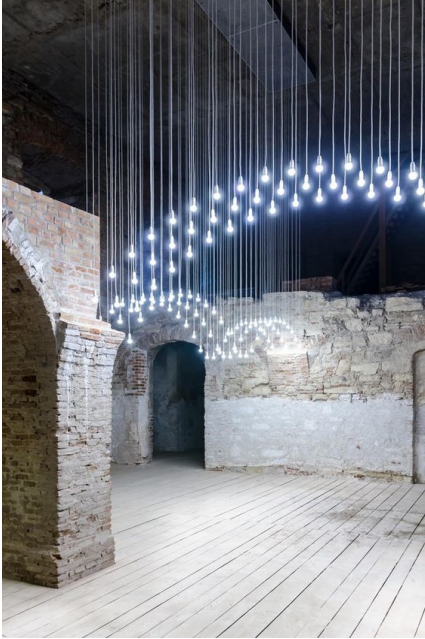
Figure 3a. "Reframe" illuminates the distinctive missing structural features of the interior of a castle in Romania (Fleşeriu and Eszter 2016).

Artistic restorations and repairs show a trend towards transparent means in order to complement the original volumes and express the “authentic image” without imposing on it. One way to generate transparency is to give the outline of the general shape of the missing object using frameworks (Fig. 3a and b). The Basilica of Siponto (Fig. 3d), by the Italian artist Eduardo Tresoldi (2017), is one of the finest examples of conceptual transparent restoration. The use of wire mesh in his works creates a material and immaterial result that tricks the eye, while this transparency “narrates shape and space of the absent matter as a representation of something that was there and then disappeared”. The other way to generate transparency is with the actual use of transparent materials, as in the case of the artist Tatiane Freitas, who repairs old wooden furniture with acrylic elements to fill the form and give a simultaneous perception of its original and current state (Fig. 3c). Thus, inspired by artists, such ambiguous solutions could also be the answer to the current materiality dilemma, between restoring and preserving, by using materials, which appear existent and non-existent, visible and invisible.

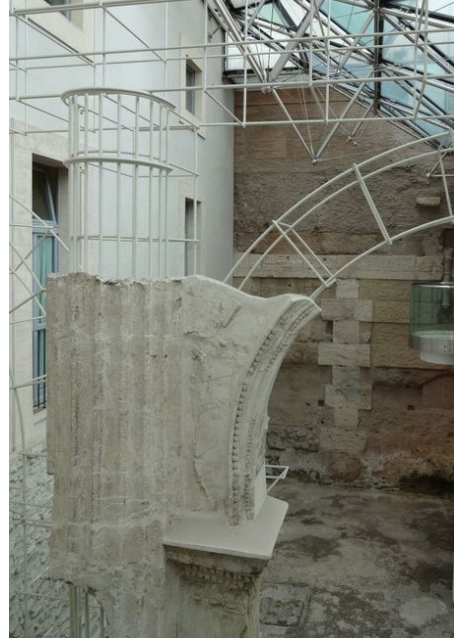
Figure 3b. Crypta Balbi's structural elements are restored with metal mesh (Rome, Italy) (Marigliani 2014).

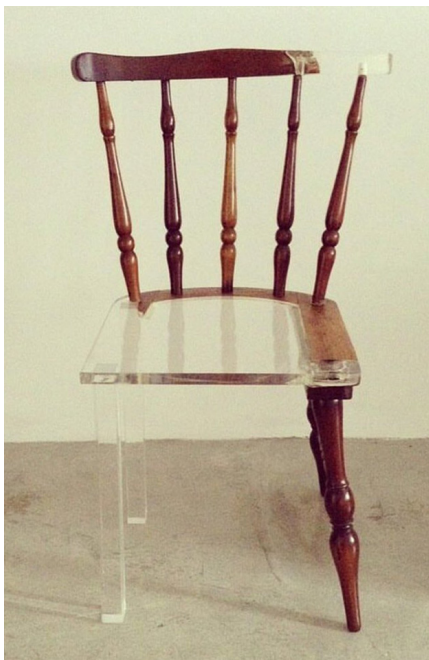
Figure 3c. "New old chair" series by Tatiane Freitas using Plexiglas to repair broken wooden furniture (Freitas 2010)

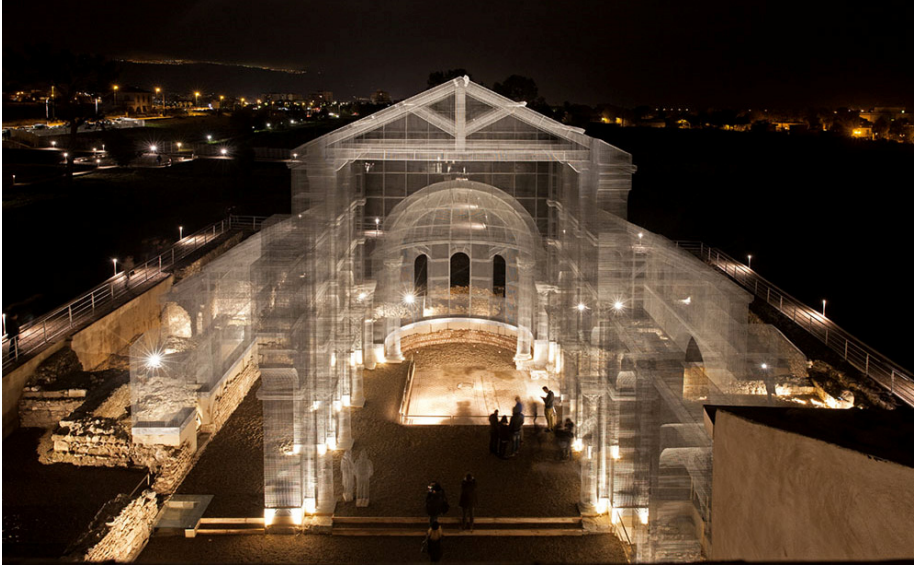
Figure 3d. Artistic restoration of Basilica of Siponto (Italy) by Eduardo Tresoldi using wire mesh to revive the memory of the ruins (Tresoldi 2016).

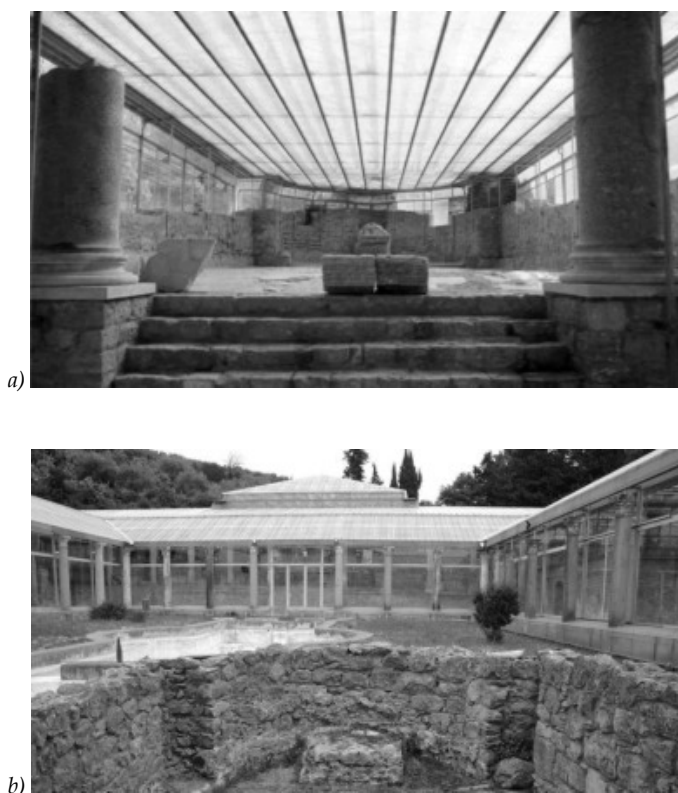
Figure 4. Restoration of Villa Romana del Casale in Piazza Armerina (Sicily) with a suspended transparent canopy made of glass and Plexiglas by F. Minissi (Vivio 2014)

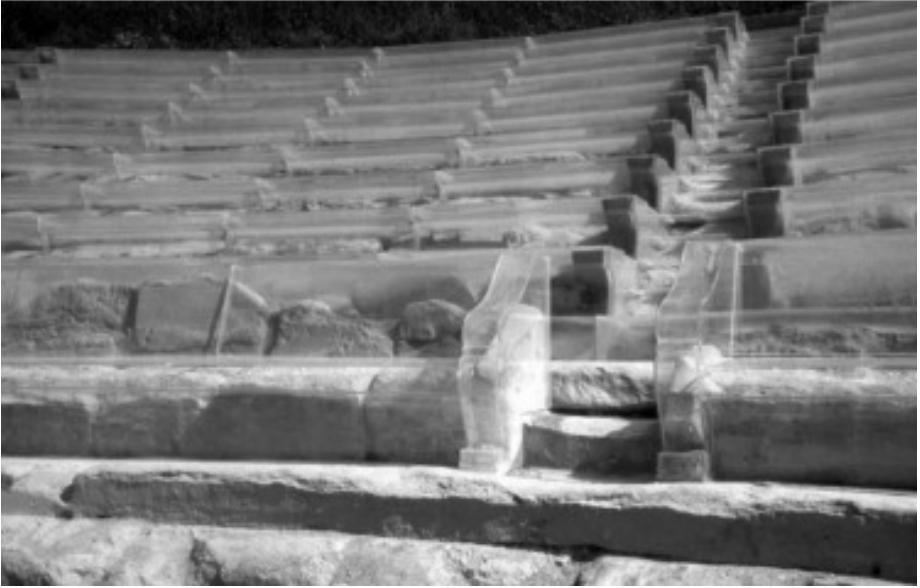
Figure 5. Restoration of the Theater of Heraclea Minoa (Sicily) by F. Minissi. Plexiglas is used to revive the original shape of the seats (Vivio 2014).

While from a conservation engineer's perspective, glass has a lot to offer as a durable restorative material, its most valuable contribution to the conservation practice lies in its transparent nature. Restoring a damaged building by glass is the closest action of not restoring it at all; all traces of history are free to narrate their own story as "wounds that are healed but not hidden" (Frigo 2017, p. 25). In this context, glass is an honest material and acts as complementary and contrasting; it "bears the contemporary stamp" as suggested by the Venice Charter (ICOMOS 1964) and does not falsify the historic evidence. Furthermore, through transparency, the monuments are related in a direct and honest way to their surroundings; the present setting and the way it has been shaped through the passage of time is what reflects their importance and values their cultural significance. Transparency can relate the structure to both its past and present setting, as it allows us to perceive the original volumes and, at the same time, the patina and natural ageing of our heritage, highlighting its unique and absolute character (Fig. 5).

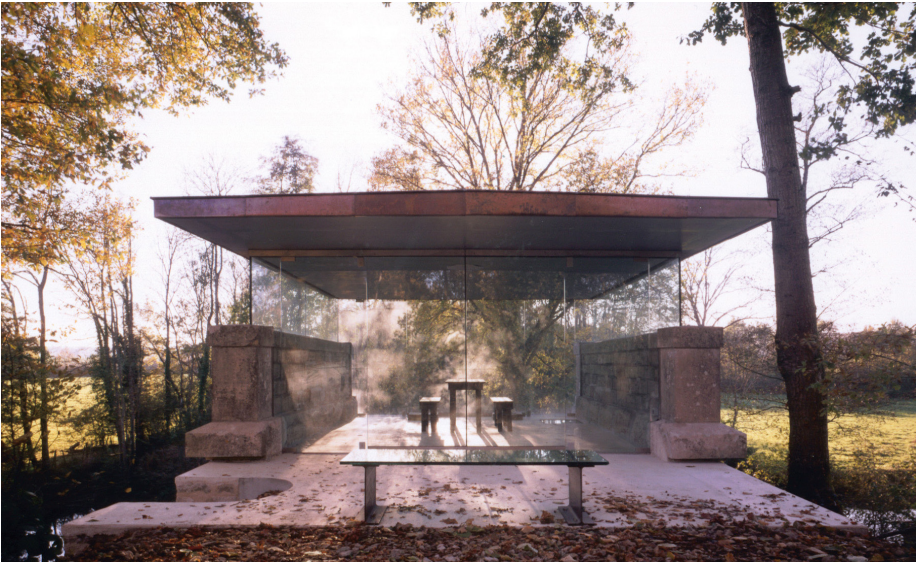
Figure 6. The temple de l' amour II in Burgundy (France) uses glass plates of minimal thickness to carry the compressive loads of the roof creating a full panorama (Kraaijvanger 2018).

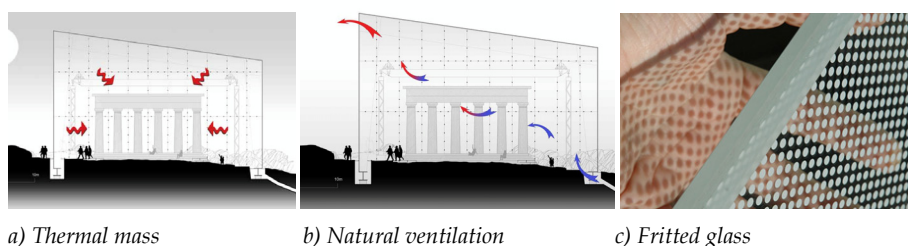
a) Thermal mass b) Natural ventilation c) Fritted glass
 Figure 7. Passive climate strategies suggested for the design of a glass canopy to protect a Greek temple (Oikonomopoulou 2012)

considering the orientation of the glass structure, passive ventilation solutions and coatings on the glass surfaces to improve the thermal performance (Fig. 7b and c) (Oikonomopoulou 2012, p. 95). On the other hand, the historic masonry walls have high thermal inertia, able to store heat and resist against temperature fluctuations (Fig. 7a). This facilitates the use of glass if the ratio between the glass and the existing surface remains balanced.

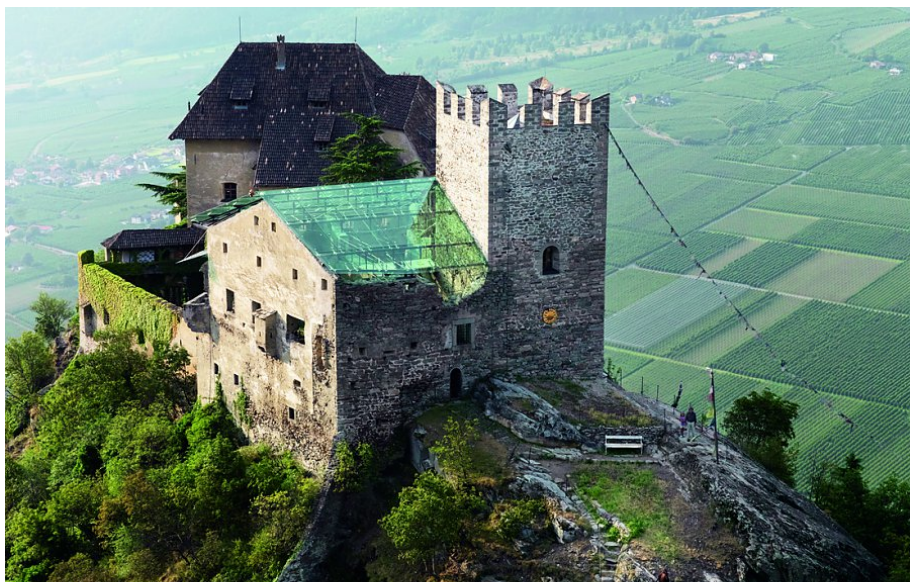
Figure 8. The glass roof of Juval Castle in Italy is and will remain a very distinct element of the historic setting in the future (Schittich, Staib et al. 2007)

Glass is not only durable because it provides an excellent resistance against the elements and protects the sensitive historic fabric against weathering; more importantly, it is durable because it is legible over the years following a completely different decay pattern which distinguishes it from the existing materials and testifies its era (Fig. 8).

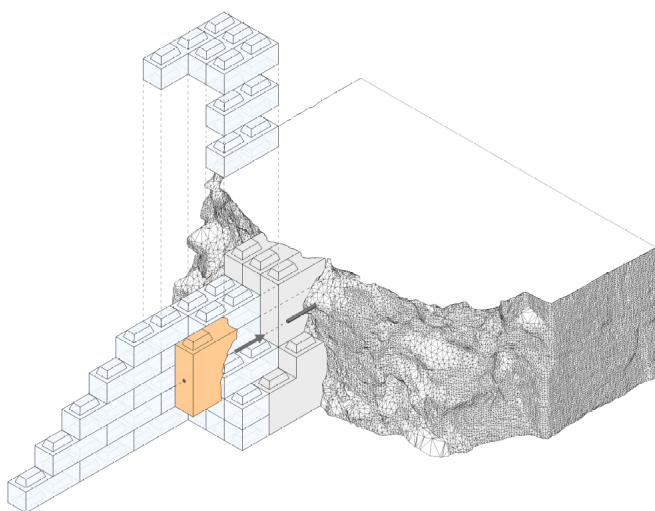
Figure 9. Demountable connection of an interlocking cast glass masonry, employing prefabricated interlocking elements, anchored to the existing historic structure with steel pins. The design was developed by the authors in the context of the 3TU.Bouw project “Restorative Glass”.

The aspect of reversibility/retreatability of a restoration technique addresses the potential for future treatment of the monument (Teutonico et al. 1997 and van Balen et al. 2005, p. 784) and lies in the connections between the structural elements. When it comes to glass three are the possible ways to achieve this: with adhesive, mechanical (bolted) or embedded connections, followed by glass welding which is not applicable in building construction yet. Due to maintenance and ease of replacement of damaged parts, mechanical and embedded connections are preferred compared to adhesives, offering the advantage of reversibility. In the context of restoration, adhesive bonding between the glass elements could be selected if maximum transparency is preferred, however, the connection to the historic materials should be achieved in a reversible way with dry connections, mechanical joints or soft interlayers (Fig. 9). Current restoration treatments

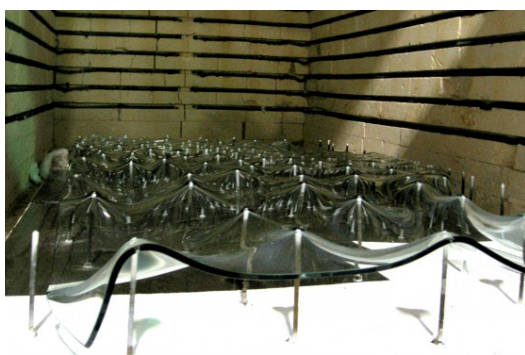
Figure 10a. Slumped glass is produced by heating up float glass to its softening temperature so that it can bend along a patterned mold (BaseHEIGHT 2017)

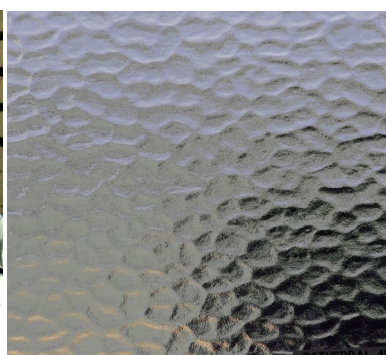
Figure 10b. Rolled-plate, figured or "Cathedral" glass is formed between two rollers, one of which carries a pattern (<http://www.bowralglass.com.au/patterned-glass>)

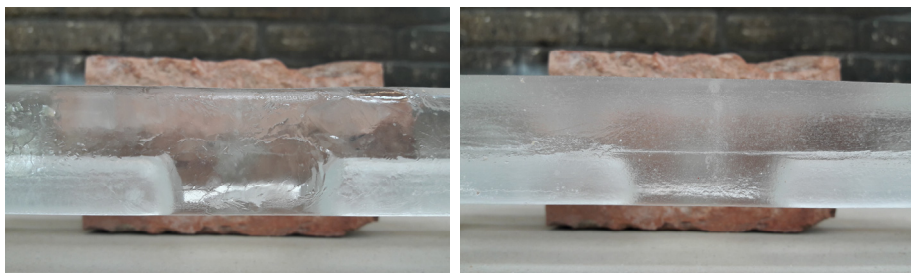
Figure 10c. Cast glass is produced by heating up the glass to its melting temperature and have it poured in a mold. Depending on the mold quality a more hazy or glossy result can be attained (Barou 2016).

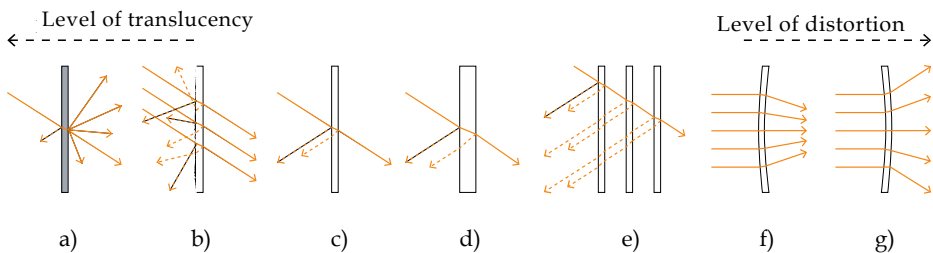
Figure 11. Degrees of optical illusions related to the surface treatment, geometry and configuration of the glass elements: a) Translucent surface diffuses the light and allows for a perception of the surroundings in a certain distance, b) Textured surface allows for the perception of the surroundings with limited clarity, c) Thin flat glass has the maximum level of transparency and minimum distortion, d) Thick cast glass has a little lower level of transparency compared to thin glass, e) Configuration with multiple layers can create a great number of reflections distorting the perceived image, f) Convex curved glass results in barrel distortion of the perceived image and g) Concave curved glass results in pincushion distortion of the perceived image.

can transmit, absorb and reflect the light, the more the layers the greater the optical illusions (Brzezicki 2017). This phenomenon is evident in cavity geometries, such as hollow glass, where the double panes create more reflections and alter the perceived image, or alternatively, in the overall configuration of the structure. A monolithic cast glass wall would create less distortion than a wall of the same thickness comprising of fins and plates under certain angles of view; the more the overlapping elements, the greater the optical phenomena (Fig. 11).

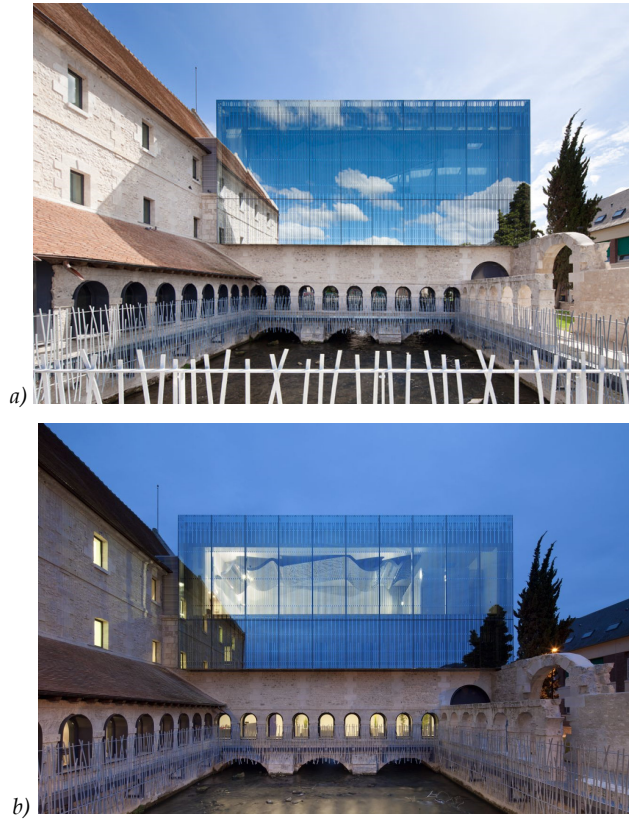
Figure 12. Louviers Music School glass façade creates different perception of the space depending of the time (Dent 2012).

Since the term “transparent” expresses the property of “permitting the uninterrupted passage of light” (British Dictionary), the lighting and viewing conditions can influence the transparency of glass. Depending on “the time of the day, the angle of the sun and the weather conditions glass can be both reflective and transparent” and “material transparency is converted into material opacity” (Blau 2010). This reflection could result either in a great asset, enabling the continuity of space or a great threat over a historic monument creating an overwhelming opposition and imposition. The function of the historic building after restoration treatments with glass is also crucial as it determines its principal character and interaction with the visitors. In the case of Louviers Music School’s extension in France, the mirror finish of the new glass façade appears discreet during the day, reflecting its surroundings and allowing for space continuity and turns transparent during the night exposing its interior (Fig. 12a and b). However, most of our historic settings are visited during the day and under, sometimes, extreme daylight conditions. Too many reflective surfaces would create disturbance in our eyes, without being able to focus, as glass would prevail over the historic materials. Contrast is acceptable and encouraged for new materials as an evidence of the era, but at the same time, demands critical thinking taking all the variables into account.

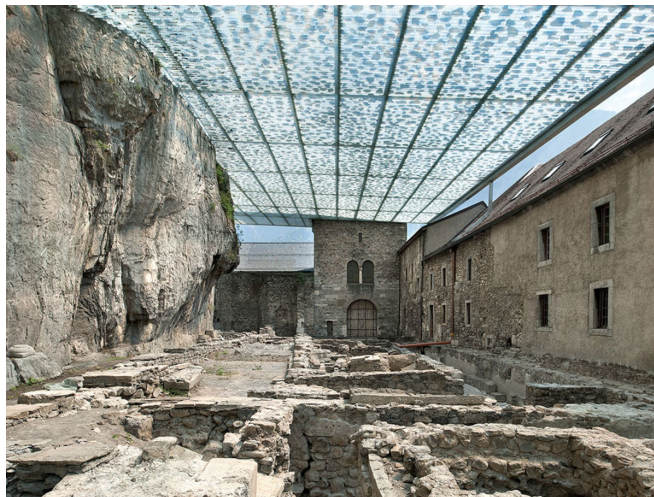
Figure 13a. Canopy on top of St. Maurice Abbey archaeological site (Detail Daily 2012)

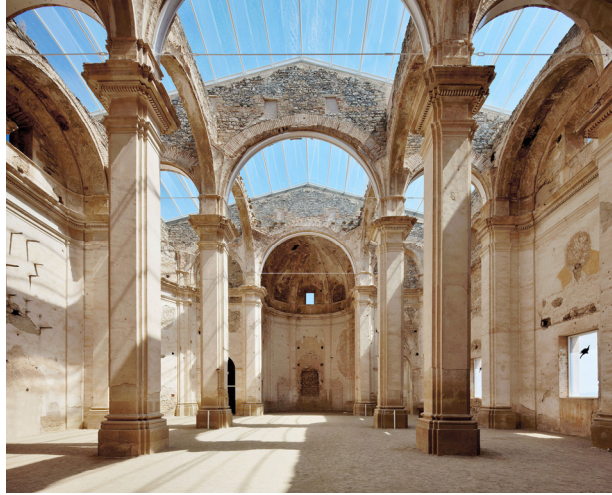
Figure 13b. Restoration of the church of Corbera d' Ebre (Ferrán Vizoso Architecture 2017)

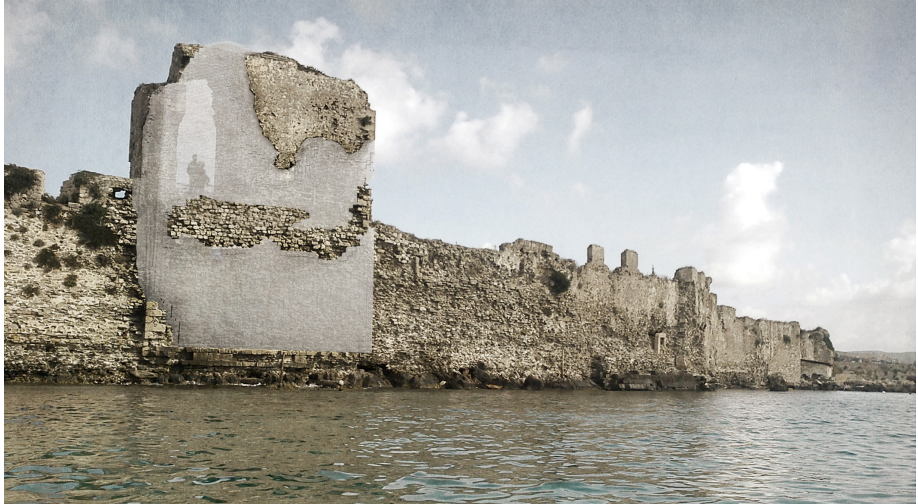
Figure 14. Restoration of the Bembo's Bastion by a glass masonry that consists of interlocking cast glass units. The glass structure fills the missing parts that have collapsed and completes the original shape of the tower (Barou 2016).

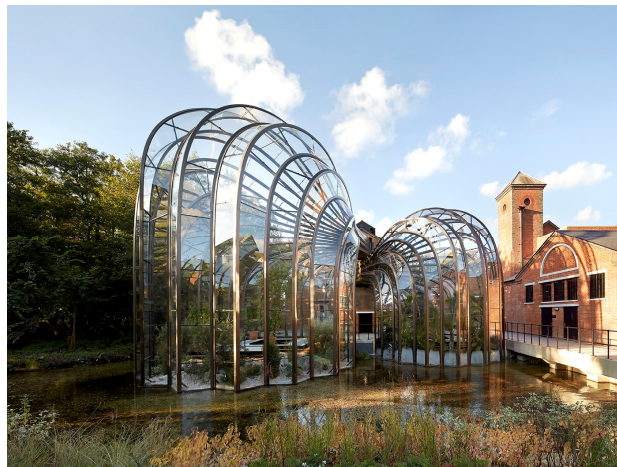
Figure 15a. Bombay Sapphire Distillery glasshouses extension in Whitchurch (United Kingdom) (Arkitecture 2015)

Both the cases of Bombay Sapphire Distillery and St. Francis convent show the potential of glass in extension structures that can completely transform a historic building (Fig. 15a and

b). The former intervention accommodates two glasshouses that recycle the waste heat coming from the distillation process, while the latter accommodates a new entrance for the convent, which is converted into an auditorium. Both structures introduce abstract contemporary forms that relate to the adjacent buildings in a distinct but harmonic way.

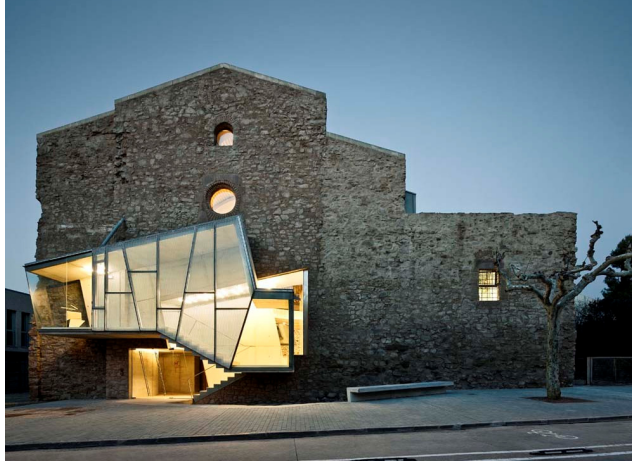
Figure 15b. The contemporary glass entrance of St. Francis convent in Catalonia (Spain) (Frearson 2012)

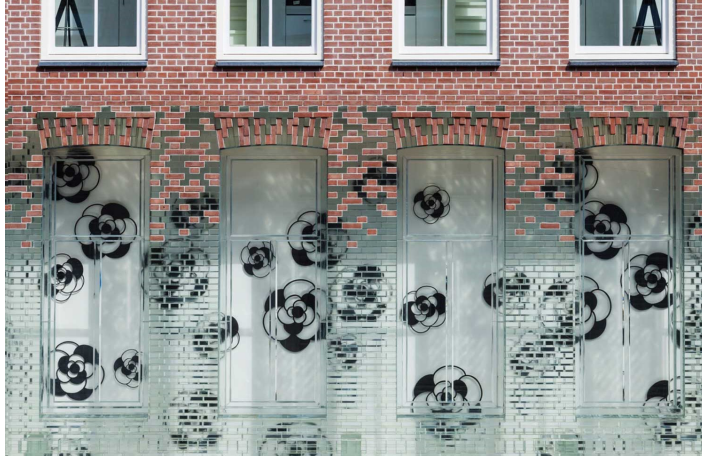
Figure 16. Detail of the Crystal houses façade in Amsterdam (The Netherlands) showing the transition of the glass-to-brick masonry with respect to the original construction technique (<https://www.archdaily.com/tag/prix-versailles>)

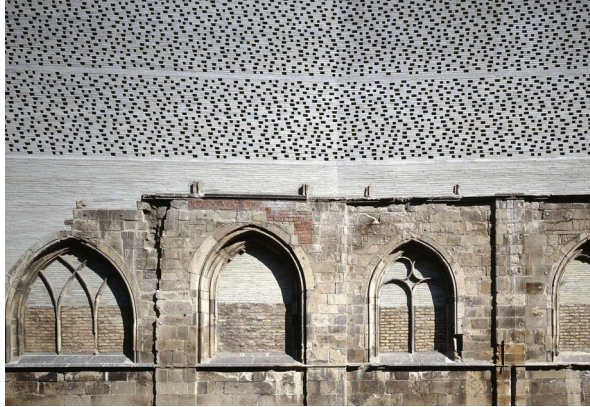
Figure 17b. The restoration of Kolumba Church, originally built in the 14th century AD, by Peter Zumthor in Cologne (Germany) follows a more abstract interpretation of the forms and materials (<https://www.stylepark.com/en/petersen-tegl/k51>).

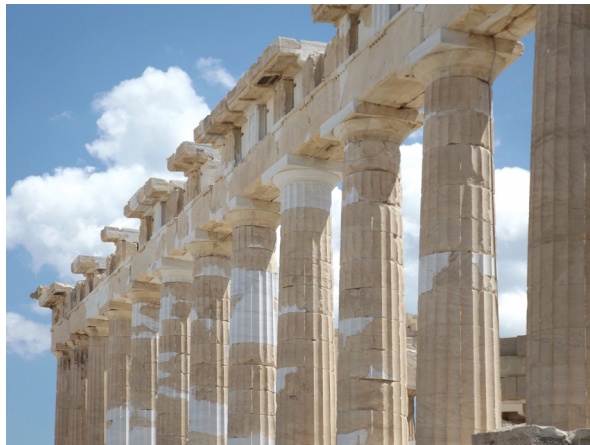
Figure 17c. Parthenon in Athens (Greece), built in the 5th century BC, is restored with the traditional technique of anastylosis in order to preserve the exact original shape and material (Barou 2016).

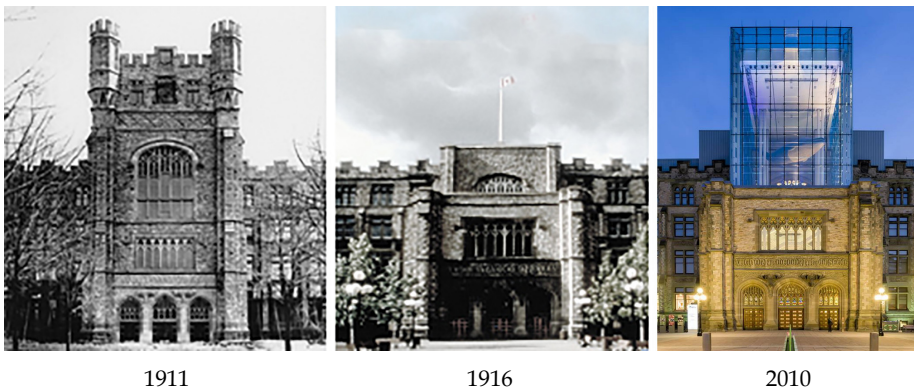
Figure 18. The original tower of the Victoria Memorial Museum in Ottawa had to be removed due to unstable soil conditions and its massive weight and was replaced by a glass tower after the rehabilitation of the monument into the Canadian Museum of Nature in 2010 (<https://nature.ca/en/about-us/history-buildings>).

proportions without details of the workmanship or the construction techniques (Fig. 21a). Interventions aiming to the protection of historic materials, as well as those that give a new adaptive character to the monuments can tolerate a higher degree of freedom for the design of the new glass structure. Solutions with abstract forms are a rather suitable approach as an indirect treatment, which can safeguard our built heritage and simultaneously stand out as iconic additions. The glass shell of the Canadian Museum of Nature stands for the memory of the original part in a completely contemporary form, which respects, however, the original volume and scale (Fig. 18).

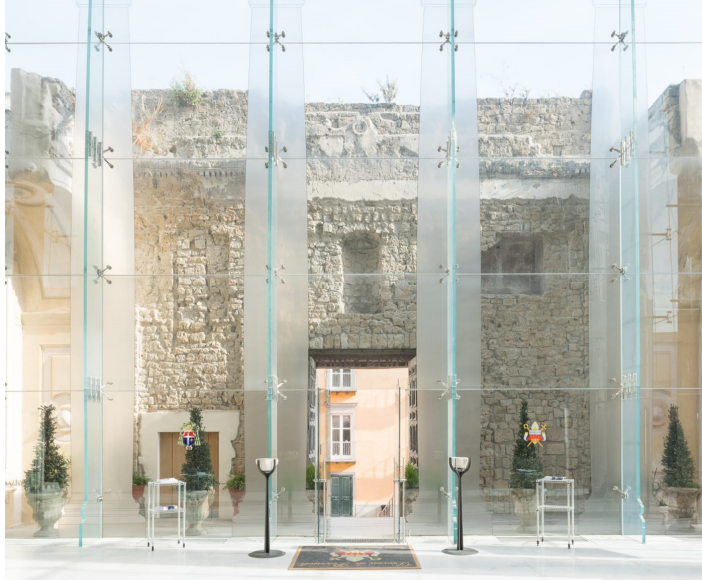
Figure 19a. The ruins of the Augustan Temple in Pozzuoli (Italy) are restored with a glass façade that consists of fins and plates outlining the shape of the original columns (Gnosis Architettura and Bardeschi 2017)

Abstract solutions with float glass can also be the answer for monuments of later eras in order to fill the form and strengthen the collapsed parts of a building. As glass is in close proximity to the historic materials, the new design should preserve the rhythm and aesthetic quality of the existing one in a harmonic coexistence. Float glass can be articulated in a way to follow the grid and main lines of the historic structure either with the right dimensioning of the elements or the position of the substructure (Fig. 19a). Float glass is not only configured in fins and plates, horizontally or vertically stacked elements can create massive glass walls, which on the one hand may decrease the overall transparency, but on the other hand create a rather interesting and unique result, such as the case of the Magdalena's fountain adaptive restoration (Fig. 19b).

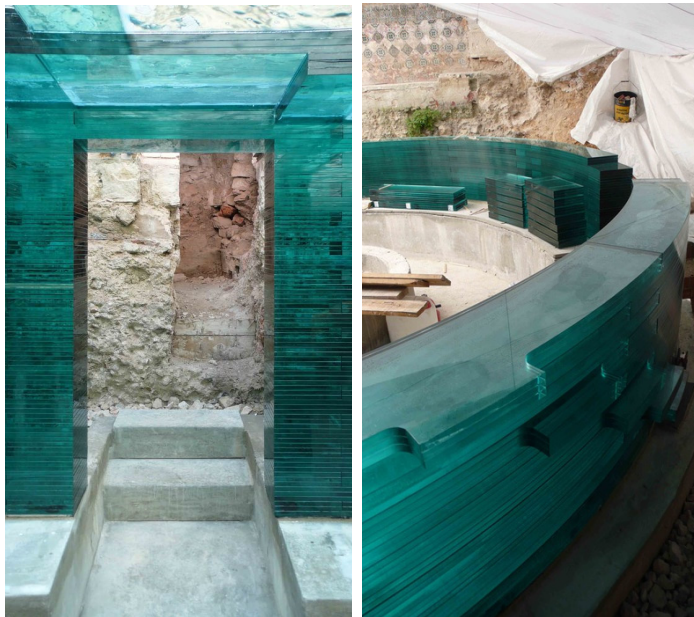
Figure 19b. The adaptive reuse of the Magdalena's fountain in Jaén (Spain) employing horizontally stacked float glass panels (Cuac Arquitectura 2018)

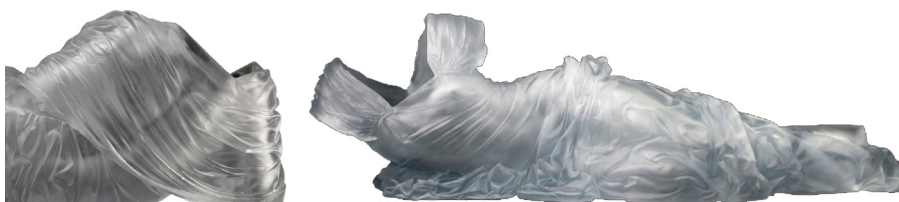
Figure 20. Glass sculptures, by the artist Karen La Monte, demonstrate the level of detailing that glass casting can achieve (La Monte 2007).

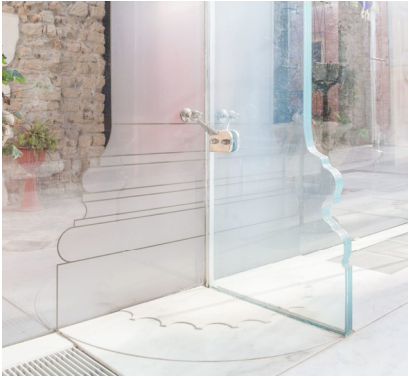
a) Float Glass

Figure 21. a) Abstract interpretation of Corinthian style column using float glass fins (Gnosis Architettura and Bardeschi 2017), b) Glass masonry that consists of interlocking cast glass units, developed by the authors for the 3TU.Bouw project “Restorative Glass” for the restoration of Lichtenberg Castle in Maastricht (Oikonomopoulou et al. 2017) and c) Hypothetical case of restoration of Gothic and Neogothic style bundled column with extruded glass tubes (Van den Broek 2017).

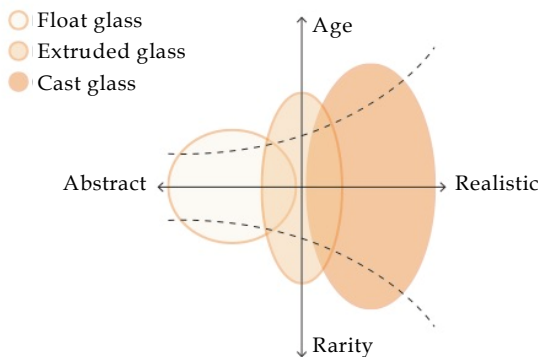
Figure 22. Relation of age and rarity of a monument to the restoration concept of an abstract or realistic approach and the range of applicability for float, extruded and cast glass respectively
