### **An assessment based on bow-ties**

Chemical Engineering Transactions

# Mechanical Integrity of Process Installations: an Assessment Based on Bow-Ties

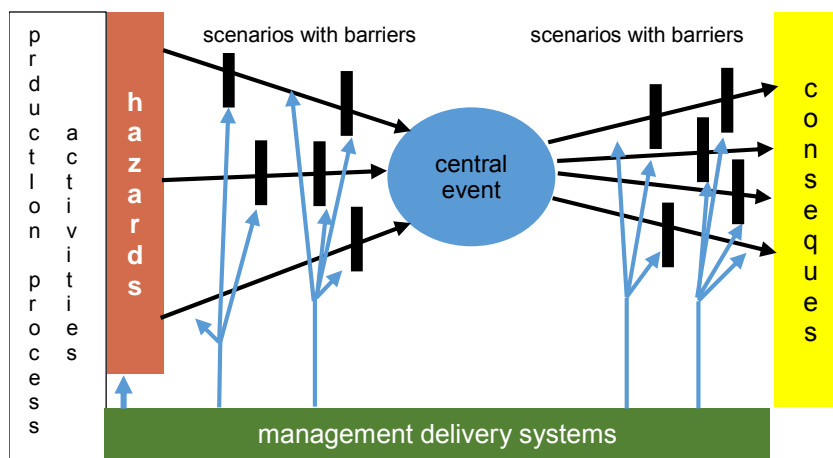
Figure 1: Bow-tie metaphor (Visser, 1998)

Bow-ties are appropriate and user-friendly for the mapping of scenarios (Chevreau et al., 2006, de Ruijter and Guldenmund, 2016). It is a metaphor for an accident process and shows the initiating event of a scenario, the consequences and the barriers that can stop the scenario from happening (Swuste et al., 2016). The simple, sequential design of bow-ties is strongly reminiscent of the 'Swiss cheese model' by Reason (1990) with the cheese slices as barriers. Figure 1 shows a bow-tie of which the explanation is included in a paper of Swuste et al., entitled "Process safety indicators, how solid is the concept?" and also published in the LP 2019 conference proceedings.

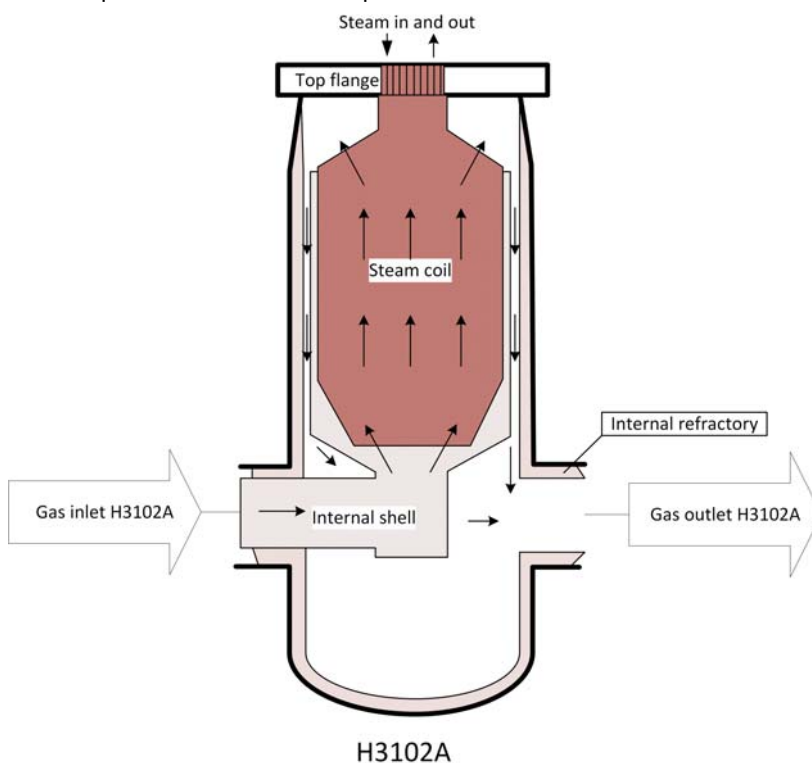
In the steam superheater, high pressure steam of 125 bar is superheated by means of hot process gas, which consists of about 35% hydrogen. The process gas decreases from 600 °C to 475 °C. Figure 2 shows the flow of the process gas which is led upwards via the internal heat exchanger and returns along the wall after which it exits on the right-hand side. The process gas that leaves the internal heat exchanger at the top passes the internal brickwork (refractory) that protects the outer wall against a too high temperature. Two time-related mechanical failure mechanisms have been identified, which can cause the steam superheater to fail catastrophically, i.e. a sudden, unstopable, total loss of the containment. In the case of damaged refractory,

the outer wall can be exposed to excessive heat for a prolonged period of time which may lead to creep (slow plastic deformation under the influence of stress and temperature) and Nelson hydrogen attack (diffusion of H-atoms into the metal causing methane to form stresses cracking).

Figure 2: Steam superheater

In case of refractory defects hot spots can occur on the outside of the wall. Although they can be observed visually during an operator round, they can easily be overlooked. The quality of the current detection and monitoring of the failure mechanism (D) is classified as poor. The internal refractory is inspected every four years during a turn-around. As indicated above, only minor defects have been found. This barrier is therefore qualified as good. In the current situation, the criticality C ( $P \times D \times B$ ) is equal to 24 ( $3 \times 4 \times 2$ ). The scenario must be provided with extra or improved barriers.

It appears that it is possible to provide this heater on the outside with indicator paint, which discolors on the hot spot due to the higher surface temperature where the internal refractory is no longer intact. Indicator paint reduces the chance that hot spots are overlooked. In addition, the outer wall can be provided with a number of temperature measurements that alarm at a high temperature. In case of a discolored indicator paint and / or one or more temperature alarms, the wall can be examined with an IR camera in order to determine whether a 'fitness for service' (FFS) analysis should be carried out. This should then indicate whether an inspection is necessary. The inspection should reveal the need for replacement or repair. If this procedure receives management attention, the quality of the detection and monitoring of the failure mechanism (D) can be regarded as good in accordance with equivalent procedures within the company. The procedure should not only be included in the safety management system but also contain some kind of management involvement when in use. In addition, the temperature alarms should not only raise an alarm in the control room but also be passed on to those who are responsible for the integrity and asset management. The criticality in the improved situation is 12 ( $C = P \times D \times B = 3 \times 2 \times 2$ ) and thus the scenario is sufficiently safeguarded. No additional barriers are required if the detection and monitoring are implemented as proposed above.

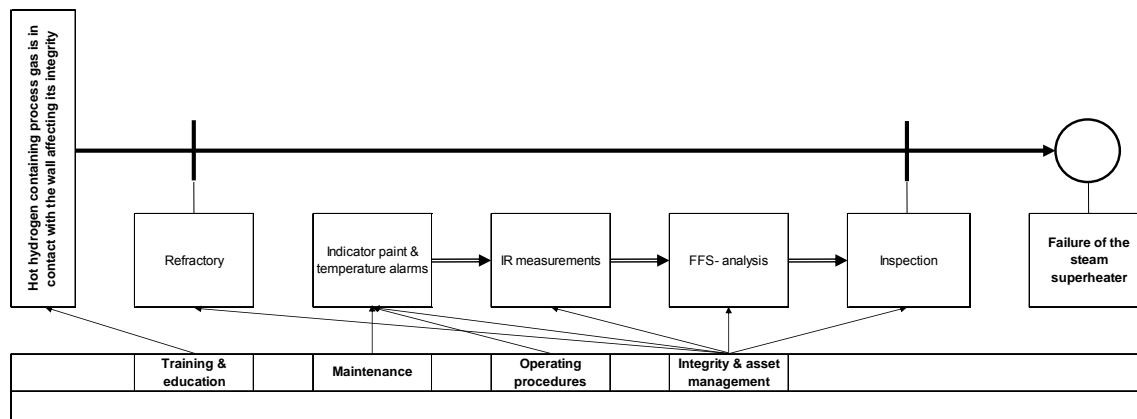
Figure 3 shows the bow-tie of the scenario with the newly implemented detection and monitoring. Together with the internal refractory, this forms a 1-out-of-2 system, that is to say that the scenario is provided with two barriers connected in series. The existing internal refractory is a technical barrier, whereas the proposed detection and monitoring of the failure mechanism is a non-technical, procedural barrier. The latter consists of a detection via the indicator paint, temperature alarms and IR measurement after which a procedure with management attention should ensure monitoring of the failure mechanism in the form of an FFS analysis and inspection. The temperature alarms can be seen as an 'early warning' regarding the failure mechanisms creep and Nelson hydrogen attack.

The figure below also shows which different departments or 'management delivery systems' support and maintain the various barrier components. The influence of the organizational factors on the barriers and how this influence can be monitored is beyond the scope of this research.

Figure 3: Bow-tie with regard to creep and Nelson hydrogen attack of the steam superheater
