Monitoring bolt tightness of rail joints using axle box acceleration measurements

Structural Control and Health Monitoring: the bulletin of ACS

M. Oregui¹, S. Li¹, A. Núñez¹, Z. Li^{1*}, R. Carroll² and R. Dollevoet¹

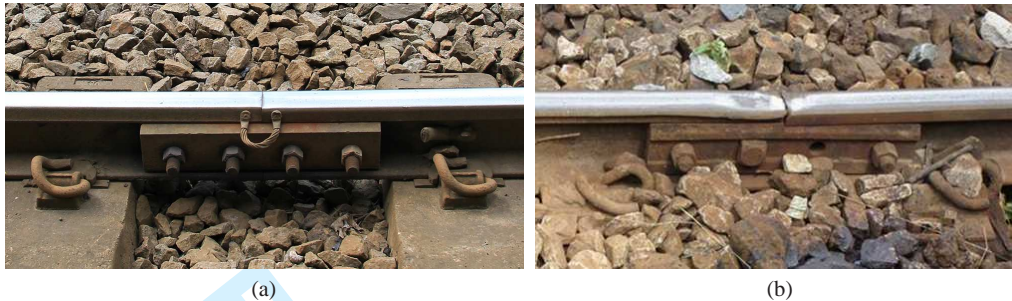
Figure 1. Two examples of rail joints: (a) invisible damage: loose bolts, and (b) visible damage: missing bolt and battered rail surface

Rail joints (RJs) are an important component in many railway networks worldwide; an example of a RJ is shown in Figure 1a. Although the use of continuously welded rail is nowadays more cost

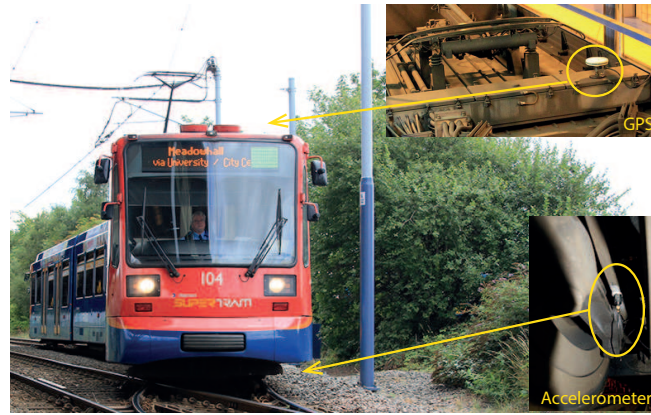
Figure 3. ABA system used with close-ups of the GPS antenna and an accelerometer

In this paper, the ABA system was mounted on a regular Supertram tram with resilient wheels in Sheffield (see Figure 3). Four accelerometers were mounted on the four axle boxes of a bogie to register acceleration measurement. The lower close-up in Figure 2 shows a sensor mounted on the Supertram bogie. The accelerometers are of piezoelectric type (MEMS), and have a range of $\pm 100g$, a frequency bandwidth of 30 kHz, and a sensitivity of 50 mV/g. The accelerometer chosen is suitable for railway application as a similar instrumentation has been under extensive test in The Netherlands for mainline applications (15).

The upper close-up in Figure 3 shows the location of the positioning GPS antenna on the tram roof. The speed signal was obtained from the meter cabinet of the tram. The accelerations, speed and position were recorded in a data acquisition system on-board of the Supertram test tram.

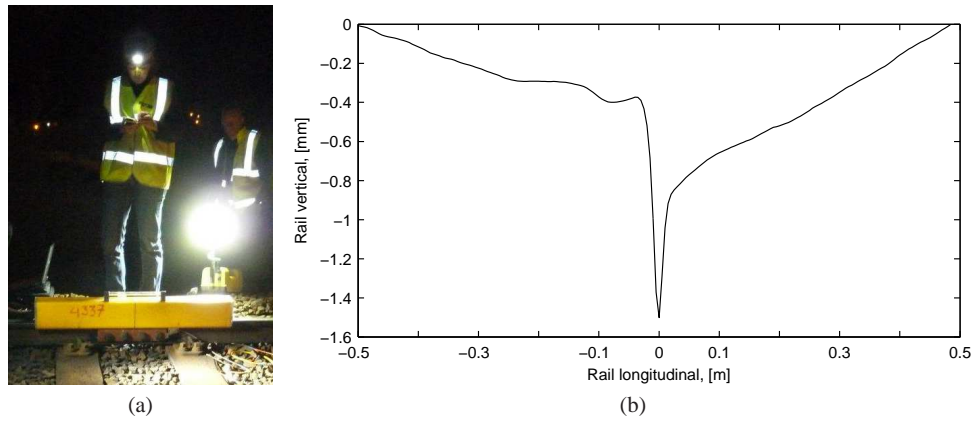
Figure 4. Rail vertical-longitudinal profile measurement: (a) field measurement and (b) a measured profile

Rail vertical-longitudinal profiles were measured using the Railprof measurement device (19), see Figure 4a. This measurement is used to better understand the condition of the RJs, specifically with respect to the status of the alignment of the rail ends.

Measurements of the rail profile at rail joints were taken every 5 mm along a length of 1000 mm. The accuracy is ± 0.03 mm, if the deviation between the first and last measuring point in a straight line is less than 0.5 mm. An example of rail vertical-longitudinal profile at a rail joint is shown in Figure 4b. The sharp deep indicates the location of the gap. In this case, the two rail ends are misaligned by 0.5 mm, whereas the amplitude of the rest of the waves observed is substantially smaller, i.e. approximately 0.1 mm. Thus, the misalignment is expected to influence the wheel-track response more significantly than the rest of the measured waves. Furthermore, from unloaded to loaded conditions, the dip of the rail joint could increase three times (2; 20). Thus, the discontinuity is significantly more prominent when the train is rolling over the rail joint than during the measurements with the Railprof.

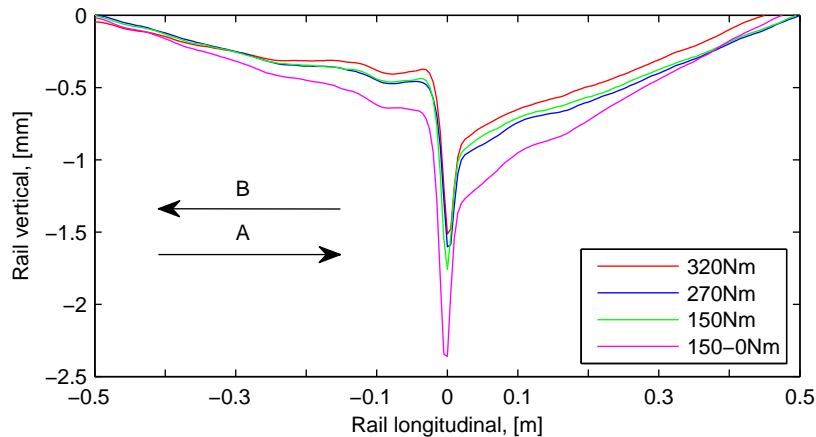
Figure 9. Measured rail vertical-longitudinal profile at the reference RJ for different bolt tightness conditions. Arrows indicate the rolling directions A and B.

39 The differences between the two traffic directions were further investigated by analyzing the
40 measured rail vertical-longitudinal profiles. Figure 9 shows that there was a misalignment between
41 the rail ends. The misalignment seems not compatible with the traffic directions because traffic
42 runs in both directions so that symmetric rail end geometry was expected. Rail end misalignment
43 was most probably caused by the field test, in which the reference RJ was reassembled one week
44 before the test, and during the test the tightness of bolts was changed from nominal value to being
45 completely loose. This misalignment is therefore a disturbance to the local track system, and is
46 causing impact between wheel and rail when the tram is traveling in the B direction. This impact
47 explains the difference between the two directions. Due to the impact, a significant amount of energy
48 concentrates at approximately 920 Hz when the wheel rolls from the gap to the end of the rail joint

in Figure 9, the misalignment increases if the bolts become looser, so that the impact between wheel and rail is larger and consequently, the energy concentrated at this frequency increases. The increase in energy concentration at approximately 920 Hz is observed by comparing from left to right the normalized global wavelet spectrum diagrams in lower row in Figure 8).

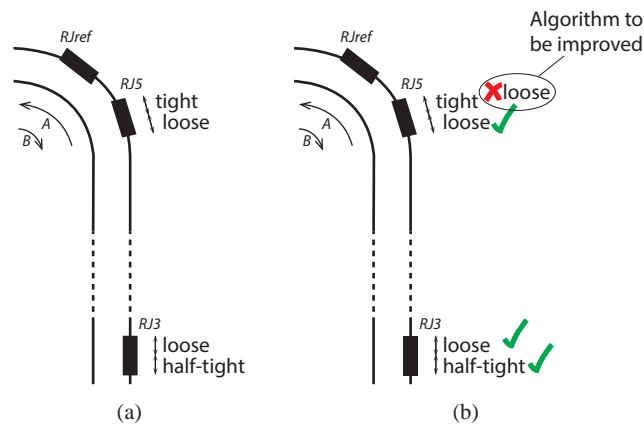
Figure 12. (a) Prediction and (b) Verification

The comparison between the prediction and verification is graphically shown in Figure 12b. The prediction for RJ3 and RJ5 agree with the verification for overall looseness condition of the rail joints. For each half of rail joints, the tightness prediction was correct for RJ3, but only for half of RJ5. Concerning misalignment between rail ends, no rail vertical-longitudinal profiles were measured at RJ3 and RJ5 for verification.

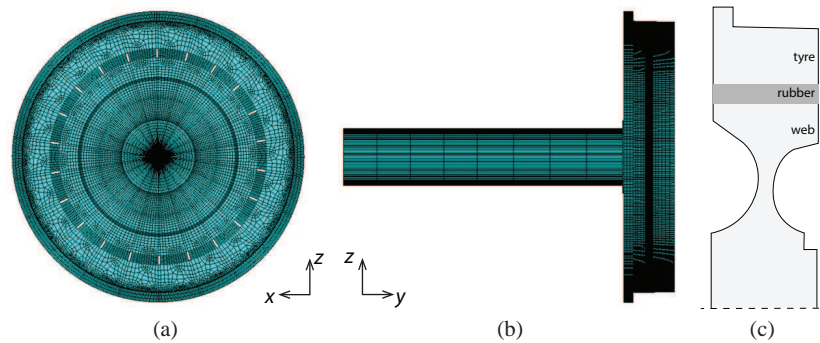
Figure 13. Finite element model of the resilient wheel and axle (a) front view, (b) side view, and (c) cross-section of the wheel.

The resilient wheel modes between 50 and 1200 Hz are shown in Figure 15, where the colors indicate the amplitudes of the vibrations. The modes are axle modes or wheel modes and within the wheel modes, they can be web modes or tyre modes (29). In the web modes, the web vibrates while the tyre barely moves due to the decoupling introduced by the rubber. In the tyre modes, the opposite happens. Further, the web and tyre modes can be classified as axial (i.e. out-of-plane deformation), radial (i.e. in-plane radial deformation) and tangential (i.e. in-plane tangential deformation) (29), where the in-plane is the xz plane, see Figure 13.
