## Recommendation of RILEM TC 243-SGM

### Functional requirements for surface repair mortars for historic buildings

## **Recommendation of RILEM TC 243-SGM: Functional Requirements for Surface Repair Mortars for Historic Buildings**

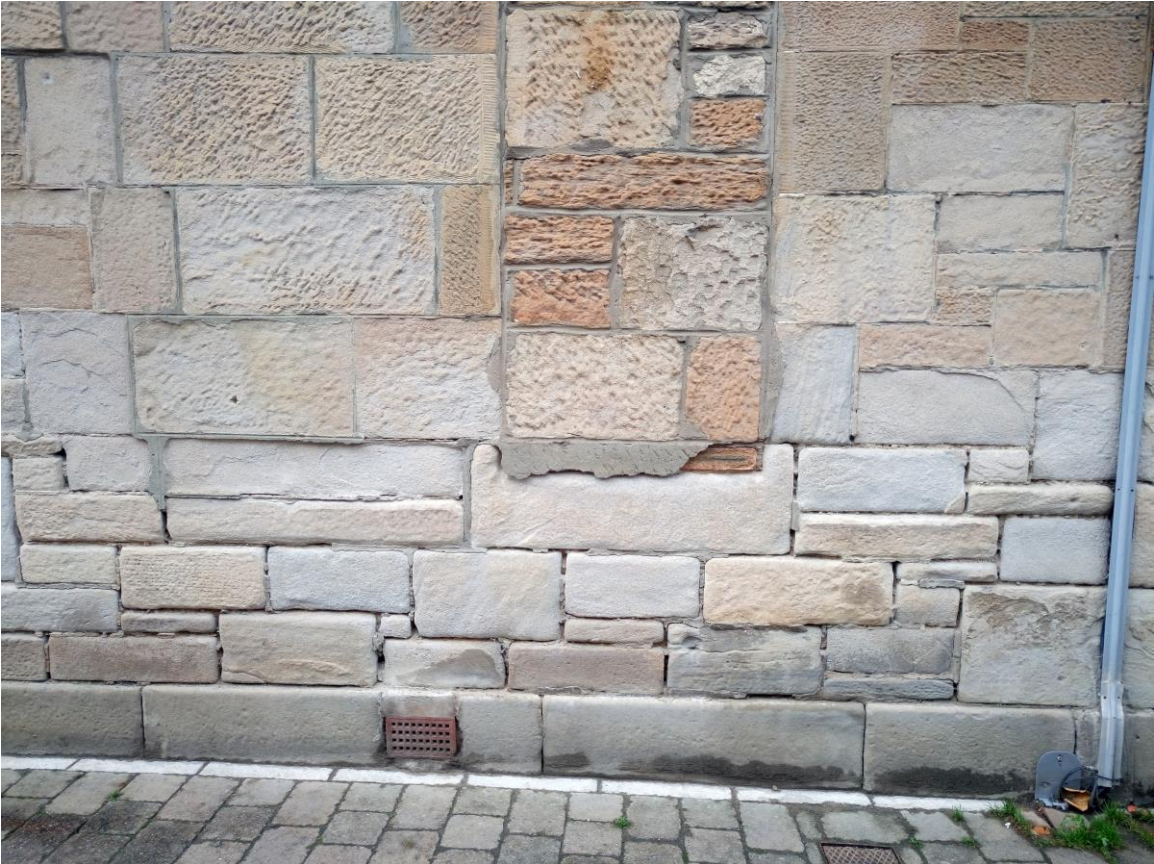
Figure 1: Advanced deterioration of a 19<sup>th</sup> century sandstone ashlar masonry façade in Bearsden, Scotland.

[10]. Fig. 1 shows the deterioration of an exposed sandstone façade; Fig. 2 shows an application of mortar to repair individual stone surfaces on a building in Glasgow.

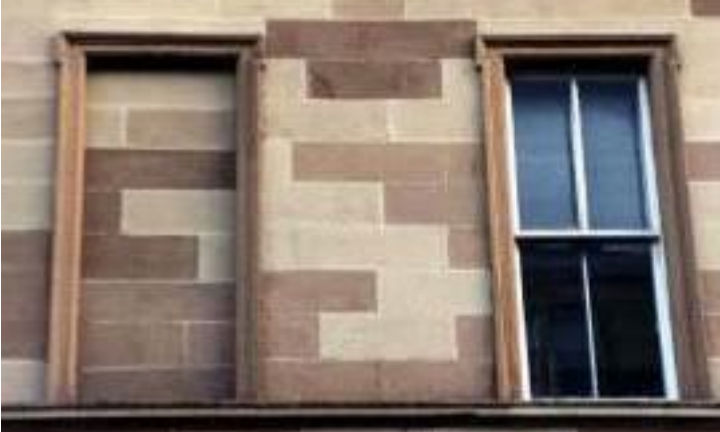
Figure 2: Example of mortar application (light parts) as a mortar repair of deteriorated stone units in Glasgow, Scotland.

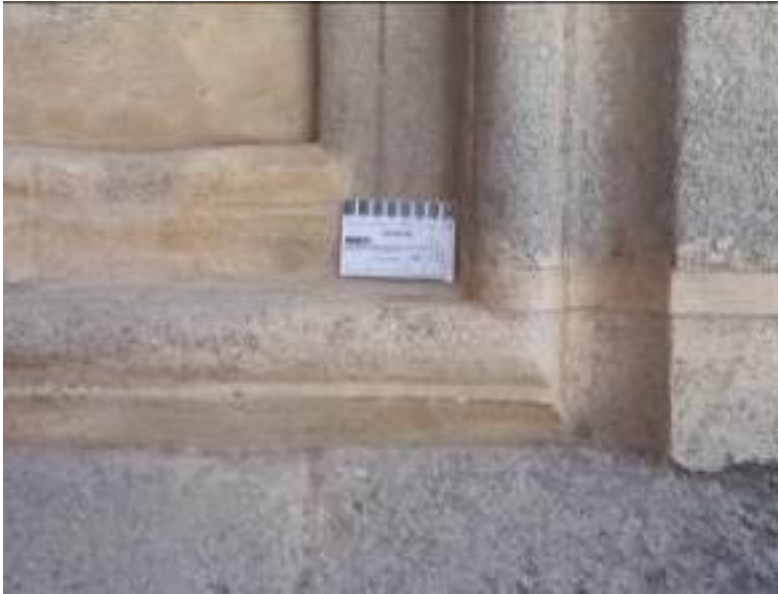
Figure 3: Mortar used to repair deteriorated stone parts and detailing of the main entrance portal of the cathedral in Évora, Portugal.

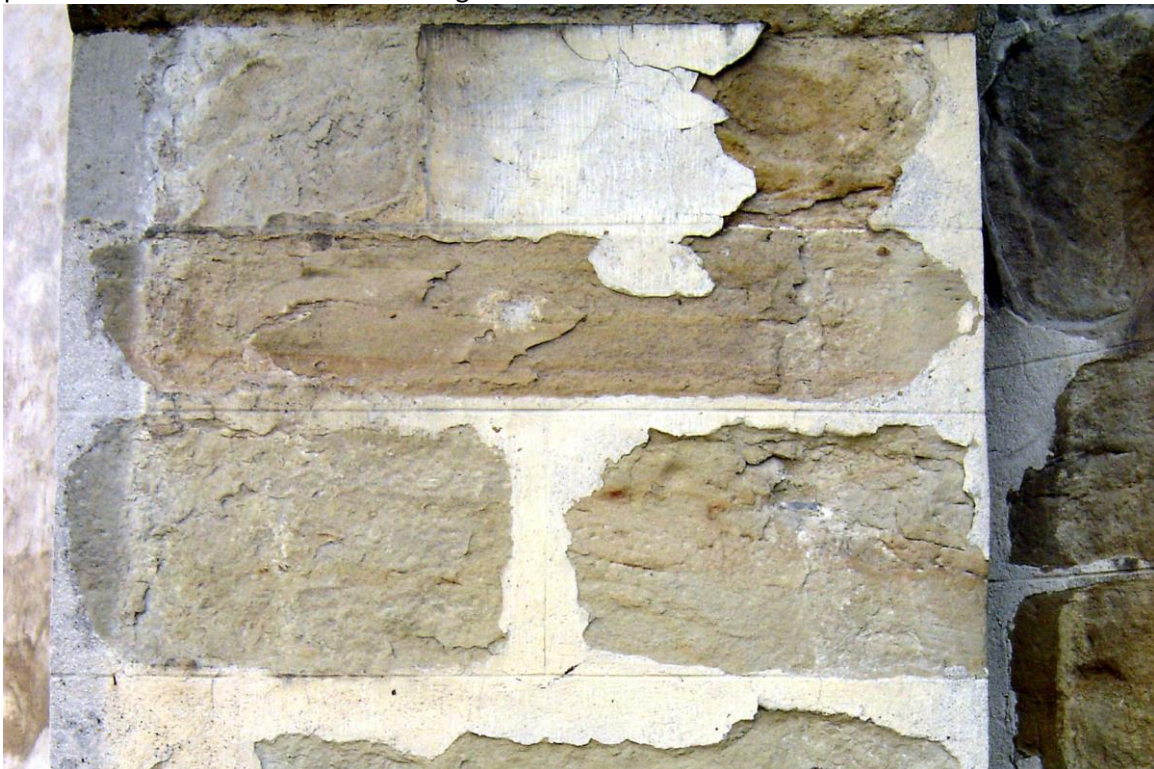
Figure 4: Mortar repair of a stone unit. Stone continues to decay. The repair material is durable but helps to accelerate decay of the adjacent stone as it collects rain water at the edges. Slovakia.

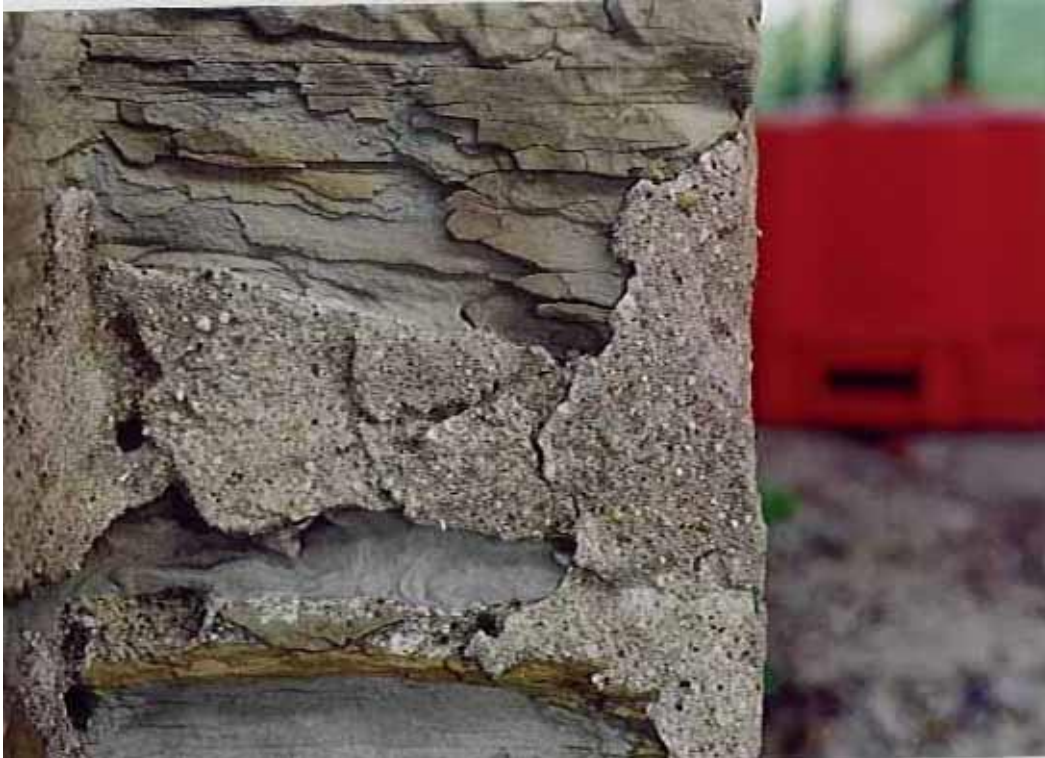
Figure 5: Failure of the surface repair due to mechanical incompatibility of the cement based mortar. Calcitic sandstone, Bergamo, Italy.

The evaluation of the performance of mortar repairs carried out in the past can provide information about the overall compatibility and durability, in order to improve their future use. Appearance and architectural quality can often be judged by visual observation. In some cases, the mortar repair appears to be performing as required, as illustrated by Fig. 3. However, there are also less successful cases as presented in Fig. 4. In this latter case, the deterioration of the stone units has continued and after several years the stone surface recessed whilst the more durable mortar repair patches remained at the original level. In this example the contrast between the colours and textures of mortar and stone is also notable. Such a situation is today aesthetically unacceptable, and the profile difference causes accelerated weathering of the stone around the edges of the protruding repair by trapping water or by wind erosion and eddies. Experience from building surveying suggests that the longevity of well executed mortar repairs is about 30 years [11]. This potentially limited life span must be taken into account in the repair design stage and in the requirements for post treatment monitoring and maintenance. Failure of the mortar may also occur as a result of mechanical and/or aesthetic incompatibility. In particular, the addition of synthetic resins in the past has led to unsuccessful repairs due to remarkable colour alteration and to very different mechanical properties between the mortars and the stone substrate (Figs. 5 and 6).

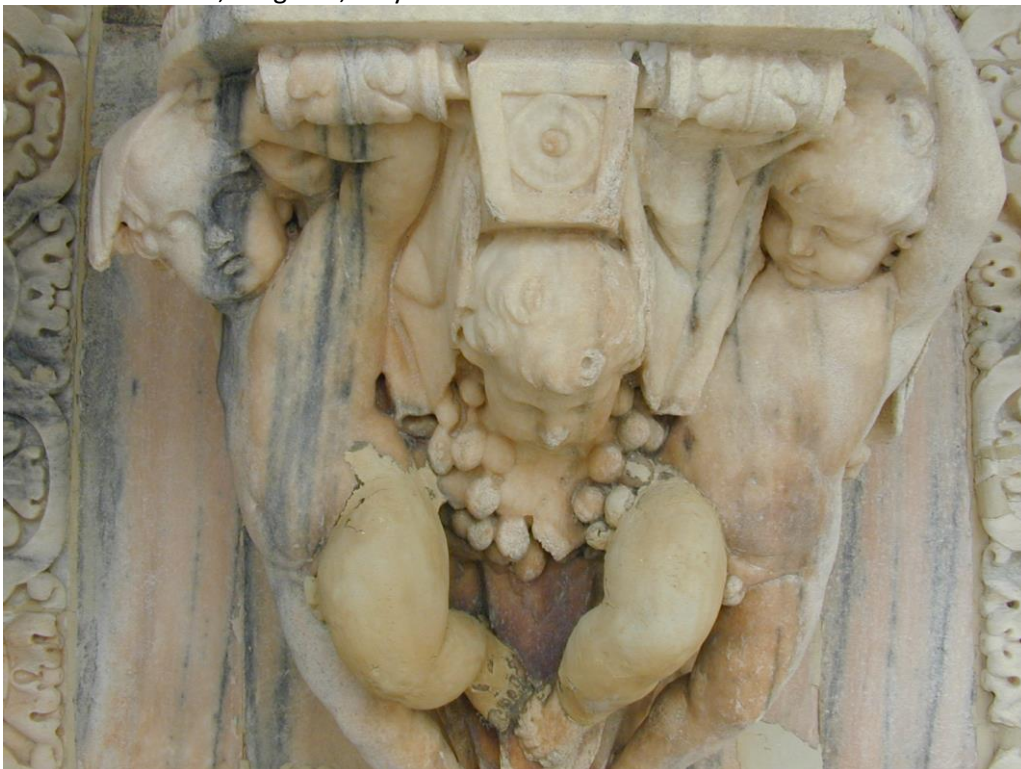
Figure 6: Alteration of appearance of epoxy resin-based repair mortars (angle's legs) on marble. Candoglia marble, Duomo di Milano, Italy.

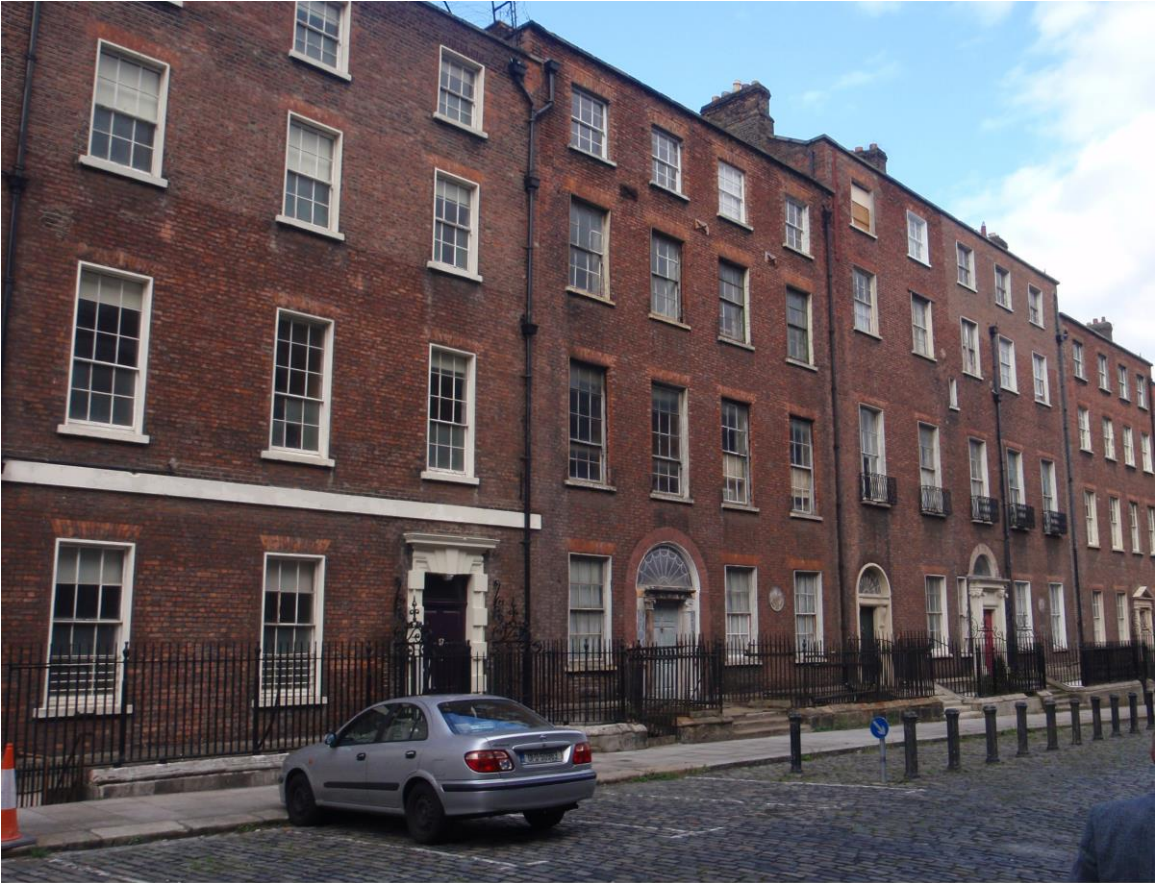
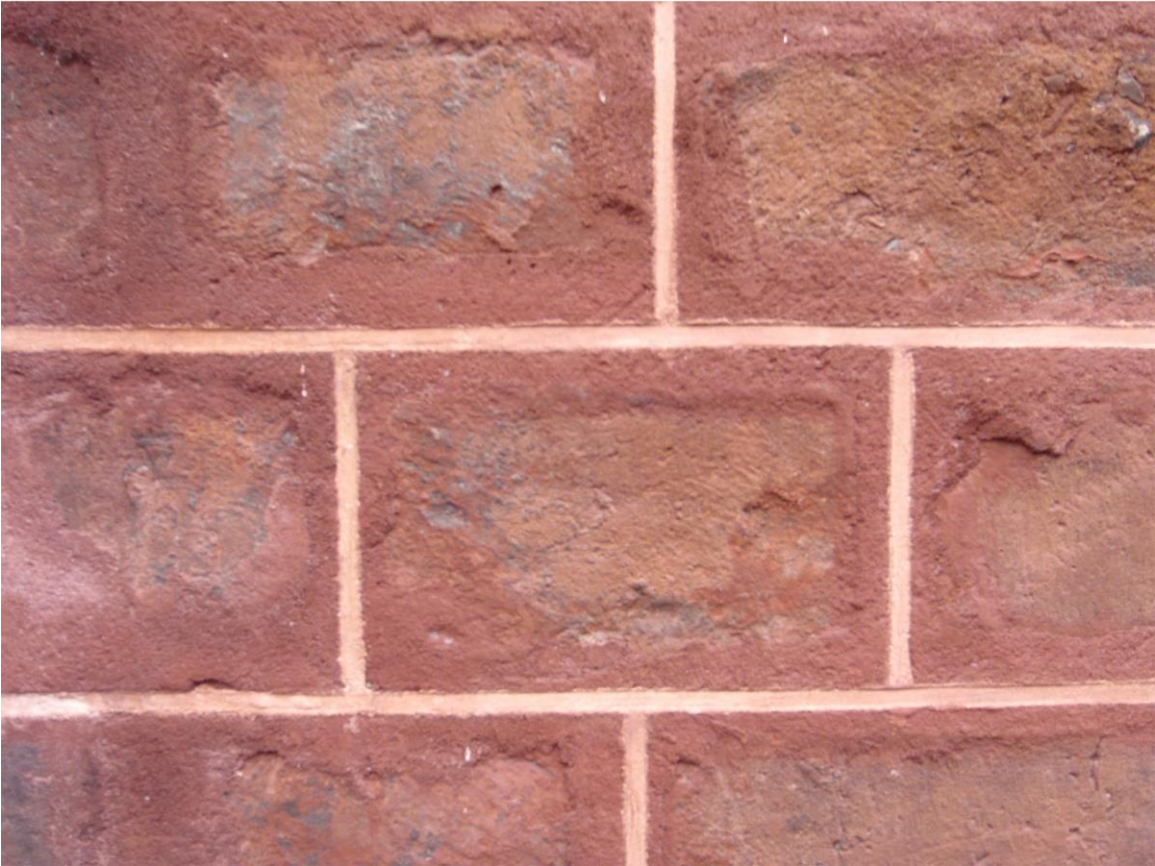
Figure 7: Mortar repair of degraded bricks allows a better appreciation of the architecture of the

earliest Georgian street in Dublin, from mid. 18<sup>th</sup> century. Henrietta Street, Dublin, Ireland.

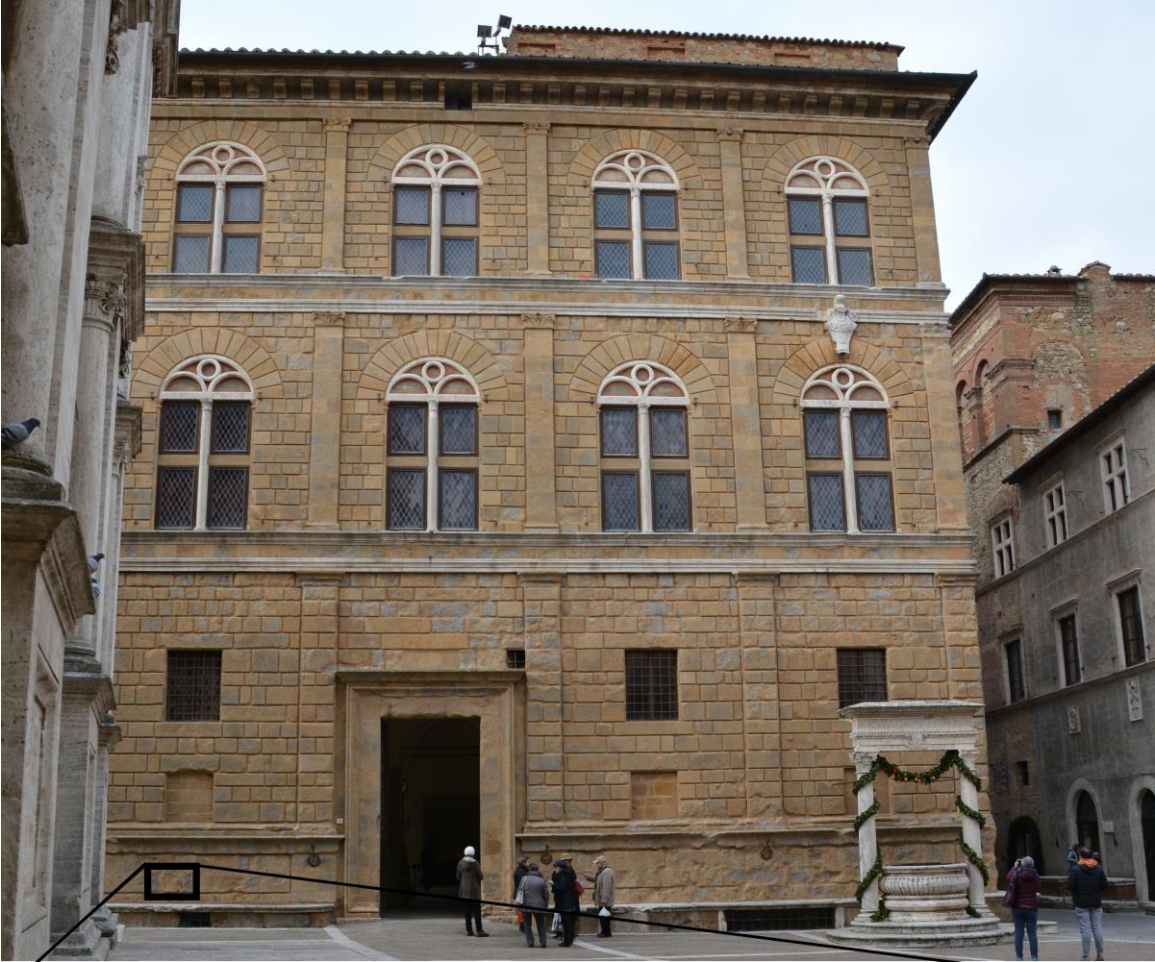
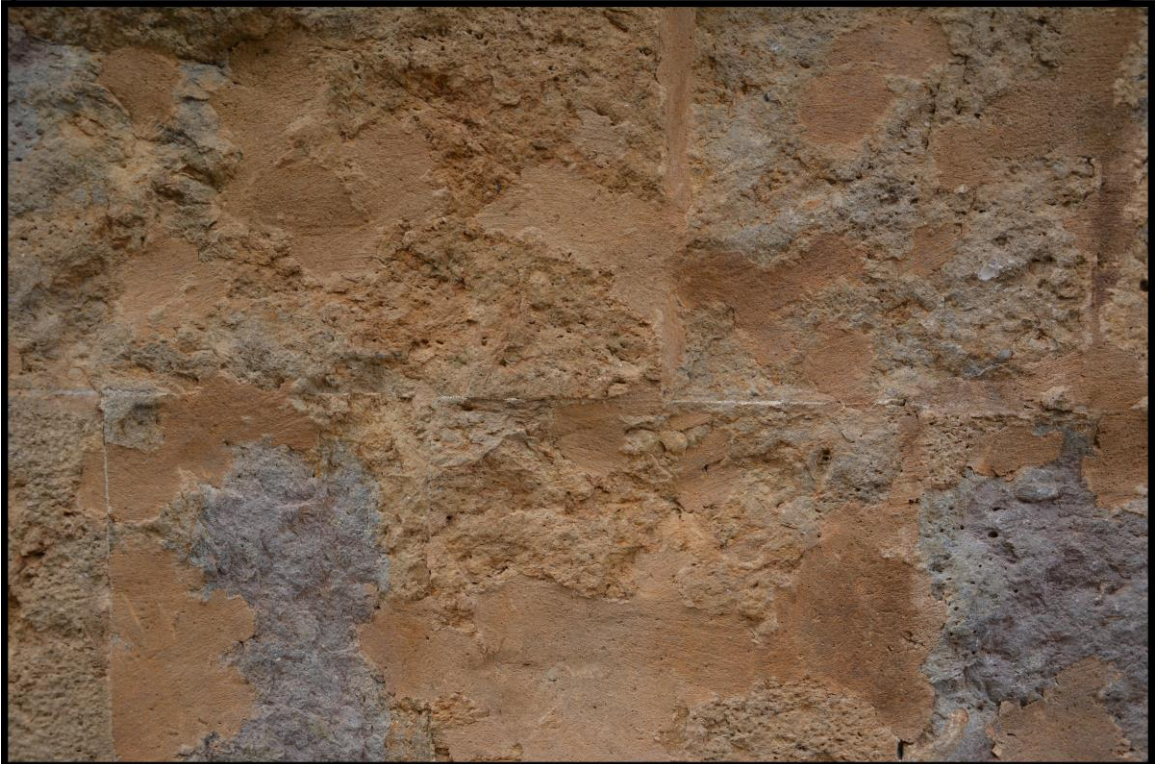
Figure 8: Mortar repair carried out on multi-coloured degraded sandstone blocks. The mortar

was used to slow down the degradation rate of stone. It was used to fill deeper voids but the weathered stone blocks were not remodelled to their original shape, see the detail of masonry with patches of mortar. Palazzo Piccolomini, Pienza, Italy.

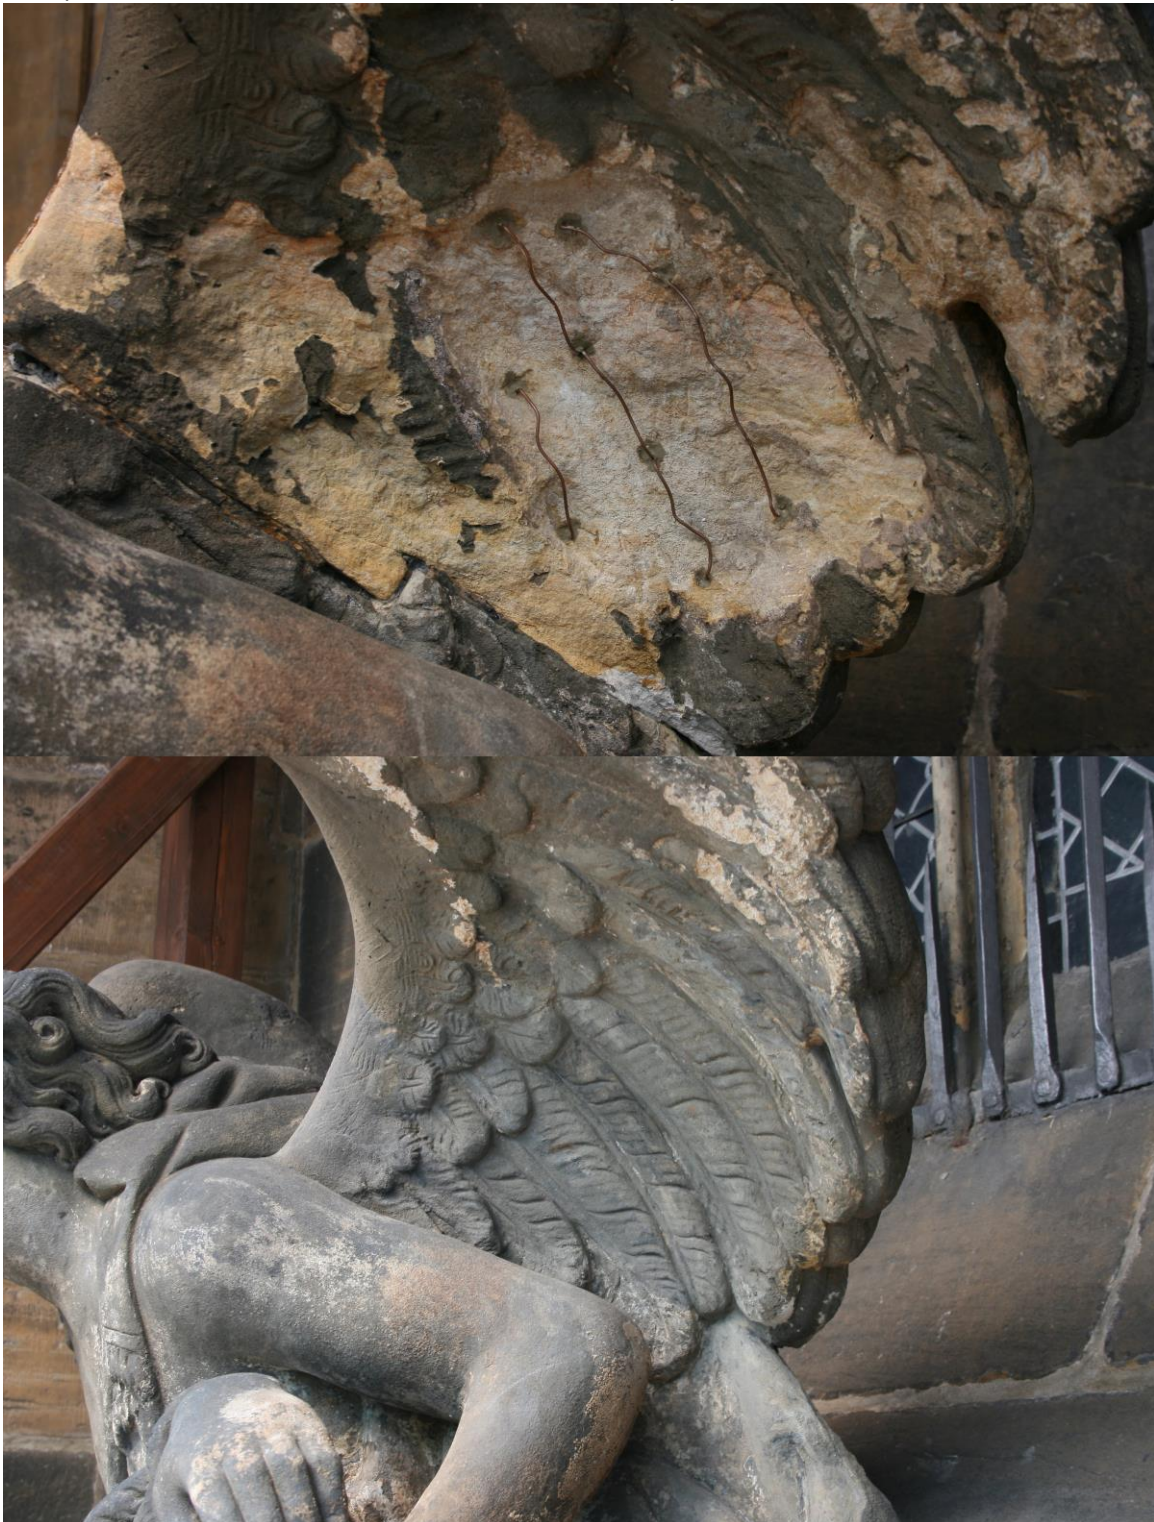
Figure 9: Mortar repair carried out on sandstone cenotaph sculpture of St. Jan of Nepomuk from 18<sup>th</sup> Century. Note the keying system of wires used to aid repair adhesion. St. Vitus Cathedral, Prague. (Photo P. Měchura 2009)

The bond between the surface repair mortar and substrate can be provided by reinforcement pins using non-corroding materials that are anchored in the substrate (Fig. 9). In this case the reinforcement carries the loads between the substrate and repair, and acts together as a system. The type of reinforcement can vary from simple wires to complex meshes. Stainless steel and/or non-corroding materials, such as nylon or fibre-reinforced composites, should be used. Reinforcement should be set back from the mortar’s surface, typically a minimum of 10 mm or at least twice the diameter of the reinforcement in order not to become exposed when the mortar weathers. Setting back also helps in avoiding problems associated with thermal expansion of the reinforcement. Wires need to be embedded into the stone for the depth of at least as much as the depth of the cavity being filled and fixed into the stone with some adhesives (usually epoxy resin or cement mortar-grouts, (Fig. 9).

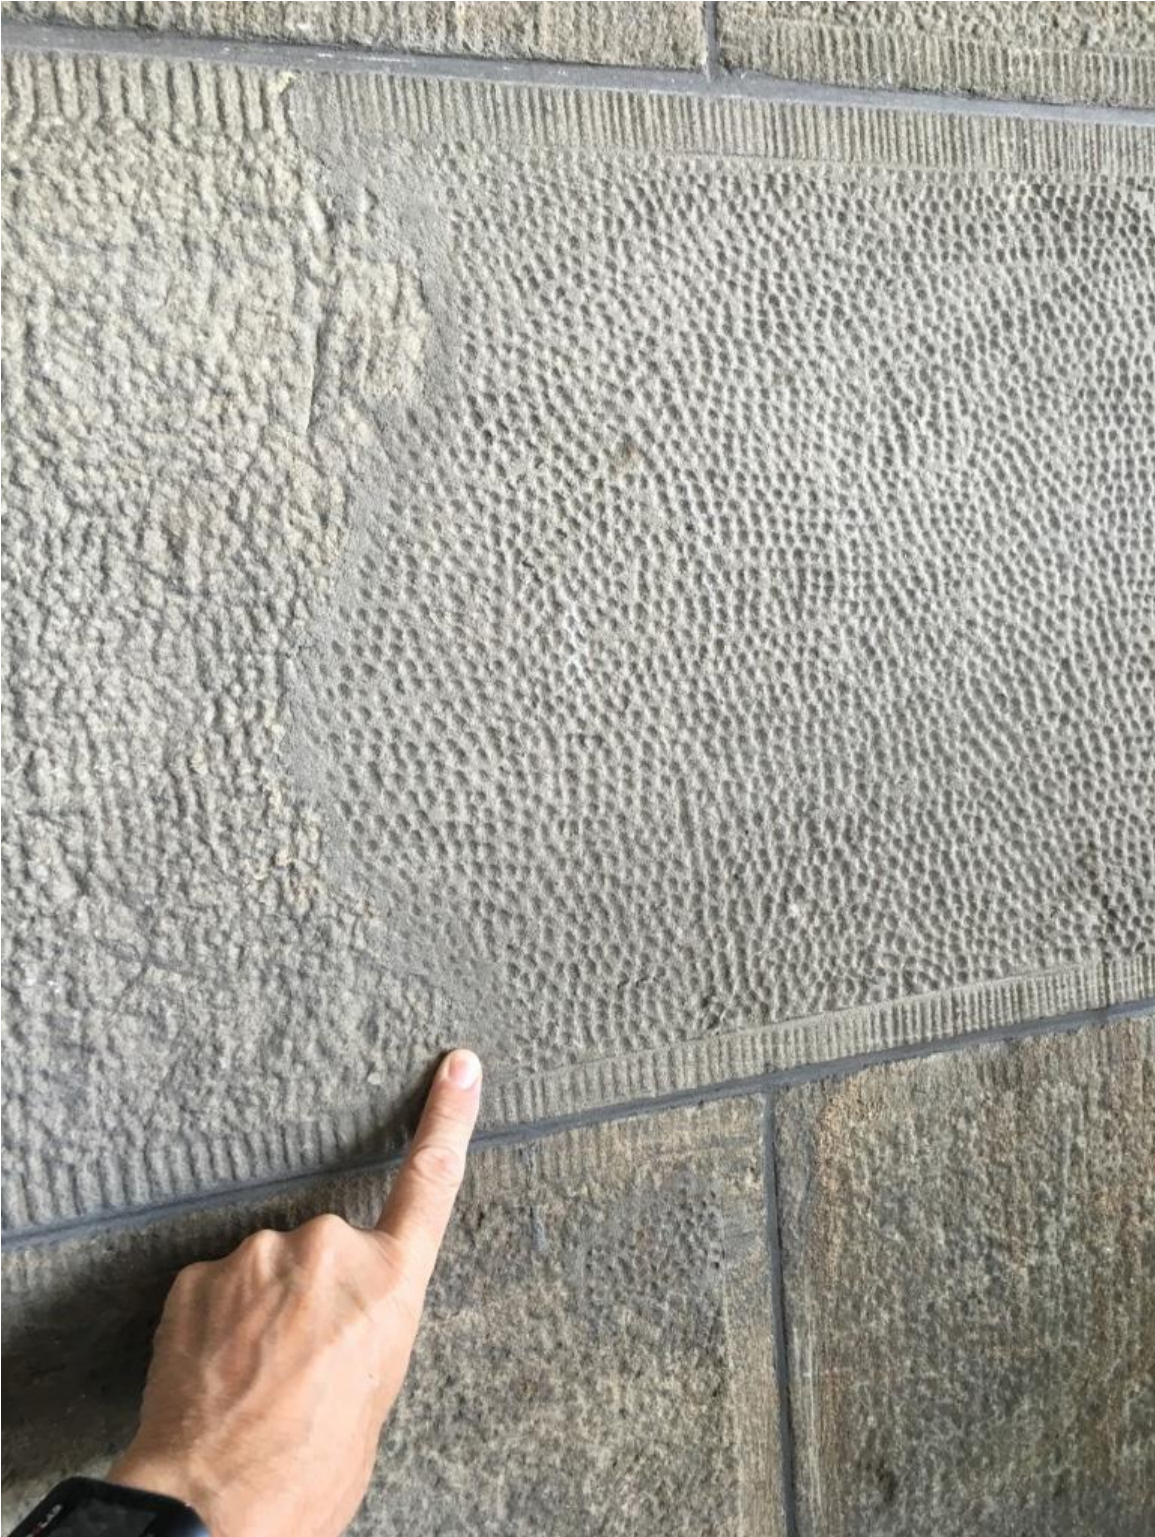
Figure 10: Stone repair (right side). Texture is adapted to the original substrate finishing technique.

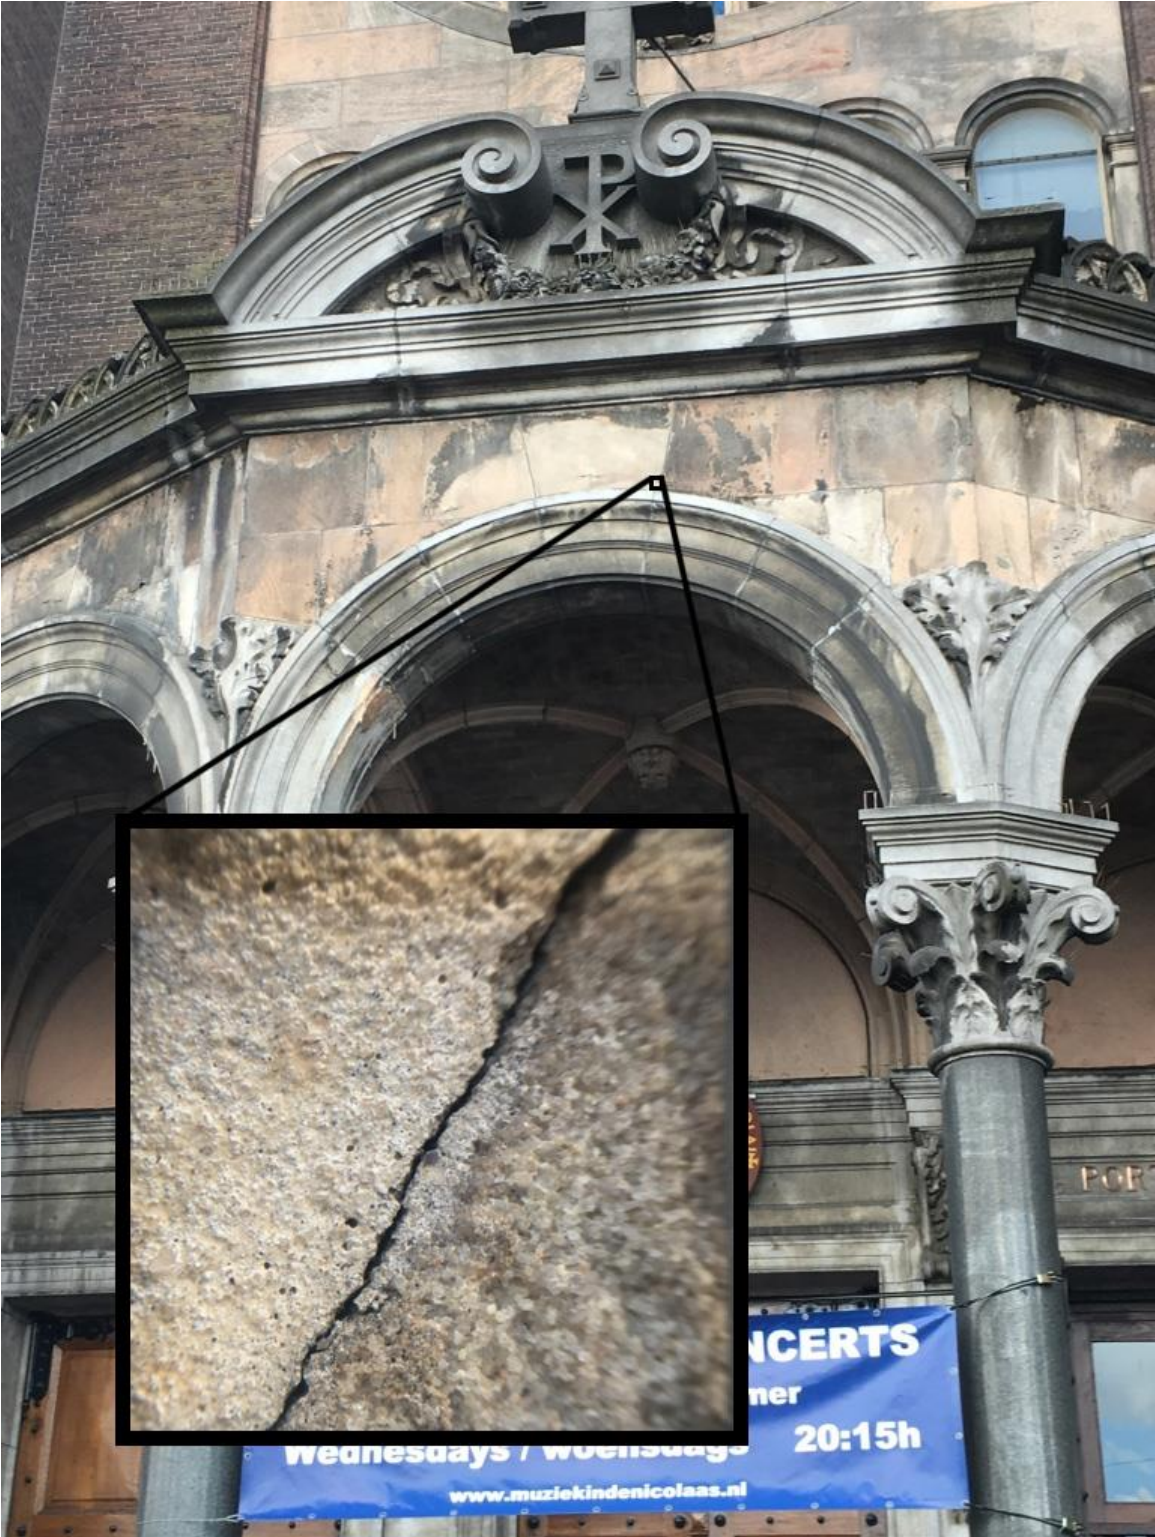
Figure 12: Stone repair with detail of a failing bond, due to shrinkage of the repair mortar. Amsterdam.

The physical and mechanical compatibility of a new surface repair mortar with the substrate is crucial because they usually completely cover some area. The new mortar therefore should not adversely contrast in permeability and water transport properties compared to the substrate. It should also have a good bond with the substrate (concerning the properties of shrinkage, bond, tensile and flexural strength), and it should have comparable values of elastic modulus, thermal and moisture expansion coefficients [39]. See also Figs. 11 and 12.
