Proceedings of the American Society for Composites, Thirty-Sixth Technical Conference

# Experimental Study on Post-Buckled Composite Single-Stringer Specimens with Initial Delamination under Fatigue Loads

## ABSTRACT

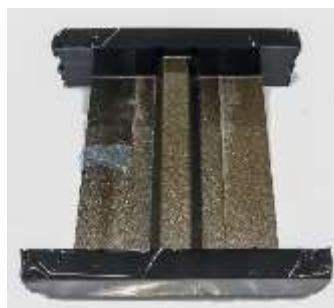
The specimen is made of IM7/8552 carbon-epoxy tape with the skin composed of an 8-ply quasi-isotropic laminate with the stacking sequence  $[45/90/-45/0]_s$ , while the stringer has 7 plies with the layup  $[-45/0/45/0/45/0/-45]$ . The nominal ply thickness is 0.125 mm. After the curing process both ends of the specimen are encased in 30 mm tabs made of metal filled casting resin RenCast® CW 2418-1 hardened with Ren® HY 5160-1 to ensure that the compressive load is applied uniformly. An image of the specimens with the end tabs before the testing is shown in Figure 2.

Figure 2. Single-stringer specimens before the test.

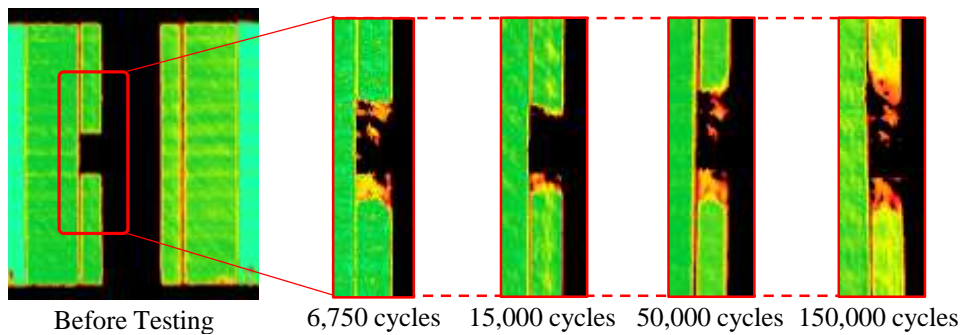
Images from the ultrasonic C-scan at different number of cycles are reported in Figure 10 and 11 for the specimens SSCS3 and SSCS5, respectively.

The delamination front for all the performed tests exhibits a rounded shape with a more extended propagation on the sides compared to the center.

Figure 10. Ultrasonic C-scan at different fatigue cycles (SSCS3).

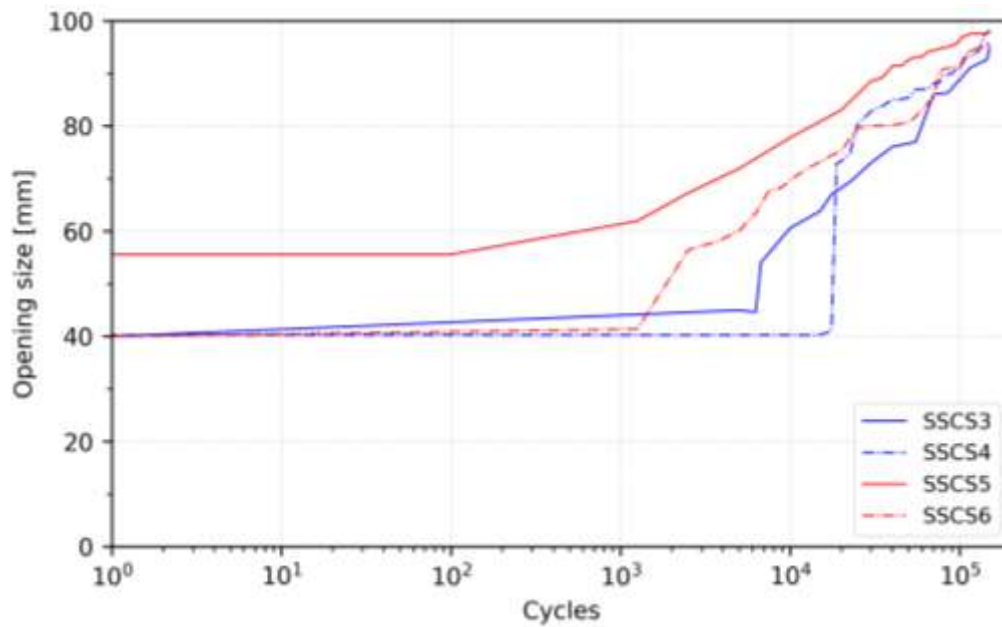
The extension of the delamination as function of the number of cycles is compared for all the performed tests in Figure 12. The opening size is reported as the average between the measurements taken at the center, and at the left and right sides of the delamination.

Figure 12. Delamination opening size with the number of fatigue cycles.

For all the fatigue test, the propagation of the delamination is fast at the beginning, then slows down gradually, as can be observed from the nearly linear trends in the semi-logarithmic graph in Figure 12. As expected, the size of the delamination is larger on average for the specimens SSCS5 and SSCS6 compared with the specimens SSCS3 and SSCS3 at equal number of cycles due to the higher maximum load. However, for all the tests the delamination length stabilizes around a value of 100 mm.
