INTERVAM

Graduation Studio - Heritage & Architecture - Re-Housing
Analysis Group Intervam - Rick Hoofd - Xiaoyu Chen - Chi Teng - Heejin Chung

This research report is a result of the first stage PI of our Graduation studio Re-Housing, which is under Chair of Heritage & Architecture at the Faculty of Architecture of Delft University of Technology.

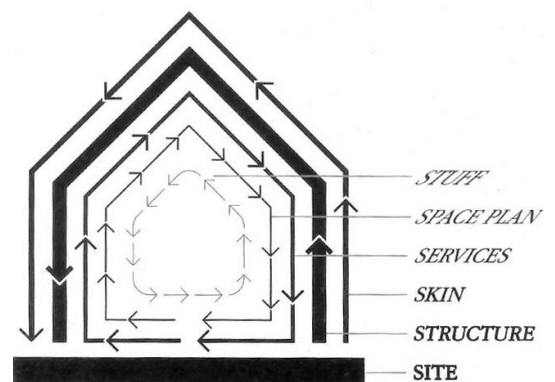
Figure 1: The 'S'-system of Steward Brand (Steward Brand, 1994)

The first part of the report is the analysis of the building system. This section is divided into seven chapters. The first six chapters are based on the concept of 'S' system presented by Steward Brand in his book "How Buildings Learn". He introduced "shearing layers of change" with a brilliant diagram (Figure 1) which illustrates how the different building components change at a different pace. Because of their exposure and response to various environmental influences, some will last longer than others. The shear layers Brand identifies are: Site, Structure, Skin, Services, Space Plan and Stuff. In addition to the Brand's 'S' system, there is another layer, the Story, to cover the intangible qualities lying behind the project.

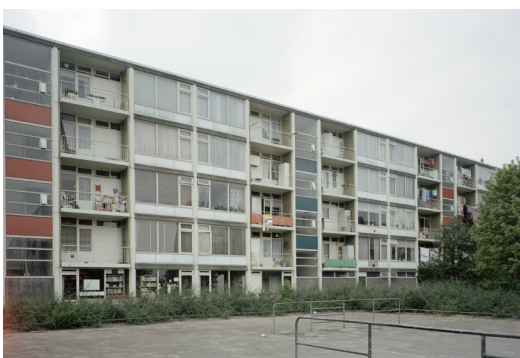
*1984 wooden window frames of the facade (before the renovation)

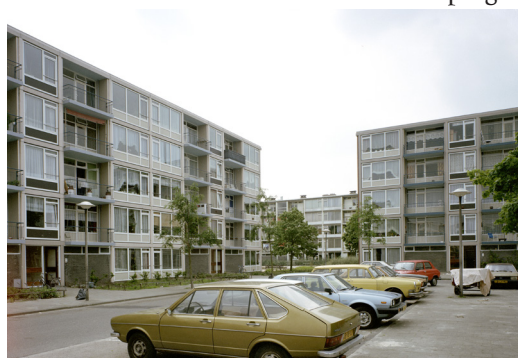
*1984 plastic window frames of the facade (after the renovation)

Frames: Wooden window frames replaced by plastic window frames (white) with double glazing, except the frames at the balconies, the storages and the entrance.(see Figure 1.3.16.)

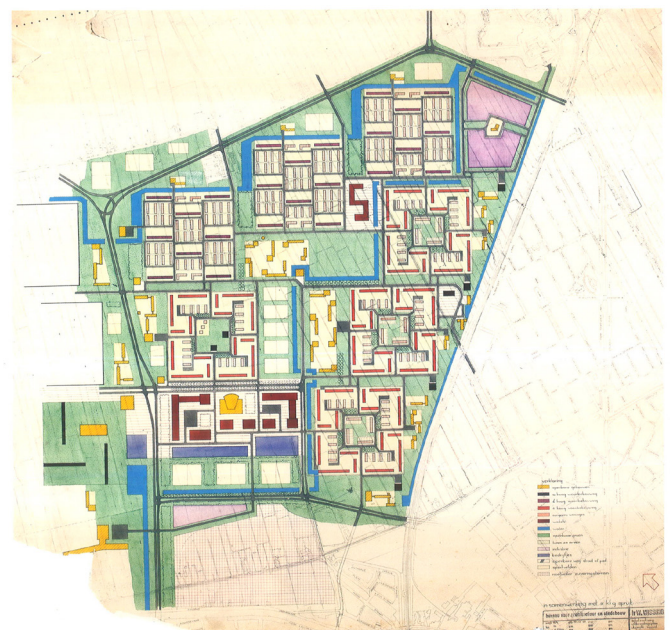
Figure 1.1.6 Expansion plan of Overvecht-Zuid in 1958 by Wissing & Spruit (image: NAI archive)

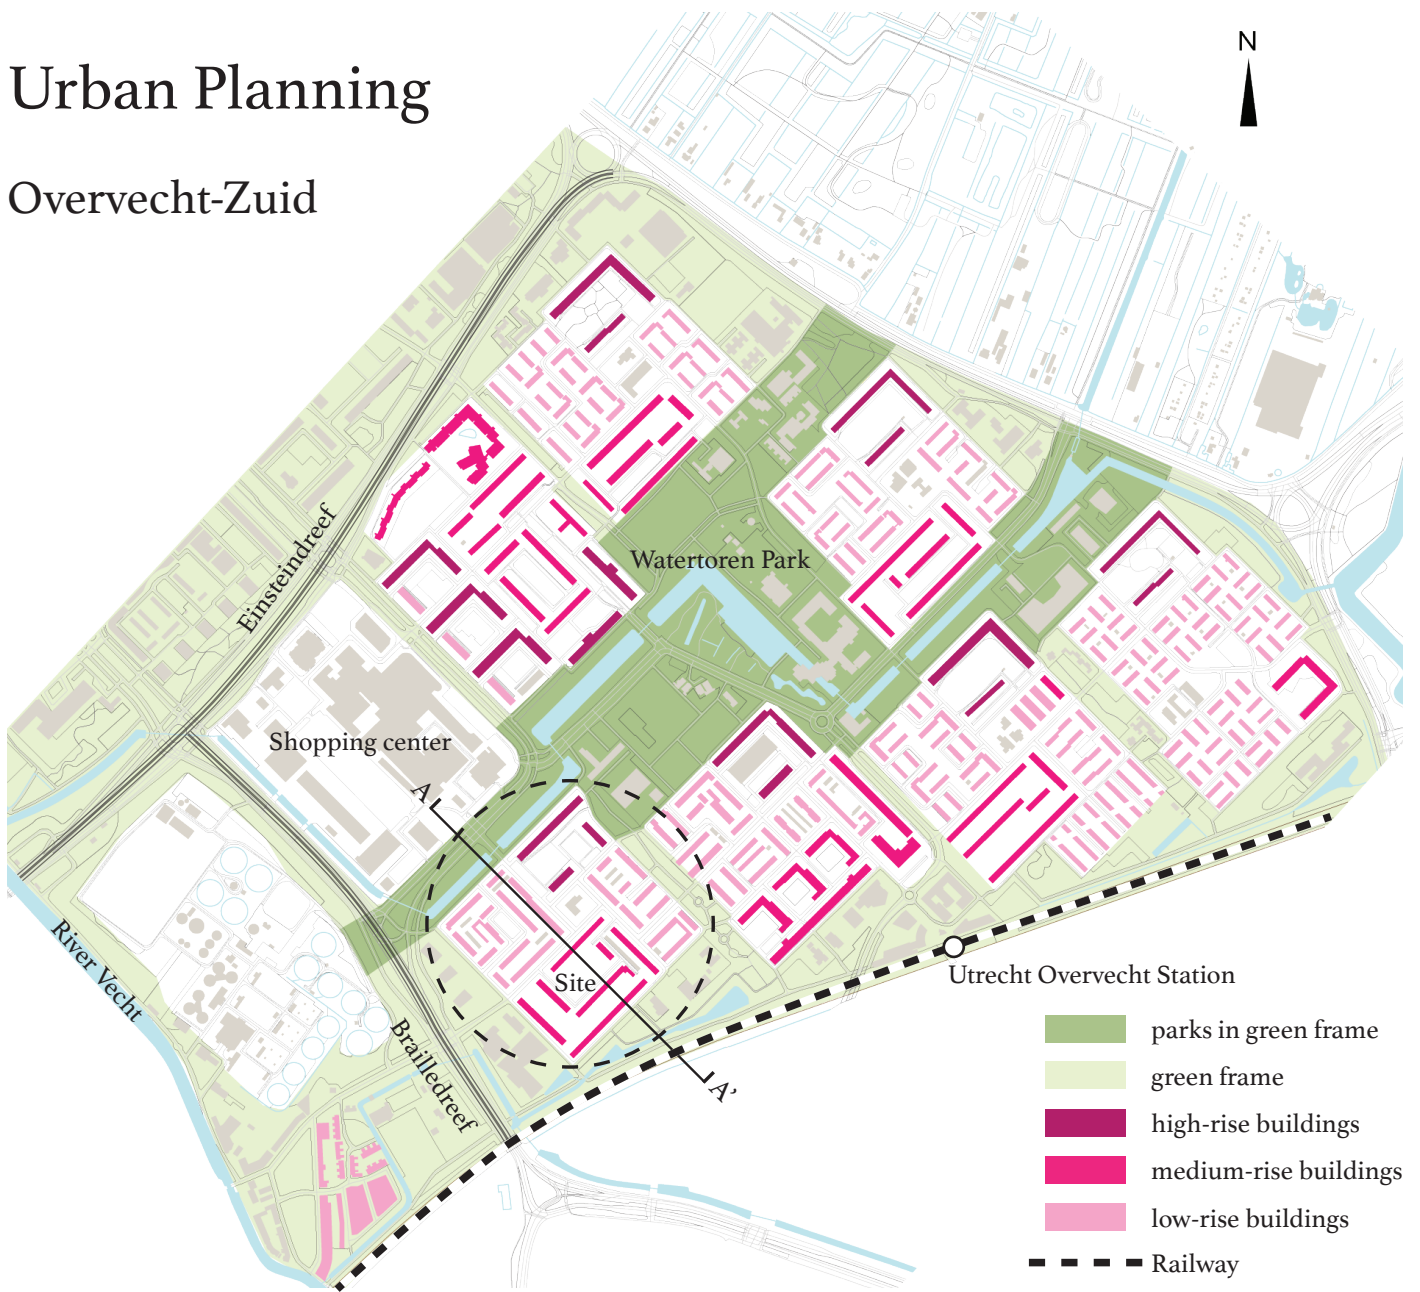
Figure 1.1.7 urban planning map

Overvecht is one of the ten districts of Utrecht located on the northern outskirts of the city. It is the largest expansion area Utrecht with 33,732 inhabitants (2015, source: www.utrecht.nl). The area is characterised by spacious greenery with stacked high-rise flats built in post-war period. Majority of the buildings (approximately 80%) is social housing. Each neighbourhood is clearly defined by the surrounding green frame. It was designed as a modern garden city with the principle of open planning. The structure of the neighbourhood consists of strips of buildings. In most cases, the buildings have more than one front side because they are facing the main street on one side and communal outdoor space on the other side.

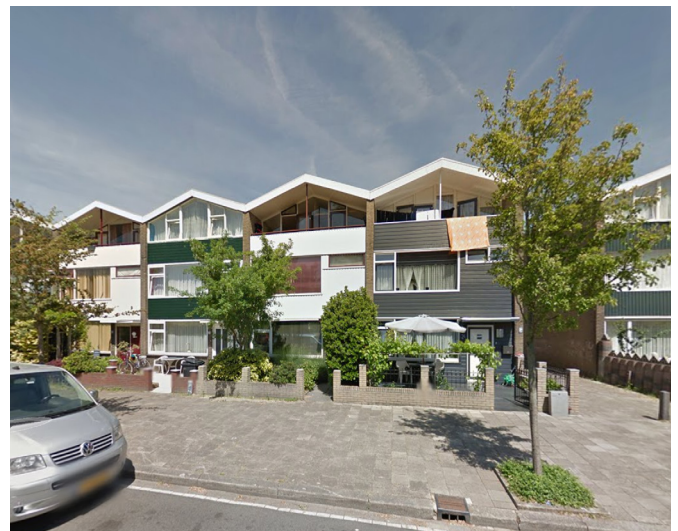
Figure 1.1.15 street view of Ebrodreef in 2015

The colour and material of the building facade have been changed over time. Some of the balconies are extended to have more interior space. The fence between the pedestrian and front yard also have different appearance by each housing.

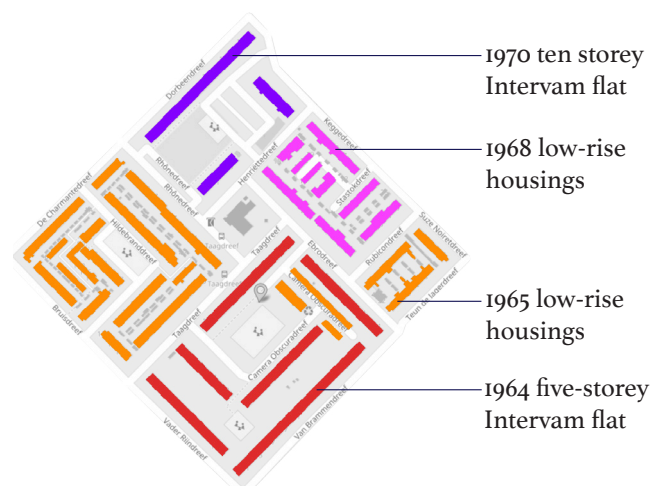
Figure 1.1.18 construction phase

In 1964 the other five-storey Intervam flat was built in Camera Obscuradreef (Figure 1.1.18). After a year the single-family houses were built next to this Intervam flat. In other neighbourhood the single-family houses, especially the keuzepanwoningen, were built earlier than medium-rise buildings. This is because the government gave extra subsidy which was 40% more than the average to this housing type (to cultuurhistorisch onderzoek en ruimtelijke analyse Utrecht NaOorlogseWijken, 2006). The medium-rise Intervam flats were the first dwellings that was built in this neighborhood. For this reason, it can be assumed that Intervam flat could be built first allowing remaining space for the following construction (Figure 1.1.18).

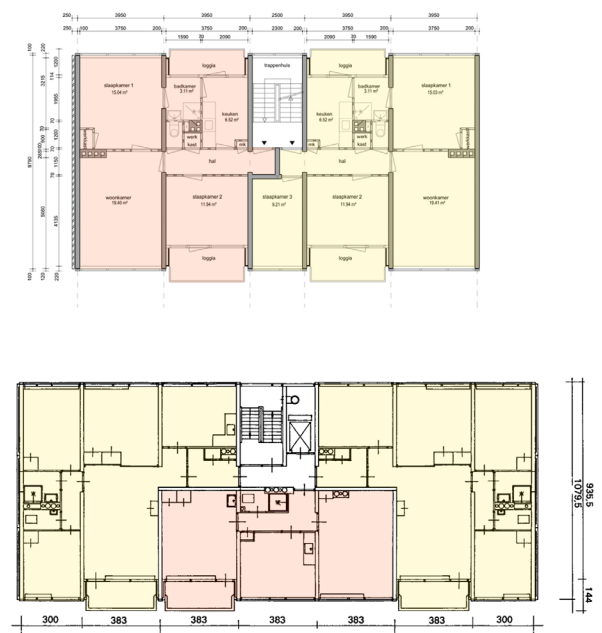
Figure 1.1.20 Intervam floor plan :
five-storey floor plan (above)
ten-storey floor plan (below)

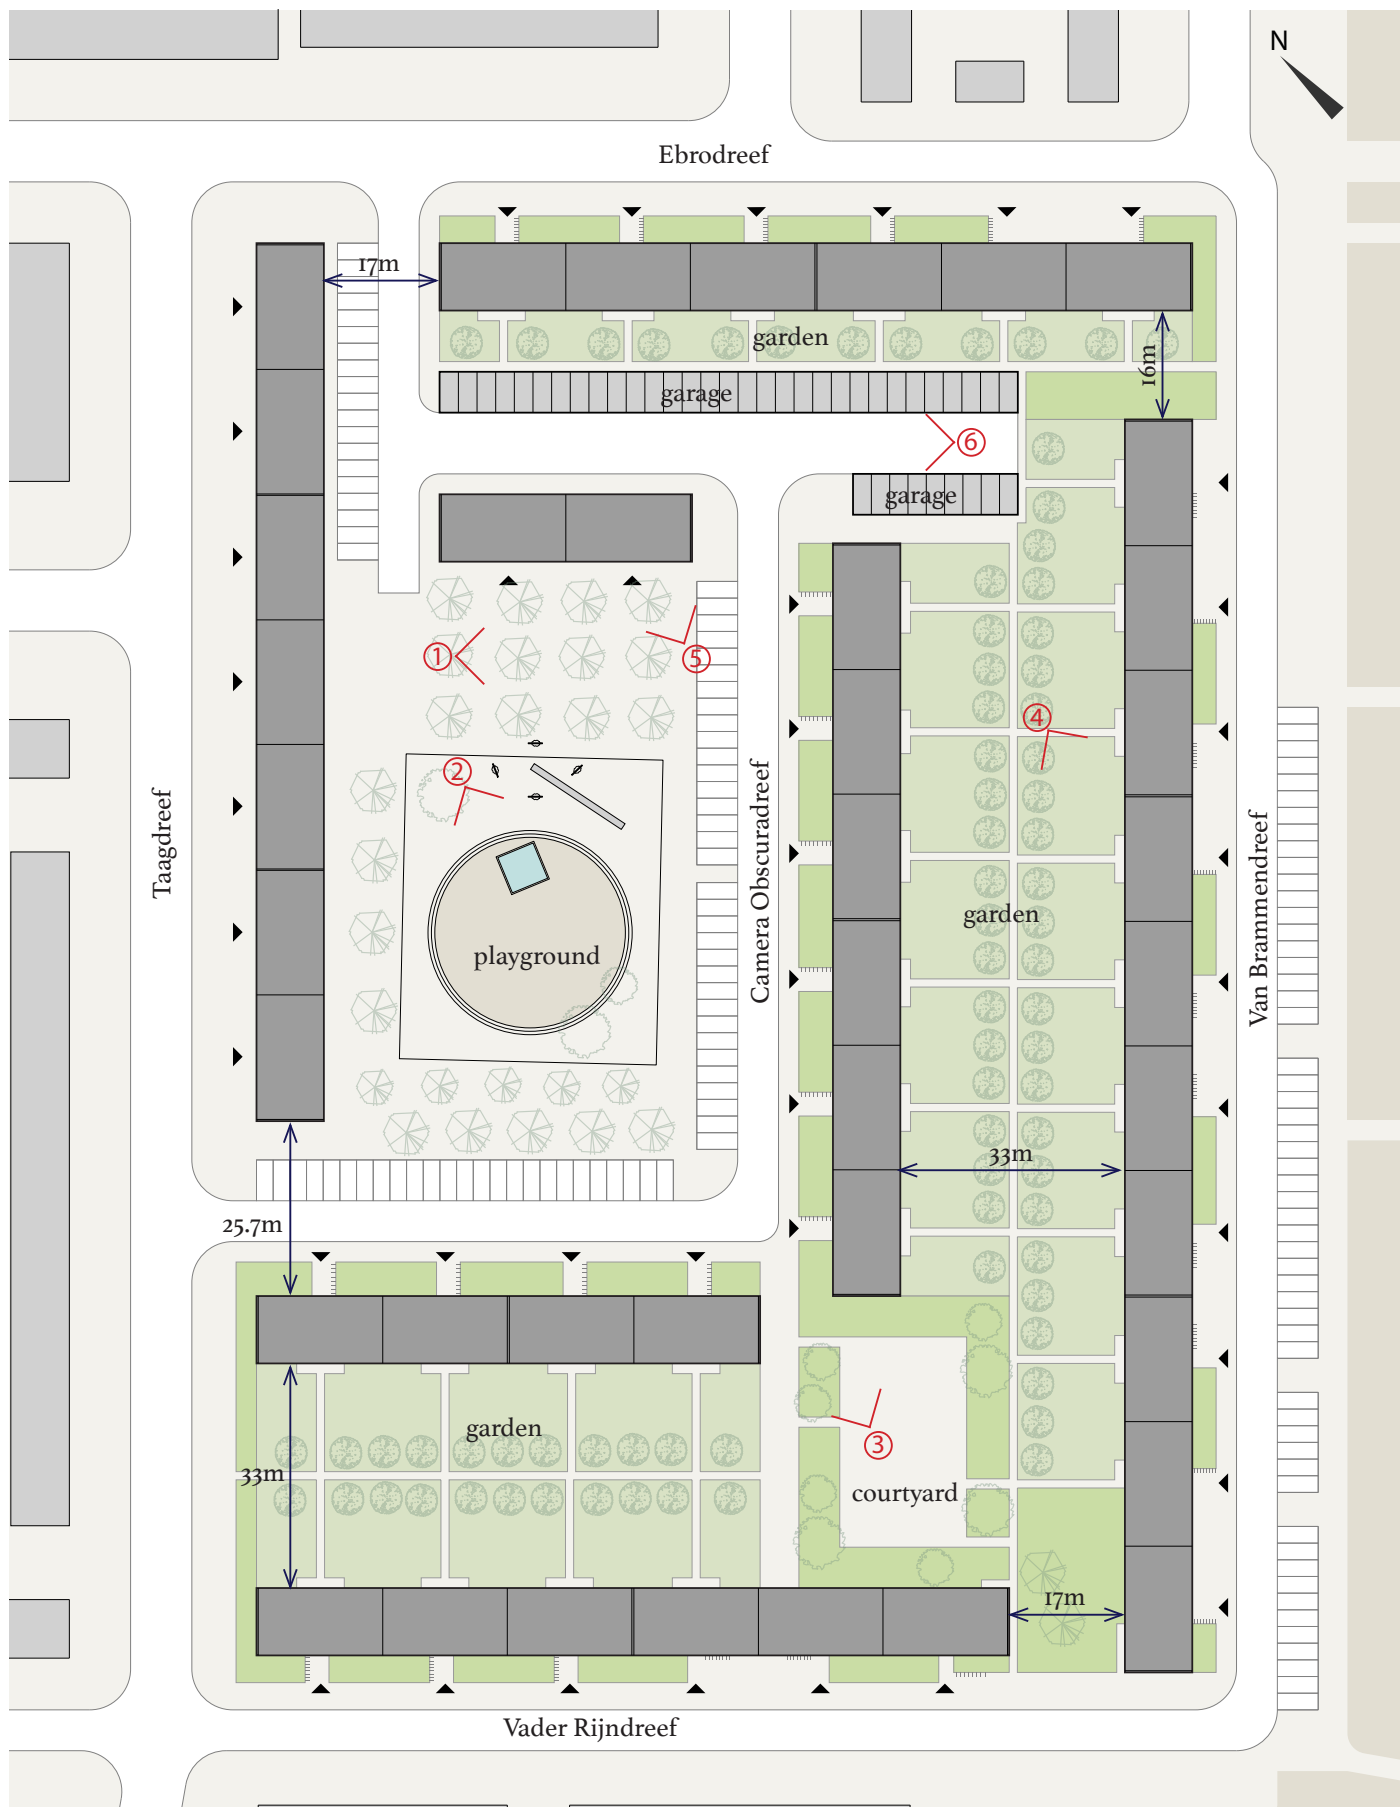
Figure 1.1.21 site plan

The project area is consist of six medium-rise housing blocks on the Taag- and Ebrodreef. The type of housing blocks is a portiekflat with five-storey. The total amount of households is 312. The outdoor area can by define by three different milieus, namely a square (Camera Obscuradreef), an inner area and the outer shell. At the square there are playground, parking space, and two-storey residential-commercial block. The design of the square was not part of the planning. The playground equipment, a sunken lawn, some benches, trees and a parking lane were included during the construction (10 cultuurhistorisch onderzoek en ruimtelijke analyse Utrecht NaOorlogse Wijken: Overvecht, 2006). Today the playground is enclosed by the fences. The ground floor of the two-storey block was designed for shops and the first floor was usually occupied by shop

owners. Right behind the shops there are ground-level garages. The inner areas is largely divided into private gardens and public courtyard. The different world of 'secret garden' is hidden behind the portiekflat. The private garden is connected to the apartments on the ground floor and first floor. The inner courtyard at the corner is a communal outdoor space with a plant box. The outer shell of the housing blocks is public green area facing the main street. Originally there were several public facilities on the ground floor along the street such as the church in Ebrodreef and public library in Vader Rijndreef. Now the public facilities today do not seem to function optimally, and the question arises whether they could have a relationship with the outdoor area of nowadays. Most shops have been closed their doors, partly because of the competition with the large supermarket near the neighbourhood.

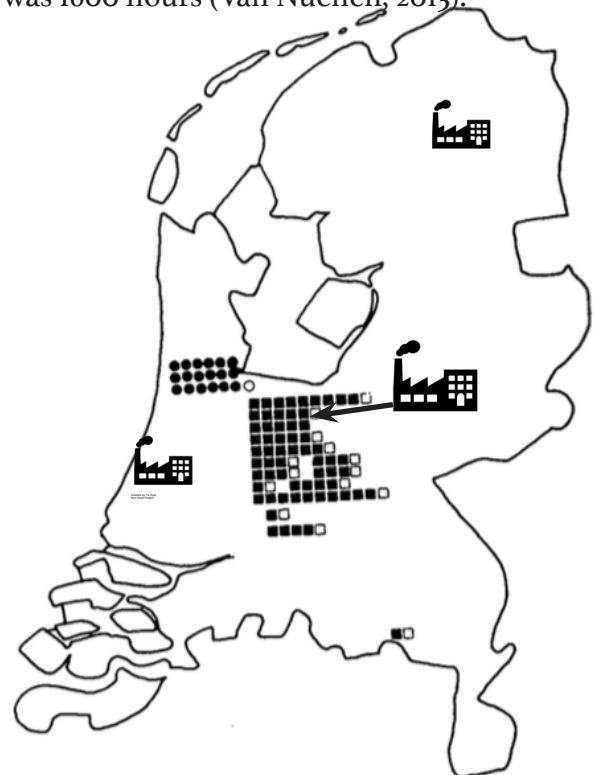
Figure 1.2.1: Factories and production. (Priemus & Van Elk, 1971).

were made (figure 1.2.2). The other two made more specialized elements such as stairs, parapets and eaves. The elements are merged together on the construction site, which have four or ten storeys (figure 1.2.3). The three factories together have a production capacity of six houses a day. The transport of the elements to the construction site was done with trucks (figure 1.2.4 and 1.2.5). By placing the elements directly from the truck, there was no unnecessary transportation on site. For one house four trucks were needed. For assembly a crane was needed called 'looppadkranen'. When two cranes were used on site, 4 to 5 homes could be built each day. Ten people (half of them unskilled) were needed to put a building together. The fast construction time and reduced working capacity are characteristic of the non-traditional-building-methods. By using the VAM system a saving of 53% on man hours on the construction site can be obtained. The total number of man-hours for one property (including factory production and on-site construction) is 1000, in comparison the average was 1600 hours (Van Nuenen, 2013).

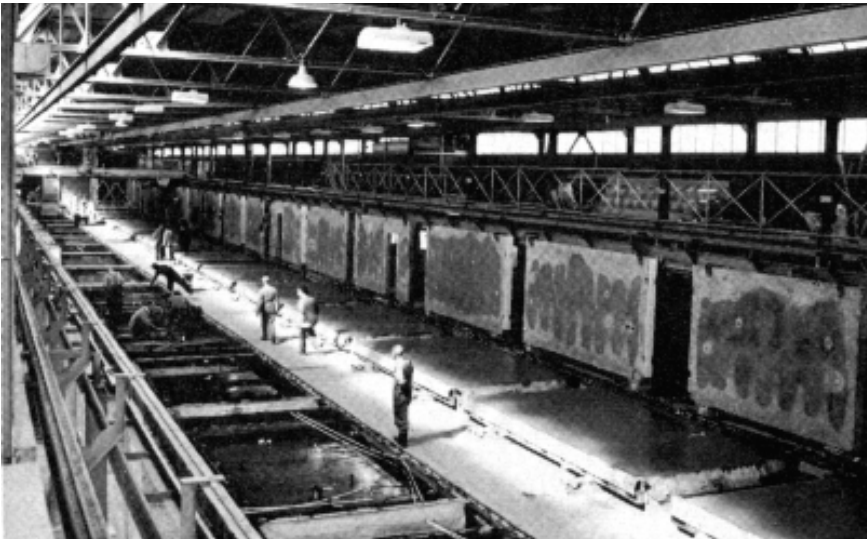
Figure 1.2.2: Factory production.

- 7 m crane
- 6 m storage large wall elements
- 3,5 m conveying (trucks)
- 8 m storage floor elements
- 10 m storage small elements
- 4 m storage window frames etc.
- Total: 38,5 meters

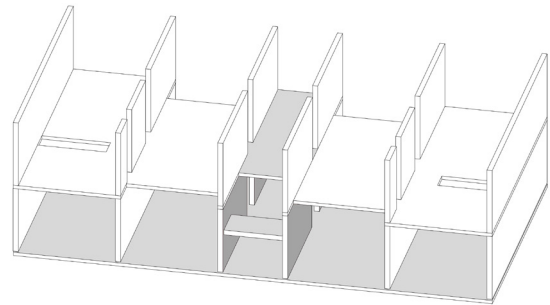
Figure 1.2.6: In-situ concrete

First the prefabricated frost edge is placed on the ground. The prefabricated frost edge is used to prevent unnecessary form work for in-situ concrete system. On top of that, in-situ concrete slab is applied on the ground floor (figure 1.2.9). The walls located on both sides of the stairwell, the landing on ground floor level and the first floor of the stairwell are built in-situ concrete as well (figure 1.2.6). On top of the ground floor a keyway (kimband) was place to set the height of the prefabricated walls. After the load-bearing walls were placed the non-bearing light-weight concrete walls were assembled on the floor (figure 1.2.7). Next to that, the strip was placed on top of the load-bearing wall to distribute the compression load from the prefab floor which was layered on top.

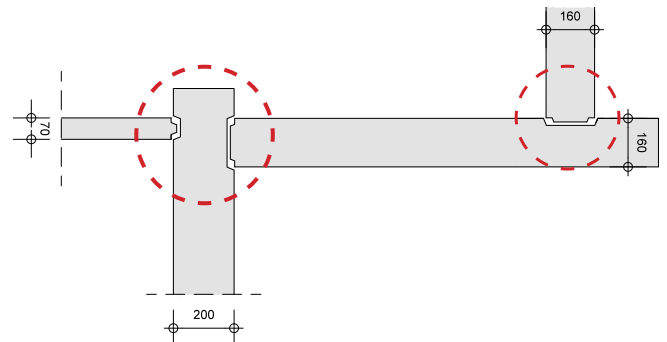
Figure 1.2.7: Connection with grooves reinforced with steel pins which connect with the wall and floor. Information: (Priemus & Van Elk, 1971)

The load bearing walls were placed on the prefabricated slab. To place the walls in the right position two tubular positioning pins were used (figure 1.2.8). The load bearing walls contain gaines. From these gaines the cavity between wall and floor were poured with cement to combine them together. After that the non-bearing light-weight concrete walls were placed on the slab as aforementioned on the ground floor. Before placing the next slab other materials such as wooden walls and door frames were laid on the floor. This saved a lot of excessive works of lugging construction materials. The prefabricated concrete elements were used on the roof as well. To create a sloping surface, cement and insulated channel plates were used. In the end the insulated channel plates which were based on closed air ducts were replaced by glass foam due to the poor insulation performance. Floating screed or screed was applied on the floor.

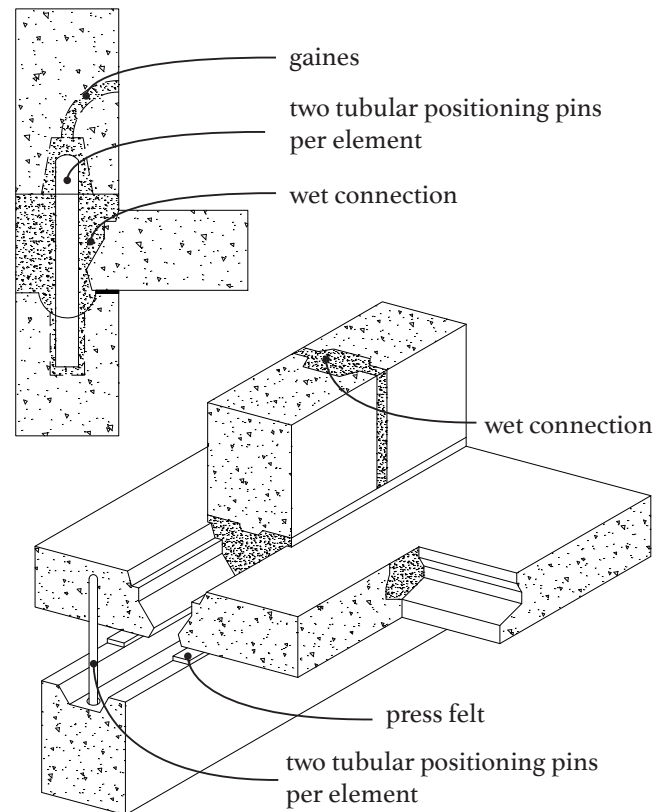
Figure 1.2.8: Construction details

- Foundation: On steel with prefabricated frost edges
- Ground floor, walls on the ground floor of the staircase and 1st floor staircase: In-situ concrete
- From ground floor: Prefabricated concrete
- Stability: Wet connection between load-bearing walls and floors. In combination with perpendicular pre-stressed walls which continue for four stories, with mutual overlaps.

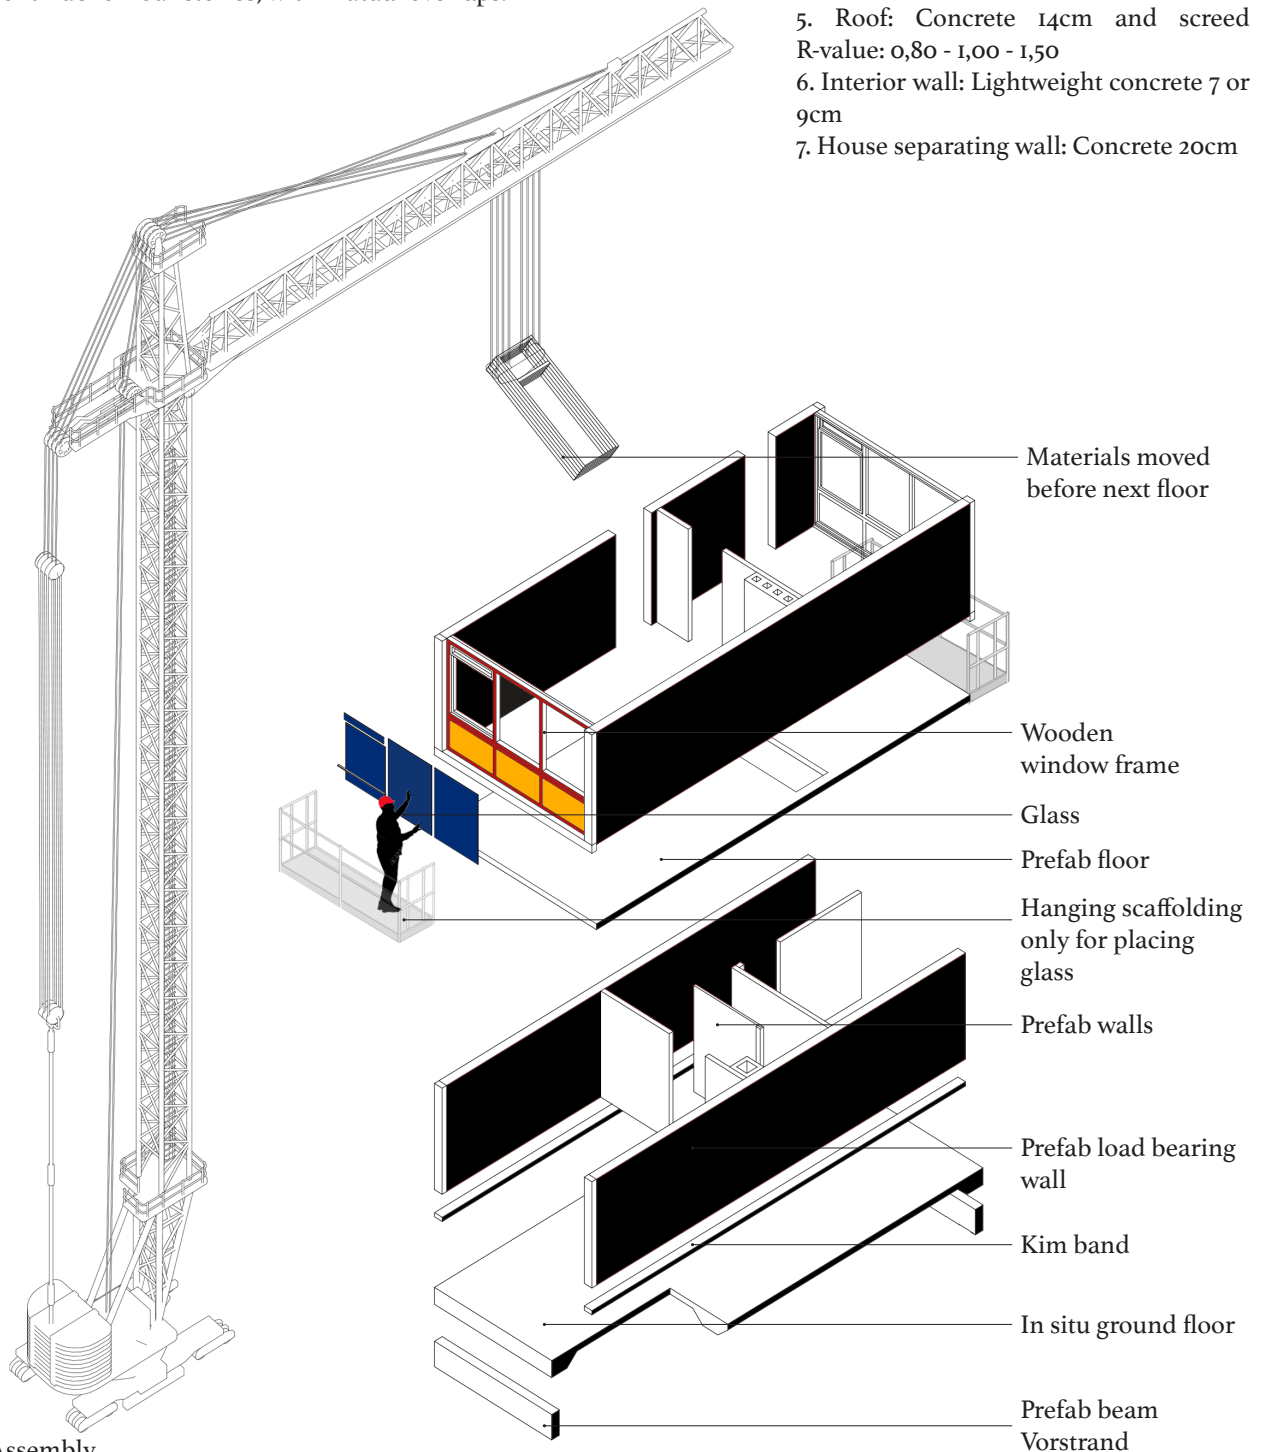
1. Exterior wall: Concrete 20cm and brick R-value: 0,60
2. Parapet: Sandwich panel with 3cm polystyrene
3. Restoration: Glassal panel R-value: 1,25
4. Floor: Concrete 14cm
5. Roof: Concrete 14cm and screed R-value: 0,80 - 1,00 - 1,50
6. Interior wall: Lightweight concrete 7 or 9cm
7. House separating wall: Concrete 20cm

Figure 1.2.9: Assembly

The whole drawing of the assembly and the prefabricated elements can be found in the appendix. As well the original floor plans.

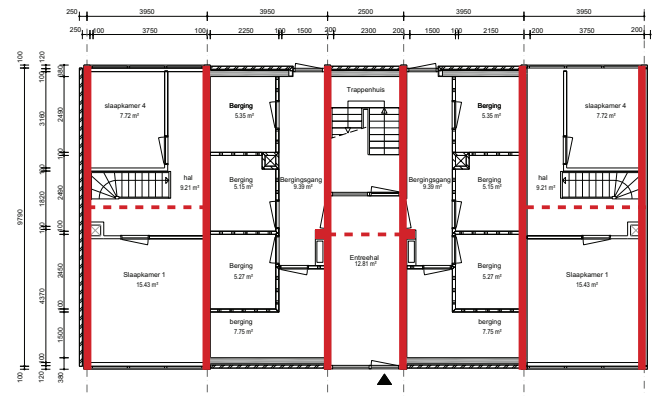
Ground floor

— Load bearing walls

The load bearing structure is still in a good condition but has big influence on the flexibility of the floor plan when redesigning. The walls are fixed with a certain distance and the space in between has a maximum of 3950mm. This gives proper dimensions of each room but this limits as well the flexibility of the floor plan. When parts of the load bearing walls are removed, constructive measures should be probably taken. The walls in between the bays can be removed with exception of the stability walls. If these are removed other stability measures should be introduced. The structure is limiting the possibility of combining apartments together. Because the apartments are separated by load bearing walls which are interlocking with the floor slabs. Small interventions of introducing stairs and doors in the structure are possible in consultation with a structural engineer. Sound can be as well a problem of the structure, the wall between apartments is 20 cm. The standard for massive house separating walls is nowadays 30 cm (SBRCURnet, z.j.).

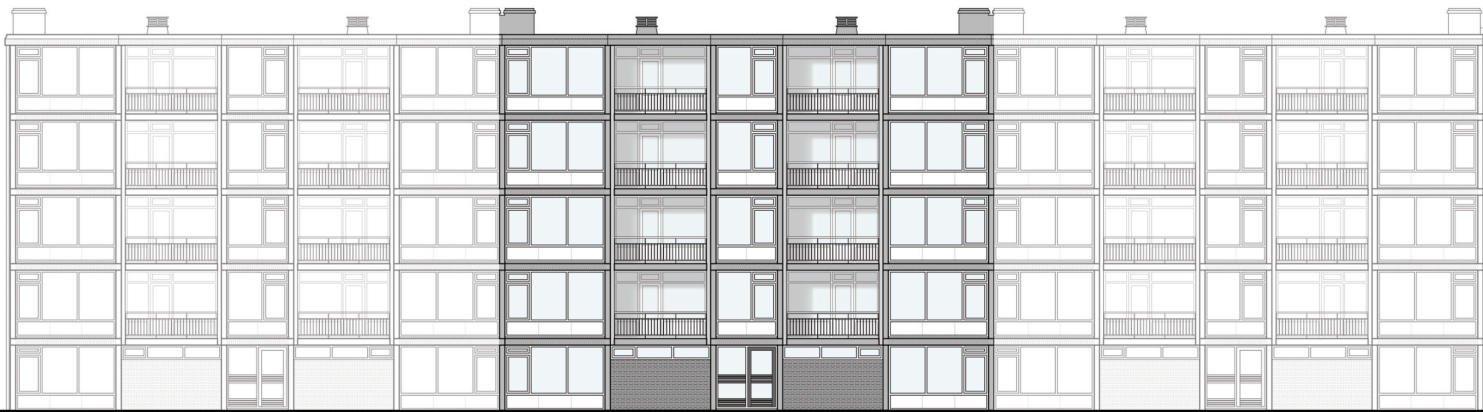
Figure 1. 3.1 Front elevation (before renovation) 1:300

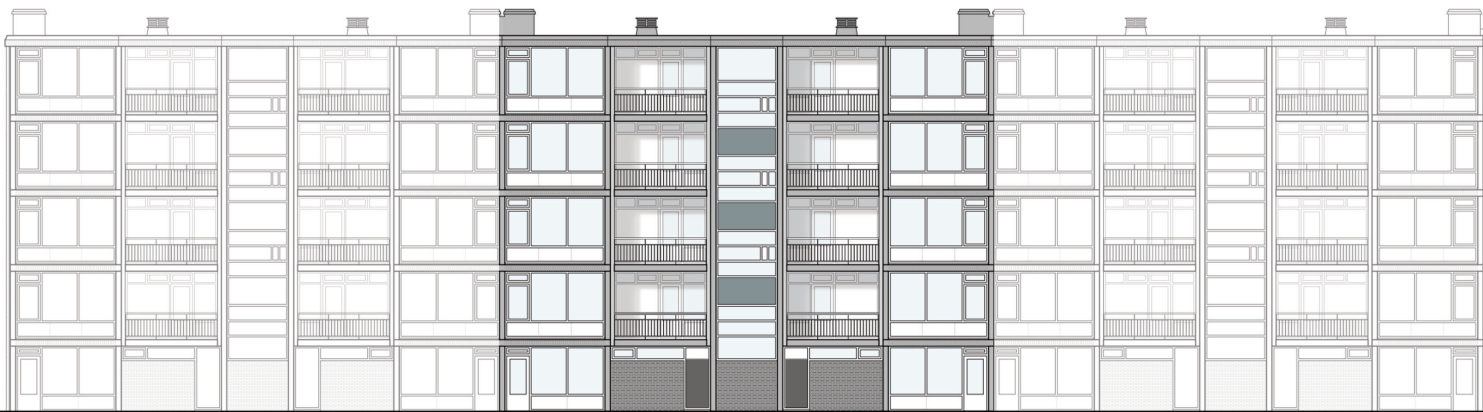
Figure 1. 3.2 Rear elevation (before renovation) 1:300

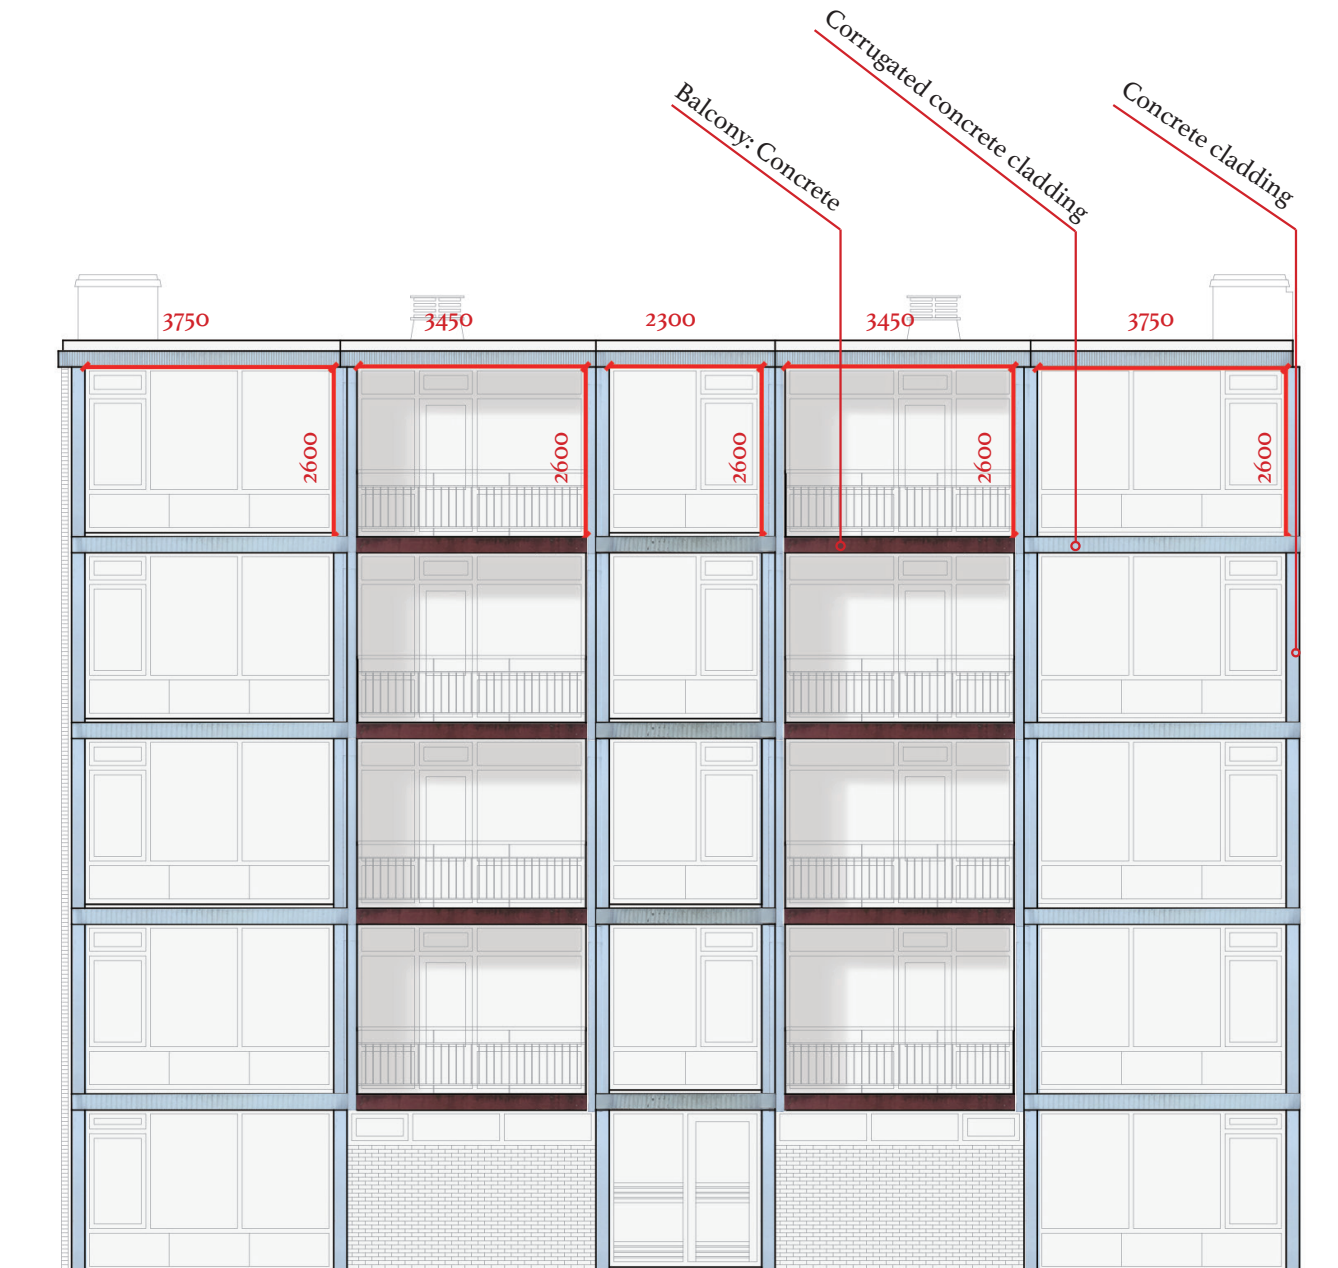
There is a reduction on the skin: only the concrete elements, which has been reduced to its minimum size to fulfill its function as protectors are rigid. The resulting large openings in the grid provide possibility for flexibility of its infill. The possibility is discussed in the following section "Infill".

Figure 1.3.3
Overview of Concrete Frame in one portiek

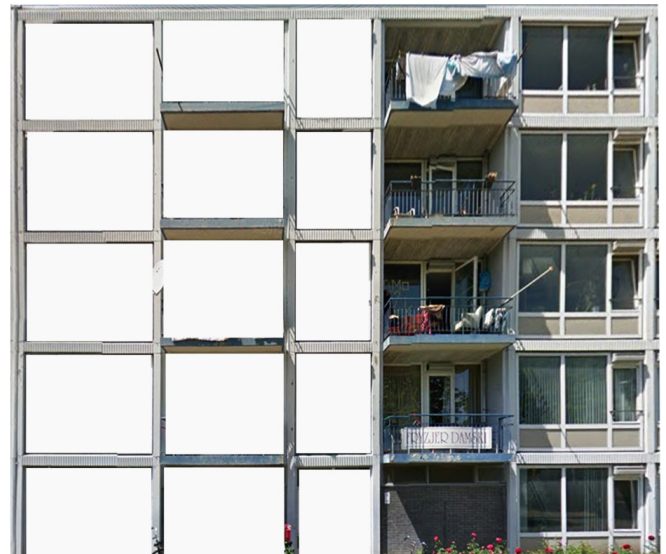
Figure 1.3.4. Comparison between a skin with the grid only and with both grid and infill

The special concrete structure system of VAM is expressed on the facade by the concrete frame, becoming a strong characteristic of Intervam flats and makes them recognizable. Nevertheless the intelligent frame is weakened by its infill (figure 1.3.4).

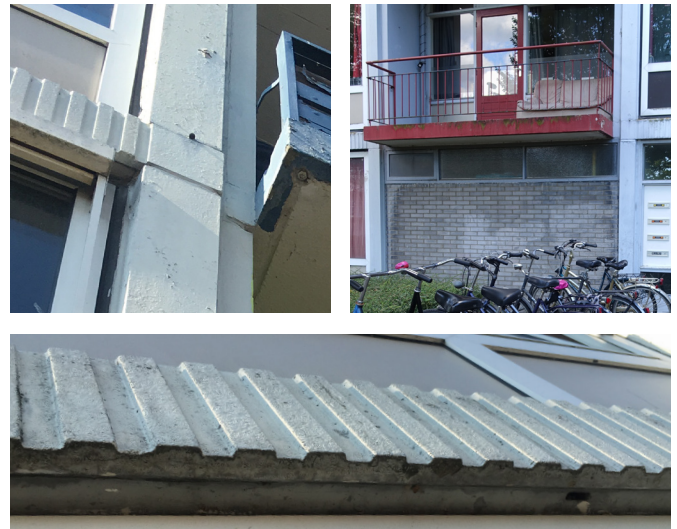
In order to protect the concrete structure, prefabricated cladding elements are attached to the structure, including the vertical concrete fragment (figure 1.3.5), horizontal elements for balcony and the corrugated horizontal elements. No literature has been found to explain the original purpose of design for these prefabricated elements, but we assume that the corrugated horizontal elements are designed for rainwater drainage, and decoration.

Figure 1.3.5 . Prefabricated fragments attached to structure

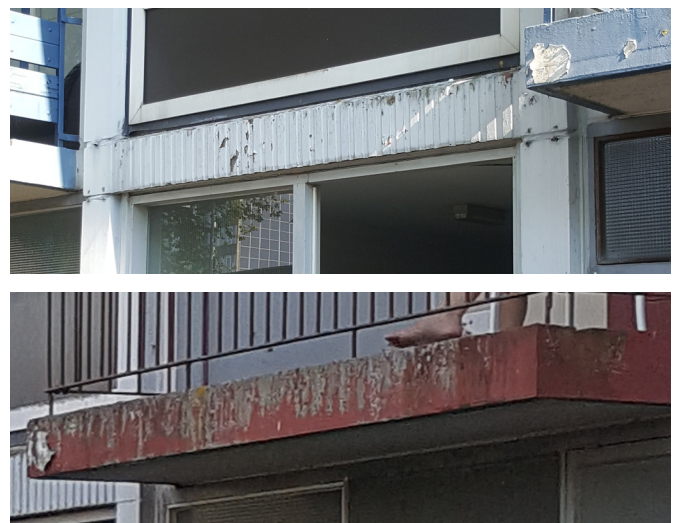
The painting on claddings of Camera Obscuradreef contributes to maintenance of the fragments, nevertheless the painting applied to it has felled off (figure 1.3.6.). Aesthetically the concrete frame is weakened because of the worn-out facade.

Figure 1.3.6 . Cladding with poor maintenance

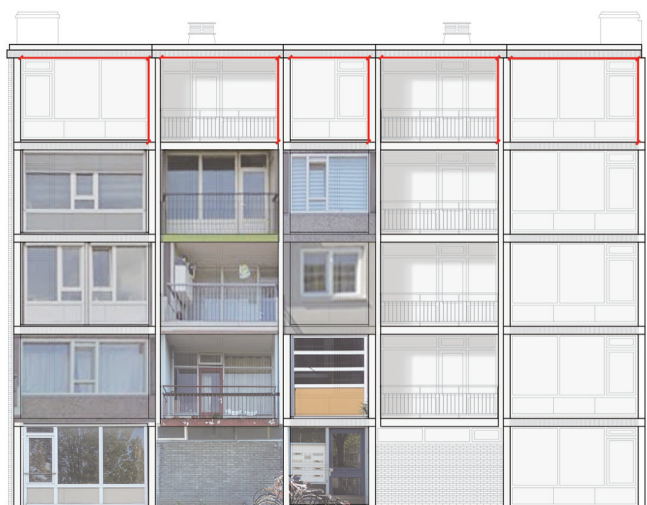
Figure 1.3.7. Concrete frame in Camera Obscuradreef filled with different elements

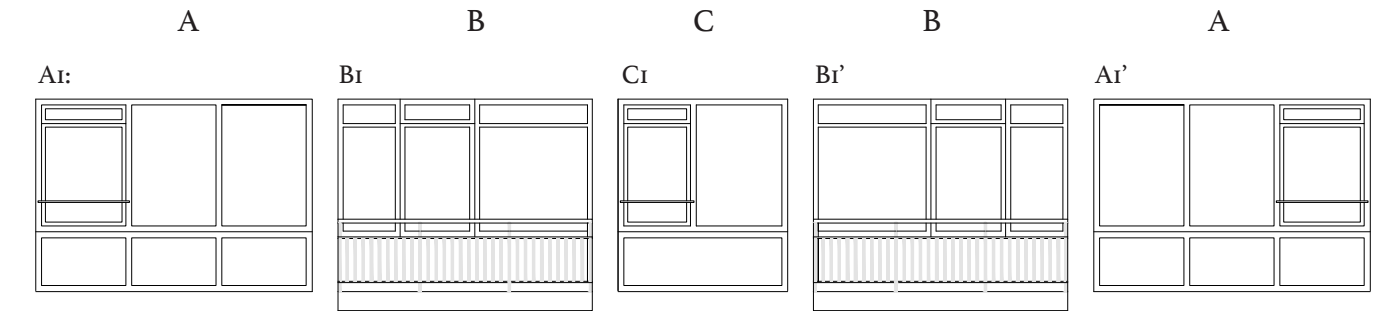
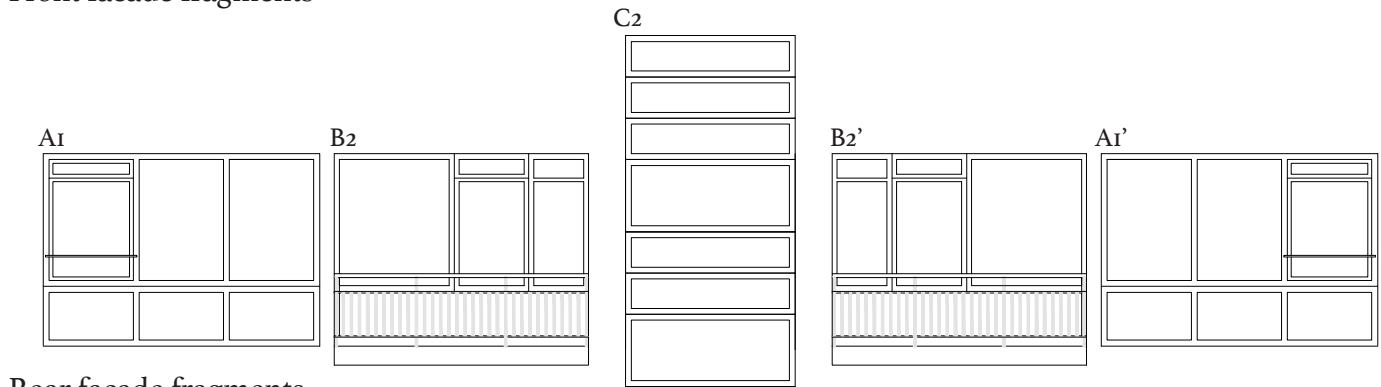
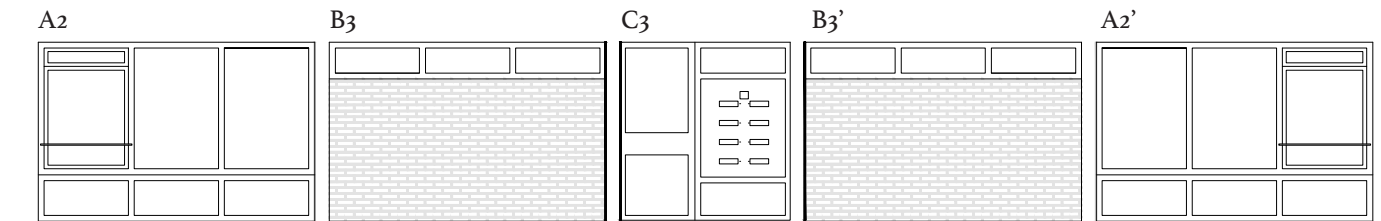
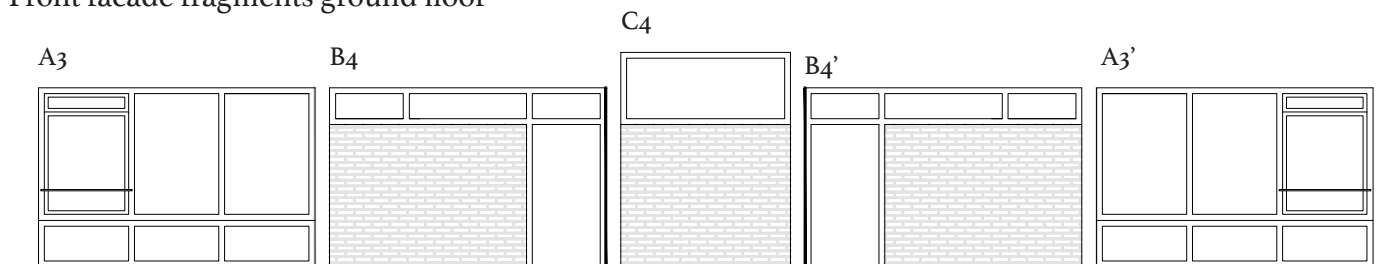
Front facade fragments

Rear facade fragments

Front facade fragments ground floor

Rear facade fragments of ground floor

Figure 1.3.12 fragments infilled into concrete grid

One portiek is consist of 5 bays and it has been copied many times next to each other. The appearance of front and rear facade is almost

same except for the one bay in the middle. The skin could be flexible according to the different functions of the ground floor.

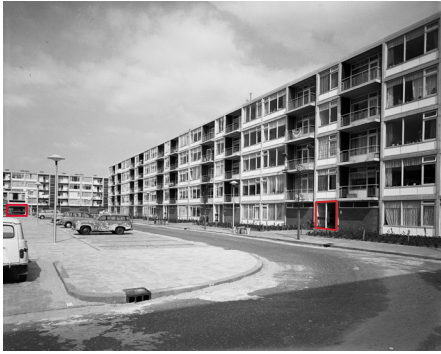
* Figure 1.3.13. 1984: Before renovation Mailbox was in the entrance hall; The passages were opened.

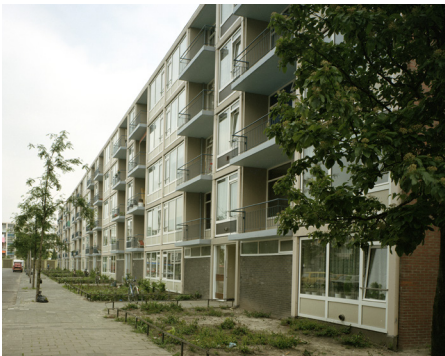
*Figure 1.3.15. 1984 After Renovation: Fall protection was added.

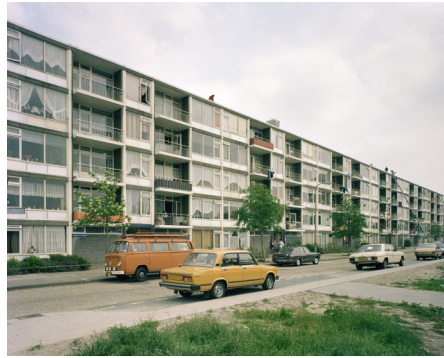
*Figure 1.3.14. 1984: Timber window frame with Single glazing

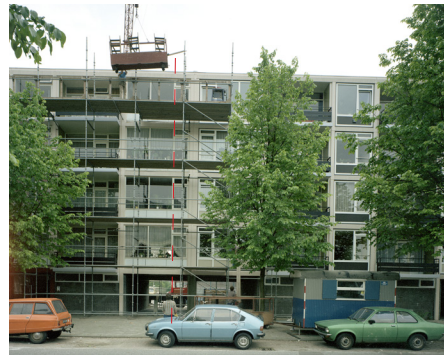
*Figure 1.3.16. 1984: Being renovated with plastic window frames

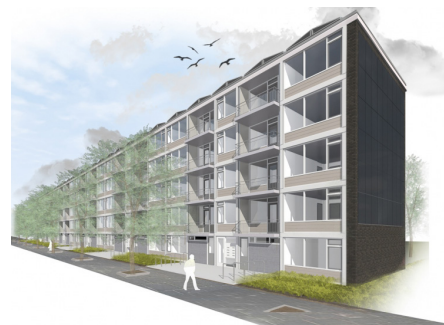
Figure 1.3.18. Future: Mitros has launched the renovation for zero-energy flat. (<http://www.onb.nl/wp-content/uploads/flat-met-toekomst-4-700x500.jpg>)

Future: To bring the building back to the future Mitros is starting a test with the Energy zero portiek where the plastic window frames will be replaced by Aluminum frames with triple glazing to save energy. The parapets are also renewed and the installations will be made to achieve energy zero standards. In 2017 the renovation will be tested for 1 year. If the results meet the requirements it will be applied on 40 houses.

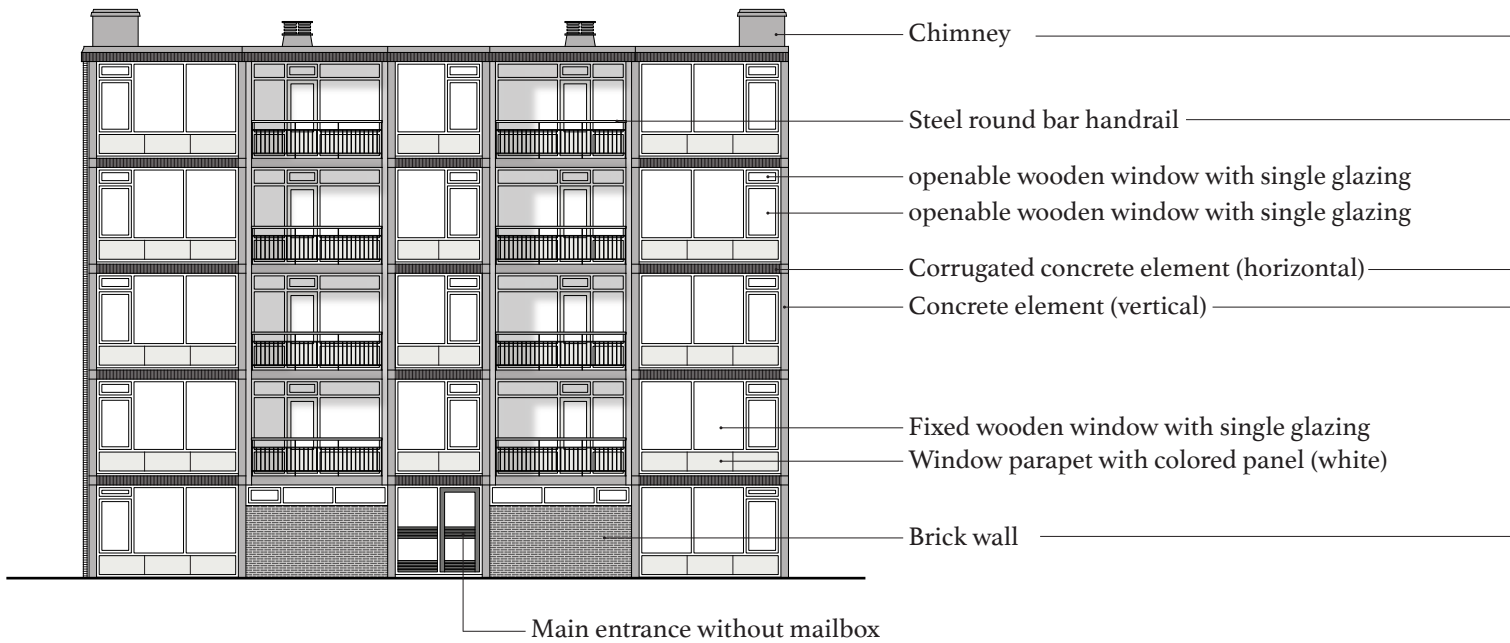
Figure 1.3.24. Front elevation (before renovation) 1:200
