INTERVAM

Graduation Studio - Heritage & Architecture - Re-Housing
Analysis Group Intervam - Rick Hoofd - Xiaoyu Chen - Chi Teng - Heejin Chung

This research report is a result of the first stage PI of our Graduation studio Re-Housing, which is under Chair of Heritage & Architecture at the Faculty of Architecture of Delft University of Technology.

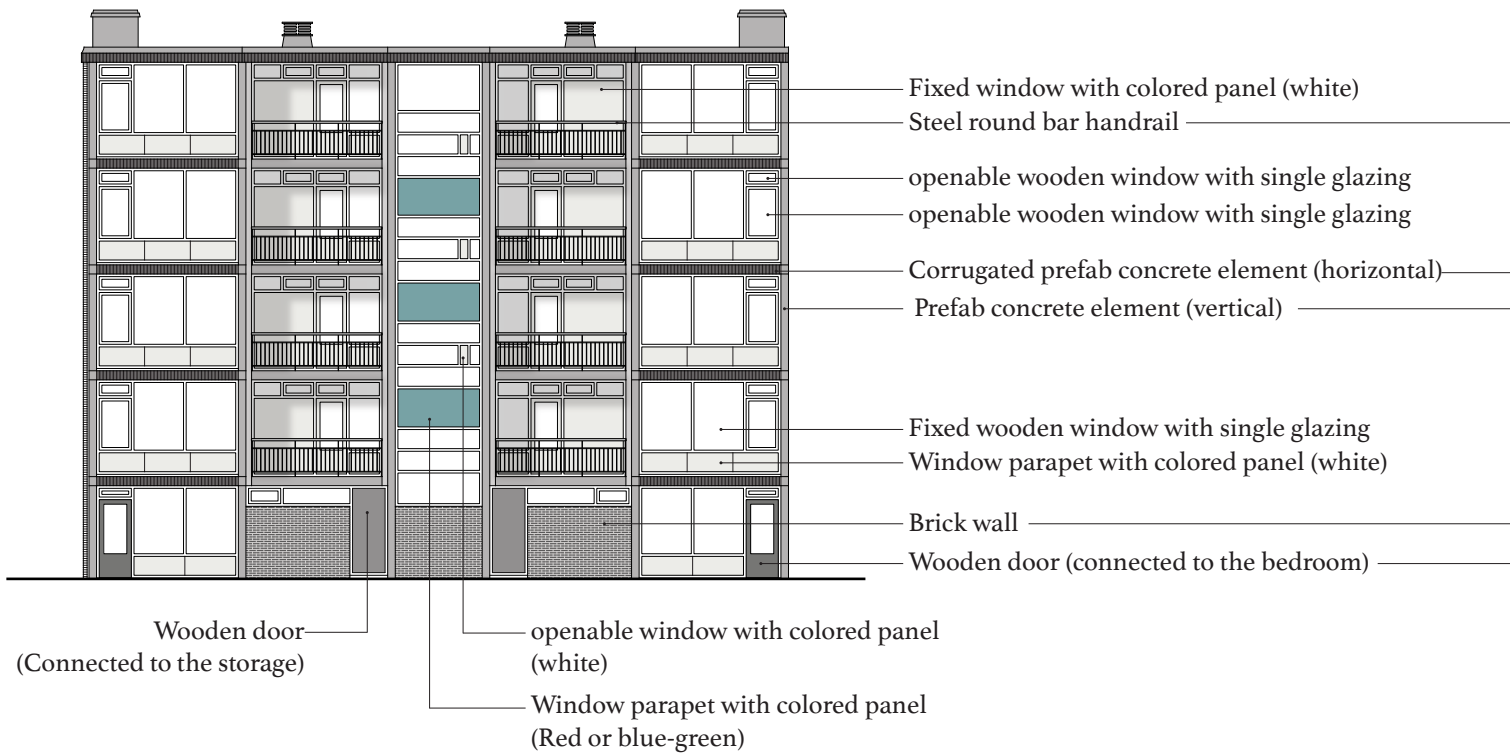
Figure 1.3.25. Rear elevation (before renovation) 1:200

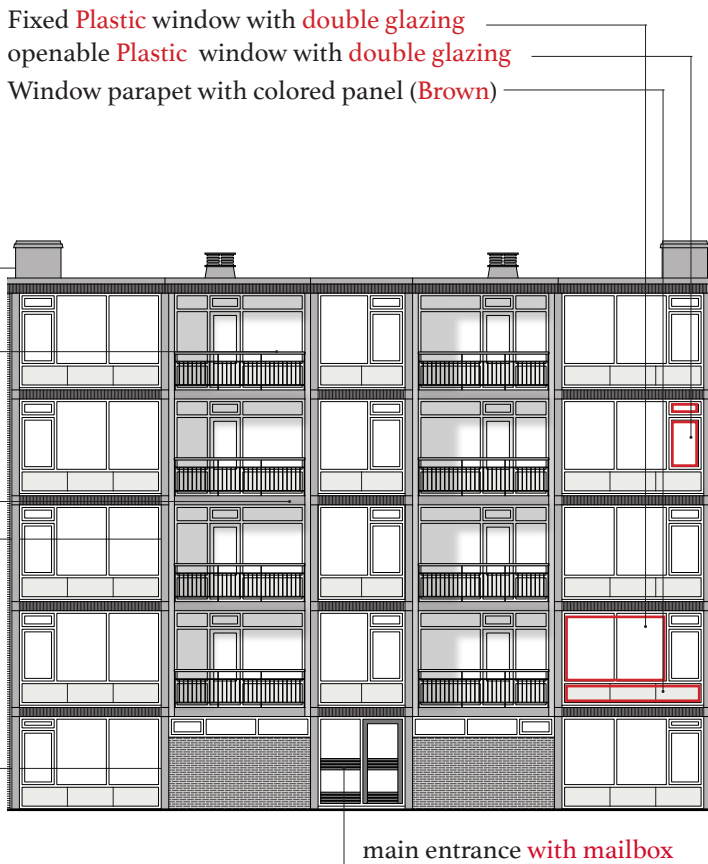
Figure 1.3.26. Front elevation (After renovation) 1:200

Aim renovation: With the renovation of 1984 the facade got a new appearance. The concrete got painted, windows were replaced by plastic window frames and double glazing, silencers and asbestos were placed as technical improvements. Possible reasons for this renovation can be: reduce maintenance, lifespan, save energy, fire safety, upgrade comfort in the rooms and create a modern appearance.

Future: To bring the building back to the future Mitros is starting a test with the Energy zero portiek where the plastic window frames will be replaced by Aluminum frames with triple glazing to save energy. The parapets are also renewed and the installations will be made to achieve energy zero standards. In 2017 the renovation will be tested for 1 year. If the results meet the requirements it will be applied on 40 houses.

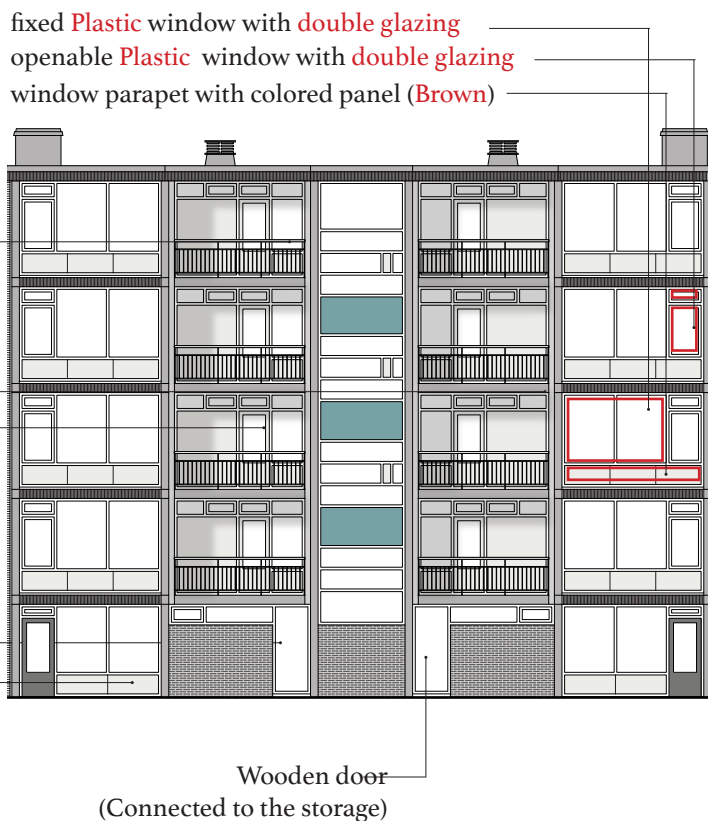
Figure 1.3.27. Rear elevation (After renovation) 1:200

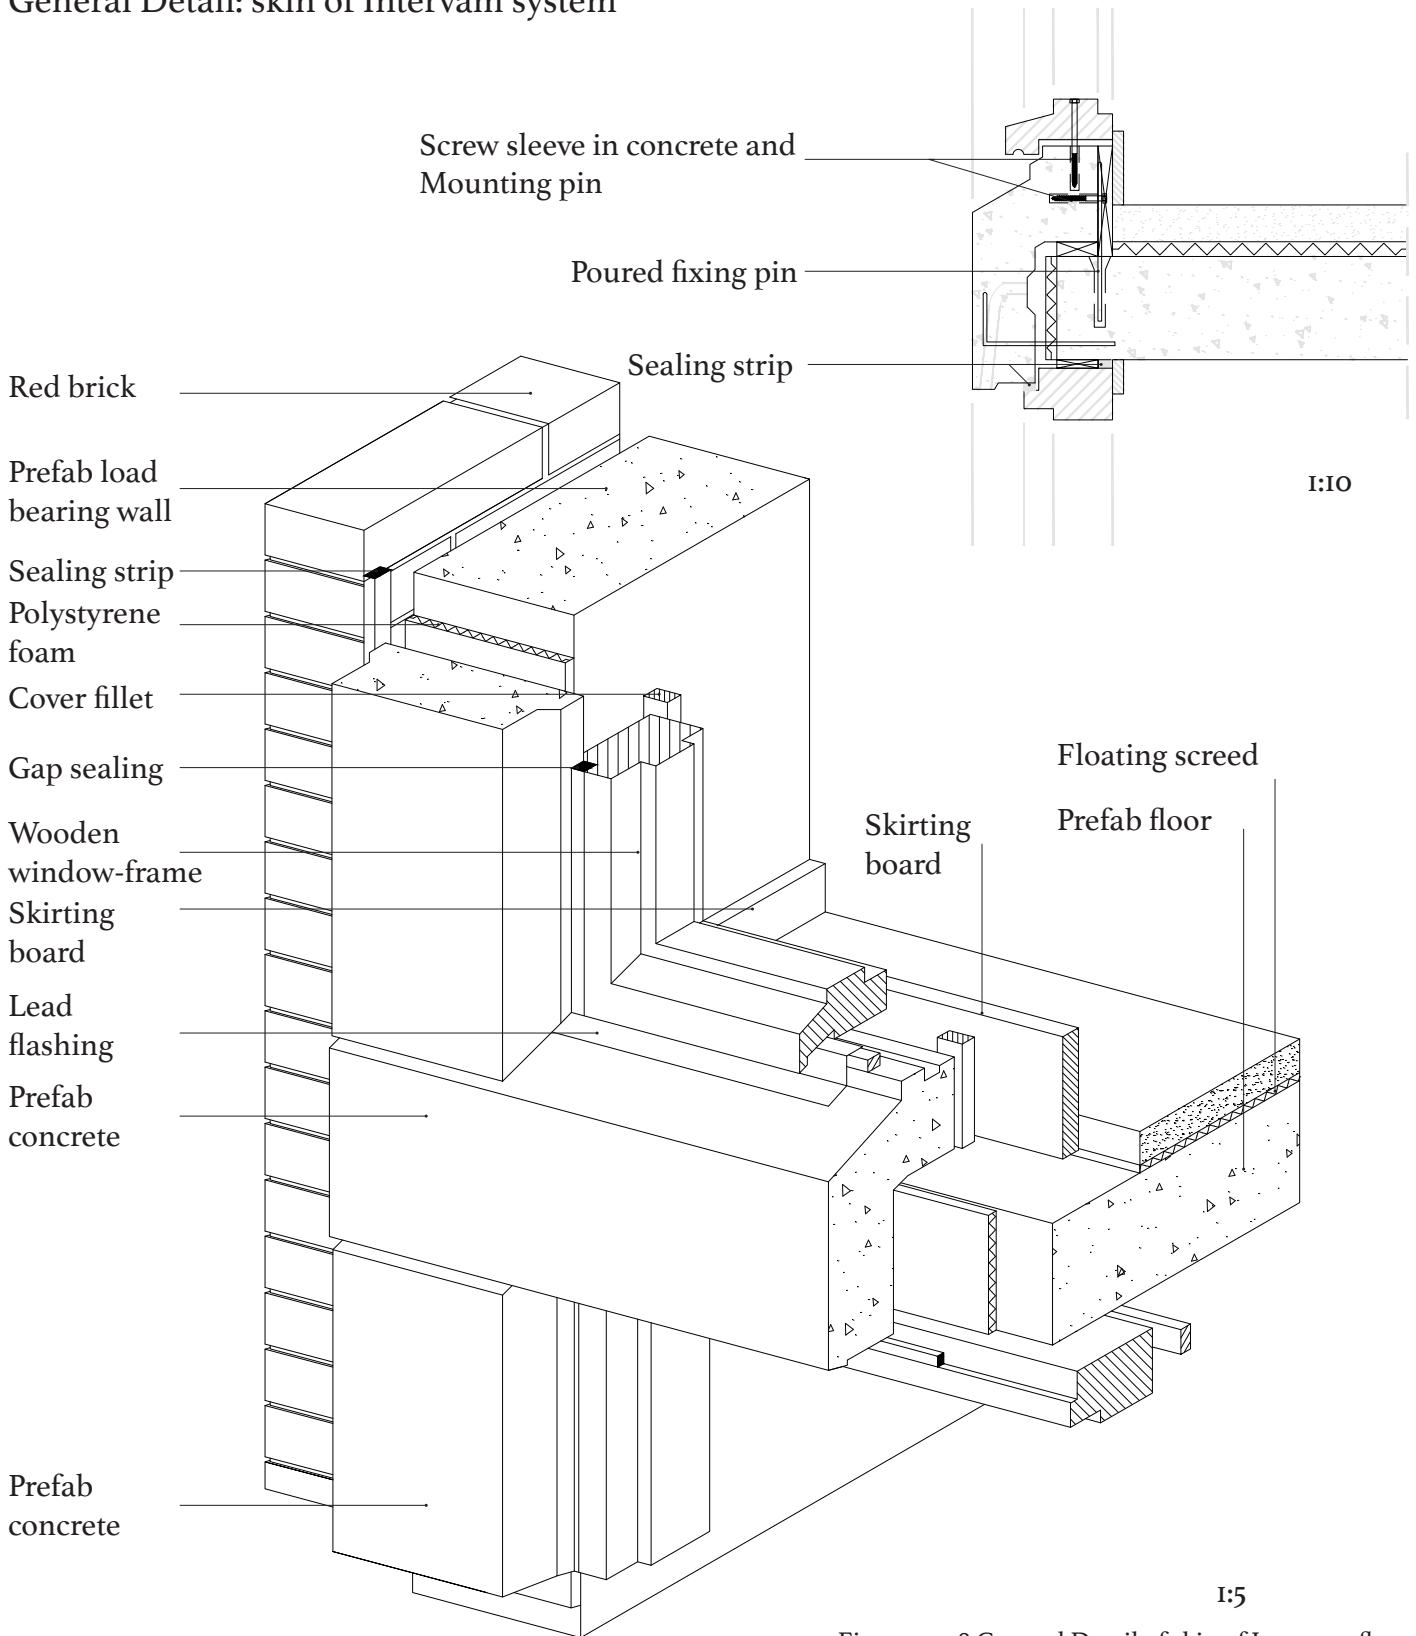
Figure 1.3.28 General Detail of skin of Intervam flat Factories and production. (Priemus & Van Elk, 1971).

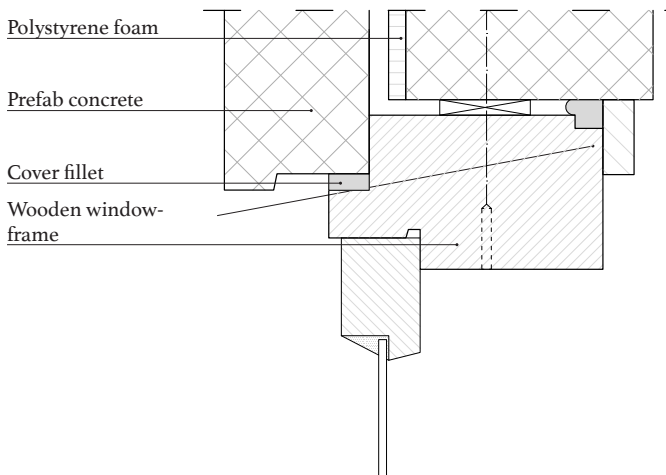
Vertical section detail

Figure 1.3.29 wooden window frame (before renovation)

Aim renovation: With the renovation of 1984 the wooden window frames has been replaced for plastic frames with double glazing with exception of the frames at the balconies, the storages and the entrance. Possible reasons for this renovation can be: reduce maintenance, lifespan, save energy, upgrade comfort in the rooms and create a modern appearance.

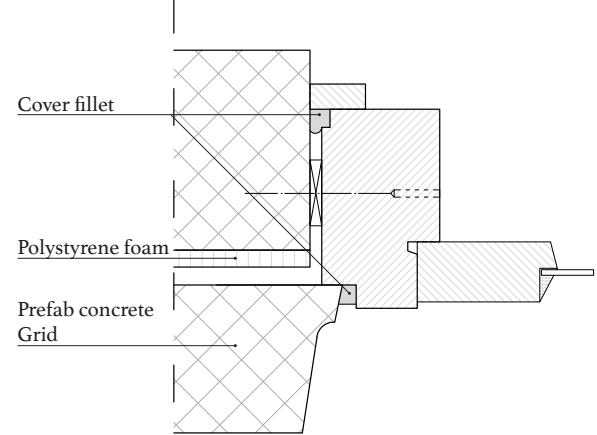
Horizontal section detail

Figure 1.3.30 wooden window frame (before renovation)

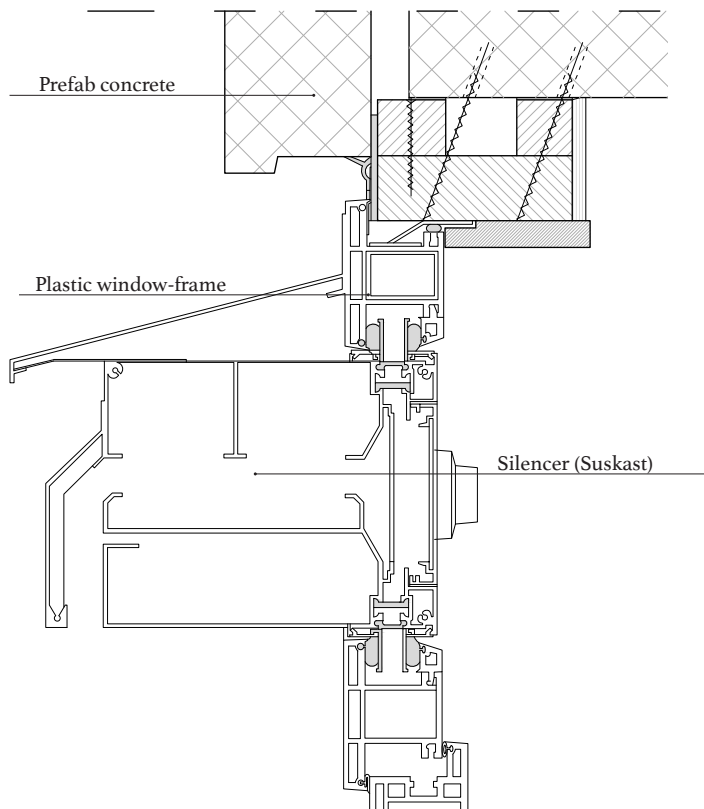
Figure 1.3.31 plastic window frame (after renovation)

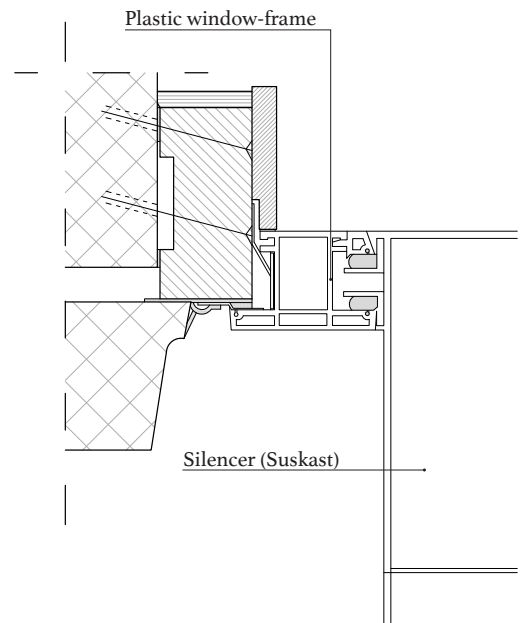
Figure 1.3.32 plastic window frame (after renovation)

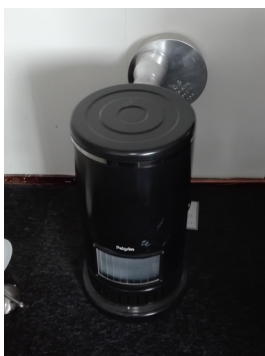
Fig. 1.2.1: Student 1: Gas heater

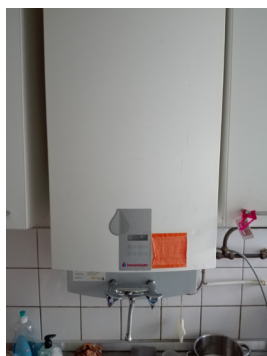
Fig. 1.2.2: Student 1: Gas boiler

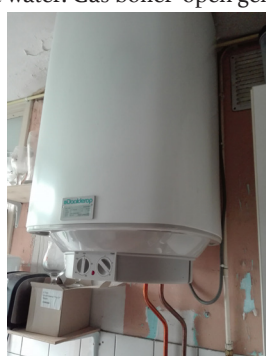
Fig. 1.2.5: Student 4: Electric boiler

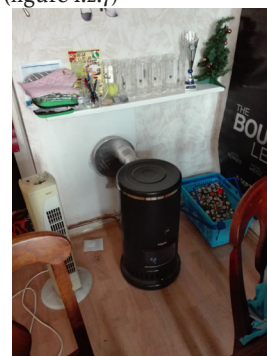
Fig. 1.2.6: Student 4: Gas+electric

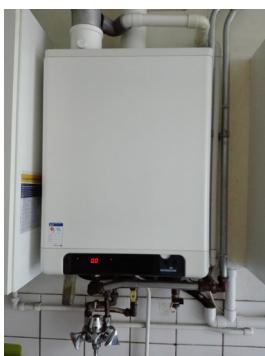
Fig. 1.2.3: Student 2: CV ketel
Student 3: placed in storage

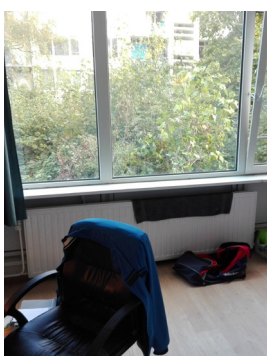
Fig. 1.2.4: Student 2, 3 and
family: Radiator

Other rooms: Radiators (figure. 1.2.4)

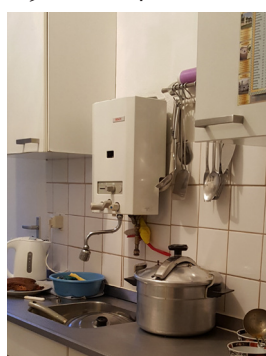
Fig. 1.2.7: Family: Gasboiler
(open geiser)

Hot water: Gas boiler 'open geiser' (figure 1.2.7)

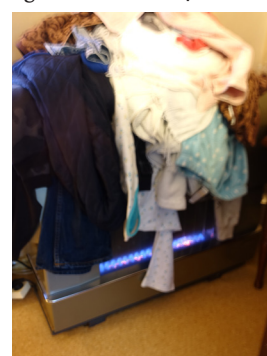
Fig. 1.2.8: Family: Gas heater
(moederhaard)

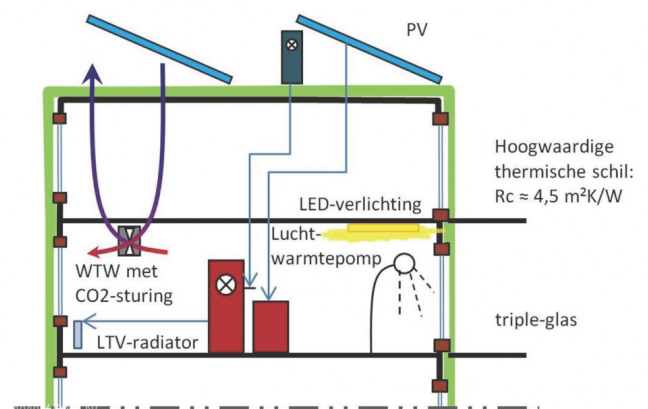
Figure 1.2.9: Energy zero system, Mitros. (n.d.).

Mitros has started a pilot project with one portiek. The 8 apartments, which are located in the portiek, will be renovated to zero energy housing (nul-op-de-meter woningen). In this project, no fossil fuel will be used to heat the dwelling (Straver, 2016). These homes are inhabited for a period and the results will be analyzed. If the results are according to the concept of 'zero-to-the-meter' another 40 properties will be renovate according to the same principal as can be seen in figure 1.2.9 (Mitros, n.d.).

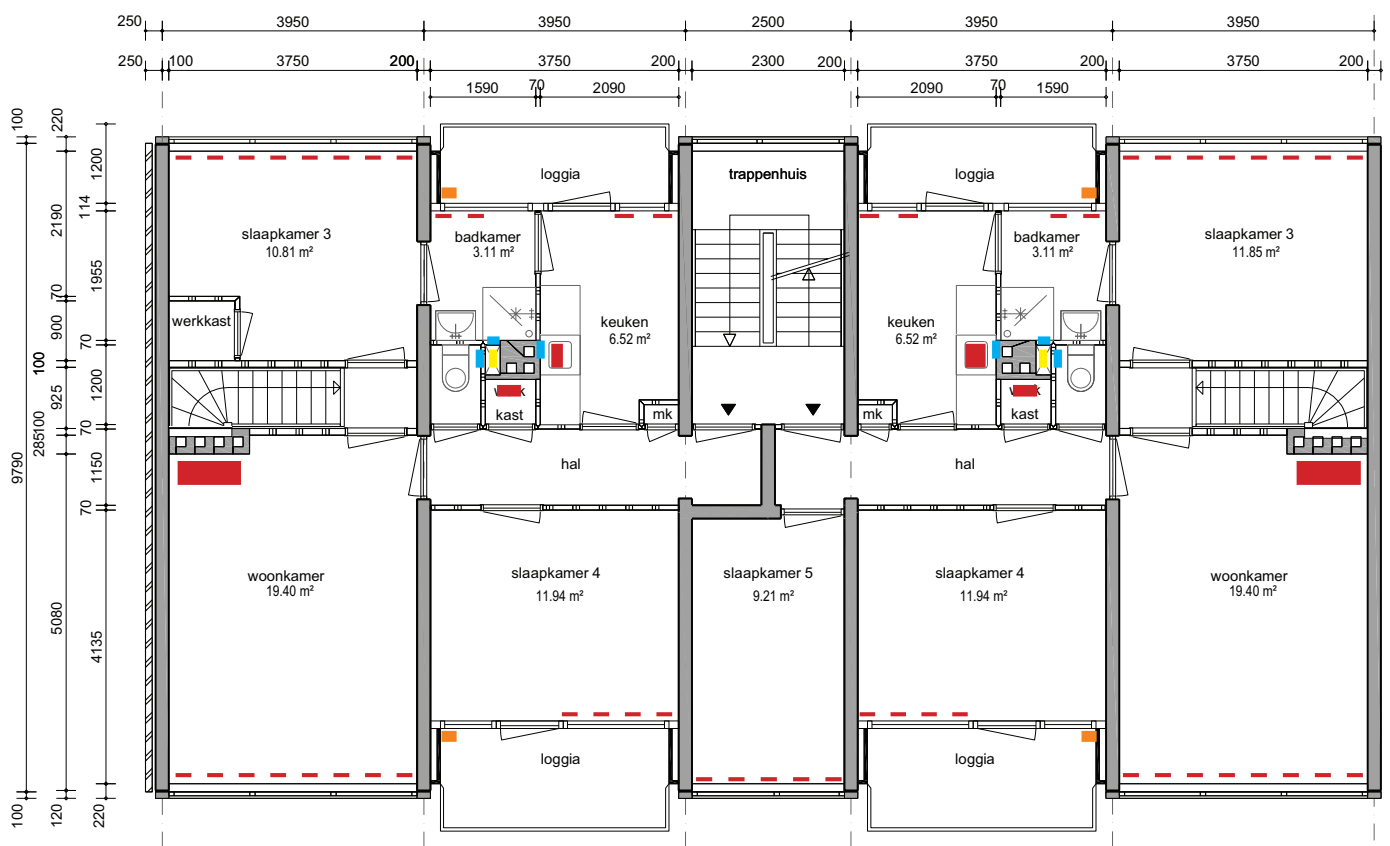
The gas line, electricity and water line is introduced from below the street into the storage to the fuse box. From the fuse box they are divided into the dwelling. Pipes for the electricity and water are cast in the prefab concrete. The rainwater is drained by the drainpipe at the balcony and the sewage water is drained by a pipe in the shaft behind the kitchen see figure I.2.10.

Figure I.2.10: Services

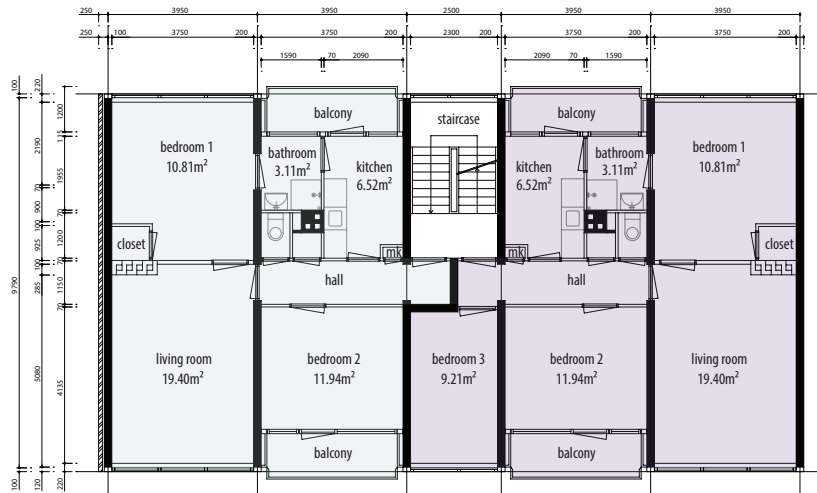
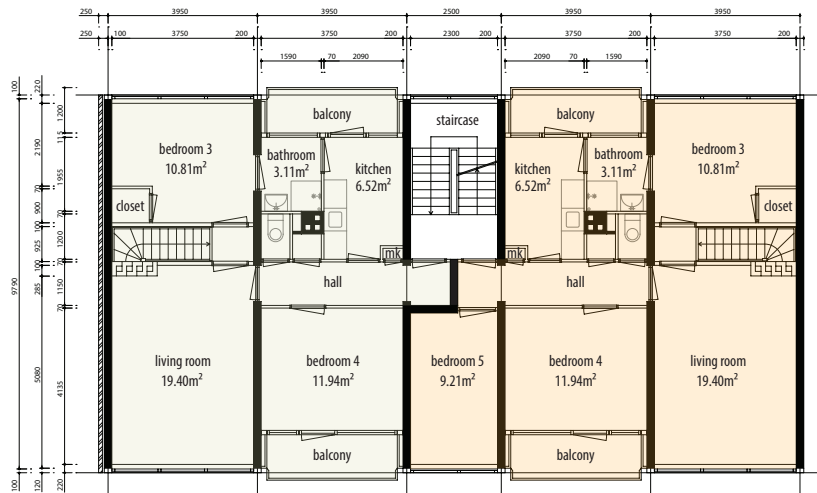
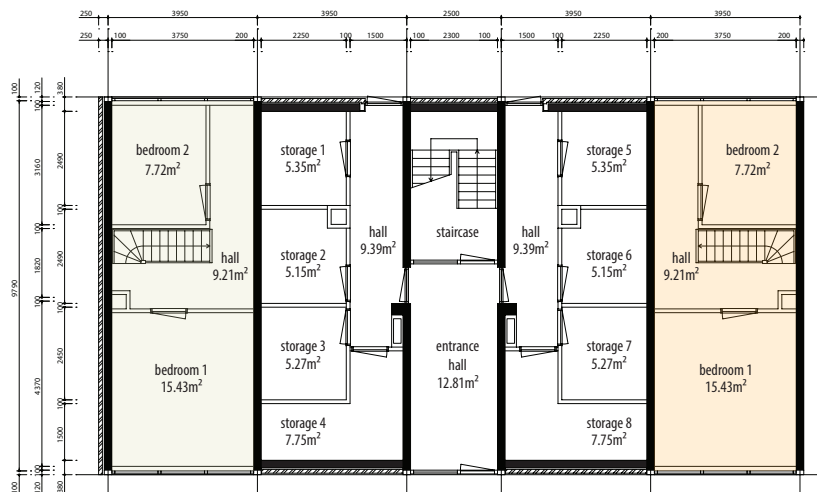
2nd - 4th floor plan

1st floor plan

Ground floor plan

Figure 1.5.2 Floor plan of dwellings in the Intervam buildings, Camera Obscuradreef, Overvecht, Utrecht

For all types of apartments, the hallway directly connects bedrooms, living rooms, kitchen and toilet. The bathroom need to be accessed from kitchen or one of the bedrooms, which might cause some inconvenience.

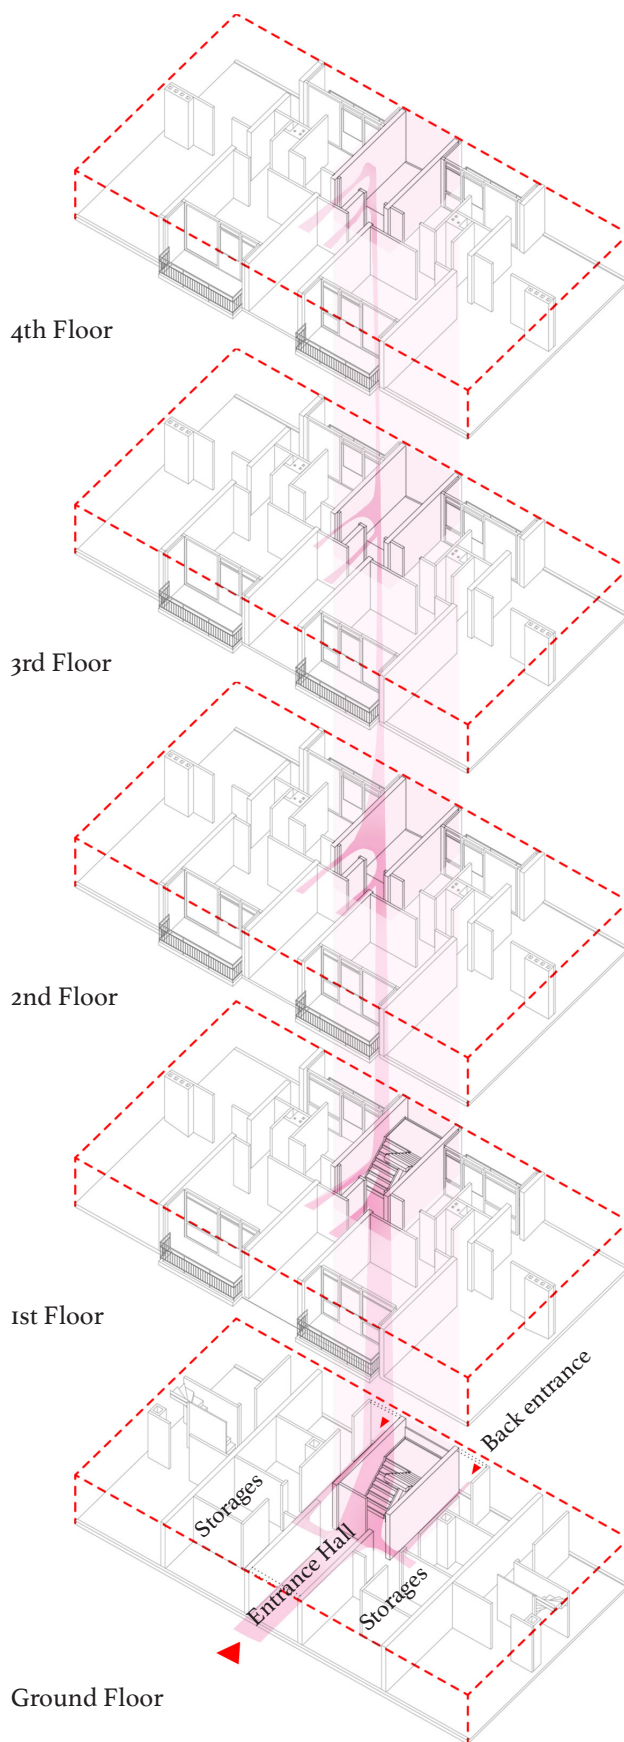
The stairwell and the entrances of each portiekflat are shared by 8 apartments. The stairwell will carry low traffic when it goes higher. One main entrance connects the entrance hall, stairwell and storages on ground floor. Two back entrances, which are more private, are used as access from gardens to storages.

Figure 1.5.3 Circulation of Intervam Portiek

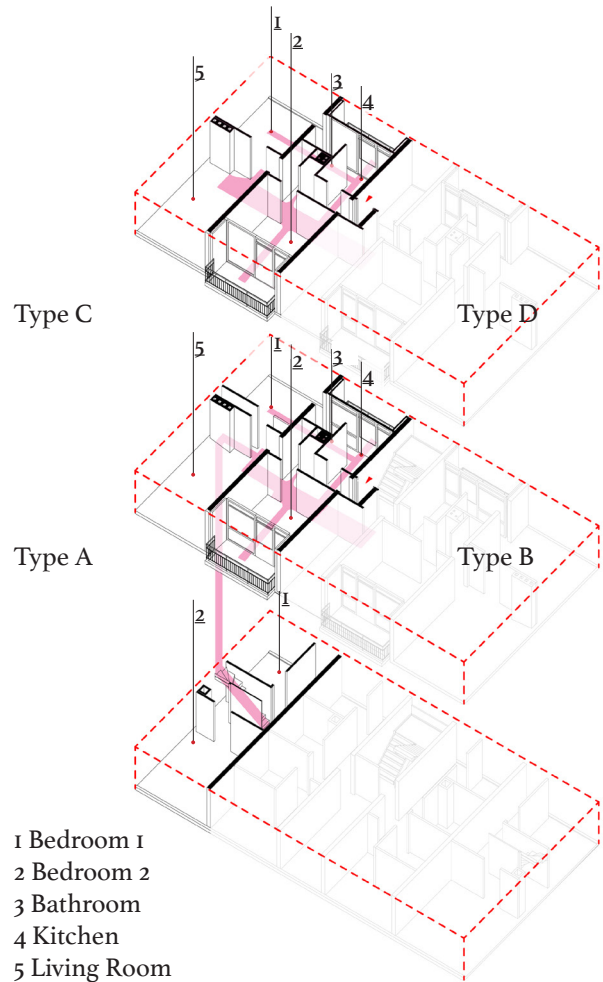
For apartment type A and type B, there are two more bedrooms on ground floor, which should be accessed from first floor. The two rooms are connected with the upper floor by a narrow staircase. The two bedrooms could be independent from the living area on the first floor because it can have its own access on the ground floor.

Diagram 1.5.4 Circulation of Intervam apartment, type A and C

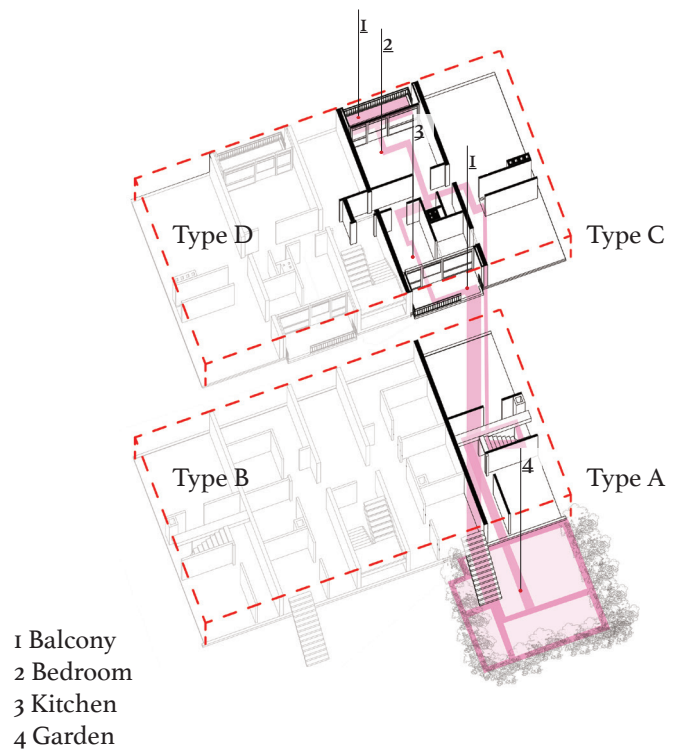
Apartment type A and B can enjoy their private gardens on ground floor. The garden can be accessed from the walkway on ground floor. Moreover, external stairs attached to the balcony on the kitchen connect the garden.

Figure 1.5.5 Circulation of Intervam apartment, type B and D

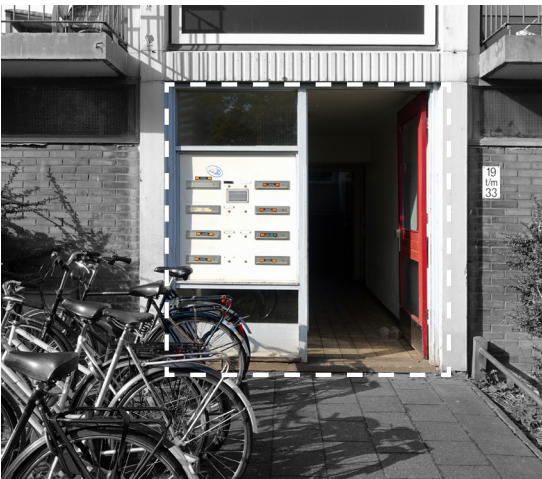
Harsh Border

Figure 1.5.6 The entrance door forms a harsh boundary which causes the immediate transition between indoor and outdoor space.

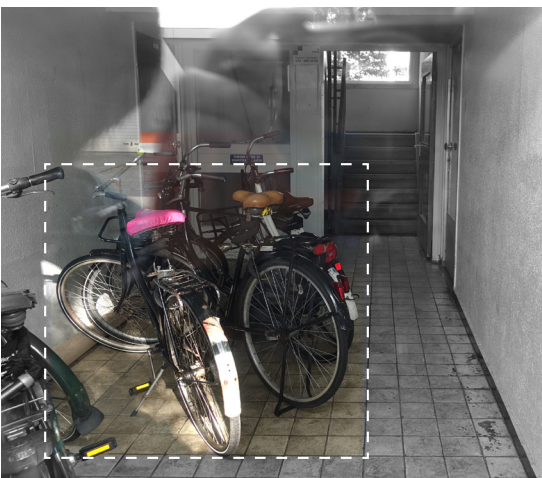
Parking inside

Figure 1.5.8 The size of the hall at the entrance is relatively small and some of them are used to parking the bicycles for security reasons, which makes them narrower.

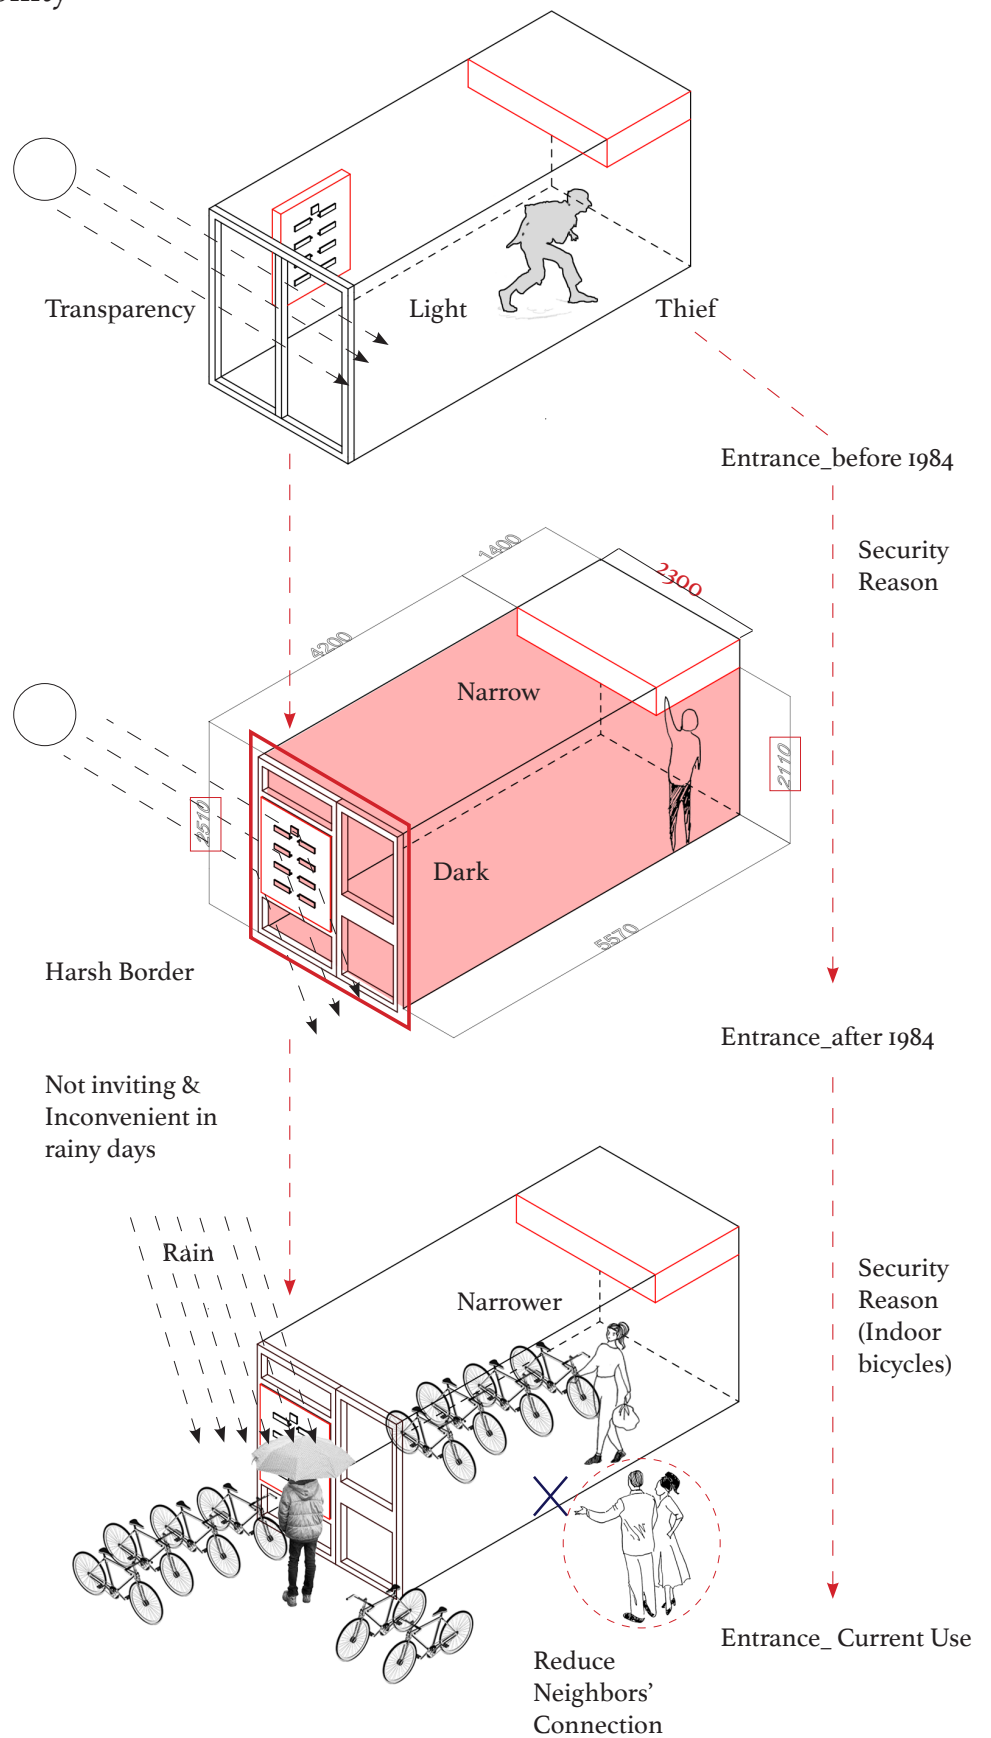
Figure 1.5.10 Entrance of the Intervam buildings, Camera Obscuradreef

The entrance of the portiekflat was designed to serve for 8 households. Before 1984, the space of entrance was bright and translucent with glass interface in its front. The mail box was arranged inside (see figure 1.5.10). Stranger and thief might get the chance to go inside and increase the potential insecurity.

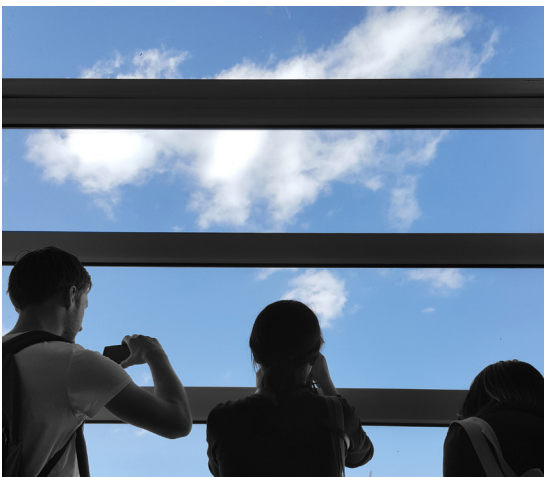
View of Nature

Figure 1.5.11 Residents get a nice view of nature through a large window at landing of the stairwell.

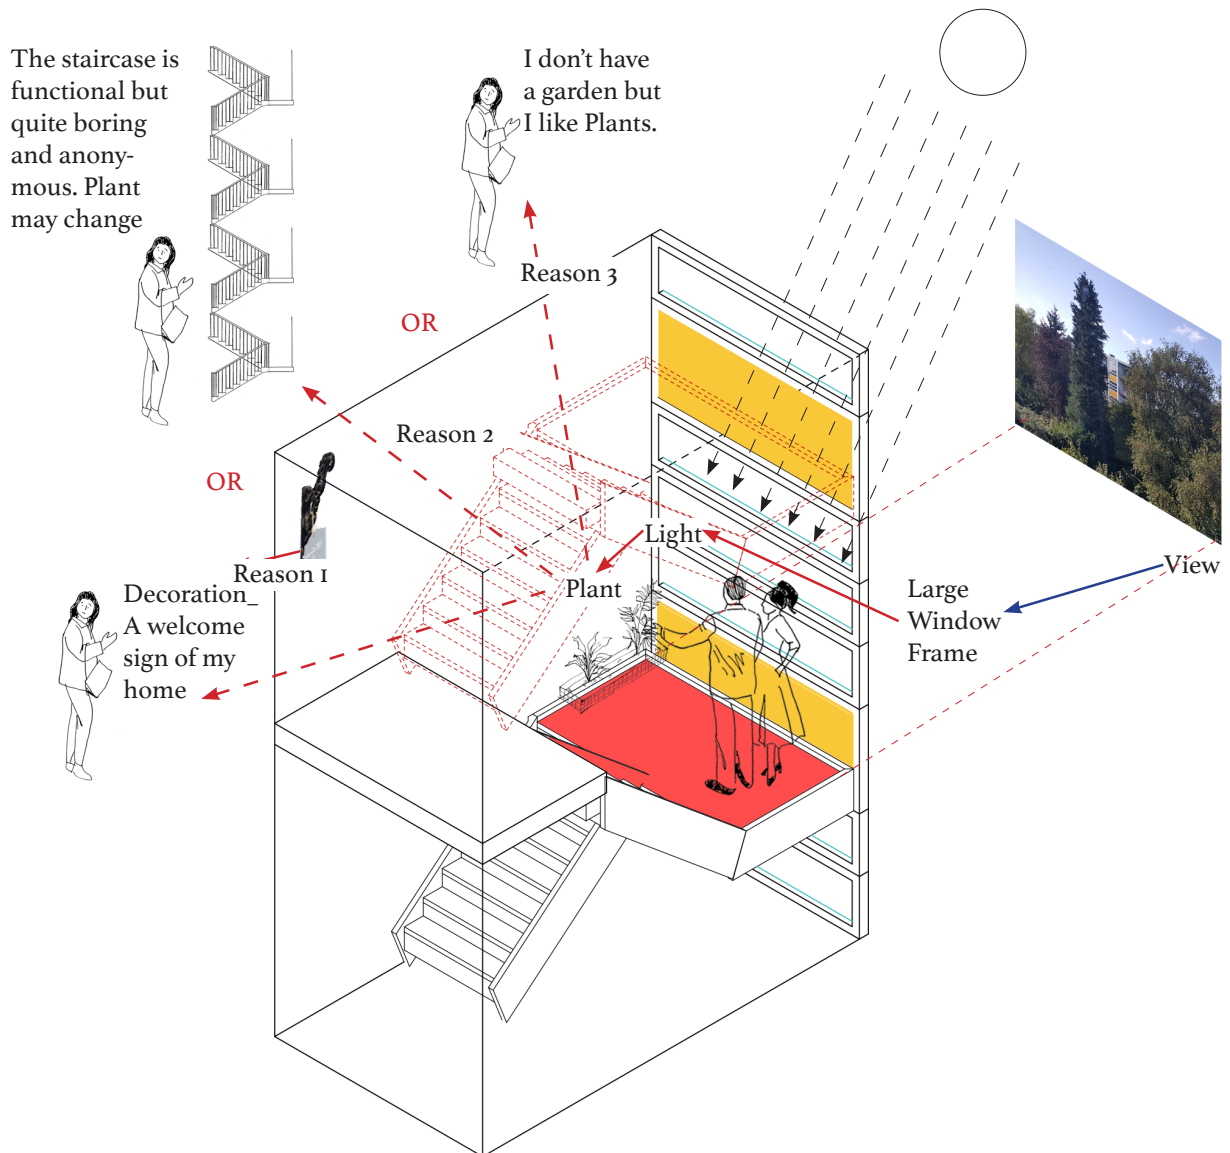
With large window frame, the stairwell is full of light and views.

Figure 1.5.15 Stairwell of the Intervam buildings, Camera Obscuradreef

The stairwell, located at middle bay of the portiek, was designed to be shared by 8 households. For people living in 2-4 floor, it is the only route to escape in case of emergency. With the dimension of 2.3m by 4.2, it is neither big or small and provided a chance for the 8 families to get to know each other. It was intended merely to be functional for circulation. But the residents began to decorate it and add expressions for it during time.

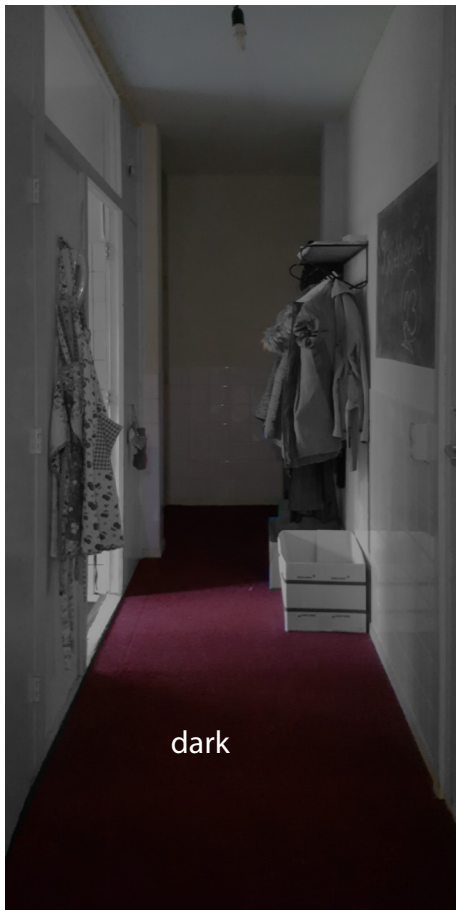
Darkness

Figure 1.5.16 The hallway is with dim light when doors on both sides are closed. Sometimes, tenants have to turn on the light even during daytime.

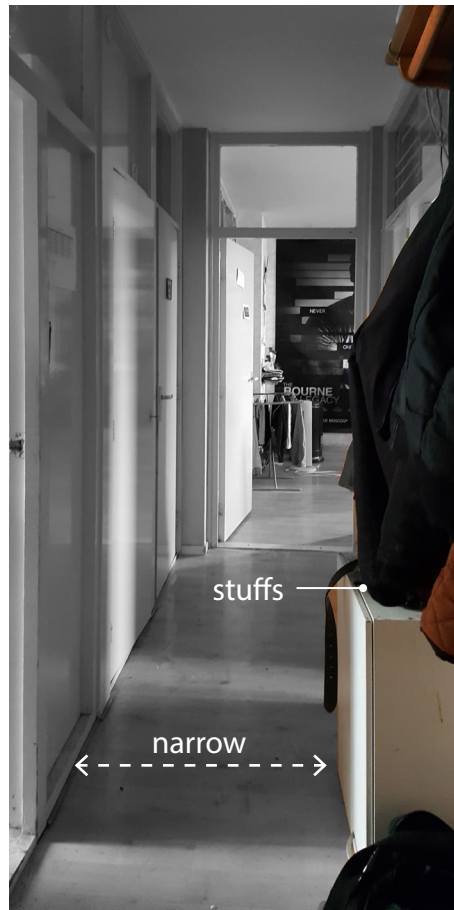
Narrow Space with Stuffs

Figure 1.5.17 Some tenants use it to put coats and shoes when they enter the house or use it as a temporary storage of stuffs, which might cause the hallway even narrower.

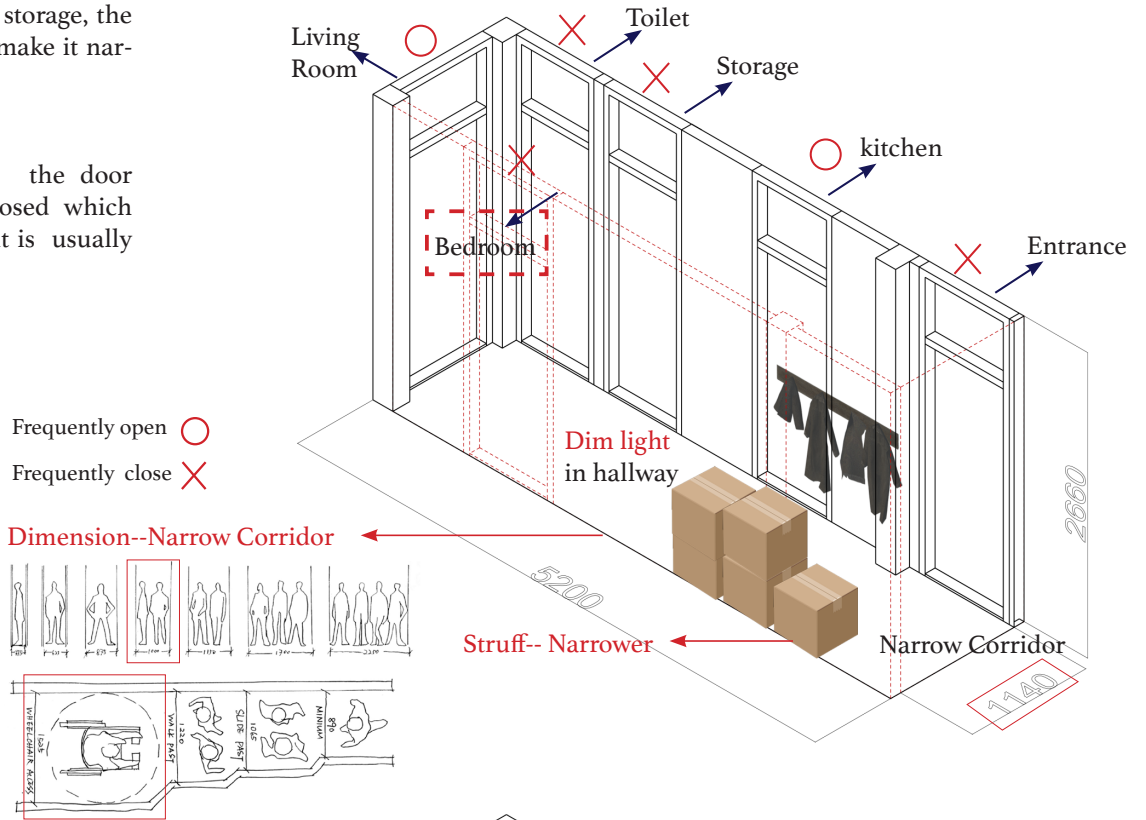
The size of a hallway only meets the minimum requirement and is not possible for wheelchair across

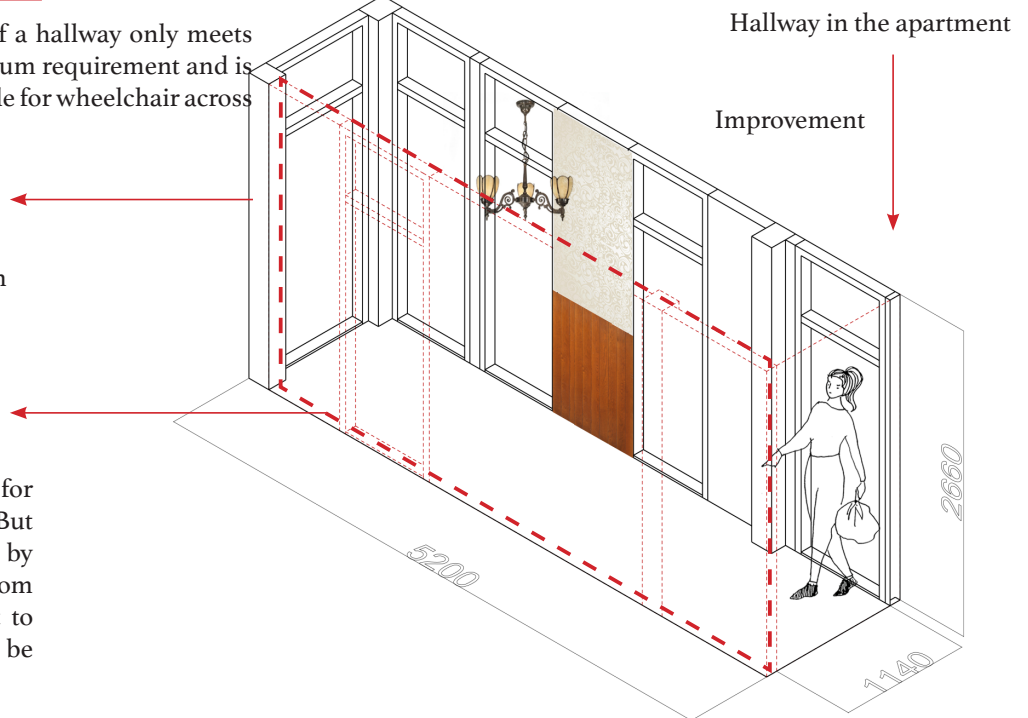
In a sense, the corridor serves for people's flow in an efficient way. But what if the corridor disappears by switching the living room and bedroom and removing bedroom's wall next to the corridor? A bonus space might be gained from the corridor.

Figure 1.5.19 Hallway of the Apartment in Intervam buildings, Camera Obscuradreef

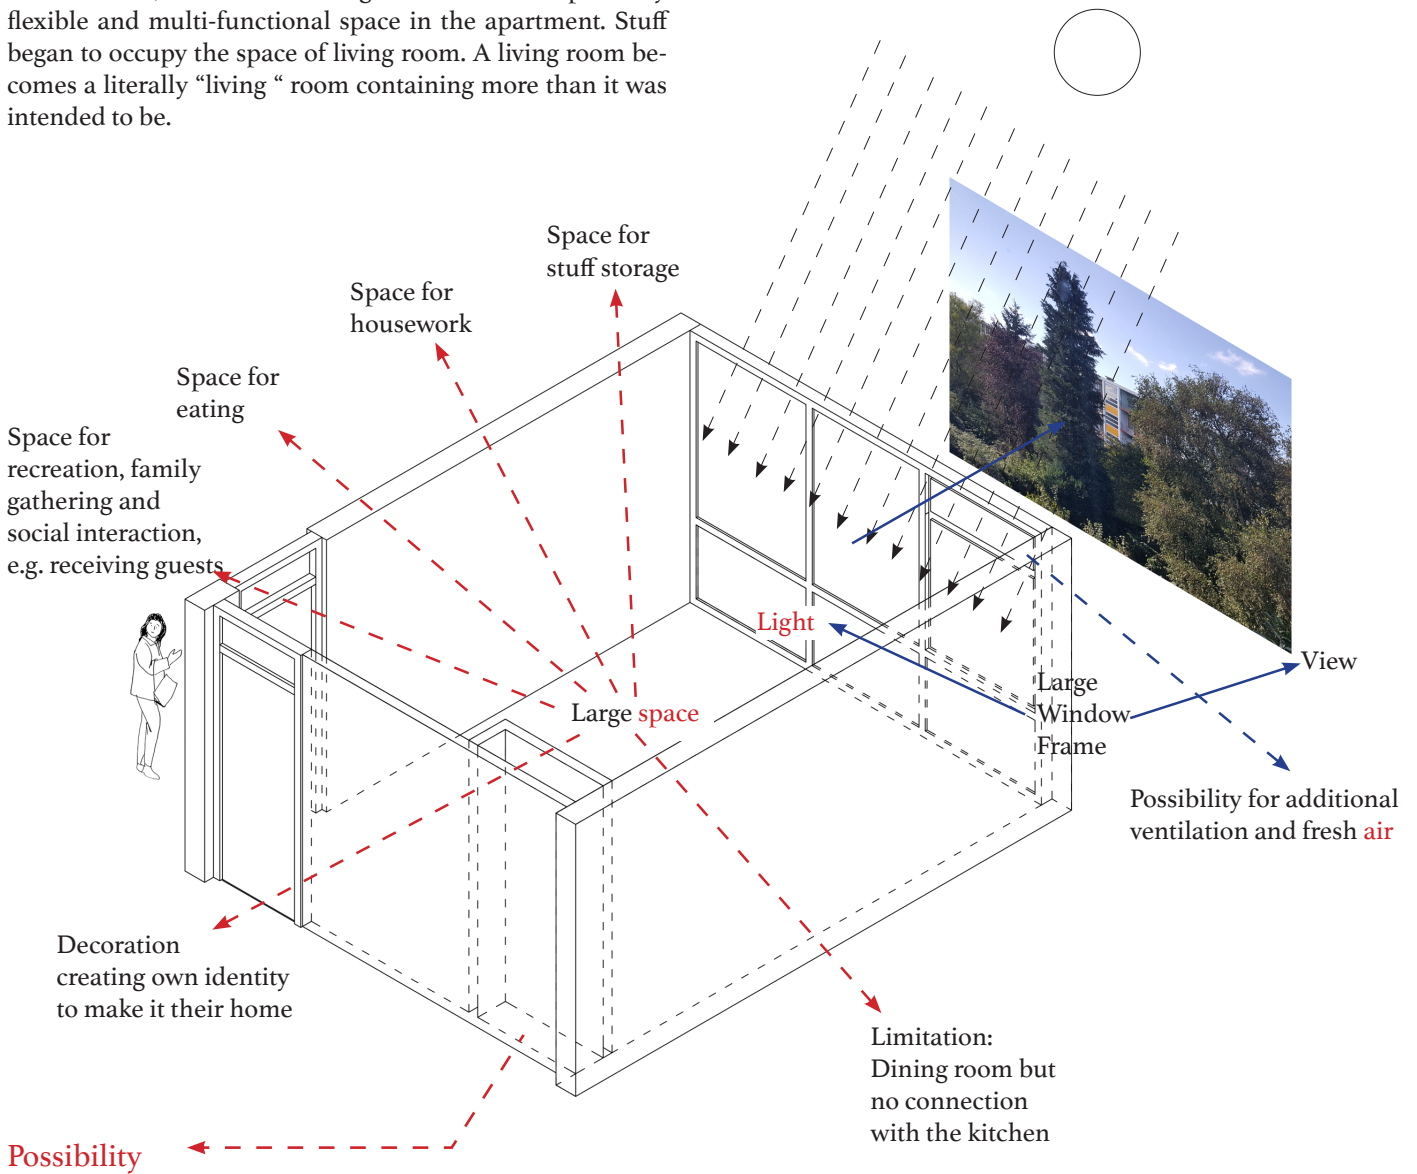
The chimney was intended to ventilate the waste gas of burning coal and later was used for gas heater in some apartments. The shifting of energy also accompanies the changing of lifestyles. The chimney might have potentials to contribute to the comfort of the interior environment and life but needs to be further explored.

Figure 1.5.23 Living Room of the Apartment in Intervam buildings, Camera Obscuradreef

The living room was designed under the manifesto of Light, Air and Space which demonstrated the optimism and enthusiasm to pursue a better life in post-war mass housing construction. Large windows were applied to let plenty of light and views penetrate inside. Before the discovery of gas, heating was only provided in living room, in which family members often spent time together. Later, such intimacy kind of being affected since every room got heated in winter.
