INTERVAM

Graduation Studio - Heritage & Architecture - Re-Housing
Analysis Group Intervam - Rick Hoofd - Xiaoyu Chen - Chi Teng - Heejin Chung

This research report is a result of the first stage PI of our Graduation studio Re-Housing, which is under Chair of Heritage & Architecture at the Faculty of Architecture of Delft University of Technology.

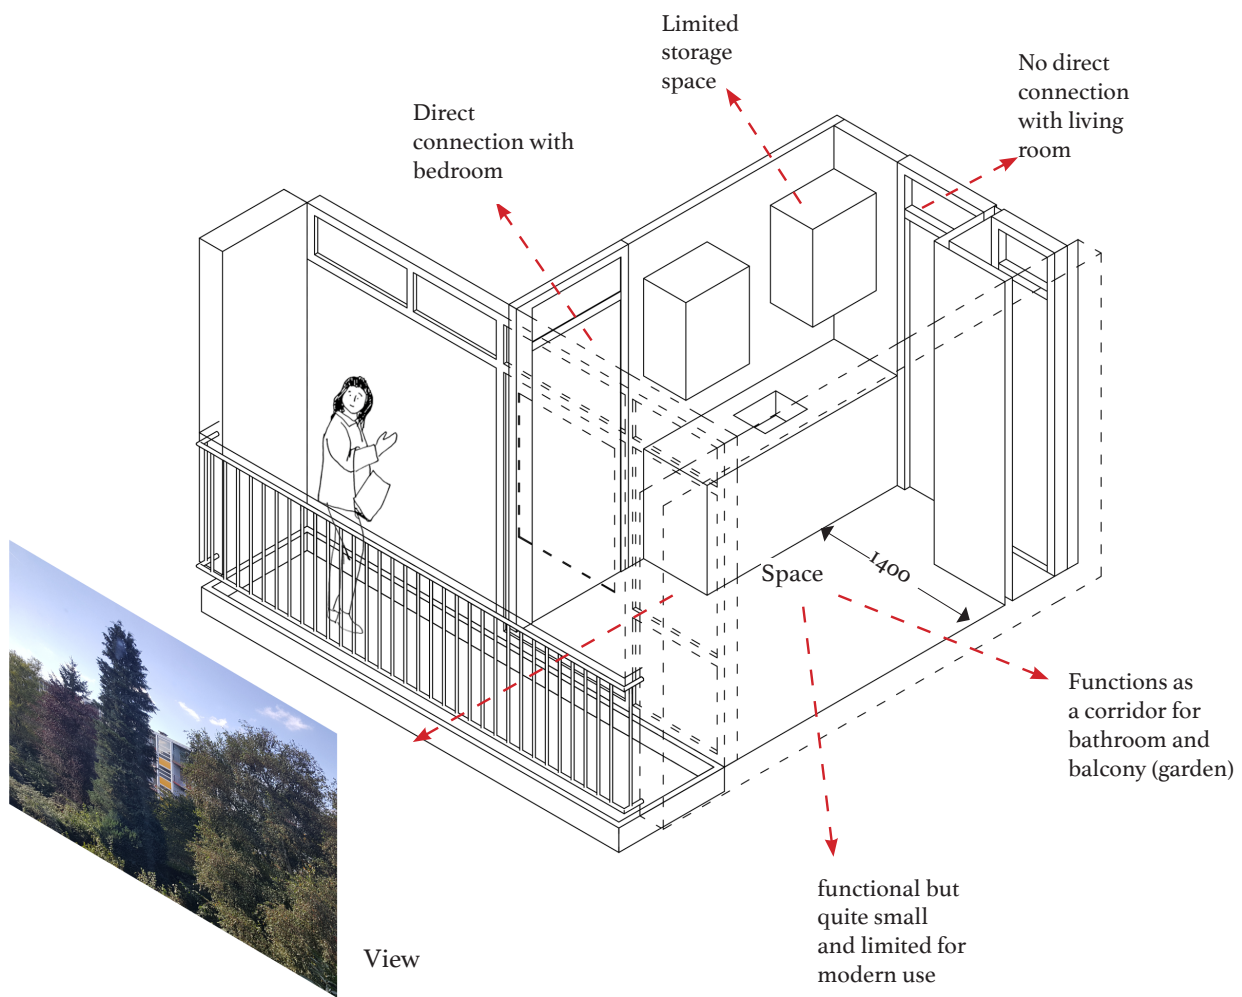
The kitchen was mainly designed for housewife previously. It is functional but quite small which can not meet some changing lifestyles nowadays. For instance, it is uncomfortable for the whole family to share cooking time together. And it lacks storage space for stuff, let alone some modern kitchen appliances with bigger size. The small space would also be disturbed sometimes by residents accessing to bathroom or balcony (garden).

Direct connection with balcony and outside is a quality of kitchen which provides good light, air, view, outside space and other possibilities for kitchen life. In an apartment without mechanical ventilation, it may also help to ventilate the smells and steams from cooking in the kitchen.

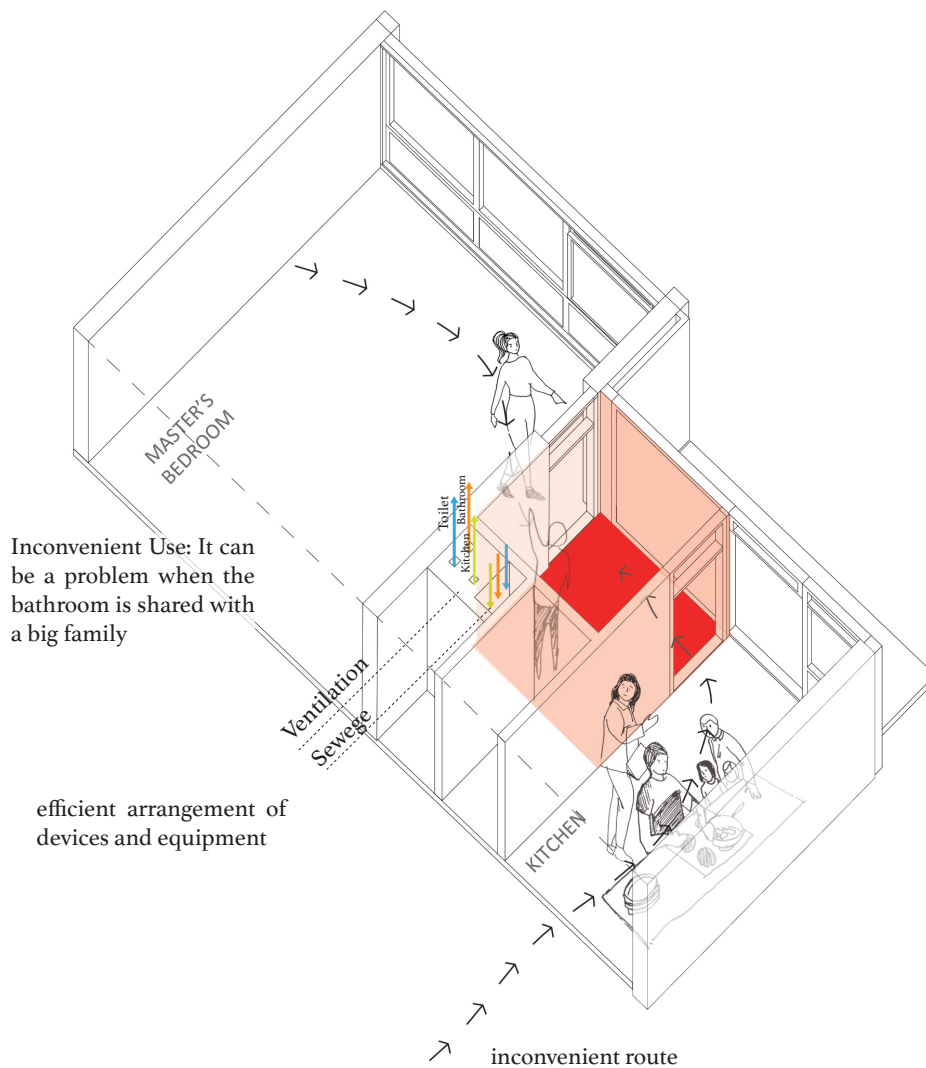
Figure 1.5.37 Bathroom and Toilet of the Apartment in Intervam buildngs, Camera Obscuradreef

The bathroom, kitchen and toilet are grouped together for a more efficient solution for ventilation and sewage water.

There is one private entrance from master's bedroom and one more public entrance from the kitchen. Entering from narrow kitchen may cause inconvenience when the kitchen is in used.

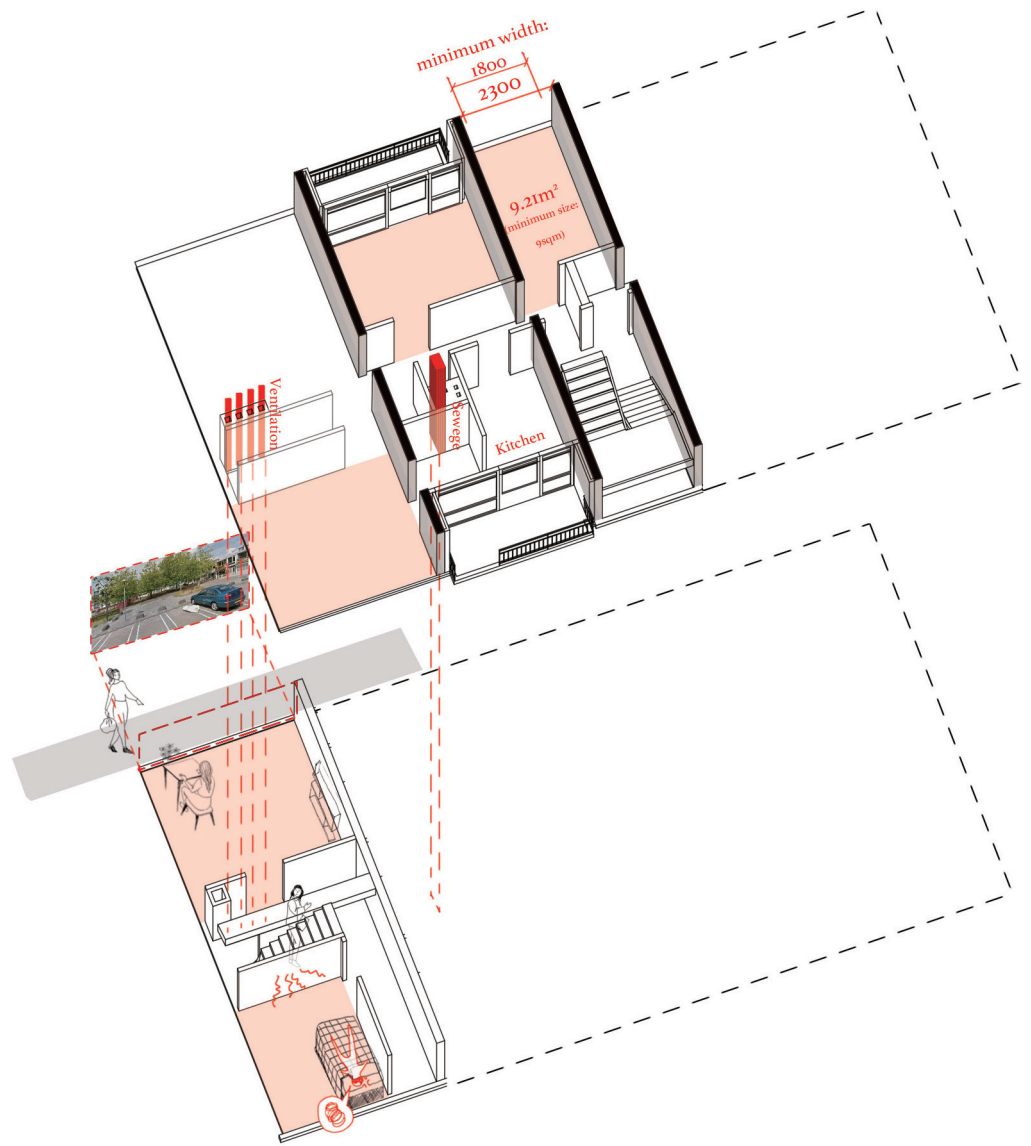
Space VS Structure
The small bedroom was limited by the rigid concrete module. However it can be a good space for storage, cloak room or guest bedroom.

Position of Bedroom VS Privacy
The privacy problem can be solved by using the space as a living room instead of bedroom. However, it was disconnected with the kitchen on the upper floor, which may bring some inconvenience. Moreover, the function of ground floor is limited, since there is no ventilation shaft and water pipes.

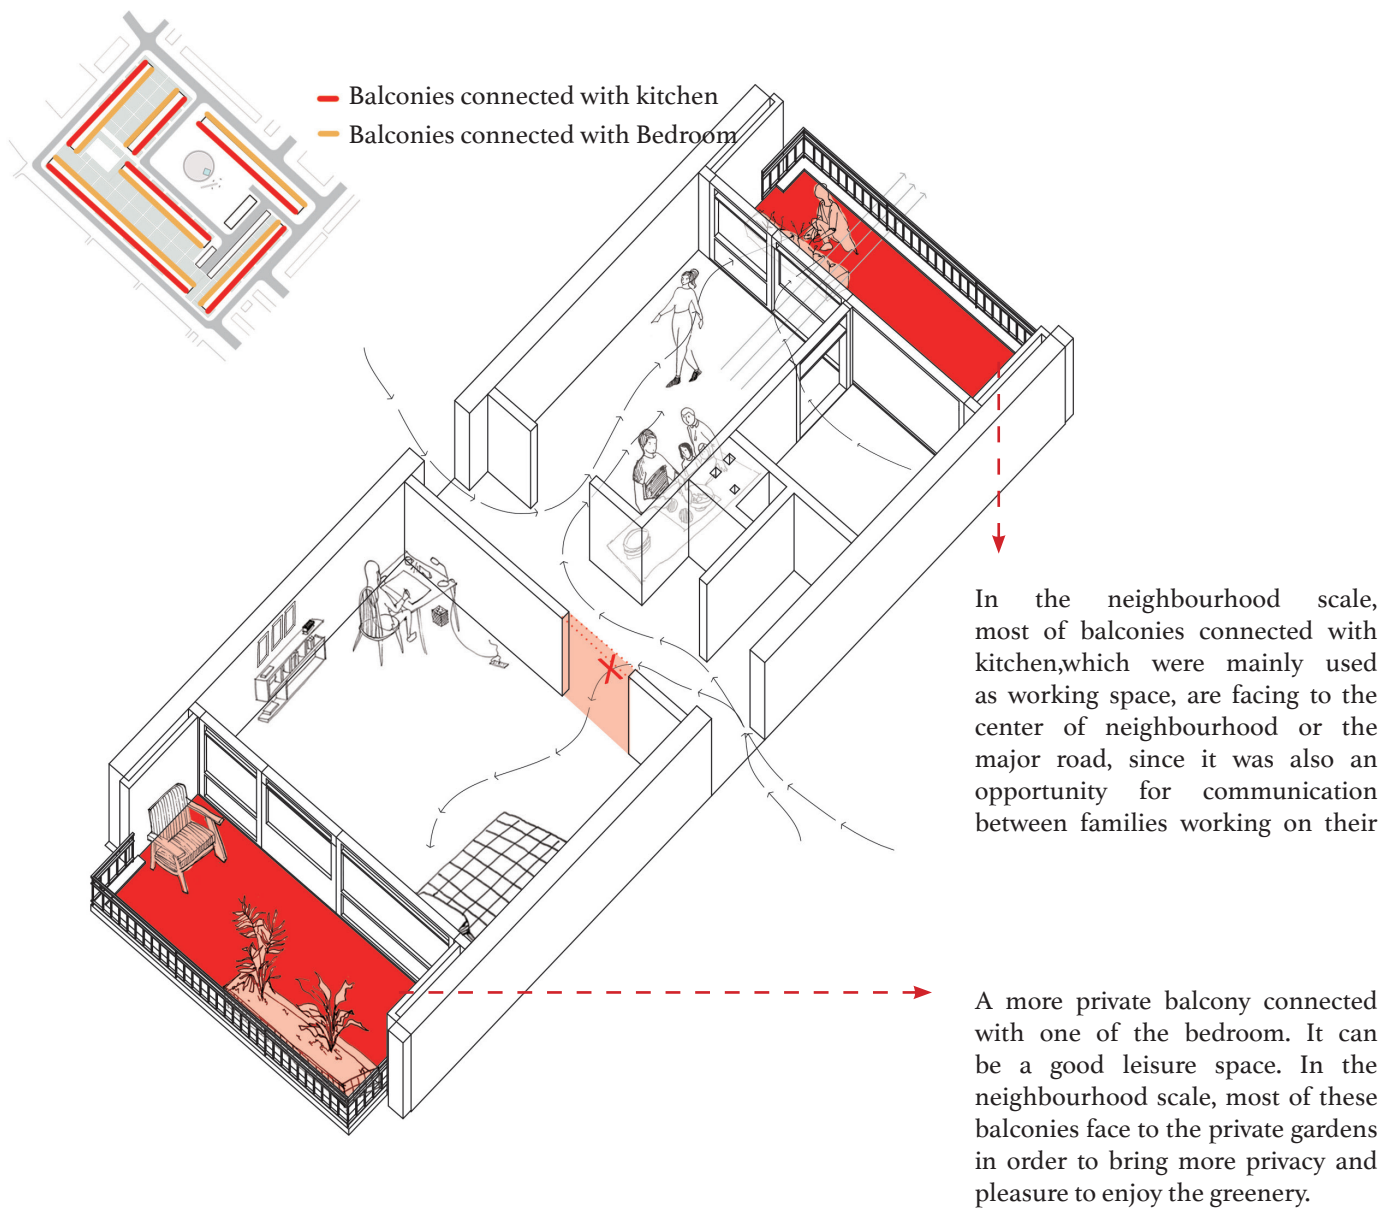
Figure 1.5.77 Balconies of the Apartment in Intervam buildings, Camera Obscura reef

By exchanging the positions of living room and bedroom, the balcony will be connected with the most communal and public space in the apartment. In this case, the balcony can be shared by the whole members freely and frequently.

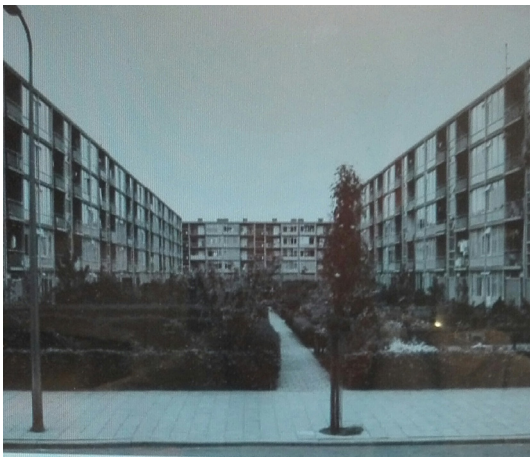
Figure 1.5.58 view of gardens in 1960s

Through time, trees and shrubs are thriving. The height of hedge breaks the view of the original open green structure (Figure 1.5.58/1.5.59). Due to different group of tenants, gardens are under different circumstances. For student group (the majority tenants), most of the gardens are not well maintained and some of them are even deserted because they view themselves just as temporary tenants. It is not worth for them to put much effort on it since they will move out after all. However, for family group, every household uses it in their own way and gives the garden its own identity. But it's still difficult to maintain since it's rather big.

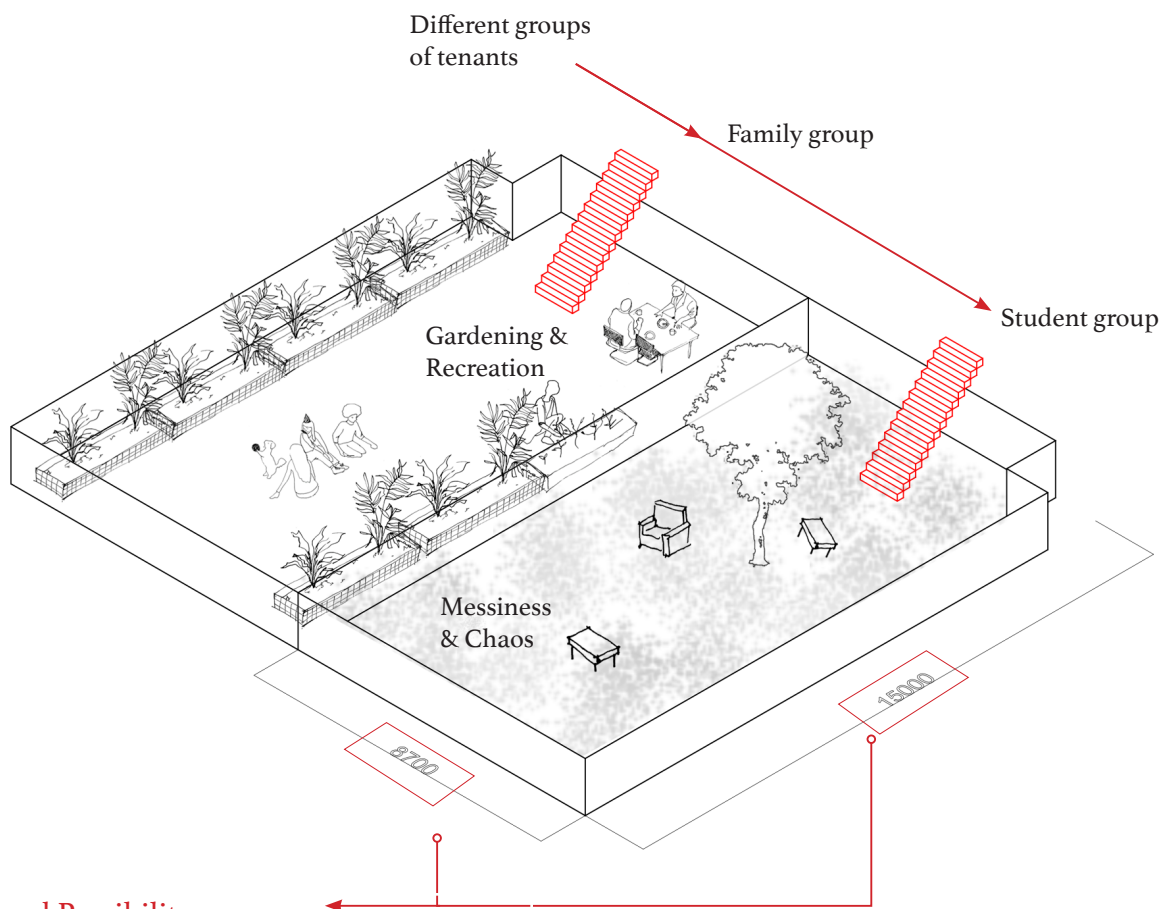
The gardens , with the dimension of 15m by 8.7m are very spacious and also are in private use. Trees and hedges help to create a natural and quite atmosphere in the gardens.

The scale of garden may cause difficulty in maintenance even for family group. One possibility is to reduce the size for less maintenance and add the extra space for public services and uses. while it might destroy the existing qualities of a spacious, private garden which exhibits the work of nature and time.

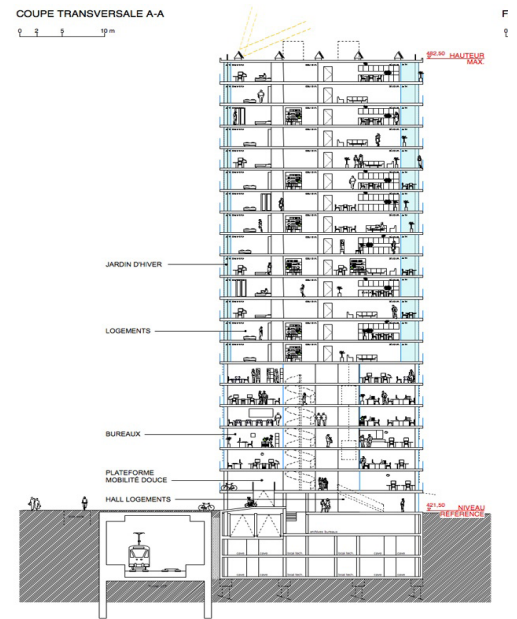
Figure 2.1.1. Section of one project renovated in plus approach.

One of the main characteristics of PLUS approach is the added new facade resulting from the added space. Original facade is replaced by a more open and transparent new skin.

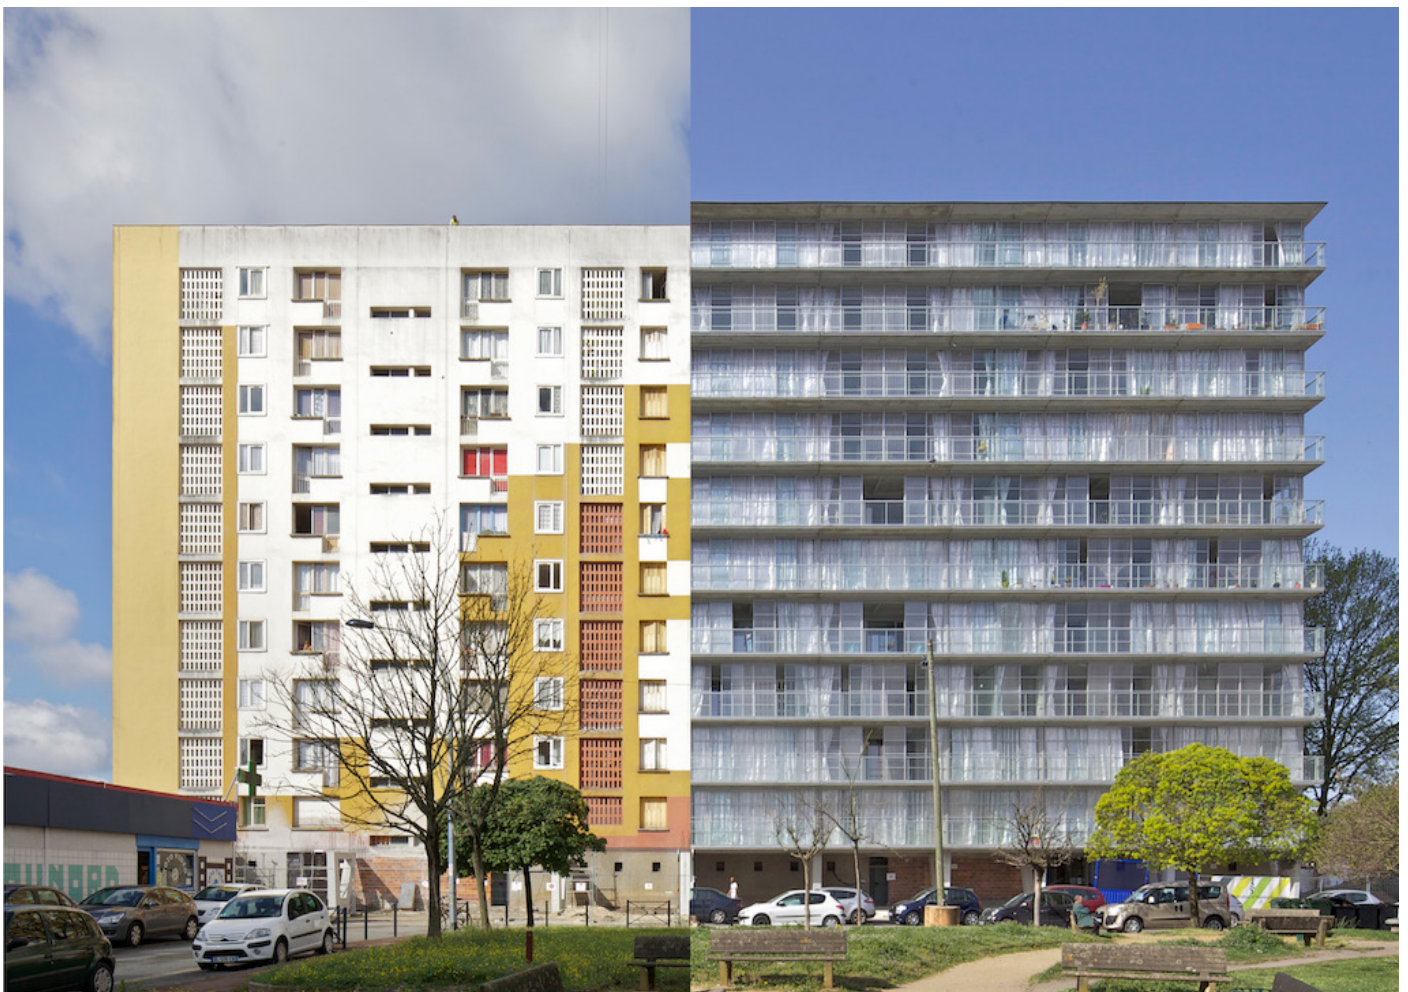
Figure 2.1.2 Elevation of one project renovated in plus approach.
Left: original condition; Right: Renovated

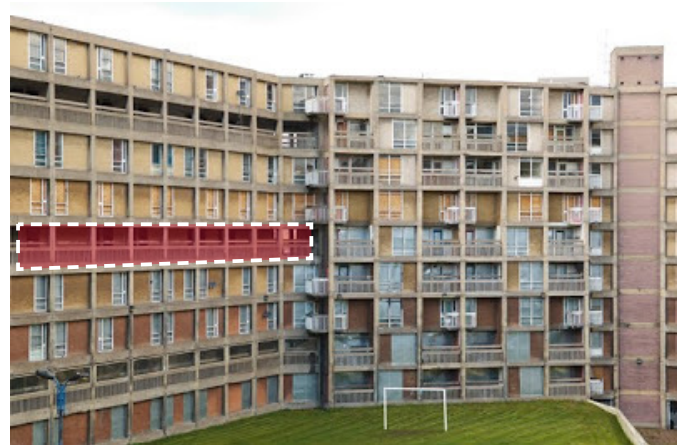
Figure 2.2.1 Before
(Hopkinson et al., 2011)

The renovation includes renovated facade, redesigned floor plan and the open-air walkways. Energy efficiency was also achieved in the renovated project.

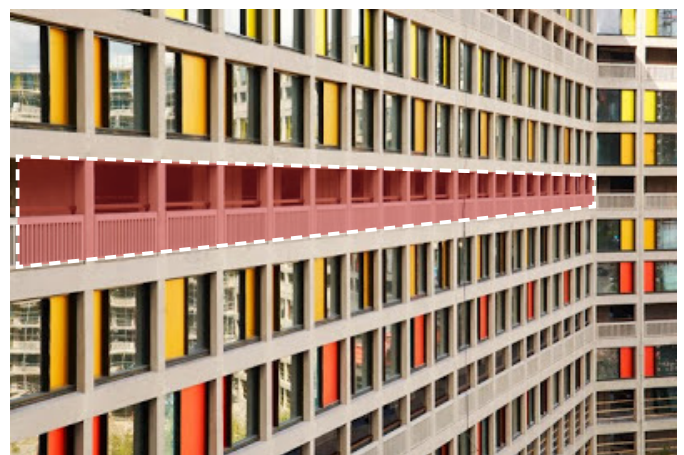
Figure 2.2.2 After
(Hopkinson et al., 2011)

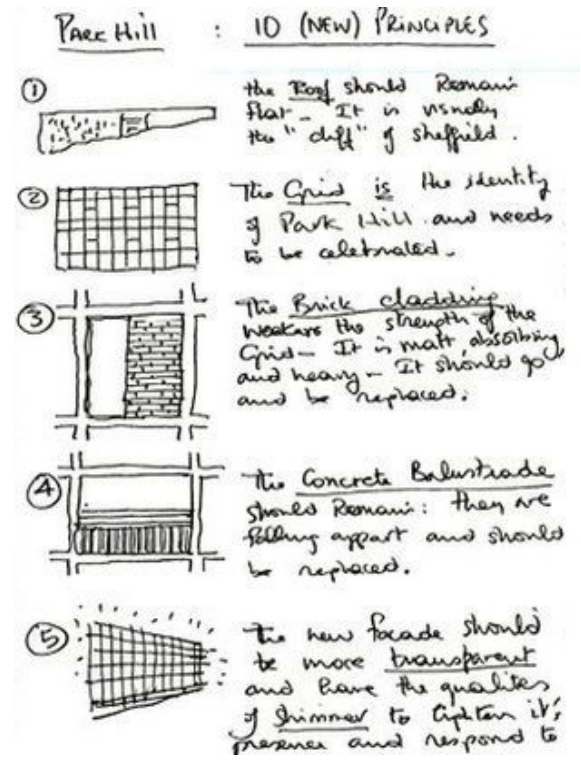
Figure 2.2.3. Architect's sketch on facade renovation (Hawkins/Brown Architects, 2011)

The architect found Park Hill to be a remarkably intelligent structure full of complexity, potential and great character. However, it was believed that the grid was weakened in the original facade. The frame was kept and strengthened by applying coloured panels and enlarged windows.

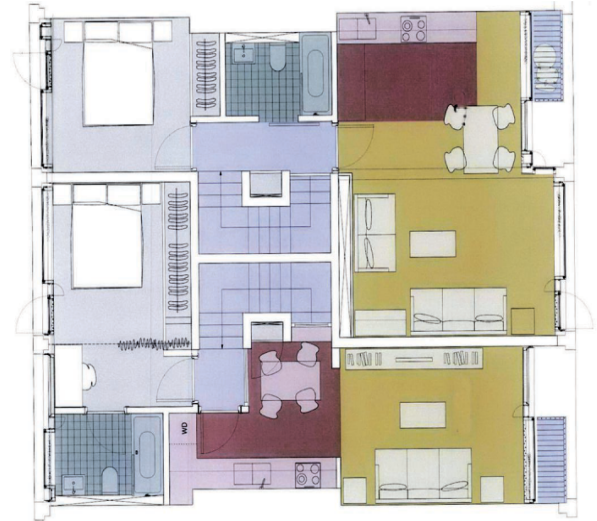
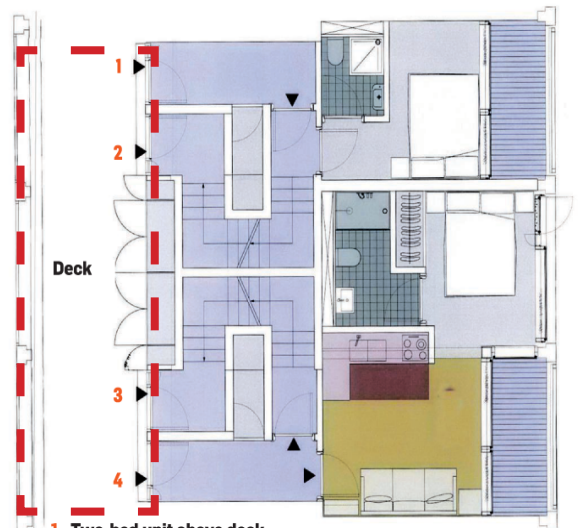
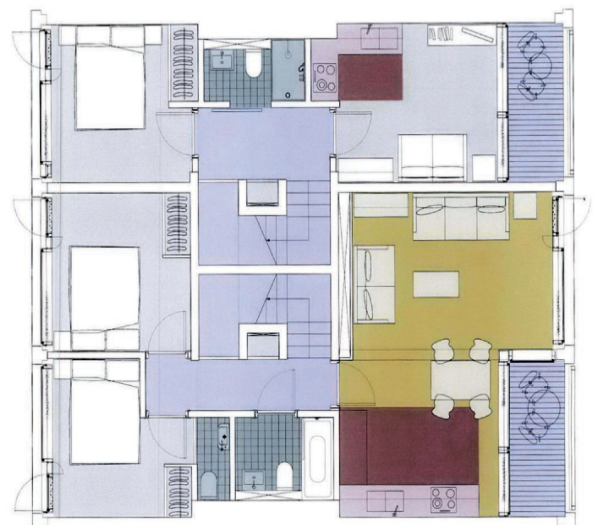
Figure 2.2.5.
Original Floor plans(Parnell, 2011)

- 1 Two-bed unit above deck
- 2 One-bed unit below deck
- 3 Two-bed unit below deck
- 4 One-bed studio at deck + one-bed unit above deck

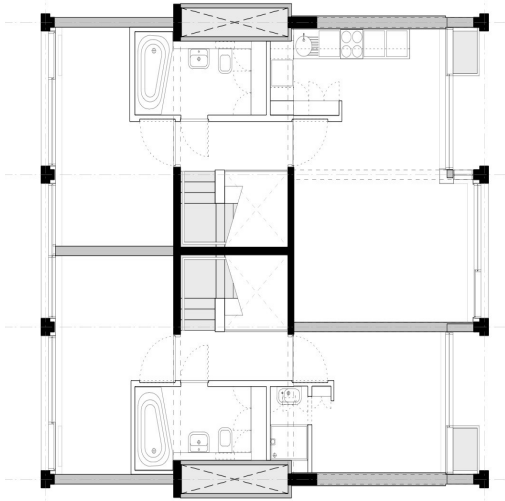
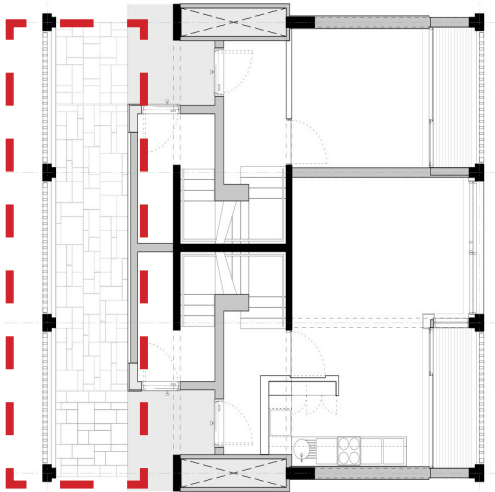
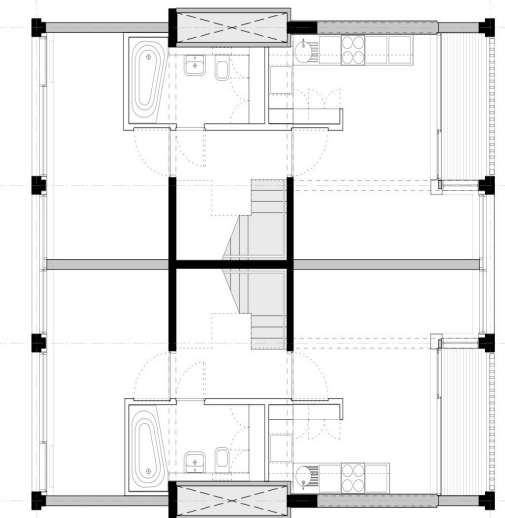
Figure 2.2.6. Renovated floor plans
(Hawkings/Brown Architects, 2011)

Modified Floor Plan
Upper Level

Modified Floor Plan
Mid Level

Modified Floor Plan
Lower Level

The redeveloped flats are bigger - about a metre has been taken from the external walkways and added in to the homes. Although milk floats may struggle to drive along them now, they still offer a generous amount of space. By reducing the width of the “streets”, the architects were able to extend the size of the apartments, creating new street-facing windows and much-needed additional storage. (Frearson, 2014)

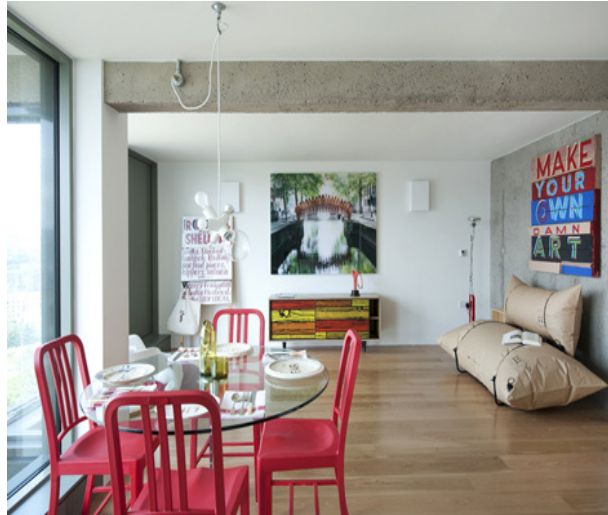
Figure 2.2.7. Renovated interior space and the preserved concrete beam (Hopkinson et al., 2011)

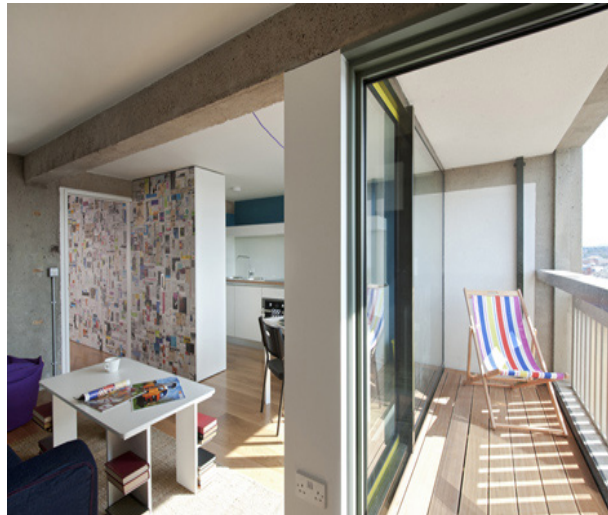
Figure 2.2.8. Renovated interior space and the preserved concrete beam (Hopkinson et al., 2011)

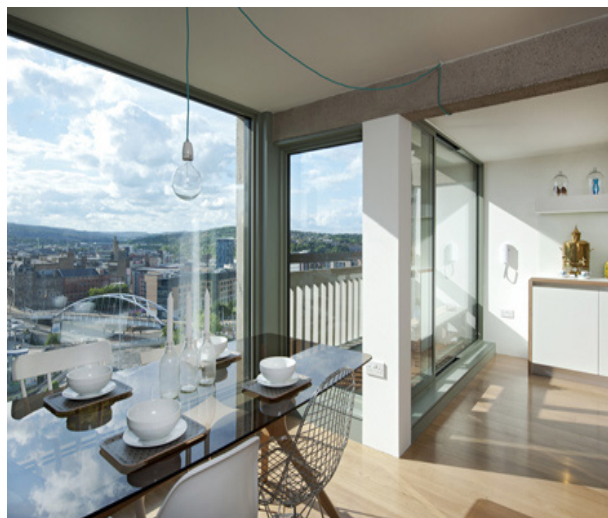
Figure 2.2.9. Renovated interior space and the preserved concrete beam (Hopkinson et al., 2011)

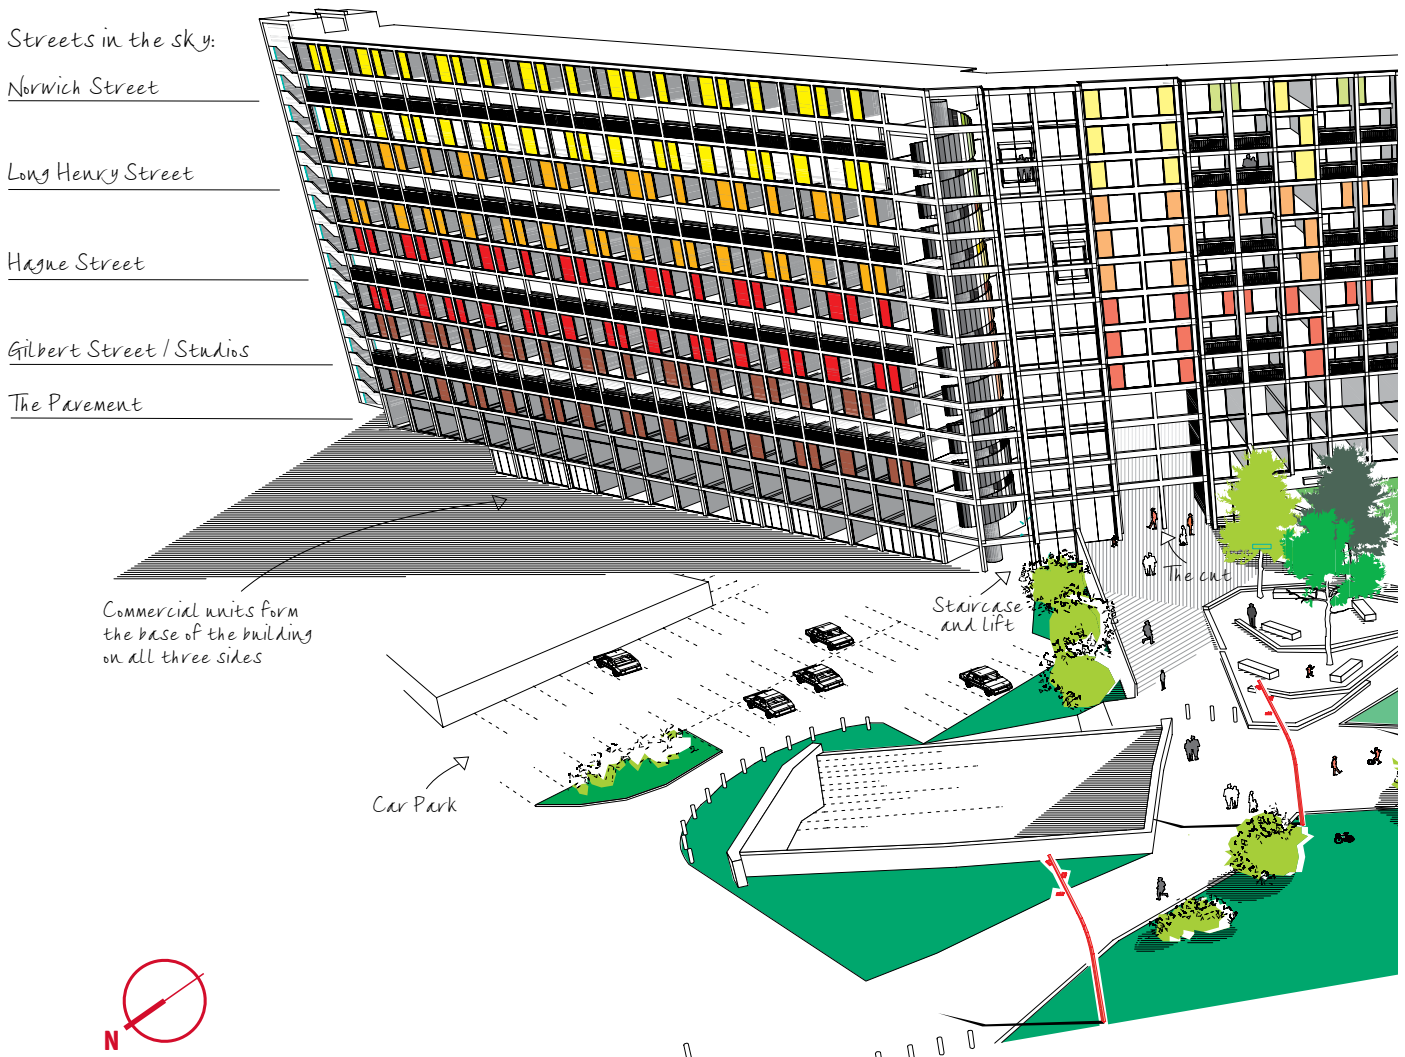
Figure 2.2.14. Function of the Ground Floor (Urban Splash, 2013)

The ground floors that face West have been converted from residential into commercial units.
 Due to the way the building works there are a variety of options for workspace or retail space - single storey, duplex or triplex. Sizes range from 500 sq ft to 30,000 sq ft. (Urban Splash, 2013)

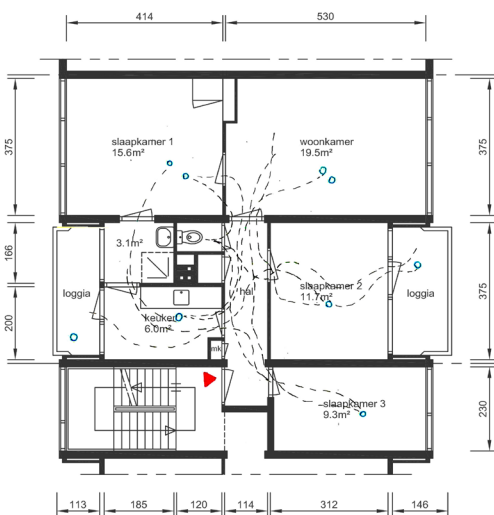
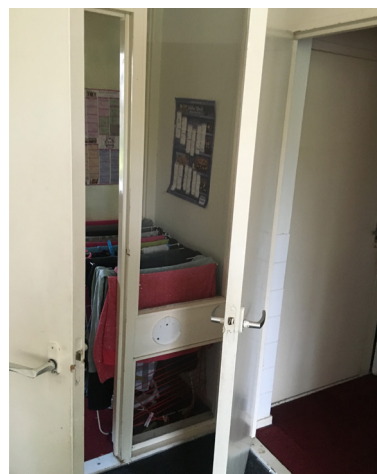
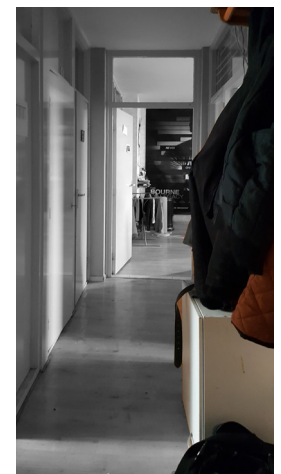
Camera Obscuradreef: the Intervam flat

In the Camera Obscuradreef, hallway is the most busy space in the apartment. It connecting every room efficiently, and has a potential for becoming a nice space for communication. However, the narrow and dark space blocks the possibility.

The door and dimension of hallways can be two main aspects to bring the quality.

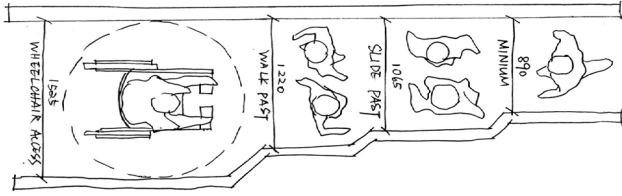
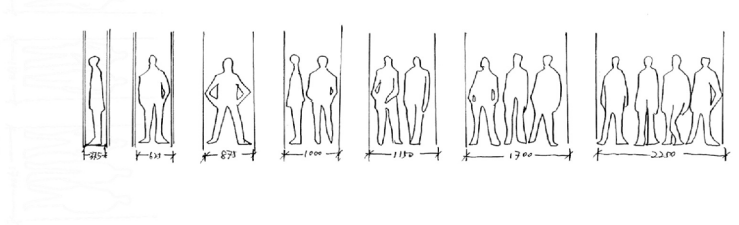
MINIMUM- Size of the Door and Size of Corridor

-Minimum requirement of size of a corridor

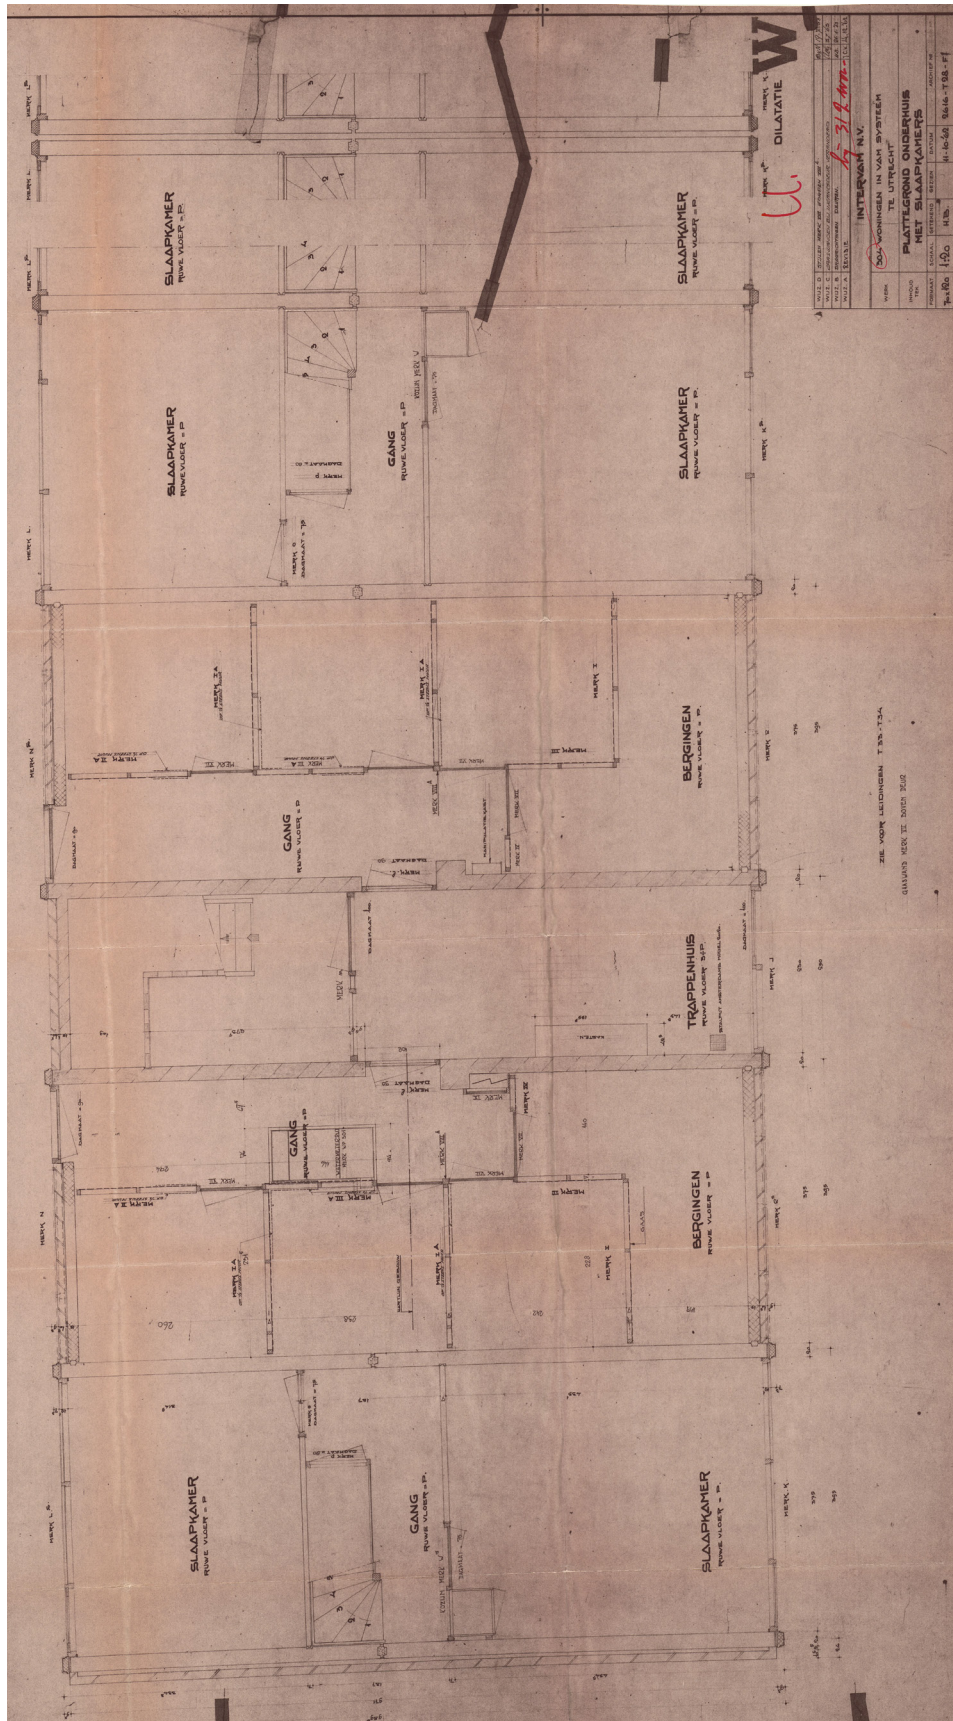
Original drawing ground floor with bedrooms

The whole drawing of the assembly and the prefabricated elements can be found in the appendix. As well the original floor plans.

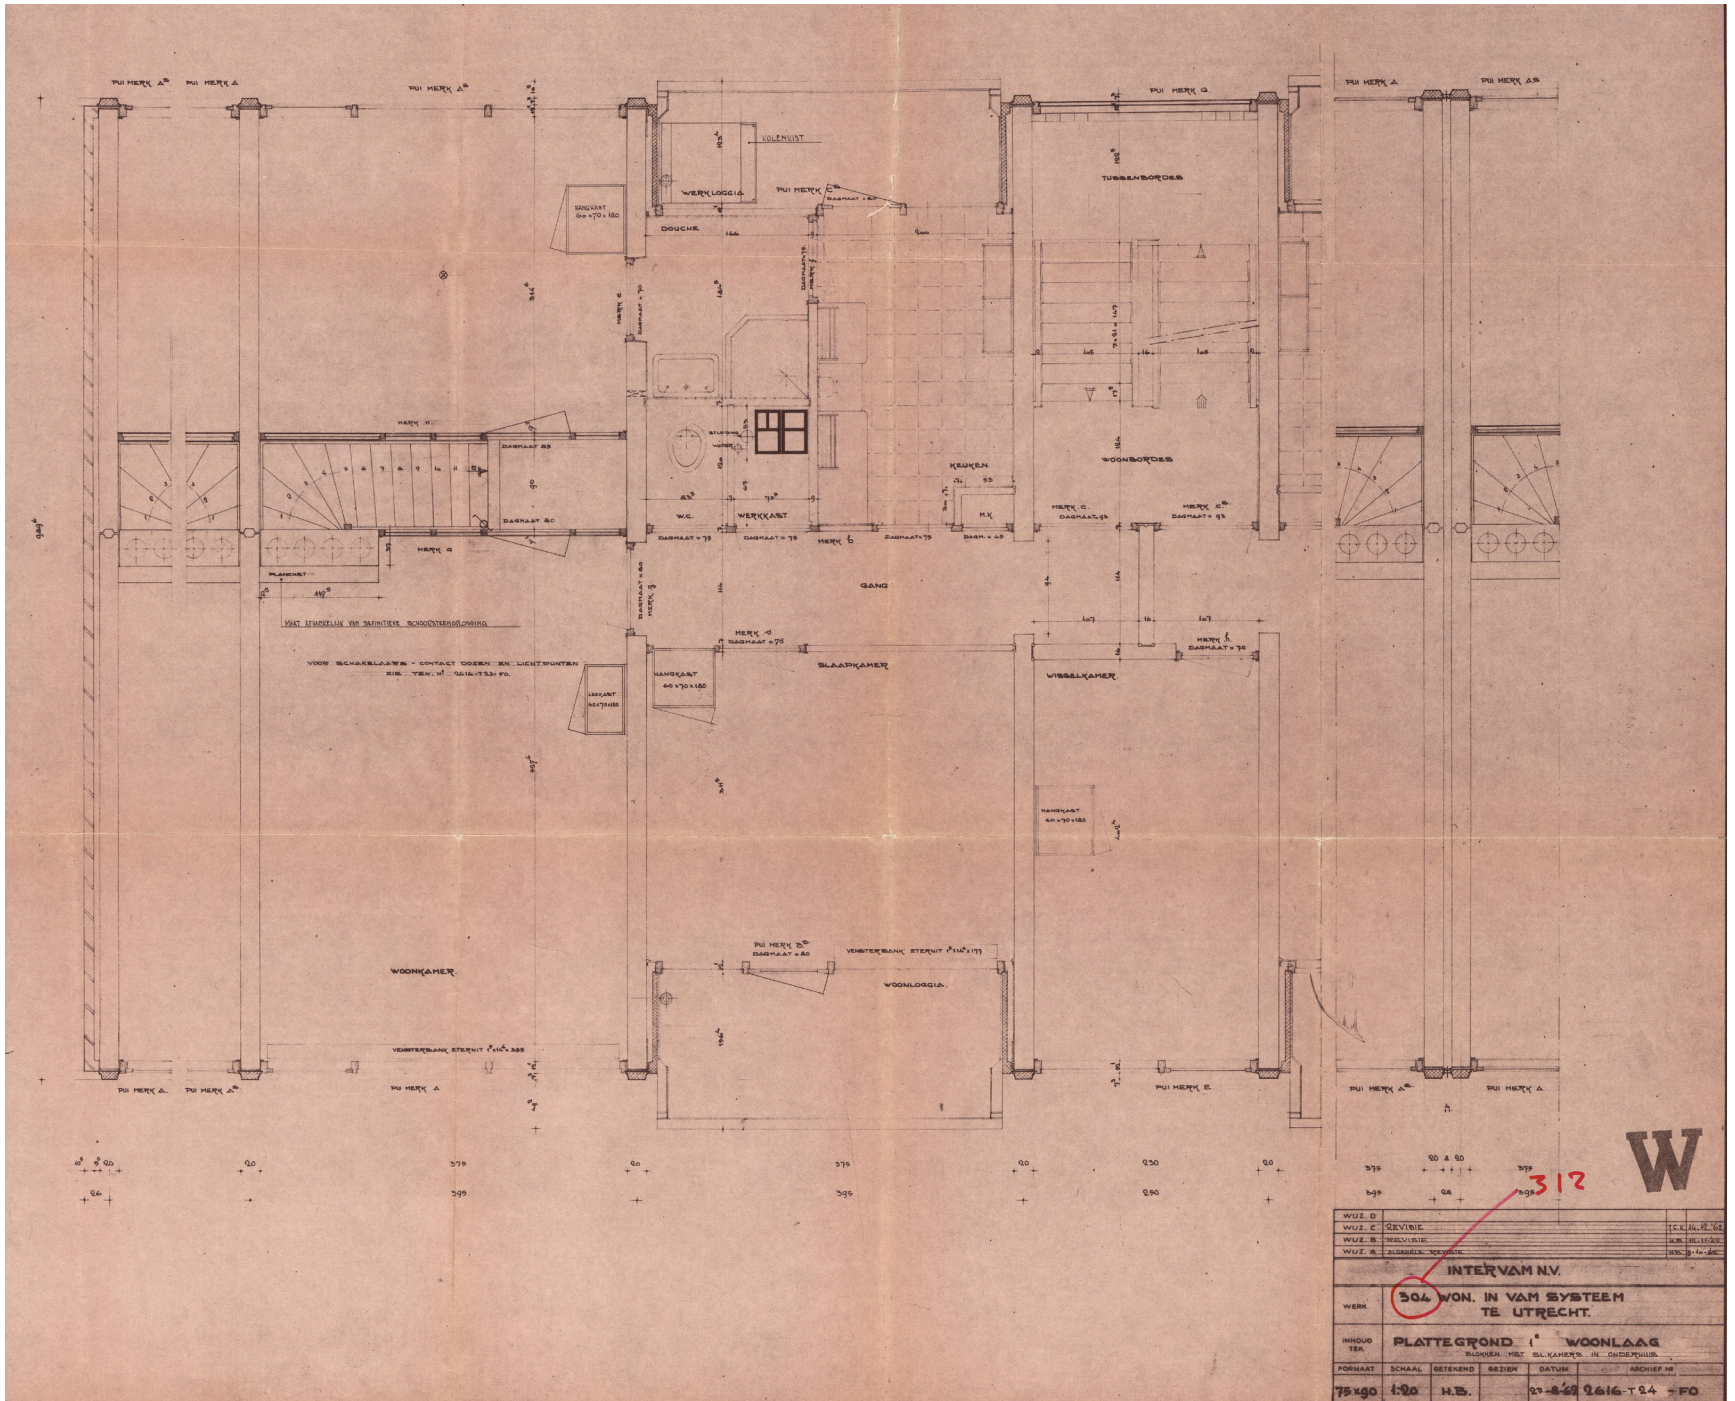
WUZ. D	REVIZIE	15.11.1924
WUZ. B	REVIZIE	15.11.1924
WUZ. A	AUSGEBILDE	15.11.1924
INTERVAM NV.		
304 WON. IN VAM SYSTEEM TE UTRECHT.		
INHOUD TER	PLATTEGROND 1^o WOONLAAG	
FORHAAT	SCHAAL	GETEKEND
75-190	1:20	H.B.
	ORDEEN	DATUM
		27-8-22 2616-124 -FO
