**A newly developed fixture and testing method for strain rate-dependent flexural properties determination of carbon/epoxy composites**

21th International Conference on Composite Materials

# A NEWLY-DEVELOPED FIXTURE AND TESTING METHOD FOR STRAIN RATE-DEPENDENT FLEXURAL PROPERTIES DETERMINATION OF CARBON/EPOXY COMPOSITES

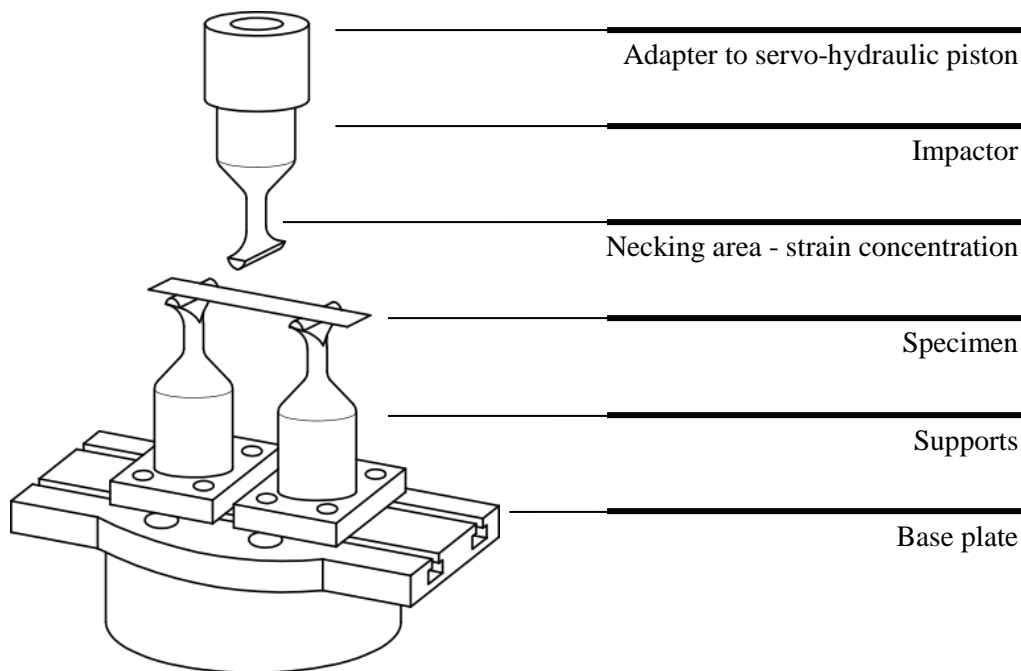
Figure 1: 3-point-bending test setup to derive strain rate-dependent flexural properties

Light weight structures have always had challenges in the design process of load bearing components (e.g. car body development in automotive industry). For automotive parts legal crash load cases are of major importance when it comes to defining wall thickness and fiber orientation. In order to ensure the vehicle crash performance finite element models are used. It is relevant to take into account strain rate properties of CFRP to obtain reliable simulation results. For quasi-static material properties, 3-point-bending (3PB) tests are normally performed to validate the material cards to be used in finite element models. Hence, for this reason it is important to have a reliable 3PB test setup that can be used to validate material cards that take into account CFRPs strain rate-dependent properties [1]. For this purpose a fixture for dynamic 3PB is developed, as shown in Fig. 1.

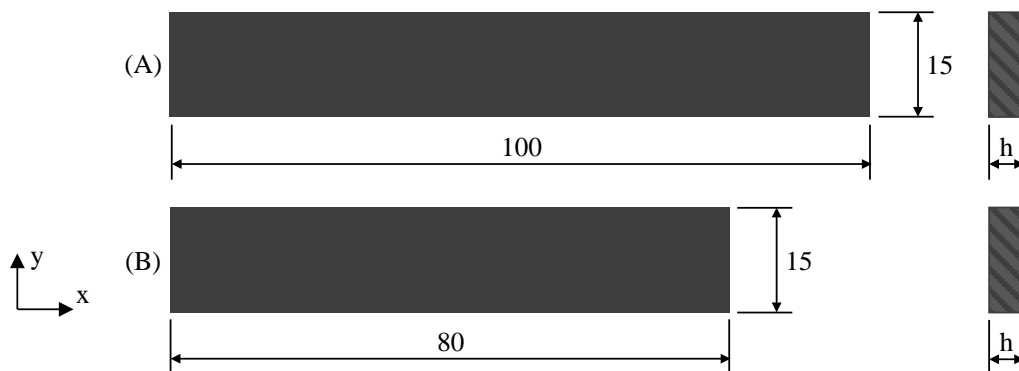
Figure 2: Specimen geometry tested with the support span of 80 mm (A) and 60 mm (B)

Geometry A was chosen because it is the shape suggested for quasi-static tests for UD laminates. It was tested with a support span of 80 mm, which mostly eliminated shear-driven failures [6]. This type of specimens were expected to have a compressive failure. The smaller specimen geometry was tested with a support span of 60 mm. Such support span is the smallest that can be obtained with the designed fixture. It was decided to reduce the support span, because trial tests had shown oscillations in the force signal for tests at high piston velocities. This was mainly due to the successive separations of the specimen from the impactor during testing.

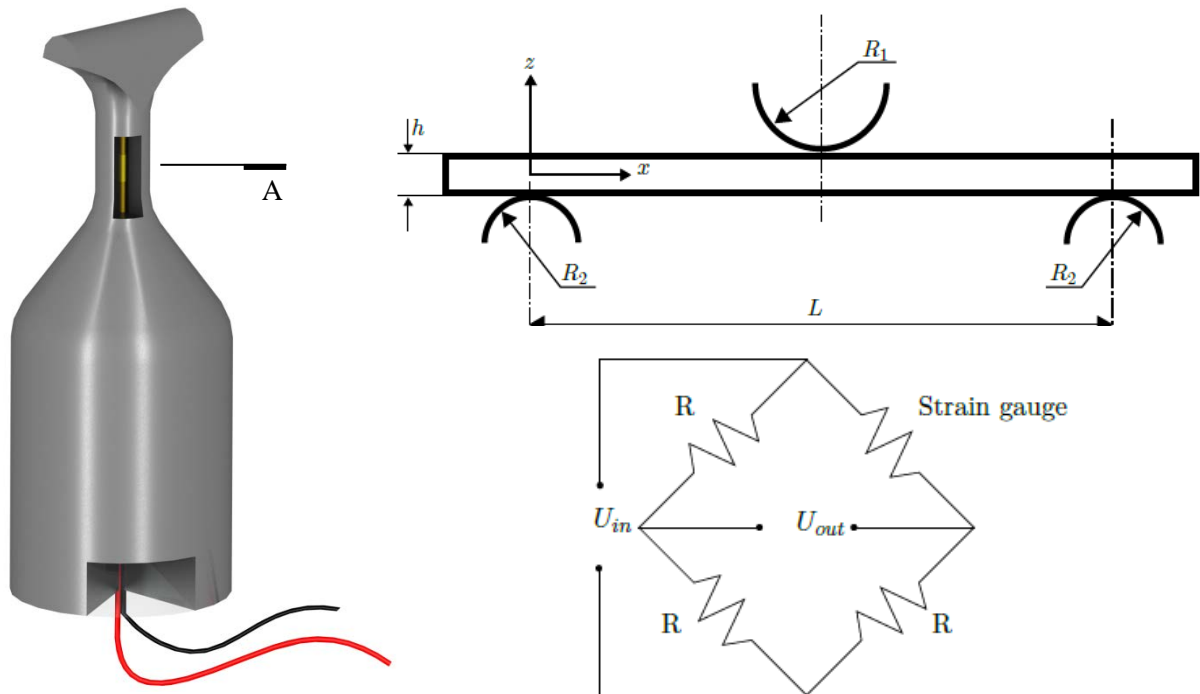
Figure 3: Basic procedure for force measurement used for the impactor and supports. 3-point bending setup and the corresponding quarter Wheatstone bridge for every strain gauge.  
Detail A - Strain gauge bonded to central hole.

To amplify the signal coming from the strain gauges a VISHAY signal conditioning amplifier [12] was used. Each fixture component was connected to a separate amplification unit. The amplification unit provides the connection to the ground and has a built-in Wheatstone bridge circuit, shown in Fig 3.

For all three fixture components the quarter Wheatstone bridge configuration was selected, it is shown in Fig. 3. Since the strain gauge had a resistance of 120  $\Omega$ , the bridge configuration with all resistors of equal resistance was selected. The amplification units provided the bridge excitation voltage  $U_{in}$  and the amplification factor  $A_{WB}$ .

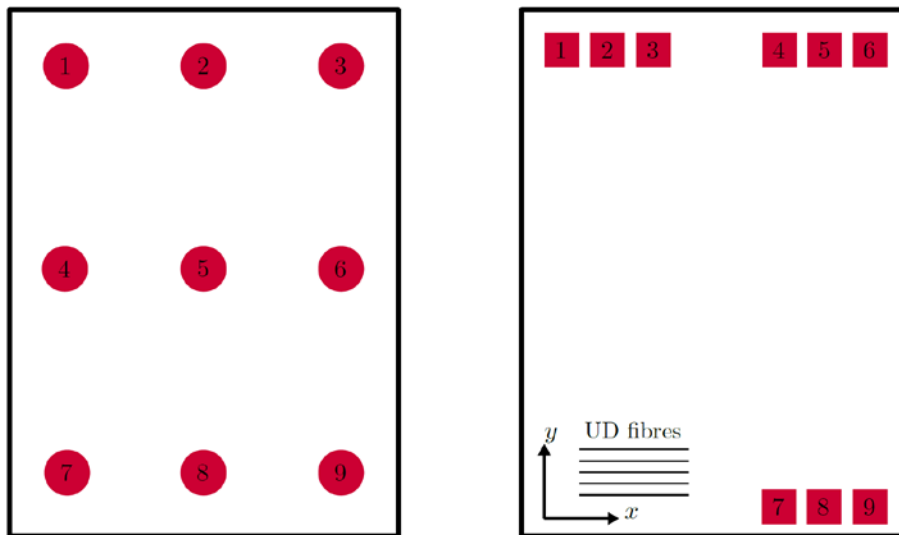
Figure 4: Positions for thickness (a) and fiber volume (b) measurements.

High quality-manufactured plates were required. In order to obtain smooth surfaces the stacked prepreps were placed between two carbon fiber mould plates, during the curing process. After the autoclave process, several quality inspections were performed. The thickness of all plates was measured using a Kroeplin IP 67 at nine different positions, as shown in Fig. 4a. The fiber volume was measured using specimens taken from the nine positions shown in Fig. 4b. The results are summarised in Table 2.

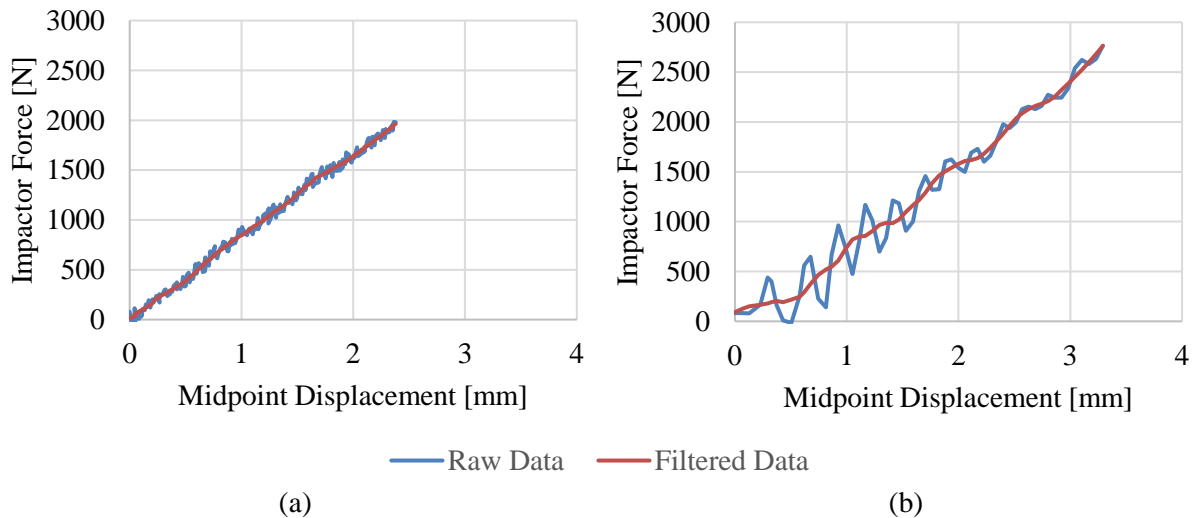
Figure 5: Filtered force signal for a 4 mm thick specimen with geometry A tested in (a) quasi-static conditions and (b) at 3m/s

The output signal coming from the strain gauges showed some fluctuations. One source of oscillation in the signal was the noise induced by the testing equipment and the setup. This resulted in small fluctuations in the signal, as shown in Fig. 5a. The other source was due to vibrations of the specimen. When the impactor hits the specimen, it slightly bounces and contact is lost between the specimen and the impactor. This behaviour induces the signal oscillations visible in Fig. 5b. The force-displacement curves (Fig. 5) were cut off at the failure point, as after initial failure a drop in the load was observed. It was therefore decided to filter the signal using a LOESS filter. The LOESS filter allows to define a smooth curve that fits the force signal. For this particular application a span of 25% was the one that best fitted the data at all testing velocities.

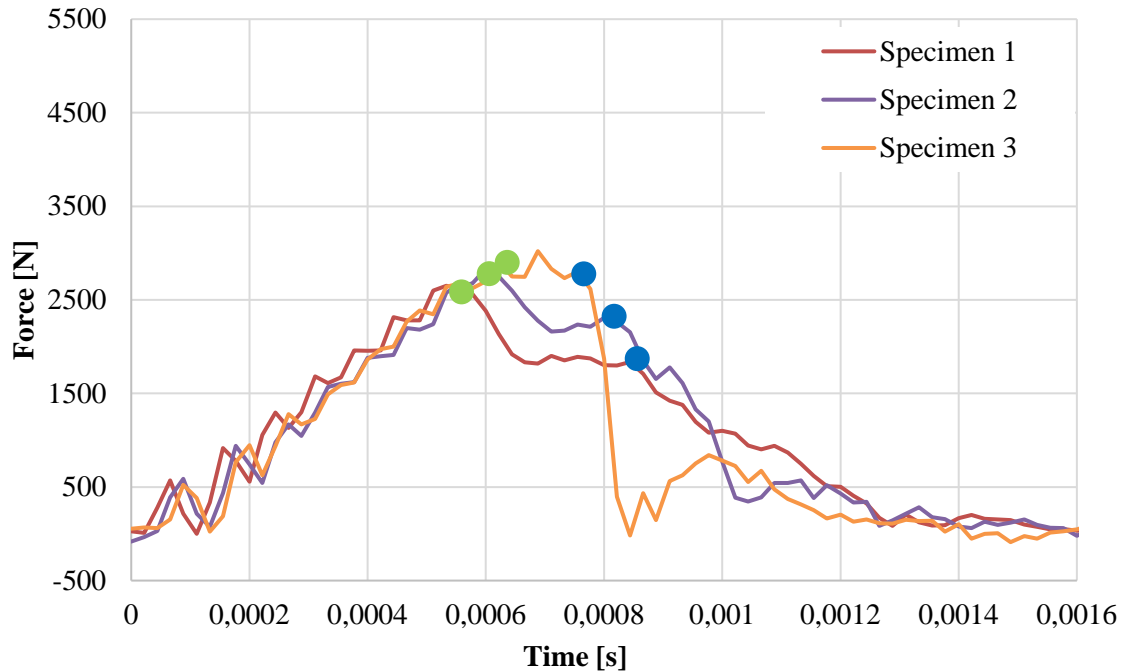
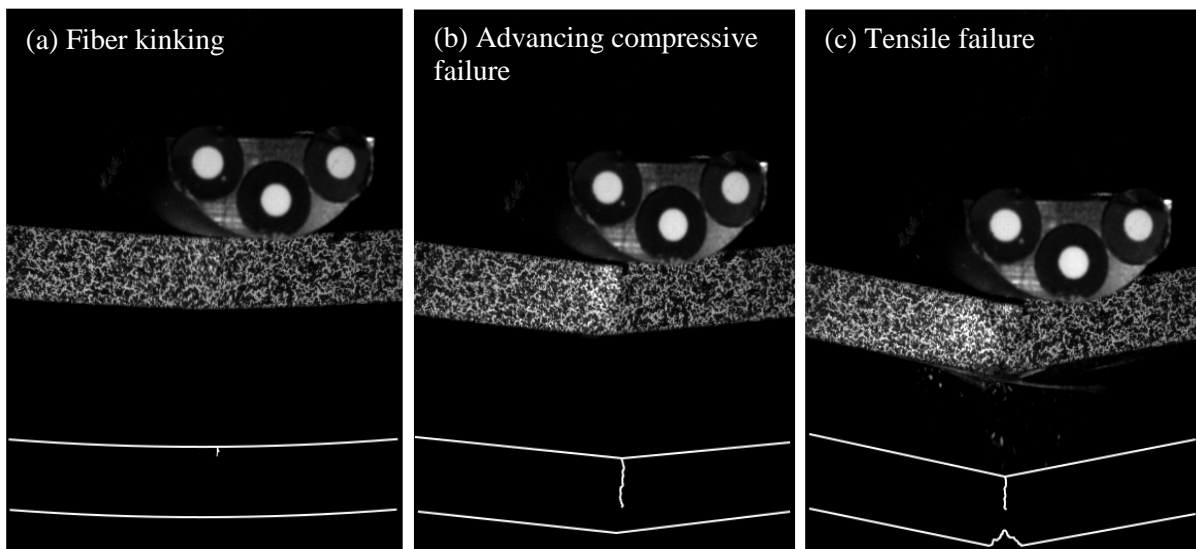
Figure 6: Failure mechanism of 3.5 mm thick specimen. Support span of 80 mm at a velocity of 5 m/s.

All the specimens tested had a compressive failure. The initial failure was fiber kinking on the compression side of the specimens, in correspondence of the contact area with the impactor. Initial failure on the compressive side of the specimen was also reported by Wiegand [8]. This is because the

region of the specimen below the impactor is the one where the material is subject to the highest stresses and strains. Moreover, being UD carbon/epoxy composites anisotropic material with lower compressive properties compared to the tensile ones [3], compressive failure was expected. For the specimens with thicknesses of 1.5 and 2 mm, once fiber kinking occurred the specimen nearly instantaneously split in two parts. Specimens with thickness of 2.5, 3 and 3.5 mm tested with both support spans and specimens with thickness of 4 mm tested with a support span of 60 mm showed a fiber tensile final failure, see example in Fig. 6. After the initial fiber kinking the fracture propagates through the specimen thickness. This event results in a reduction in the applied load or in a plateau where the applied load remains constant. Once the tensile failure strain is reached on the tensile surface of specimen, tensile fiber breakage occurs. The result is a sharper decrease in the load signal.

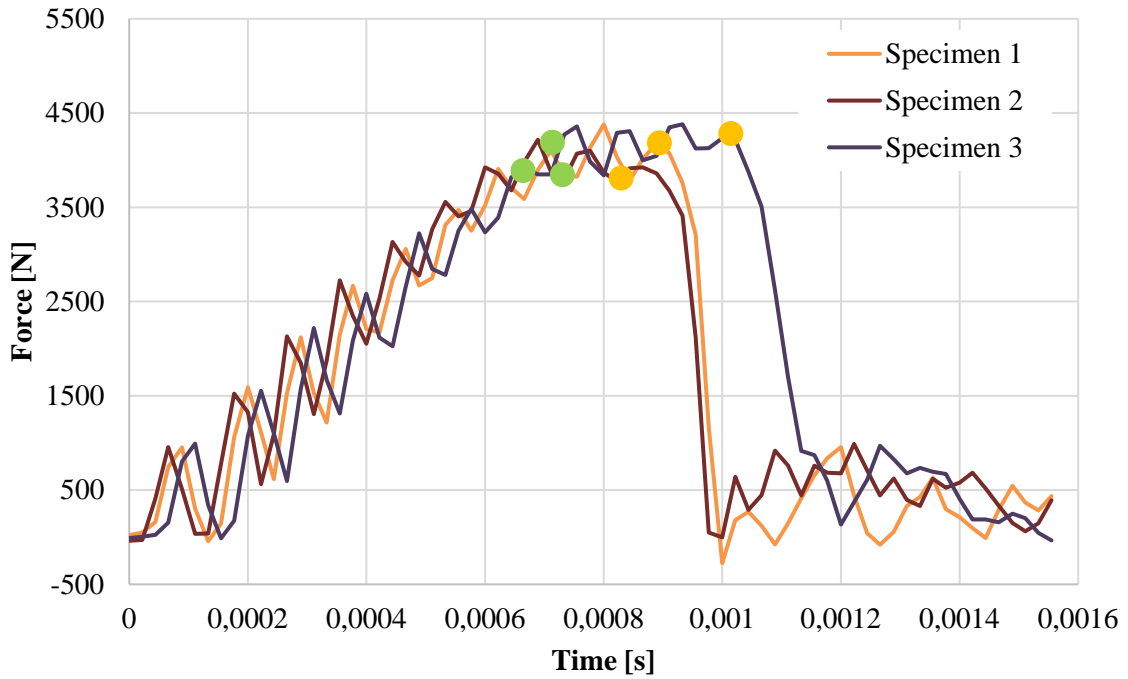
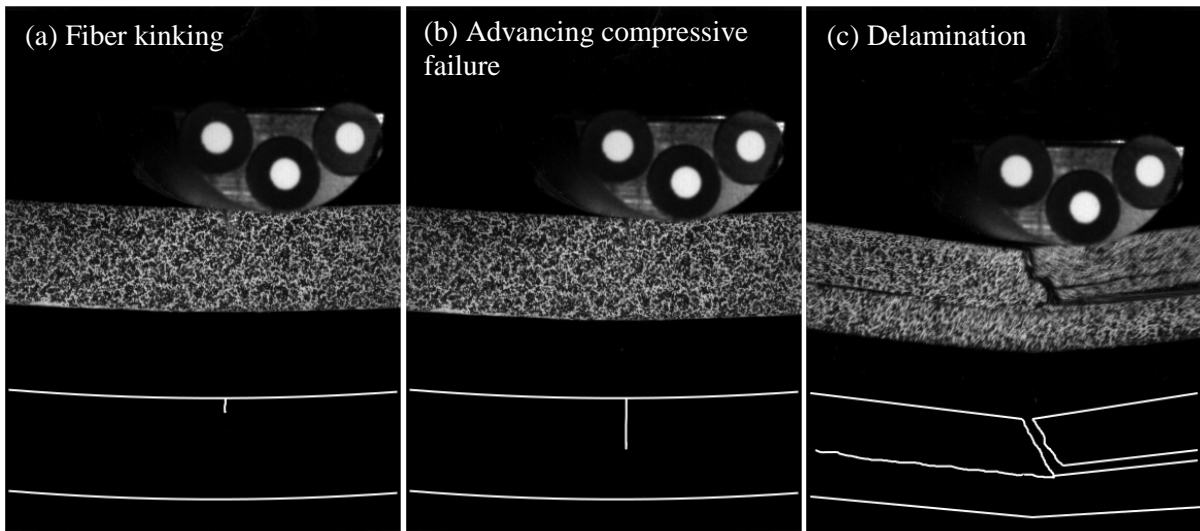
Figure 7: Failure mechanism of 5 mm thick specimen. Support span of 80 mm at a velocity of 5 m/s.

Specimen with thickness of 4.5, 5.0 and 5.5 mm tested with both support spans and specimens with thickness of 4 mm tested with a support span of 80 mm showed delamination as final failure mode. An example is shown in Fig. 7. Once fiber kinking occurs on the compression side, the applied load remains constant while the fracture propagates through the thickness. At the occurrence of delamination the load

signal goes instantaneously to zero as the specimen is split in two parts. This behaviour is due to the fact that, as the ratio between specimen thickness and support span decreases, the influence of shear stresses increases [6, 11].

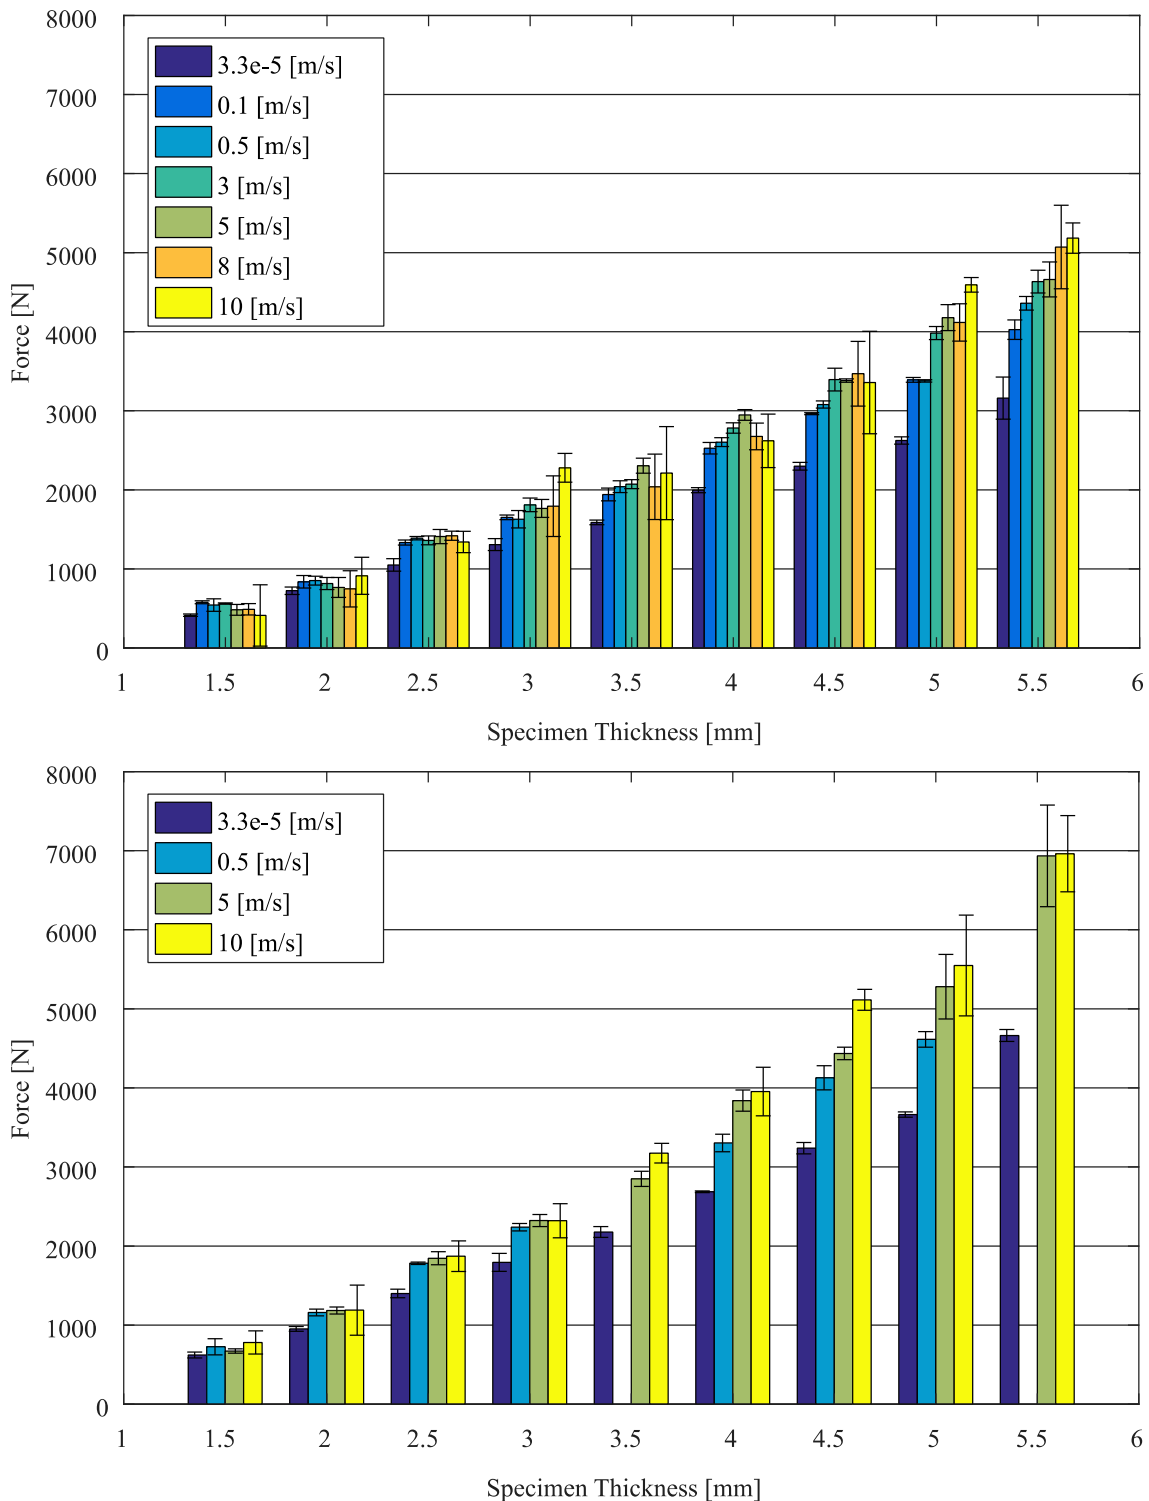
Figure 8: Maximum force at failure. Support span 80 mm (top) and 60 mm (bottom)

The maximum force coming from the smoothed force signal for the tests performed is summarised in Fig. 8. For each specimen thickness, the bar plots display the maximum load reached at every velocity tested. As three replicates were performed, the displayed value is the average of the three tests and the error is given as the standard deviation. Even though the designed fixture is not suitable to test thin laminates, specimens with thickness from 1.5 to 3 mm were tested because this thickness range is the most used for standard material characterisation of structural components. These specimens are the ones which show high variation in maximum force and there is no delineated trend in the maximum force as the testing velocity increases. This is mainly observed for tests with the larger support span. As general trend, specimens with a thickness higher than  $\geq 3$  mm show an increase of maximum load with increasing testing velocity.

When the support span is 80 mm, this is true up to testing velocities of 5 m/s. For example, for the specimens with thickness of 4 mm and 3.5 mm, at high velocities the maximum force decreases compared to the one obtained at 5 m/s. Another outcome is that high deviation in the results is observed, as for specimen with thickness of 4.5 mm and 5.5 mm. This behaviour could be due to specimen vibrations during testing. Results obtained with the smaller support span show a more homogeneous increasing behaviour.

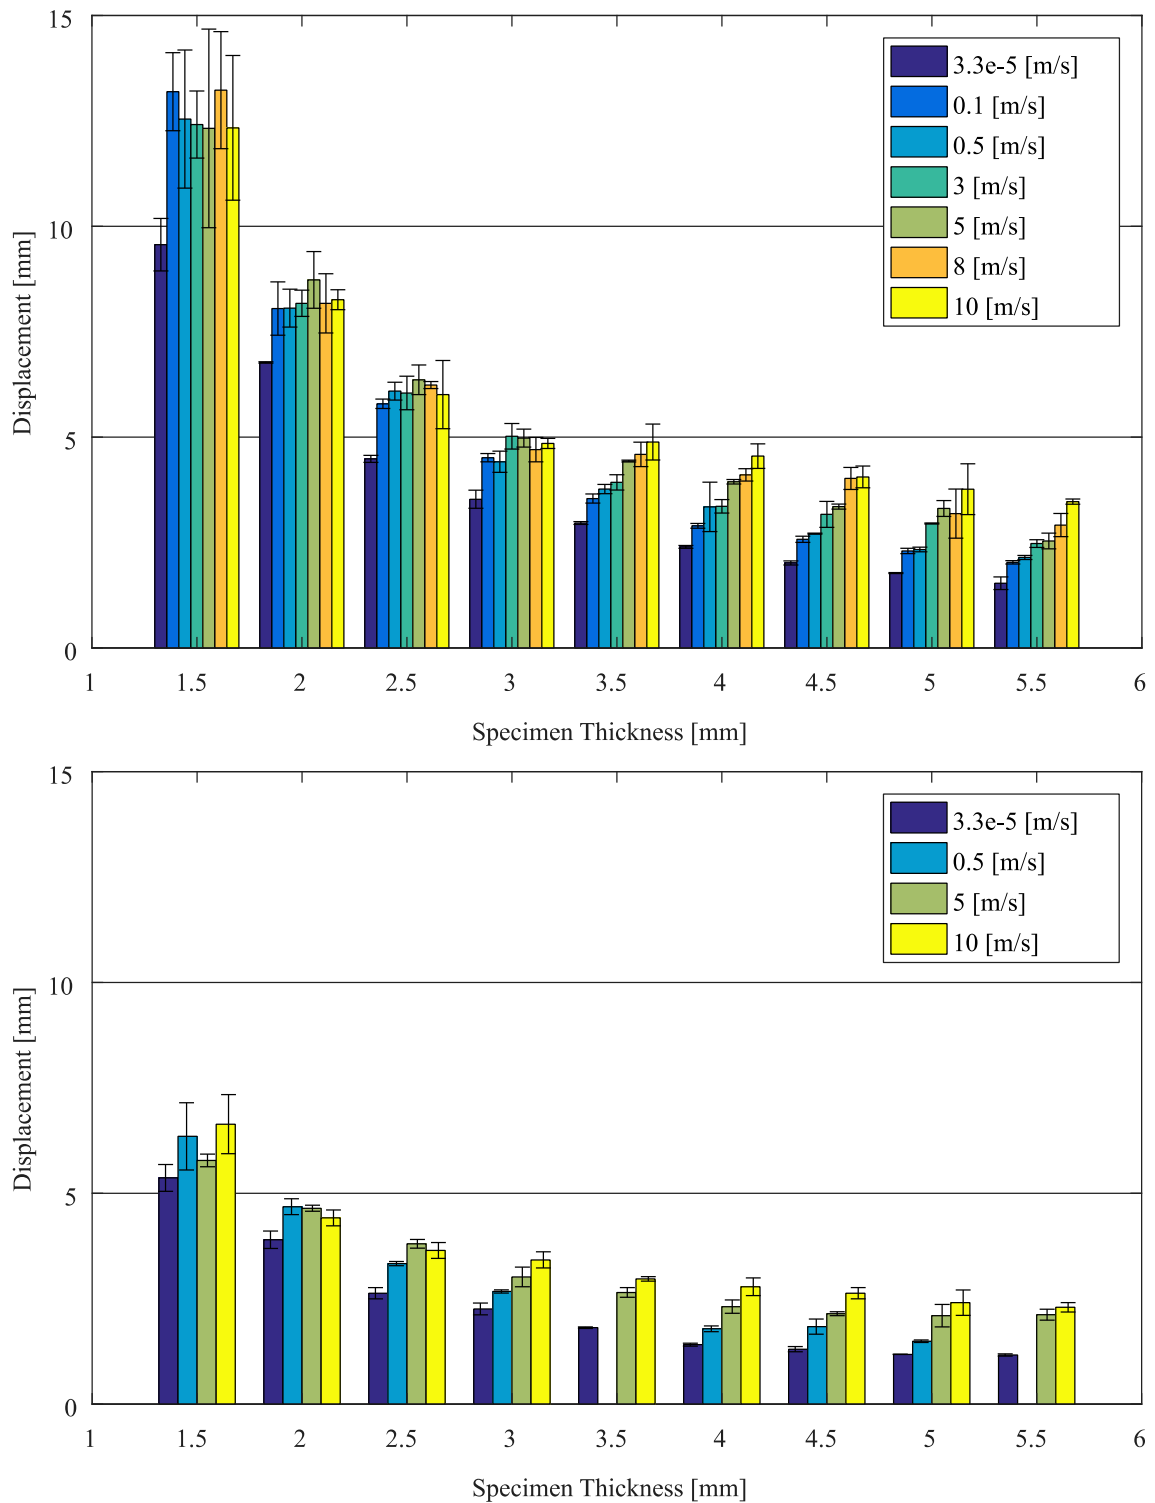
Figure 9: Maximum midpoint displacement at failure. Support span 80 mm (top) and 60 mm (bottom)

The specimen displacement was obtained from the analysis of the pictures taken with the high-speed cameras. The results are shown in Fig. 9. As expected, the midpoint displacement decreases with the increase in specimen thickness. This is due to an increase in the beam stiffness. As a result, increasing the testing velocity gives an increase in maximum displacement. For thicknesses higher than 3.5 mm

the maximum displacement for tests performed at 10 m/s is in all cases nearly twice the displacement measured in quasi-static conditions. This behaviour is observed regardless of the support span.

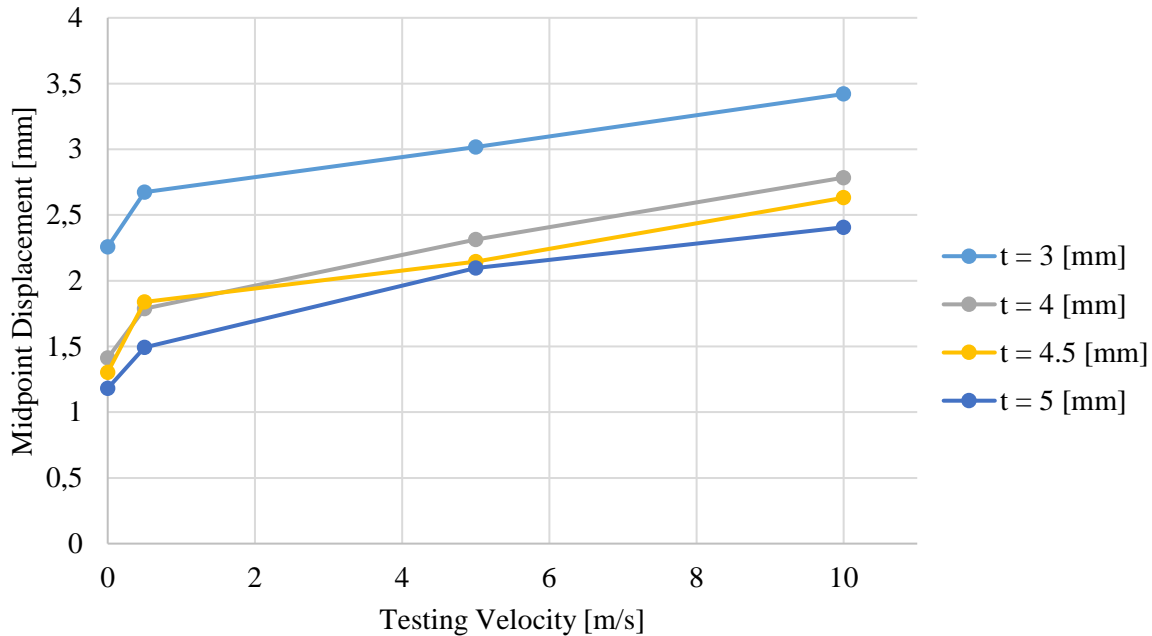
Figure 10: Specimen displacement vs. testing velocity. Support span 60 mm

In Fig. 10 the relationship between the specimen midpoint displacement and the testing velocity is shown. The general trend is an increase in displacement with increasing testing velocity. In all tests performed the results show a high increase in specimen displacement between the quasi-static velocity and low testing velocity of 0.5 m/s for support span of 60 mm. The increase between the other testing velocities is not as steep, and the curves have a tendency to flatten. This behaviour suggests a logarithmic relationship between the specimen midpoint displacement at failure and the testing velocity.
