Deflections and Natural Frequencies as Parameters for Structural Health Monitoring

The Effect of Fatigue and Corrosion on the Deflections and the
Natural Frequencies of Reinforced Concrete Beams

Proefschrift

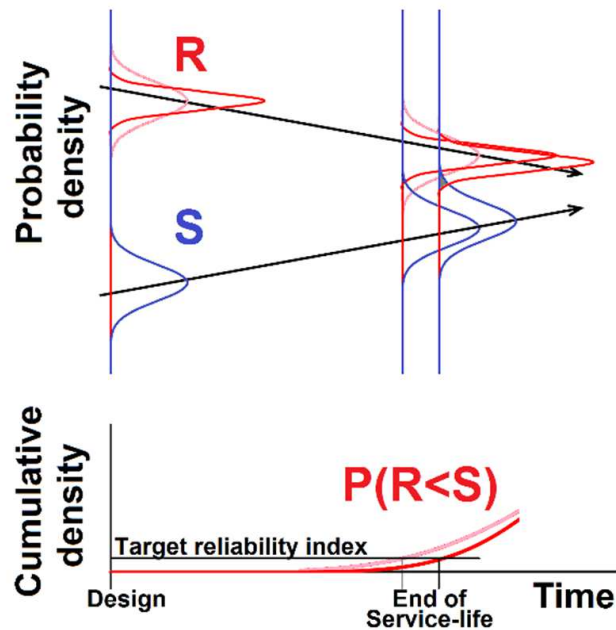
Figure 2-3: Schematic illustration of the probability of failure with time. The curves represent the same densities as in Figure 2-2. Due to a reduction of the uncertainty in the resistance, the probability of failure change. As result of this change, the service-life can be extended.

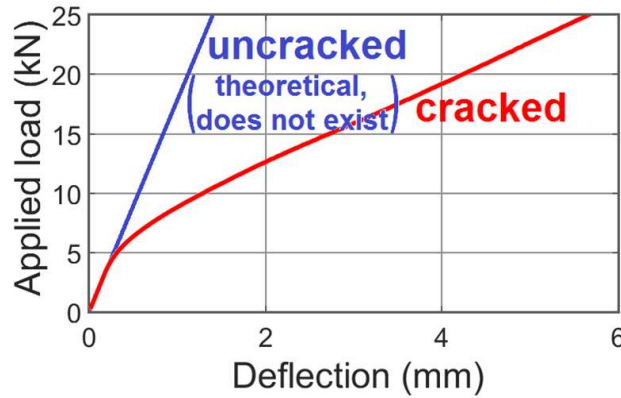
Figure 2-7: Load-deflection of a RC beam, loaded in a four-point-bending configuration. The red curve corresponds to the deflections of a cracked beam. The blue curve shows the theoretical deflections of a RC beam in an uncracked situation.

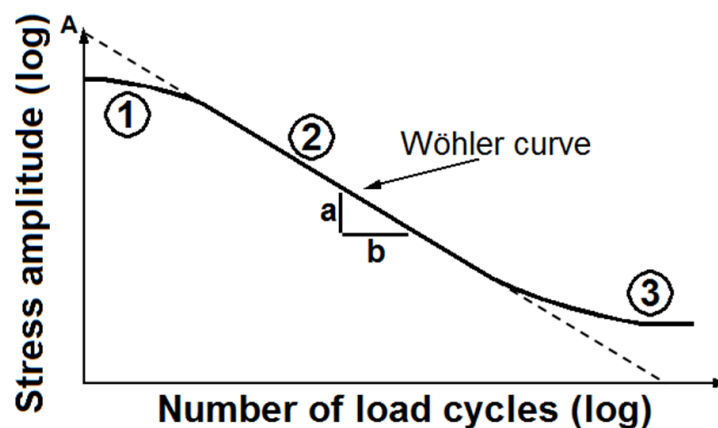
Figure 2-12: Standard S-N (Wöhler) curve. In the first stage, the yielding strength is decisive in the load bearing capacity. The second stage contains a logarithmic relation between stresses and cycles. This relation is expressed in Equation (2-6). In the third stage, the number of load cycles before failure tends to infinity.

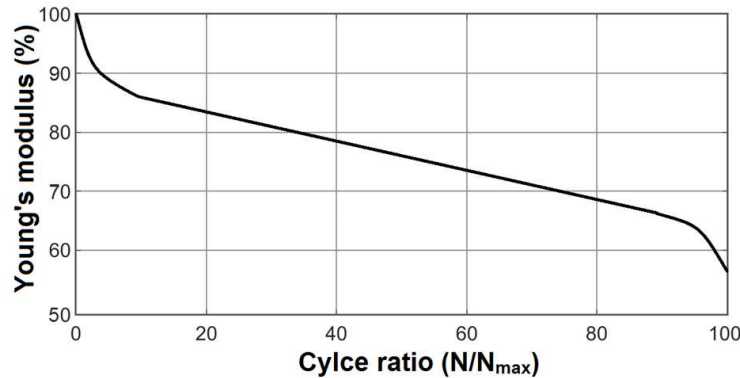
Figure 2-13: Potential development of the Young's modulus of concrete [60]. The horizontal axis shows the ratio between the number of load cycles (N) and the maximum number of load cycles until failure (N_{max})

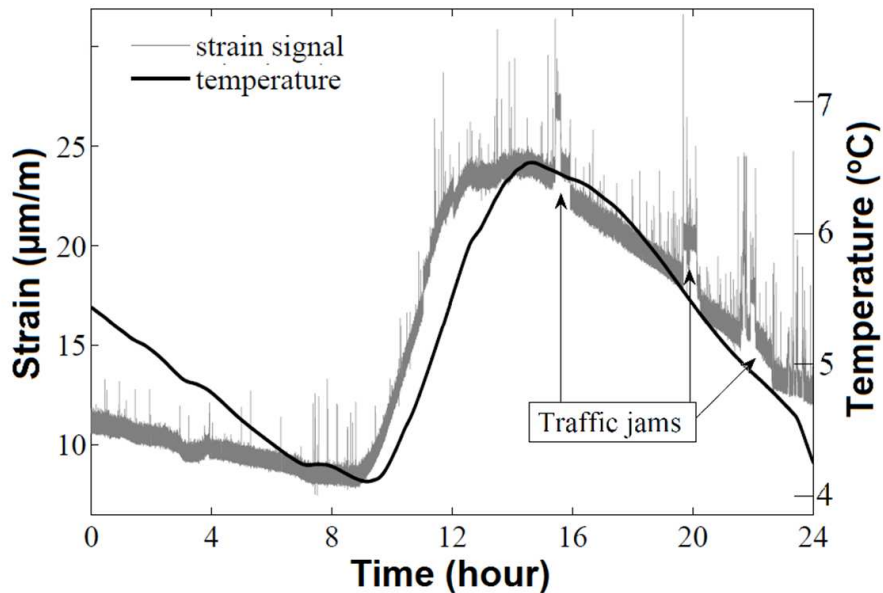
Figure 3-6: Influence of temperature and traffic jams on a strain signal. The data for these signals are derived from sensors which are located in the middle of the first span of the bridge.

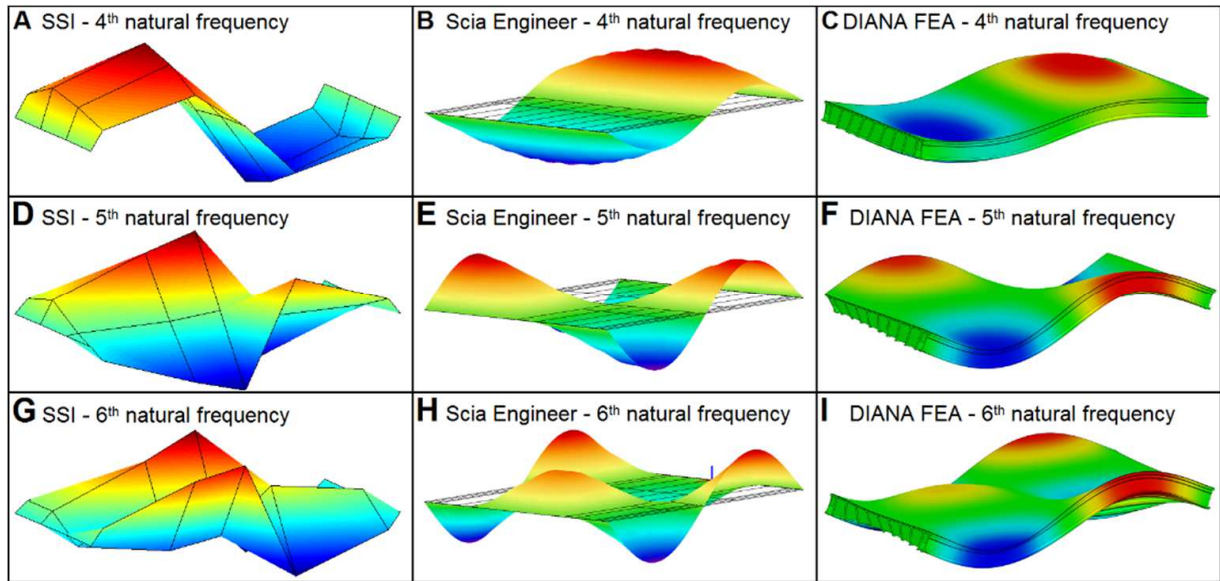
Figure 3-14: Mode shapes of the second order natural frequencies of the bridge (4th, 5th, and 6th natural frequency). Different methods and computer programs were used (SSI, Scia Engineer, DIANA FEA).

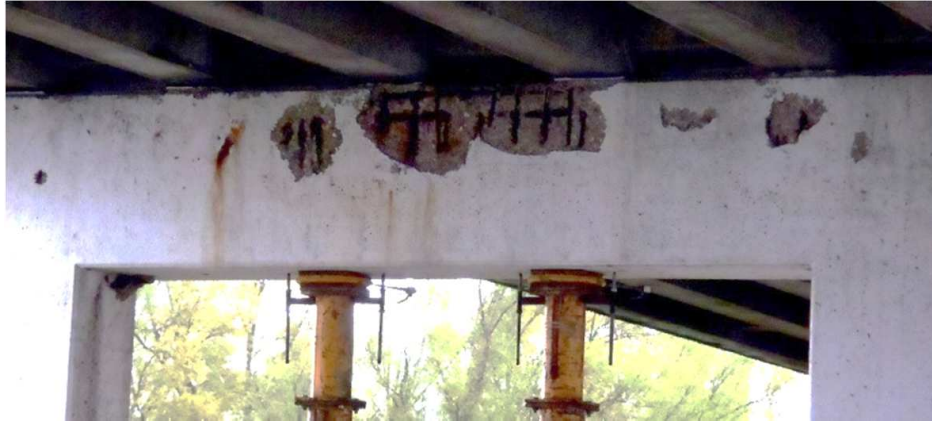
Figure 3-16: Corrosion and spalling of a supporting beam from the Nijkerkerbrug, a RC bridge in the Netherlands.

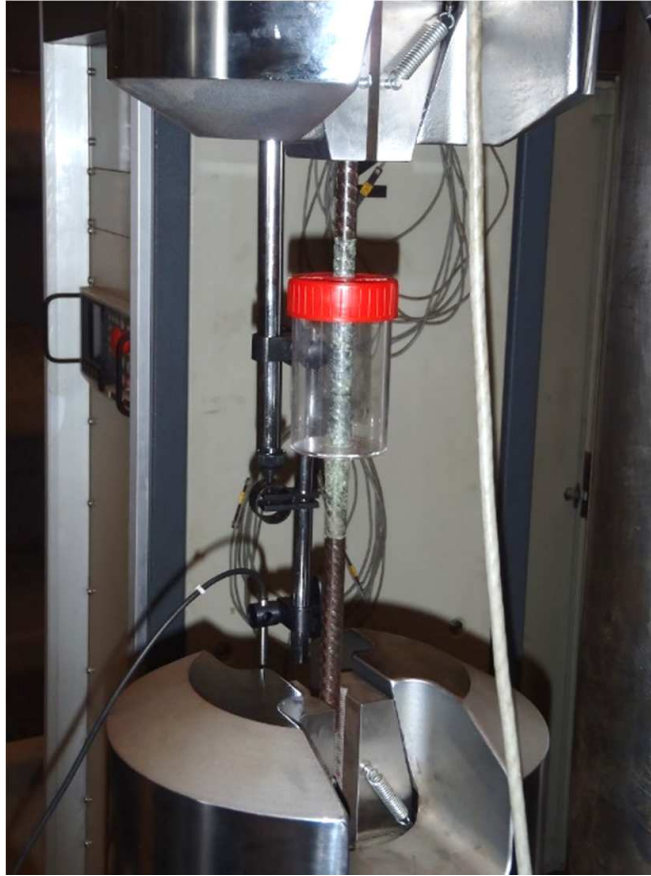
Figure 4-1: Picture of the test setup. In most dynamic tests, the cup was filled with a chloride-solution to create a local chloride rich environment.

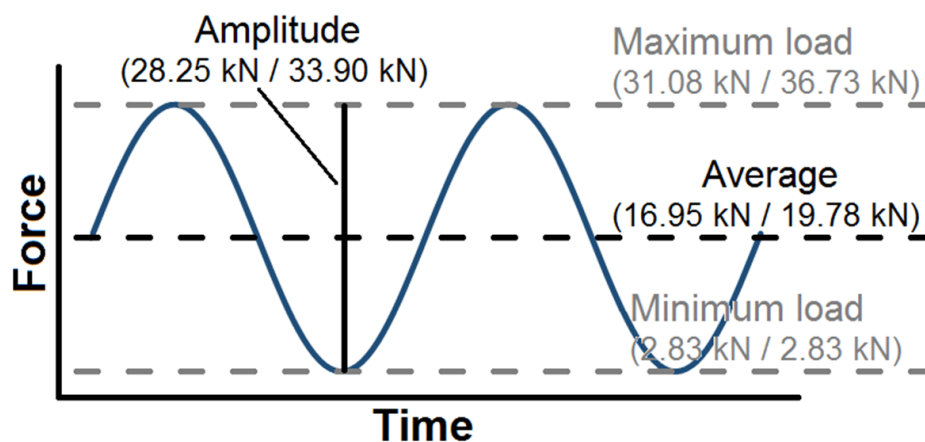
Figure 4-3: Illustration of the applied dynamic loads on the plain steel bars.

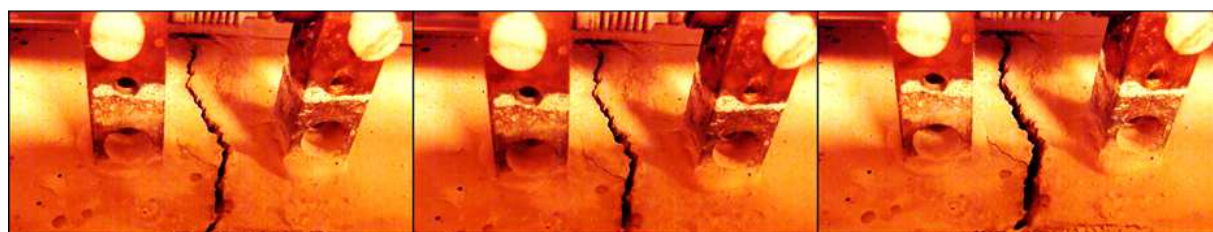
Figure 4-35: Cracks on top of one of the beams (beam exposed to tap water) of Test 4A, during dynamic loading.

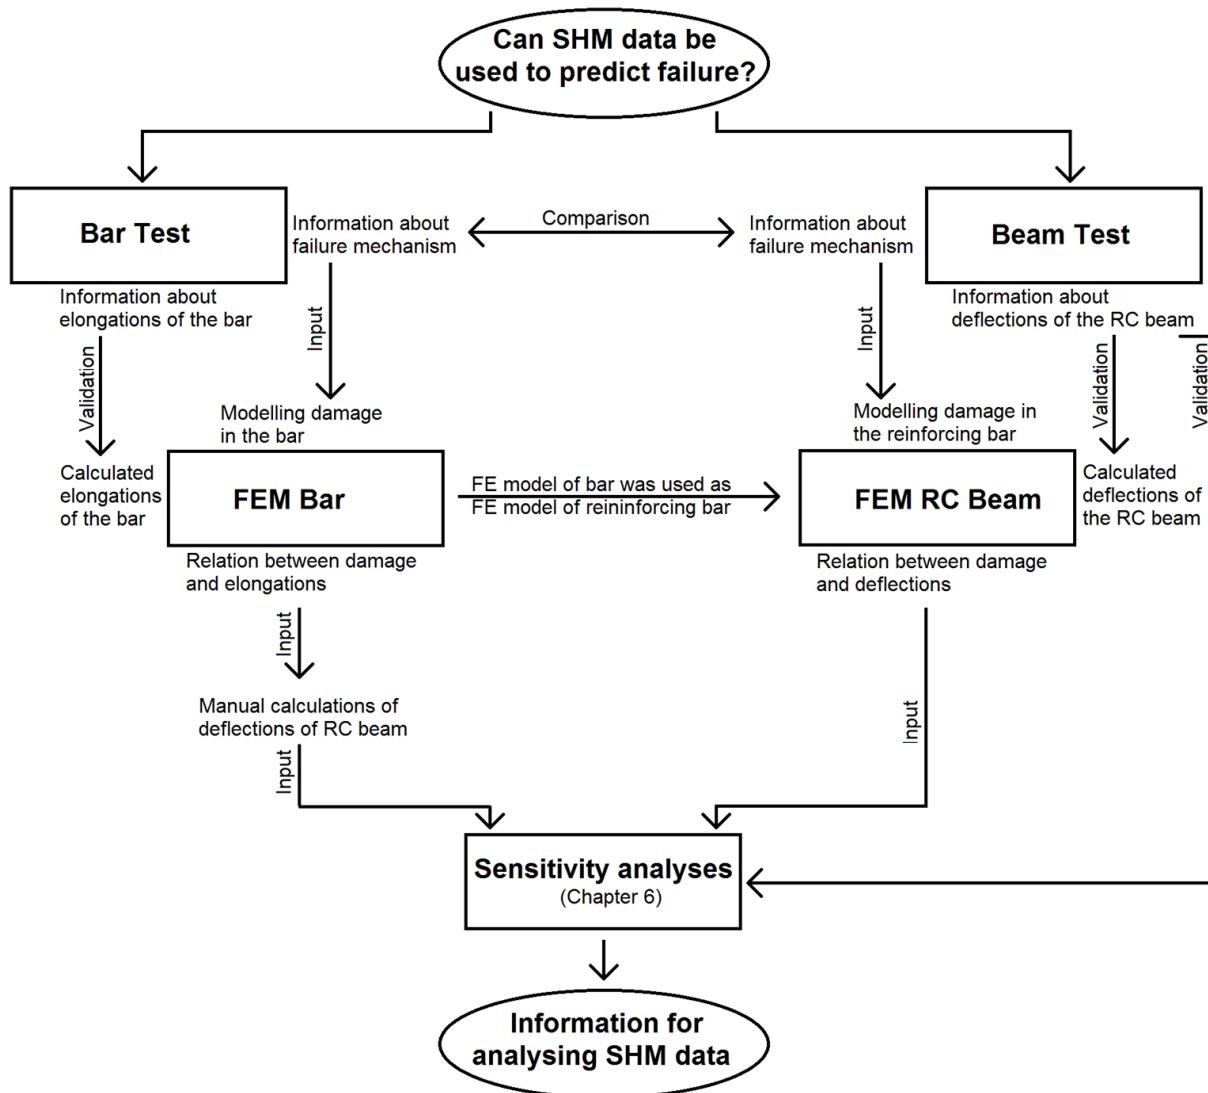
Figure 5-1: Relations between test results, FE models, Sensitivity analyses, and a SHM system. (FEM = Finite Element Method, SHM = Structural Health Monitoring).

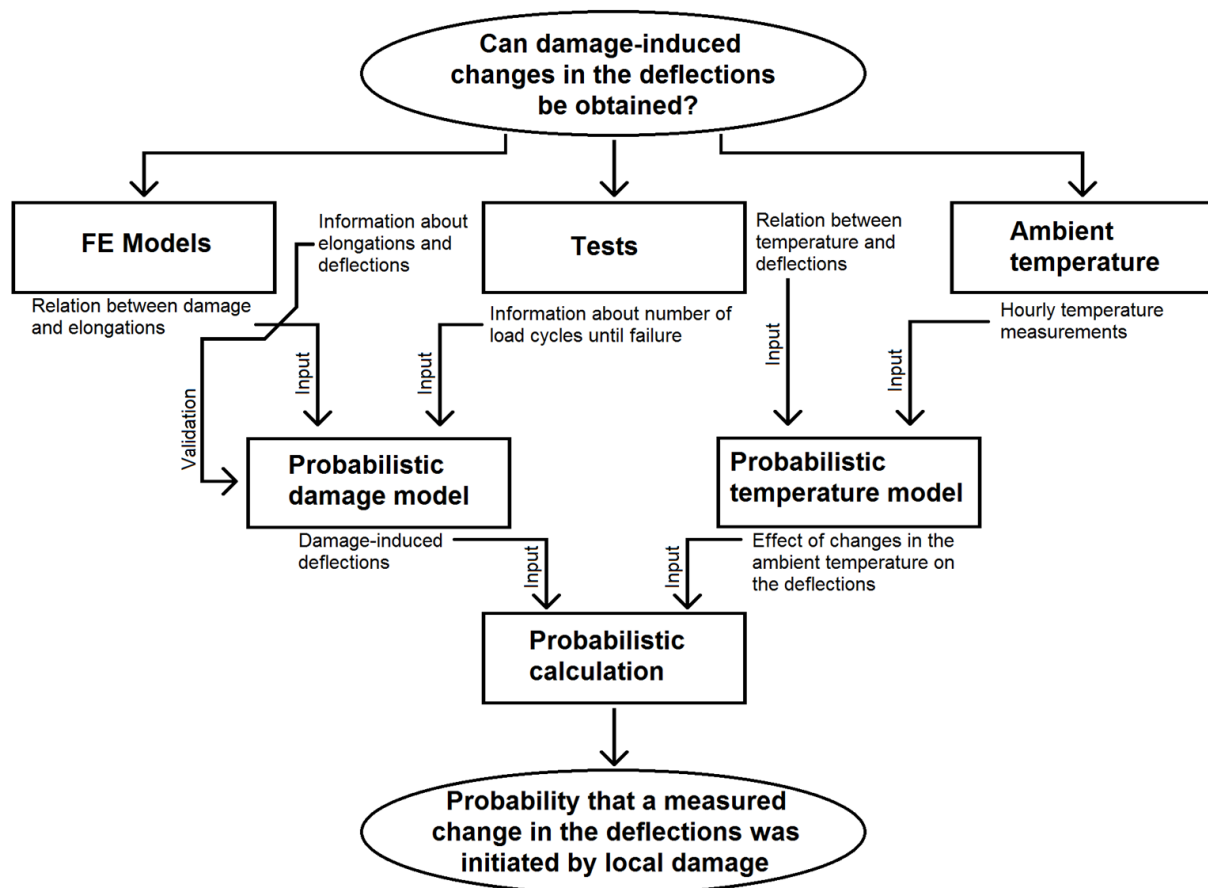
Figure 6-1: Relation between tests, FE models, and Probabilistic models for the deflections of the RC beam.

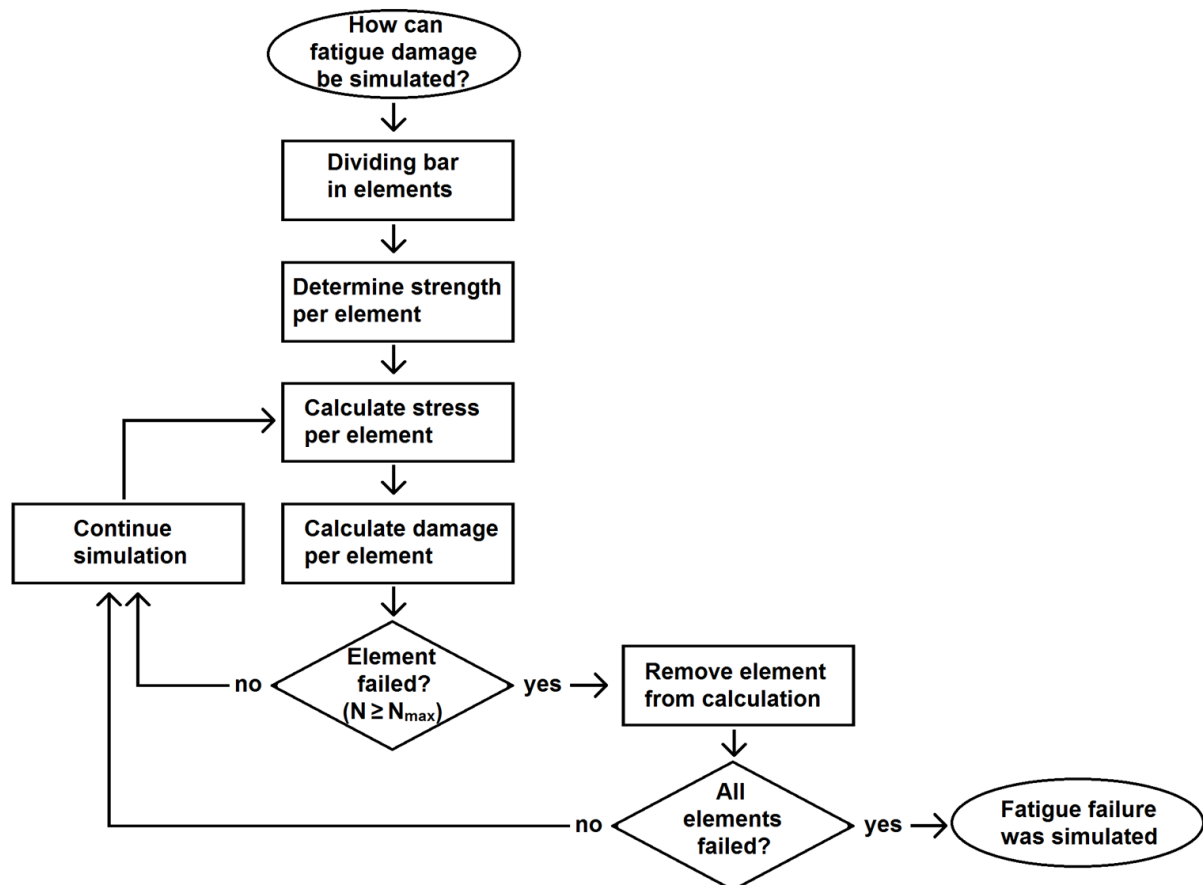
Figure 6-2: Flowchart for the Monte Carlo simulation.
