Managing erosion of mangrove-mud coasts with permeable dams – lessons learned

2020

Ecological Engineering

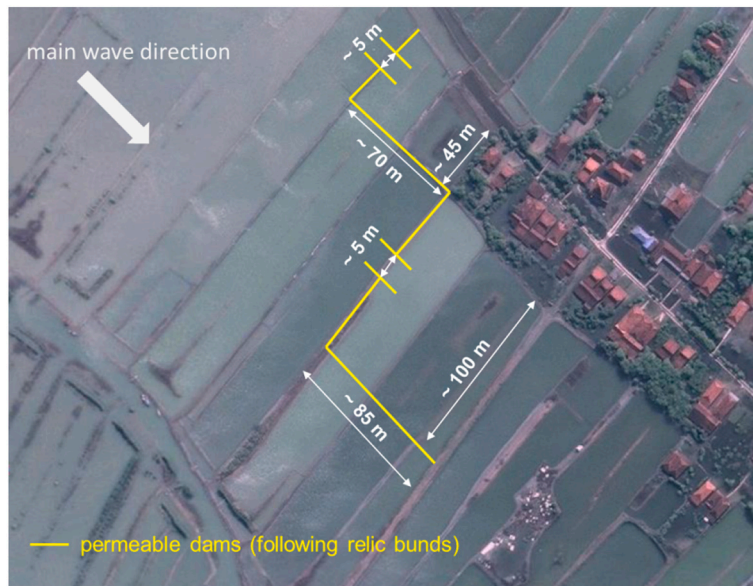
Fig. 5. First permeable dam pilot project in Indonesia in 2013, Bogorame, Demak.

Two sedimentation basins were created by erecting permeable dams on the lost lands at the head of Bogorame, as this part of the village was severely at risk to erosion and flooding. Fig. 5 shows the remnants of the bunds previously forming the now-lost aquaculture ponds. The

permeable dams were placed on top of these remnants, as they form a stable underground, reducing the risks of local scour. Construction of the dams was finished in November 2013. Fig. 6 presents the measured sedimentation volumes in the two sedimentation basins, showing a mean sedimentation rate of about 0.5 m in the four most dynamic months, whereas elsewhere erosion continued. Based on these promising results, many more dams were constructed in Demak coastal area with a total length of more about 13.5 km, built and funded by various partners, with slightly modified designs, while still based on best engineering practices. Simultaneously, an extensive monitoring and basic research program was set up, in conjunction with a socio-economic development program with the local stakeholders (see Section 5).

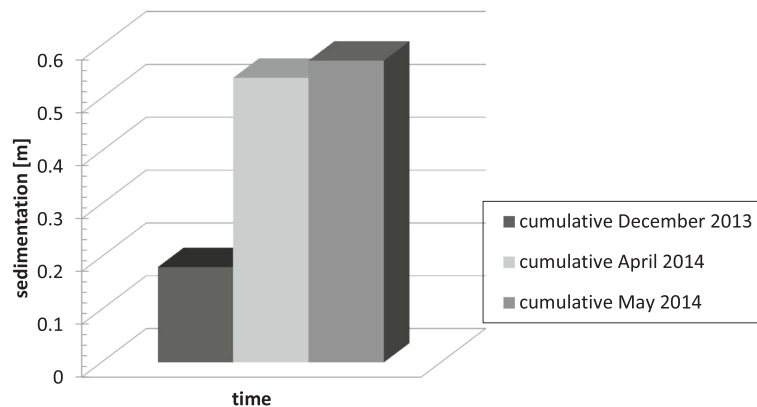
Fig. 6. Measured sedimentation rates 2013 pilot, Bogorame, Demak, Java, Indonesia.

Initially, these permeable dams trapped considerable amounts of sediment and overall, bed levels behind the dams raised. At some locations spontaneous mangrove colonization was observed. Also, local communities planted *Rhizophora* in several sedimentation basins. Fig. 7 shows some photographs of the sedimentation patterns observed. First observations of longer term monitoring results indicate initial sedimentation behind the dams, but on the longer term sedimentation rates reduced considerably. More thorough analysis of these long-term results was on-going at the time this paper was written. Over longer times, mangroves survived in only a few of the most protected sedimentation basins. Elsewhere, juvenile mangroves disappeared after one

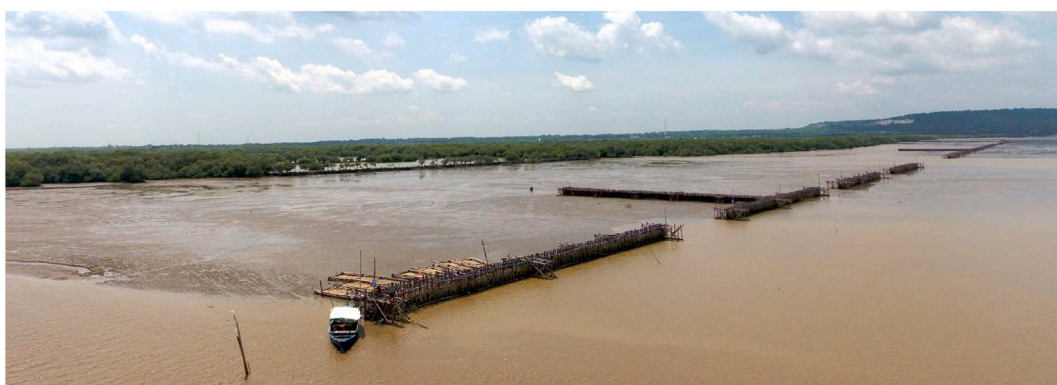
Fig. 8. Example of permeable dams in Gresik Regency, close to Solo River, Java, Indonesia (photo by MMAF early 2019).

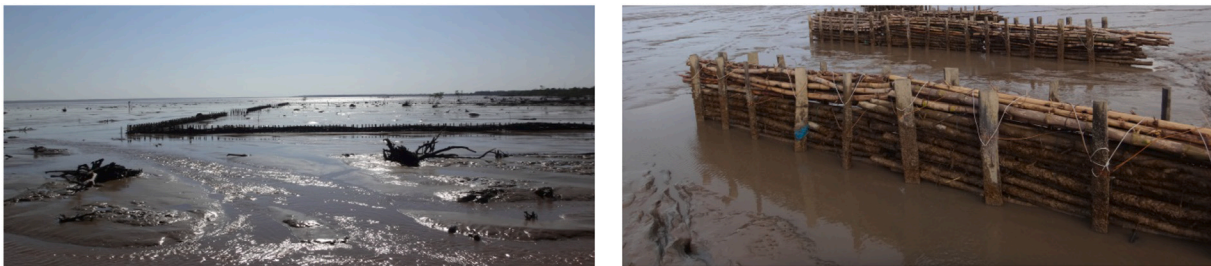
Fig. 11. Permeable dams constructed near Weg naar Zee, north of Paramaribo, Suriname (photos by E. Van Lavieren).

series of permeable dams were constructed, as shown in Fig. 11, the locations of which are indicated in Fig. 10. Next to these constructions, a small-scale mangrove replanting program was executed in 2018. This work was mainly aimed at involving local stakeholders in mangrove rehabilitation efforts, and no systematic monitoring program was executed.

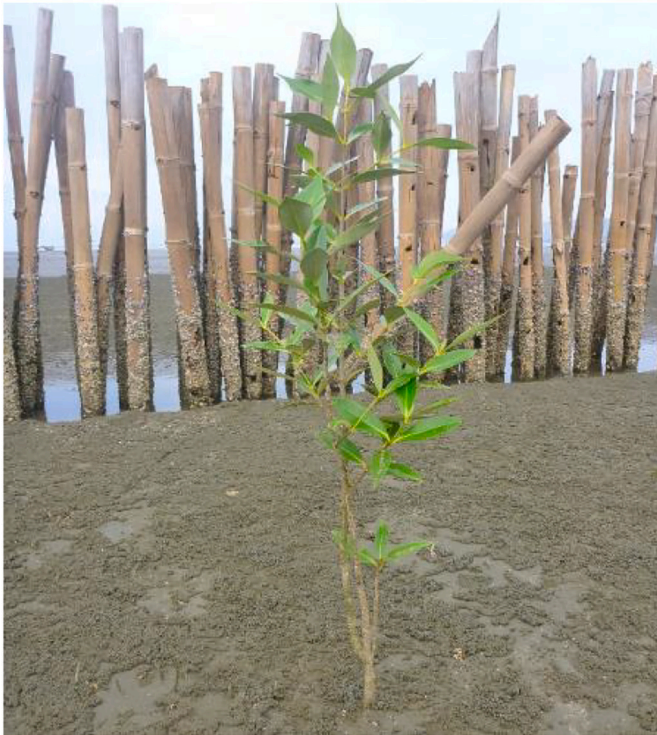
Fig. 14. Sedimentation and *Avicennia marina* behind the bamboo fence on Klang Island, Thailand.

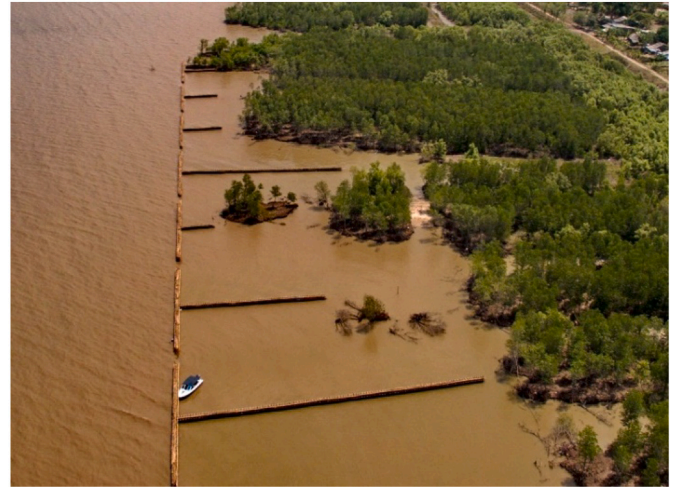
Fig. 16. Wave dampening effect of bamboo T-dams in Ca Mau Province, Viet Nam (courtesy R. Sorgenfrei, 2016).

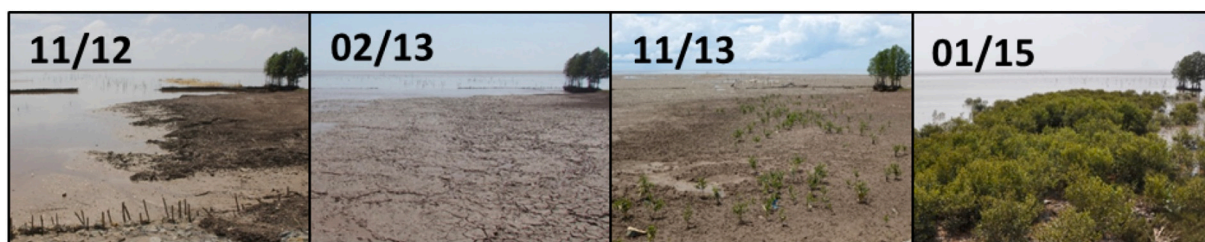
Fig. 17. Natural regeneration of *Avicennia* on restored floodplains in Soc Trang Province from the construction of the T-fences in October 2012 until January 2015 (Photos: GIZ Soc Trang, R. Sorgenfrei).

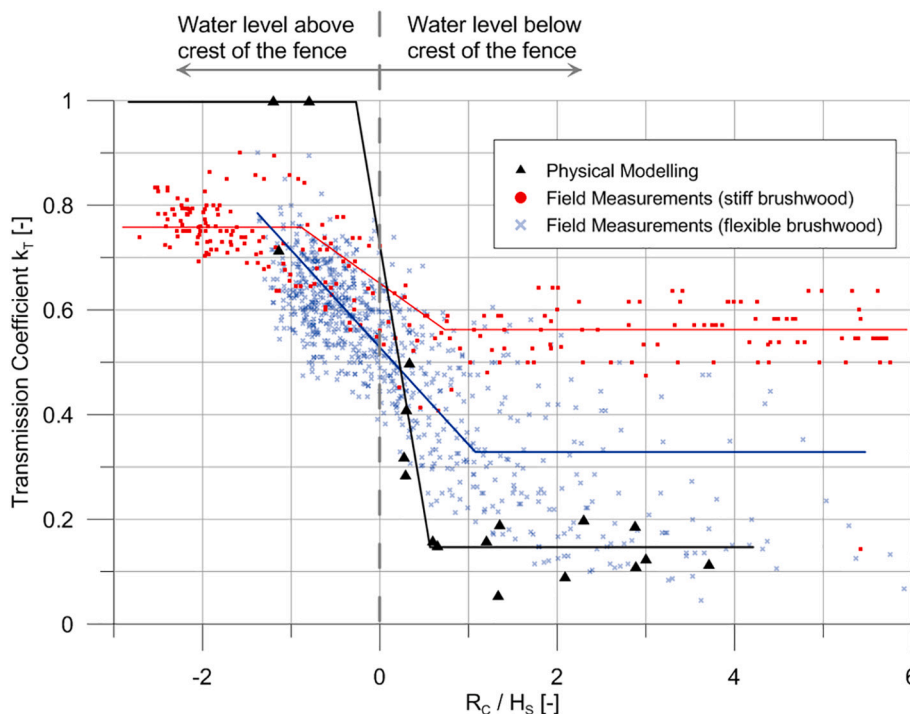
Fig. 19. Wave transmission coefficients of bamboo fences under various hydrological conditions (modified after Albers et al., 2013).

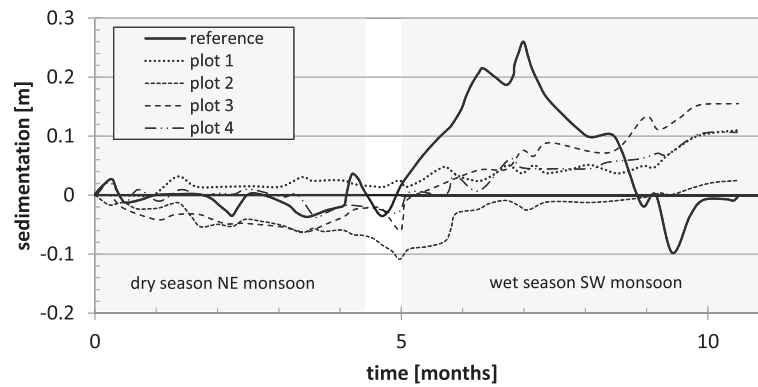
Fig. 24. Measured sedimentation rates in Vietnam pilot plots – from GIZ, Practical Experience from Kien Giang Province, 2012.

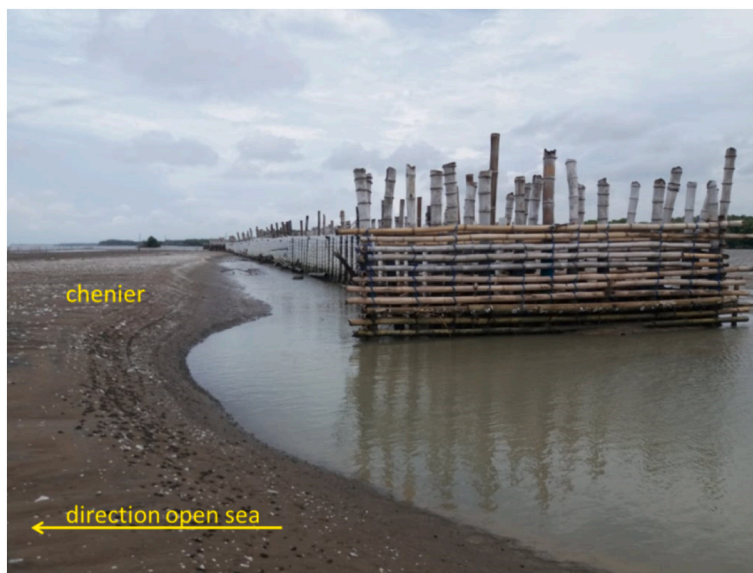
Fig. 27. Chenier approaching permeable dam at Wonorejo, Demak, Java, Indonesia.

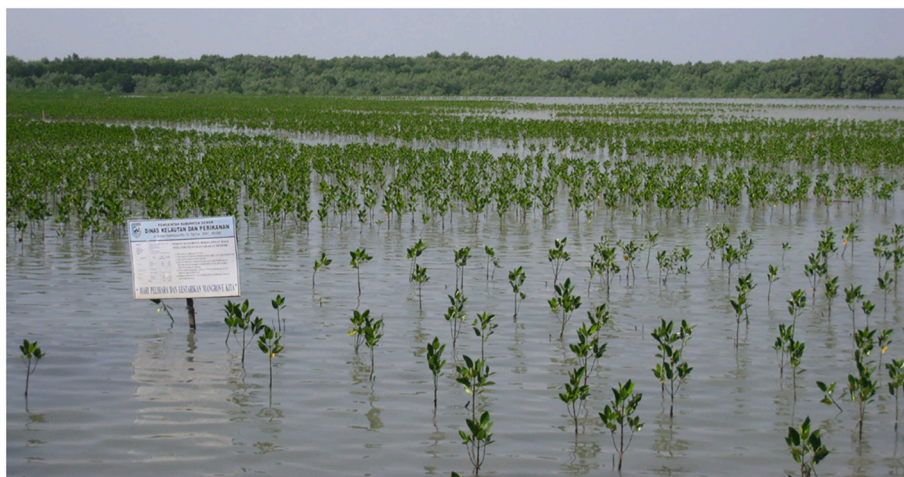
Fig. 33. *Rhizophora* planted on mud flat.

Overall, mangrove replanting is often done with red mangrove propagules, irrespective of habitat suitability (Fig. 33). As a
