Measuring Wave Run-Up, Overtopping And Damage Of Rubble-Mound Breakwaters In Scale Model Tests

Proceedings of the HYDRALAB+ Joint User Meeting

MEASURING WAVE RUN-UP, OVERTOPPING AND DAMAGE OF RUBBLE-MOUND BREAKWATERS IN SCALE MODEL TESTS

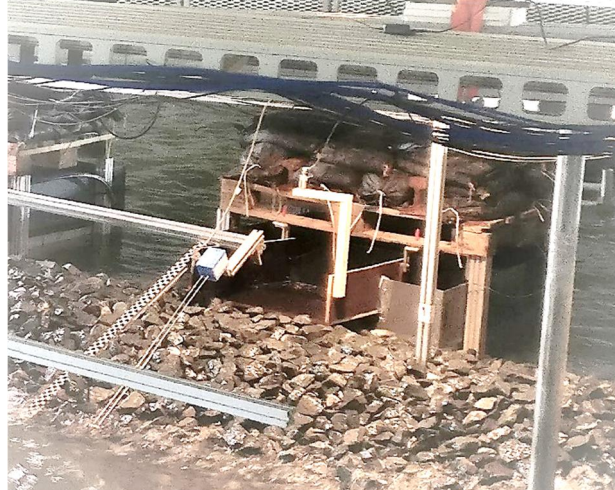
Fig. 3 there is a picture from the entrance of the overtopping reservoir at the breakwater root. In addition to the chute, the acoustic wave gauge to identify overtopping events and the graduated staff deployed in front of that reservoir can be seen. During the tests, a video camera recorded the free-surface on the graduated staff. It is expected that run-up parameters can be extracted from such videos using the methodology of Bornschein et al. (2014).

Figure 3. General layout at the entrance of an overtopping reservoir (run-up wave gauge, acoustic wave gauge to identify overtopping events, graduated staff).

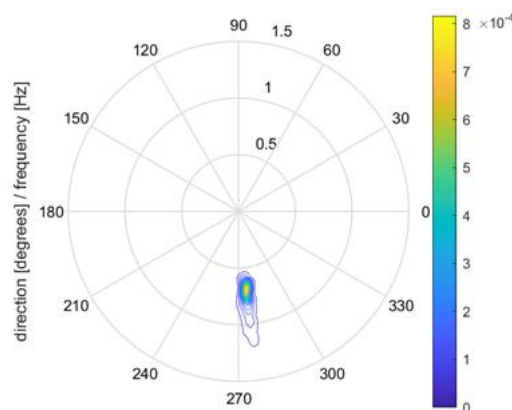
The MATLAB toolbox DIWASP (Johnson, 2002) was employed to evaluate the directional spectrum of the waves at the location of the arrays made of acoustic wave probes. The six probes in each array were used to estimate the directional spectrum with the iterated maximum likelihood method of Pawka (1983). Since in this set of tests the wavemaker generated long-crested waves only, the estimated directional spectra are quite narrow, with most of the energy concentrated around the direction of 265° (this corresponds to waves propagating at an angle of 95° to the wavemaker and an angle of 65° to the normal to the breakwater). This can be seen in Fig. 6 with the estimated directional spectrum in front of the wavemaker for test 18.

Figure 6. Directional spectrum estimated with the iterated maximum likelihood method. Data measured at the array of acoustic wave probes 3.3. Test 18: Hs = 0.150 m, Tp = 1.45 s.

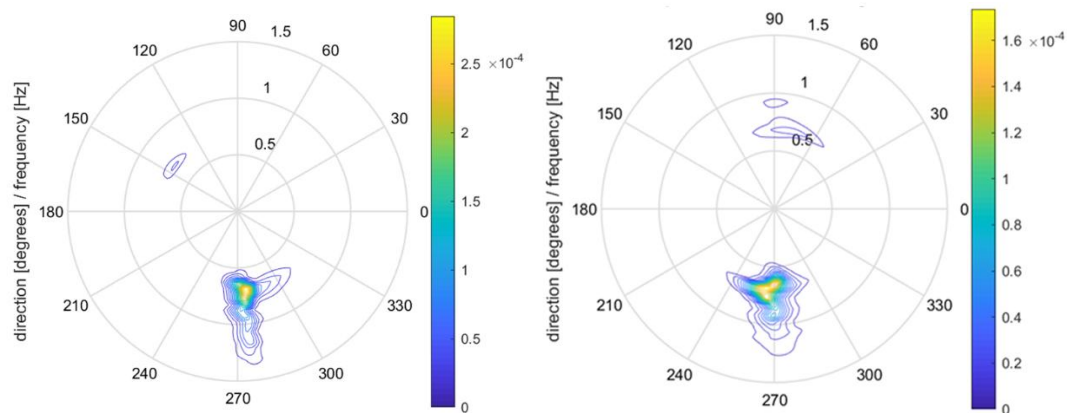
Fig. 7 presents the directional spectra obtained with such procedures for test 18 (Hs = 0.150 m Tp = 1.45 s). The agreement between the wave characteristics determined from the directional spectrum estimated from the probe + ADV data (Hs = 0.144 m Tp = 1,46 s Dir = 264°) with the

ones from the spectrum estimated with the array data ($H_s = 0.159$ m $T_p = 1,46$ s $Dir = 276^\circ$) is a foreseen consequence of the similar shapes of the directional spectra shown in that figure.

Figure 7. Directional spectra estimated with the iterated maximum likelihood method. Test 18: $H_s = 0.15$ m, $T_p = 1.45$ s. Left: data measured at the array of acoustic wave probes 3.3. Right: data measured at acoustic wave probe 3.2.6 and ADV 2.3.

One final test with the DIWASP toolbox was carried out with the free-surface elevation measured with the acoustic wave probe 3.2.6 (the central probe of array 3.2, the one in front of the breakwater head) and with the horizontal velocity components of the flow measured with ADV 2.3, the one closest to that acoustic wave probe. Since the ADV measurements did not start at the same time as the acoustic wave probes, the cross-correlation between the two signals was evaluated to find the time lag between them.
