Published in

Proceedings of the Coastal Engineering Conference

FIELD MEASUREMENTS OF VERY OBLIQUE WAVE RUN-UP AND OVERTOPPING WITH LASER SCANNERS

Patrick Oosterlo, TU Delft, P.Oosterlo@tudelft.nl

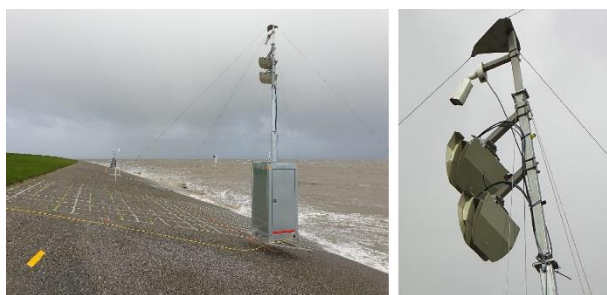
Figure 2 - Left: New laser scanner system next to the overtopping tanks on the dike in the Eems-Dollard estuary. Right: from the bottom to the top: Laser scanner 1, laser scanner 2, video camera.

An extensive field measurement project is being performed in the Eems-Dollard estuary in the north of the Netherlands for a period of 12 years. The measurements started in 2018, measuring wind, water levels, waves and wave run-up and overtopping. The estuary consists of deep channels and shallow tidal flats and is part of the Wadden Sea, a shallow shelf sea, see Figure 1. A particular aspect for this area is that the dike design conditions are characterized by very obliquely incident waves, up to 80° relative to the dike normal. As the reliability of the models as used for the Dutch dike safety assessment has not been sufficiently validated for such conditions, the aim of the measurements is twofold. First, to better understand the processes yielding nearshore wave conditions, ultimately leading to improved numerical prediction models. Second, to better understand the processes related to oblique wave run-up and overtopping, leading to improved prediction methods. In the project, the wave overtopping is measured with four wave overtopping tanks built into dikes at two locations. The laser scanner system of Oosterlo et al. (2019) has since been upgraded and has now been placed next to two of the overtopping tanks on the dike in the Eems-Dollard estuary to measure during actual severe winter storms, see Figure 2.

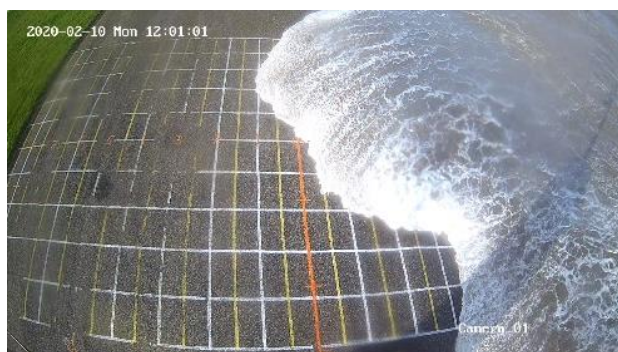
Figure 3 - Snapshot of a very oblique wave running up the slope during storm Ciara.

The focus of the paper will lie on the measurements performed during storm Ciara. Storm Ciara was an extratropical cyclone that hit large parts of northern Europe starting on 7 February 2020. Measurements were performed from 10 to 12 February 2020. Ciara was the first actual storm that was measured with the laser scanner system, and immediately tested the system to the extreme. Ciara was a highly unique storm, with offshore directed wind at the measurement location and waves that turned somewhat on the shallow flats in front of the dike to become almost alongshore directed waves at the dike. Hence, Ciara caused highly complex conditions at the measurement location with very oblique wave attack with angles of incidence up to 75°. This posed large challenges for measuring e.g. the 3D front velocities and the overtopping volumes and discharges, also see Figure 3.
