**Root causes of failures in sustainable urban drainage systems (SUDS)
an exploratory study in 11 municipalities in the Netherlands**

Blue-Green Systems

Root causes of failures in sustainable urban drainage systems (SUDS): an exploratory study in 11 municipalities in the Netherlands

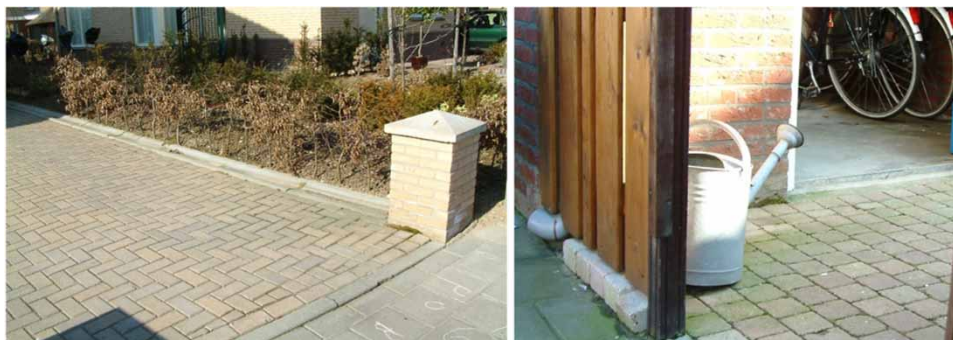
Figure 1 | Two cases (#13 and #15) of technical failures in SUDS with a failing function of conveyance. Left: an obstacle interferes with the transport of water by an open gutter. Right: due to insufficient slope of the garden, the storm water flows into the shed.

- *Conveyance*: The most common technical failure identified for conveyance systems was *Interference with obstacle* (7 out of 25 cases) (see Figure 1 for an example). This technical failure was previously mentioned by Boogaard *et al.* (2006). The second most common failure is *Insufficient slope* (4 out of 25 cases), which is also in line with previous studies (Boogaard *et al.* 2006; Pötz 2016).

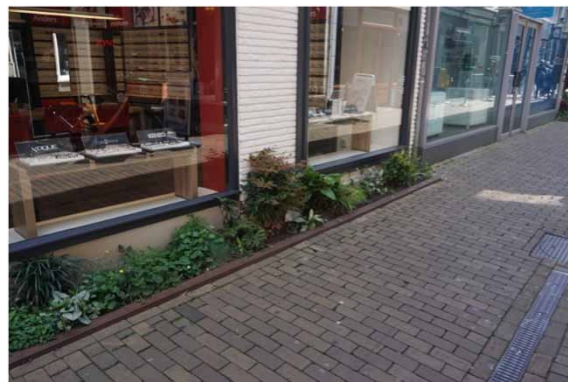
Figure 3 | Case #30: a facade garden, which has been assigned the root cause embedded practices of involved actors. A facade garden is typically constructed surrounded by raised borders. Preventing runoff to be drained into the garden, this reduces the effectiveness of the SUDS.

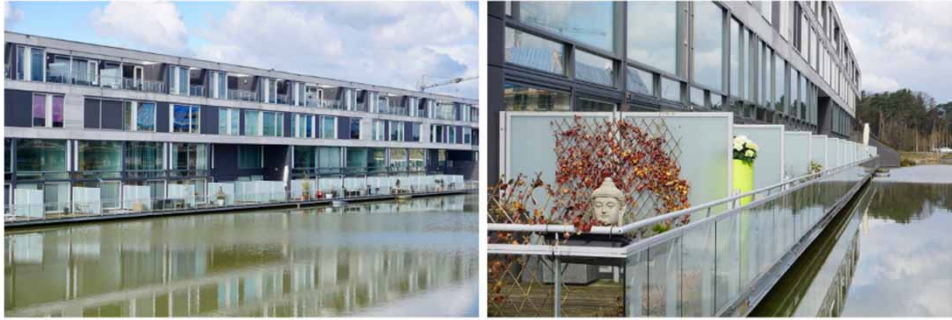
Figure 4 | Case #60 has been assigned the root cause poor communication between different actors. Due to lacking communication between the architect and the municipality, the houses were built only 0.15 m from the water level. This minimized the storage capacity of the surface water, while the water was initially designed as a storm water detention pond with a freeboard of 0.70 m.

An example of such poor communication leading to malfunctioning SUDS is illustrated in Figure 4. The interviewee explained that architects typically want to minimize the distance between the ground-floor level of the house and the water level (in this case 0.15 m), aiming for a closer connection with the water – a so-called ‘living-on-water-experience’. The municipality, however, generally designs water systems with a large freeboard

(in this case 0.70 m) to increase the storage capacity of the water, which could prevent urban flooding after heavy rainfall, as well as water shortage in case of drought. These requirements, however, were not communicated clearly in the decision-making process, which eventually resulted in the houses being constructed with little freeboard. As the storage capacity now had to be realized elsewhere in the urban water system, this brought along high costs.

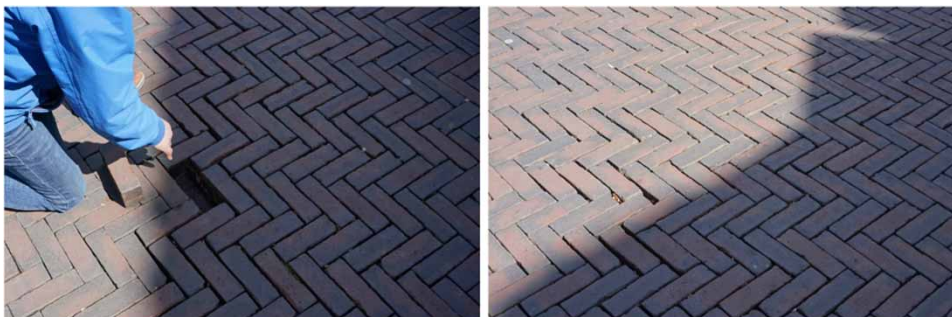
Figure 5 | Case #29 has been assigned the root cause *Incomplete knowledge* about the interactions of SUDS with other urban systems. Due to the impact of cars as well as street sweeping, the joints of the permeable pavement bricks vanished. This decreased the overall performance of the SUDS, i.e., the stability of the road surface.

Figure 5 presents an example of the unexpected impact of car traffic on the performance of permeable pavement. After the implementation of the pavement, it turned out that car traffic resulted in friction between the stones. This damaged the joint fillings between the bricks and eventually led to their disappearance. As the practitioners had no experience with permeable pavement yet, they did not anticipate the long-term effects of cars on this type of porous pavement construction.

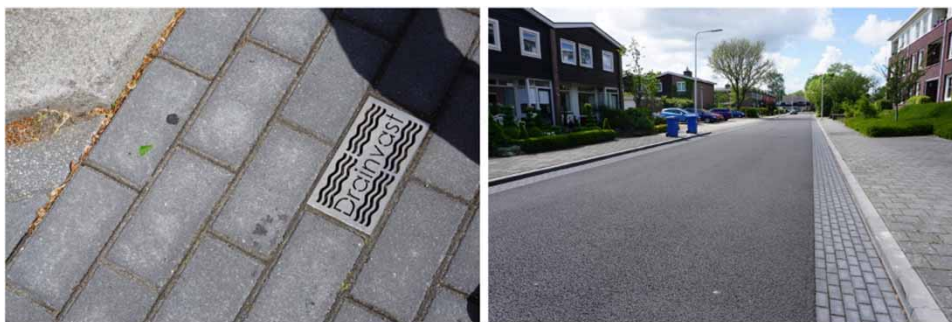
Figure 6 | Case #33 has been assigned the root cause *Incomplete knowledge* about the internal technical processes. The pavers were separated by joints filled with a permeable material, allowing water to infiltrate. Even after a small rainfall event, however, water remained ponding for at least 1 h. As such, it was thought that the permeable material had become clogged, leading to a malfunction of the SUDS.

explained that this incomplete knowledge typically stems from the limited monitoring that is carried out in SUDS. They argued this prevents learning and results in unnecessary failures. In addition, one interviewee reported that in some cases, designers do not have the knowledge and/or experience to properly understand the internal processes occurring in SUDS. This relates, for example, to incomplete knowledge about the subsoil. As compared with sewers, the subsoil forms an important part of SUDS, particularly in the case of infiltration facilities. The design is then often based on the very limited information available about the subsoil, if at all. When SUDS are then constructed in practice, the subsoil sometimes has other characteristics than expected, resulting in malfunctions. For instance, the soil contains more clay, or groundwater levels are higher than expected, decreasing the permeability of the soil, or reducing the subsurface storage capacity, respectively. An example is provided in [Figure 6](#).

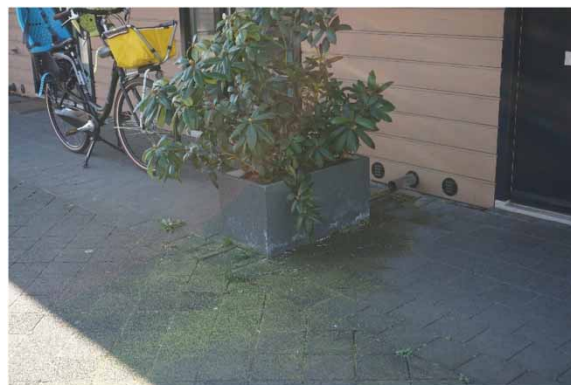
Figure 7 | Case #8 has been assigned the root cause actual use of SUDS. A flowerpot was placed in front of a dwelling's water outlet, preventing water to be discharged properly.

They could, for example, put a flowerpot in the gutter (Figure 7). The rain pipe collects the storm water from the roof and discharges the storm water into the gutter at street level. The water is then transported overland, and thus kept visibly (as opposed to the traditional subsurface lateral house connection), toward the infiltration facility. When placing a flowerpot in the gutter, the intended flow path of the storm water is blocked.
