## Chloride Ion Penetration into Cracked UHPFRC During Wetting-drying Cycles

Proceedings of the 3rd RILEM Spring Convention and Conference (RSCC 2020)

**Abstract** The subject of this paper is the extent to which, during wetting–drying cycles, chloride ions can penetrate Ultra-high-Performance Fibre Reinforced Cementitious Composites (UHPFRC) specimens subjected to combined mechanical and environmental load. Pre-cracking was obtained by subjecting prismatic specimens ( $40 \times 40 \times 60\text{mm}^3$ ) to four-point bending until a predefined crack opening displacement (COD) is reached, using a dedicated test setup. Three target CODs were studied: 300, 350 and 400  $\mu\text{m}$ . Exposure to a concentrated chloride solution (3.5% NaCl) was used as an environmental load. Specimens were subjected to wetting–drying cycles for one year. After this exposure period, the chloride penetration was characterised both qualitatively (by colourimetric analysis with silver nitrate) and quantitatively (by determining the chloride profile). The effect of damage level on chloride penetration and its impact on structures durability is discussed in the current paper.

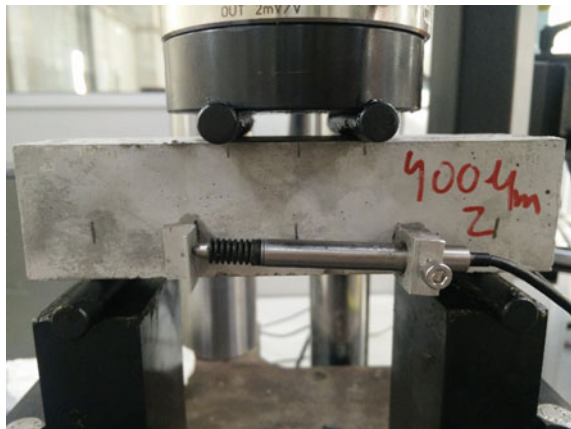
**Fig. 1** Four-point bending test cracking method

After 28 days of water curing, prismatic specimens were cracked by imposing different crack open displacements (COD), namely, 300, 350 and 400 µm, through four-point bending loading, according to the procedure described in EN 12390-5 (Fig. 1). The test was carried out employing an Instron 300 kN Instron testing machine, under displacement control with a displacement rate of 0.003 mm/s. Two linear variable differential transducers (LVDT) were fixed on each side of the specimen, perpendicular to the loading direction, to monitor the COD (Fig. 1). When the target COD was achieved (COD<sub>load</sub>), the specimens “3.0%-350-i” and “3.0%-400-i” were unloaded, and the residual COD was recorded (COD<sub>res</sub>).

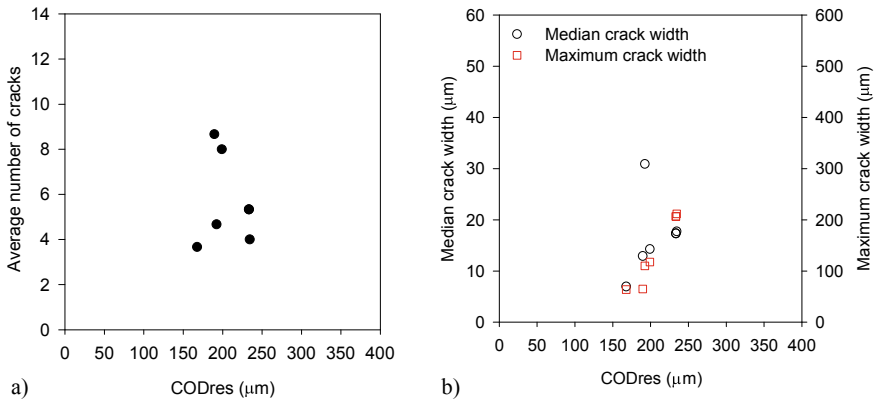
**Fig. 5** **a** Average number of cracks and **b** relationship between COD<sub>res</sub> and median/maximum crack width

The average number of cracks observed over a length of 40 mm remained below 9 (see Fig. 5a) while the median of crack width results is under 32  $\mu\text{m}$  (see Fig. 5b, black marks). These results agree with previous findings of the authors [6]. The maximum crack width (see Fig. 5b, red marks) results seem to increase with the increase of  $COD_{res}$ .
