## Fill-In-Glass Restoration

### Exploring Issues Of Compatibility For The Case Of Schaesberg Castle

12th International Conference on Structural Analysis of Historical Constructions

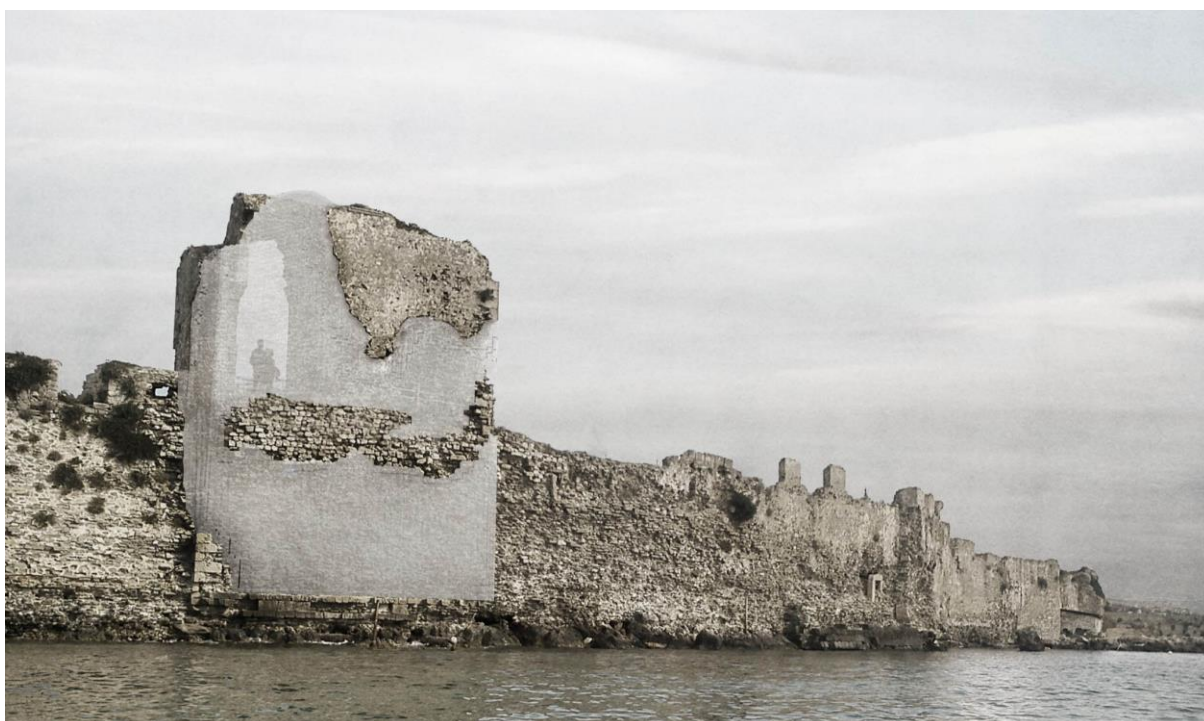
**Figure 1:** Fill-in-Glass Restoration design proposal for the consolidation of Bembo's bastion in Greece [6].

Glass is proposed as a solution in this on-going materiality debate. The aesthetic qualities, durability and mechanical properties of glass are some of the benefits of using it in conservation practices [3]. In particular, a *Fill-in-Glass Restoration* approach introduces glass elements in order not only to complete the missing form of the damaged structure, but also to reinstate its structural integrity (Figure 1). Both the new and old materials work together in an integral way, raising attention to compatibility<sup>1</sup> issues, as the most critical part. The authors address this topic on three interdependent levels; *aesthetic*, *structural and material compatibility* and demonstrate that the design of the interface between the different materials is the most challenging and yet unknown aspect.

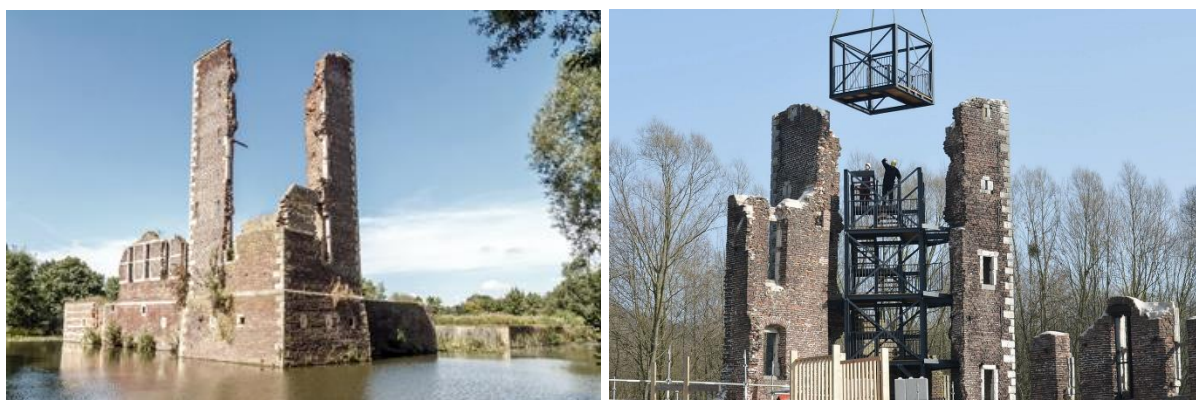
**Figure 2:** The remaining tower of Schaesberg castle before (left) and after (right) the latest consolidation.

Over the last centuries the castle slowly fell into decline mainly due to neglect and lack of maintenance. Other causes of decay are WWII and vandalism which resulted in extensive loss of historical materials, such as stones and anchor plates. Previous consolidation attempts, archaeological and geotechnical works, fluctuations of the underground water level and ground porosity are assumed to have contributed to settlement of the soil and consequently the foundations. Today, the remaining tower is temporarily supported by a new steel structure built on top of a concrete ballast, in order to stabilize the walls (Figure 2). Steel tie anchors connect the new structure to the masonry walls at different levels to reinstate stability and counteract the wind loads. The steel structure is accessible through a staircase, which makes the tower functional as viewpoint.

Despite its temporary nature, such structure is rather incompatible with the restoration and conservation principles, as well as visually and physically intrusive to the historic materials. In the context of *Fill-in-Glass Restoration* approach a proposal is made for the permanent consolidation of the remaining tower using structural glass components to reproduce the corner walls of the tower and reinstate their structural integrity. The restoration aims to:

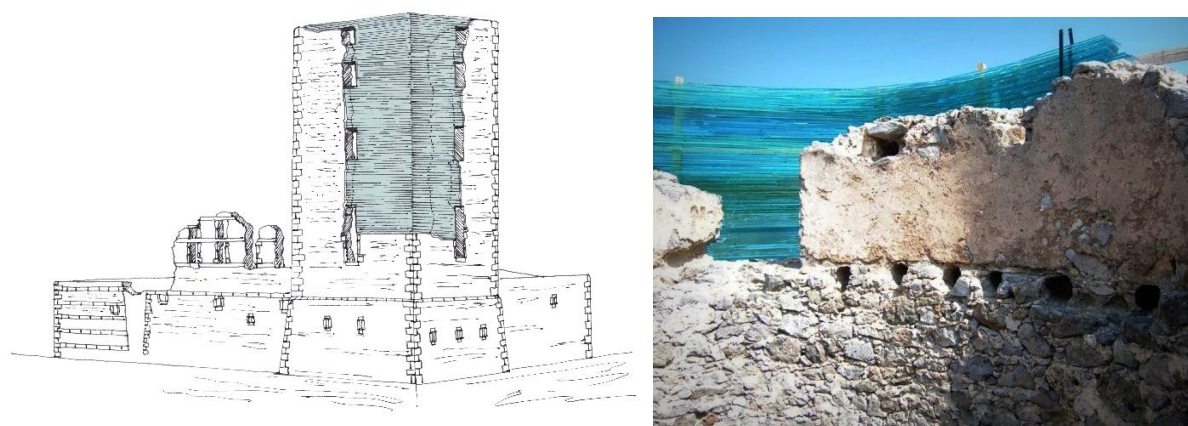
**Figure 3:** Proposal for the restoration of Schaesberg Castle with horizontally stacked glass elements (left) and the perception of glass and masonry as an artistic installation on a historic flourmill designed by the artist C.Varotsos (right) [9].

In this context, for the case of Schaesberg Castle a stacked float glass system is explored (Figure 3). The existing construction system of building is based on masonry composed of field fired clay bricks, Kunrade limestone and lime based mortar. The tectonics of the historic construction is defined by this layering of units bonded together with the mortar. Hence, a stacked configuration of float glass elements is chosen to resemble this layering in an abstract way, respecting the principles of the original construction method. The appearance of the glass assembly is more translucent than transparent and depends highly on the glass recipe<sup>2</sup>, bonding properties<sup>3</sup> and thickness (Figure 3). In general, the advantages of horizontally stacked float glass configurations are the following:

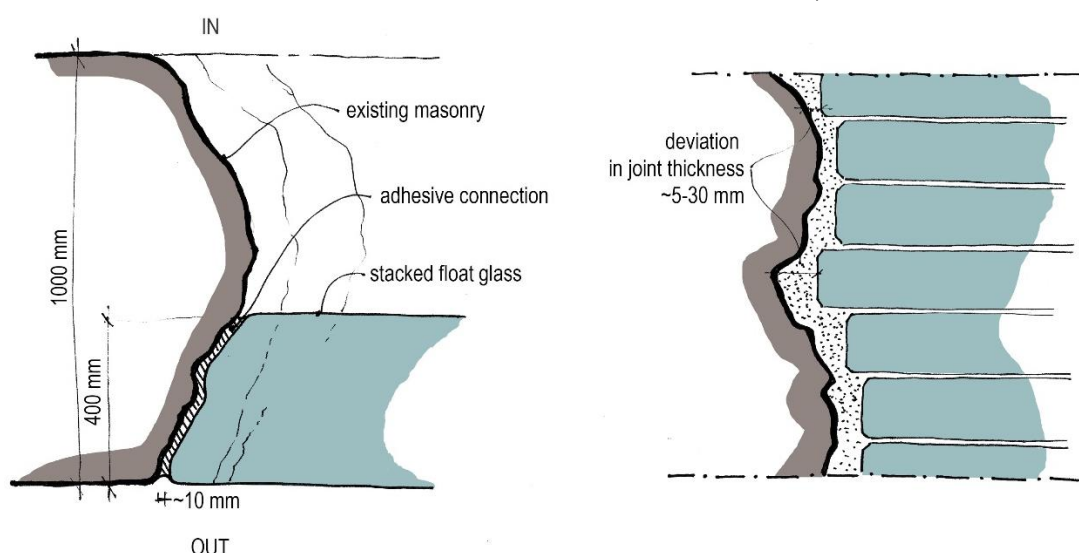
**Figure 4:** Detail of the interface in plan (left) and section (right).

The geometry of the interface is highly influenced by this of the historic structure and glass assembly. 3D-scanning technologies in combination with post-processing treatment of glass plates (prior to lamination) with a water-jet cutting machine can result in a glass assembly with the exact imprint of the ruinous surface. Layer by layer, glass follows the geometry of the existing wall (Figure 4). Due to construction and manufacture tolerances a joint thickness that varies between 5 and 30 mm appears realistic and defines the characteristics of the connecting materials. The two main categories of connecting materials that are taken into consideration are mortars, which are already used in masonry structures, and glues, which are widely used in glass applications. The requirements for each of these alternatives are as follows:

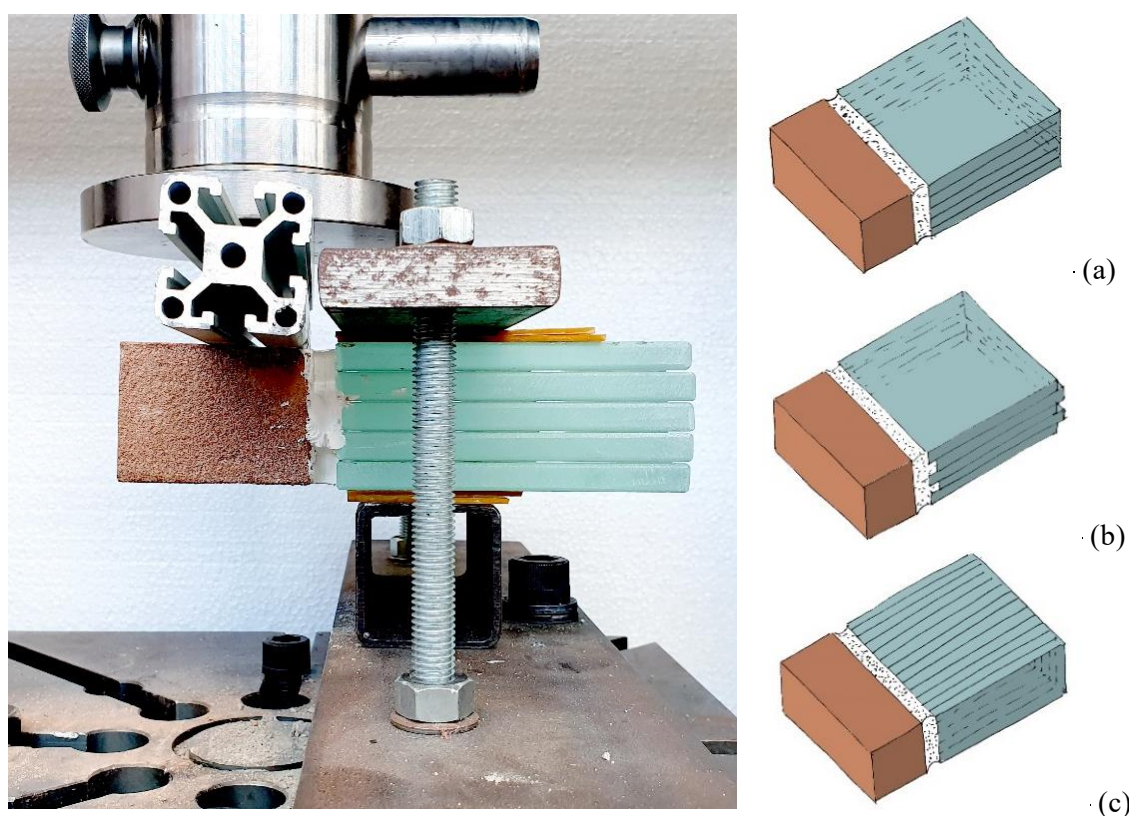
**Figure 5:** Left: Set-up 1 in testing machine and right: (a) Set-up 1 (glass is stacked horizontally), (b) Set-up 2 (glass is stacked horizontally in a saw-tooth pattern), (c) Set-up 3 (glass is stacked vertically).

Three different set-ups are used in order to evaluate the shear bond between stacked glass assemblies and brick masonry, as shown in Figure 5. Set-up 1 introduces shear forces perpendicular to the stacking plane, set-up 2 introduces shear forces perpendicular to the stacking plane with the glass plates arranged in a saw-tooth pattern and set-up 3 introduces shear forces parallel to the stacking plane. Set-up 2 aims to create a more realistic representation of the connection compared to set-up 1, with a fluctuation of the thickness joint that is possible to occur due to the rough, uneven surface of the ruin.

The shear tests are performed in a *Zwick Z100* machine. A specially manufactured steel frame is used to clamp the glass assembly to the base and restrain any movements. Soft PU layers, 3 mm thick, are placed in between glass and steel to avoid the hard contact between the materials and ensure an even load distribution. The vertical load is introduced by the displacement of the crosshead against an aluminum tube and then on the brick in two different speeds: 1mm/min, for the first three materials, and 5mm/min for the following two.

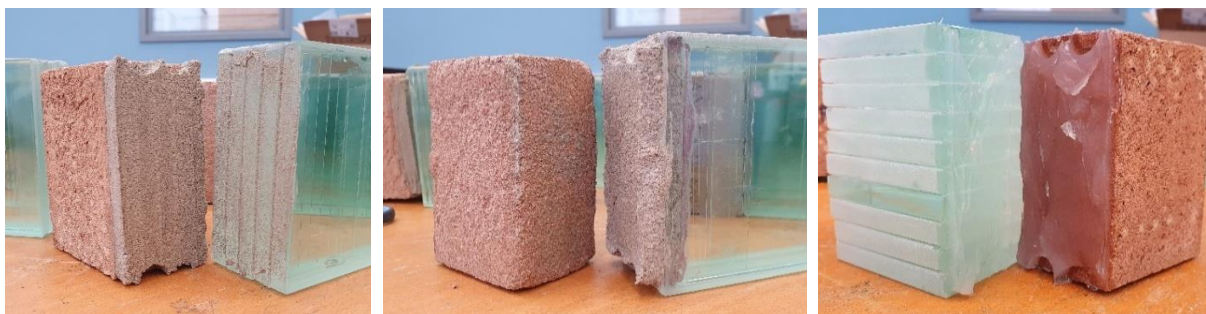
Figure 6: Left: Adhesion to glass, middle: Adhesion to brick, right: Cohesive failure

All tested materials show favorable failure modes, namely adhesion to glass, adhesion to brick and cohesion, often in combination. Therefore, the connection works as the weakest link and no damage occurs to either the brick or the glass. An overview of the characteristic failure modes and their occurrence is shown in Figure 6. In general and as expected, the mortar and tile adhesive fail in a brittle way, whereas all adhesives (glues) exhibit significant deformation capacity and the ductile behavior of the joint. For the mortar and tile adhesive, failure mostly occurs by delamination of the glass, which indicates the weak adherence bond to the non-porous glass surface. Most of the adhesives (glues) show the opposite result; failure occurs either by cohesion or by delamination of the brick.

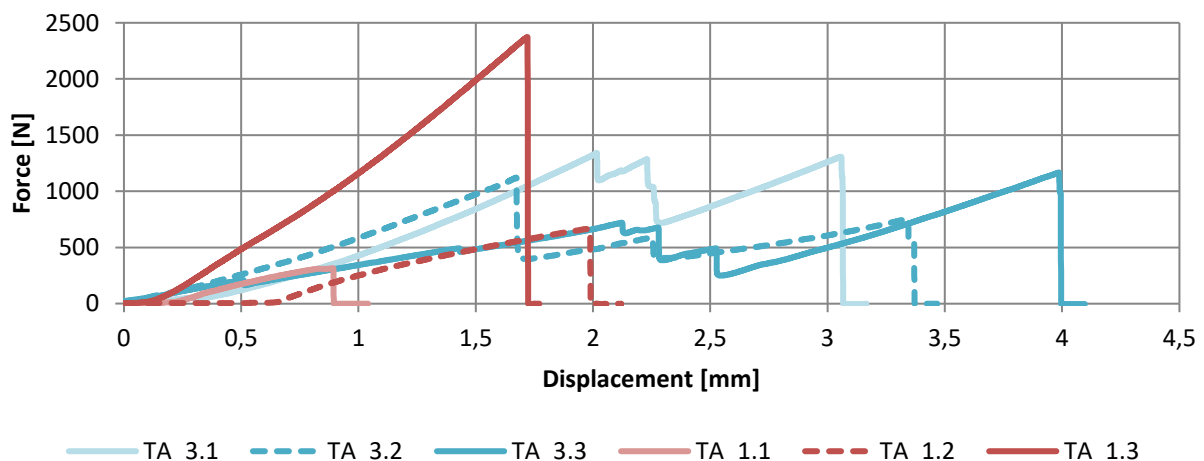
Figure 7: Force-Displacement diagram of tile adhesive joints for set-up 1 (1.1-1.3) and set-up 3 (3.1-3.3).

The orientation of the stacked glass elements (set-up 1 compared to set-up 3) plays an important role for the tile adhesive joints. In set-up 3 both the average maximum vertical force and displacement are significantly increased, whereas the joint demonstrates some ductility. This is evident in the force-displacement diagram as shown in Figure 7. Introducing the shear forces parallel to the stacking plane results in higher deformation capacity of the joint. Set-up 3 shows a consistent increase of the joint stiffness after the first crack occurs, avoiding brittle failure compared to set-up 1.
