Recommendation of RILEM TC 271-ASC

New accelerated test procedure for the assessment of resistance of natural stone and fired-clay brick units against salt crystallization

Materials and Structures/Materiaux et Constructions

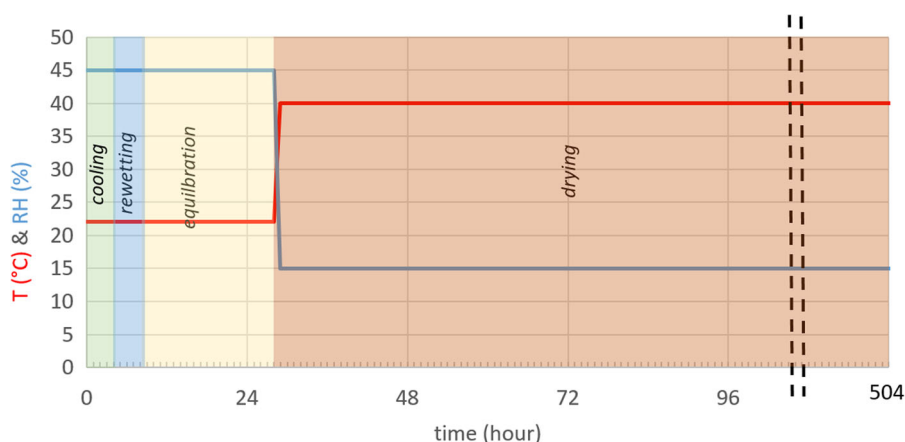
Fig. 6 Representation of a 3-week T and RH cycle of the propagation stage— Na_2SO_4 test

- 4 h cooling of the specimens at room conditions ($T = 22 \pm 2 \text{ }^\circ\text{C}$ at $45 \pm 15\% \text{RH}$). The sealing is removed from the bottom and the mass of the

- Rewetting with 80% of the water amount used for the initial contamination, by capillarity from the bottom at room conditions ($T = 22 \pm 2 \text{ }^\circ\text{C}$ at $45 \pm 15\% \text{RH}$). After rewetting, the weight of the specimen is recorded ($m_{\text{rew } n\text{-after}}$, where n is the number of the re-wetting), and the bottom of the specimen is sealed.
- Drying at room conditions ($T = 22 \pm 2 \text{ }^\circ\text{C}$ at $45 \pm 15\% \text{RH}$) up to 24 h from the start of the re-wetting.
- 476 h drying at $40 \pm 2 \text{ }^\circ\text{C}$ / $15 \pm 5\% \text{RH}$
