Testing, Characterisation, And Modelling Of Nehobo Floors For Groningen Seismic Assessment

Intermediate Report: Laboratory Tests and Numerical Models

Laboratory Tests and Numerical Models
INTERMEDIATE REPORT

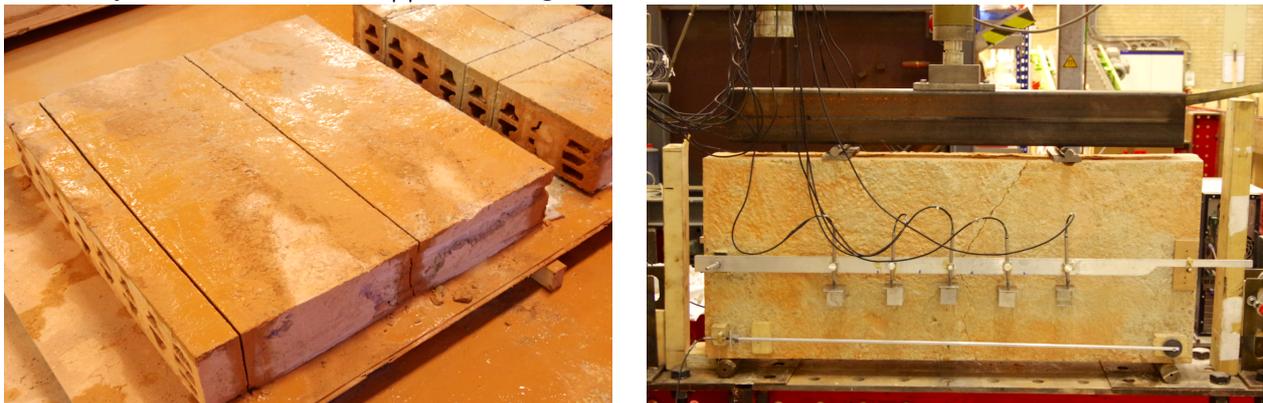
For the in-plane bending test a section is cut out of the NeHoBo floor panels (1.6x1.1m) that were extracted from the Zijlvest donor houses (Loppersum) (Figure II.1).

Figure II.1 (3.1&3.3). In-plane bending samples cut from NeHoBo panel (left) and four-point bending test set-up for in-plane bending of NeHoBo floor sample (right).

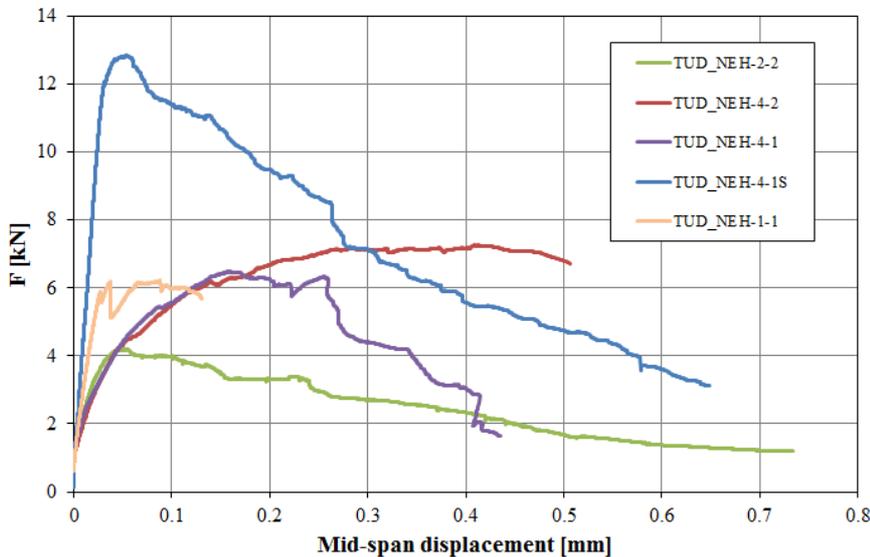
been tested (so far). If translated to values of strength, the four pre-cracked samples achieve an average of 110kPa in flexural strength, while the undamaged sample scored 220kPa. From the curves presented in figure II.2, the direct tensile strength can also be obtained; in this case, the tensile strength is 75kPa (and the standard deviation is 11kPa) for the four pre-damaged samples and 150kPa the average for the undamaged one. For the samples with the damaged concrete top layer, the 5% characteristic values are then 70kPa and 55kPa, for flexural and tensile strength, respectively.

Figure II.2 (3.12): Force-displacement curve of in-plane bending test samples.

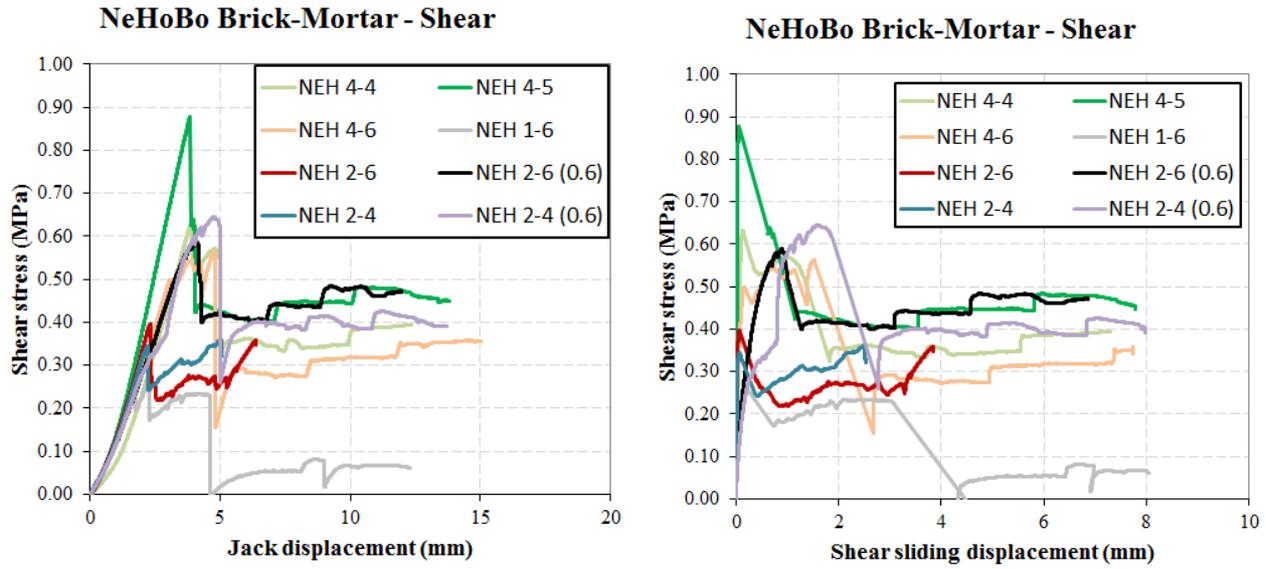
Figure II.4 shows the shear test results of the NeHoBo brick-mortar interface shear samples. The displacement is presented both for the jack and the displacement sensors on the sample itself.

Figure II.4 (3.16). Shear stress-displacement : (Left) relative displacement of the jack; (right) relative displacement of the central brick from displacement sensor readings.

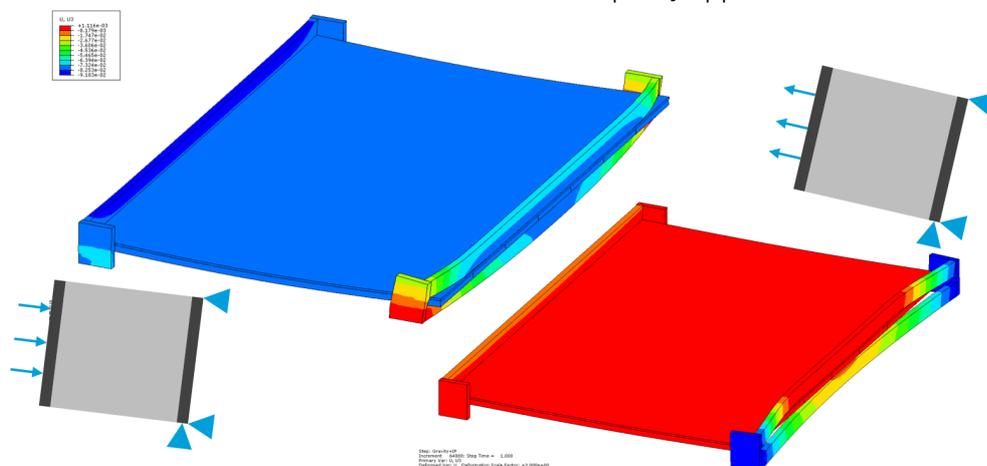
The computational models of the floors consist of plates supported on wall stubs. For the Zijlvest donor houses, as a case study, the floor is 5.40x7.70m². The plates are loaded in-plane on one side of the model to verify their capacity of transferring in-plane loads (see figure II.6). Many variations of these floor models were analysed, including different boundary conditions, material properties, overburdens, etc. (the reader is referred to section 4.2.2). Here it was observed that failure of the floors occurred by sliding over their supporting walls. Accordingly, the values of overburden become the most influential as they determine the capacity against sliding via friction; while the strength of the floor material is less important. For low values of overburden, corresponding to a NeHoBo floor on the upper level of a structure, considering the restraint and strength provided by the supporting wall, a capacity upwards of 20kN was obtained. For floors in the middle of a structure, restrained by walls below and on-top, with a higher value of overburden at the connection between the floor and the walls, the capacity approached 100kN.

Figure II.6 (4.22). Longitudinal in-plane loading of the floor system. Slide-over of the floors at the connections with the wall stubs is observed.

To analyse the capacity of the floor, the use of the analytical model shown in figure II.8 is recommended. Modelling properties for the use of a continuum composite material have not yet been derived; instead, a more complex modelling approach has been taken employing estimates for the individual components of the floors (bricks, concrete, mortar) as seen in figure II.6, but this is not recommended when evaluating general buildings.

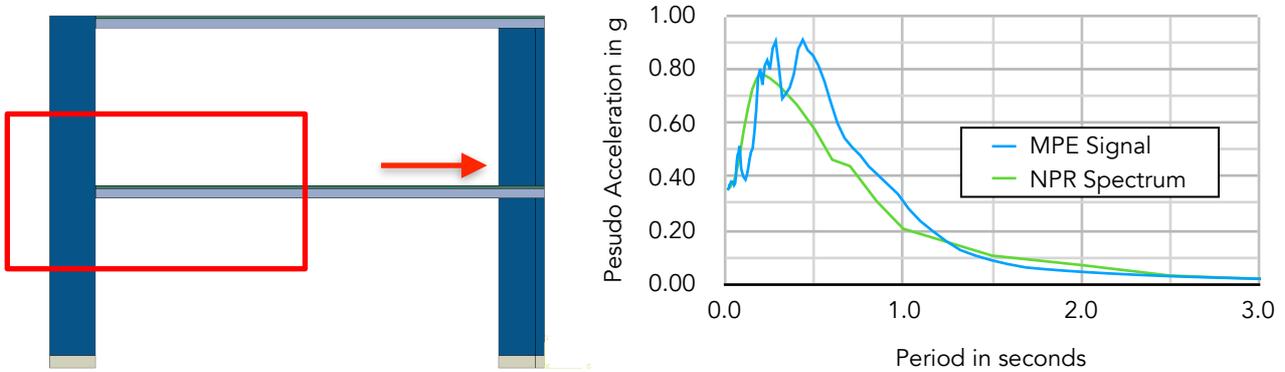
An analytical calculation was performed to estimate the potential forces on the floors. The total weight of the house (including a live load, and the weight of the roof and of the outer leaves of the cavity wall) was computed to be 650kN. Considering a half section of a floor (as seen in on the left of figure II.7) and lack of lateral strength on one side of the structure, the tributary weight to be mobilised by the floor was pegged at 150kN. In the case of an induced earthquake with a PGA of 0.35g, the pseudo acceleration obtained by the NPR (2017), for the computed natural period of 2 seconds of the house, is 0.075g. This corresponds to a force of 11kN. This force is lower than the capacity of even the weaker top floor (20kN)

Figure II.7 (4.44 & 4.45). Sketch of the house and the tributary zone for earthquake forces running through the floor (left), and spectrum of NEN (2017) compared to a synthetic earthquake signal.

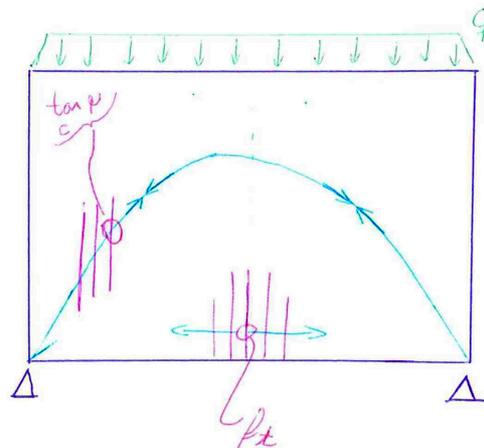
Additionally, an analytical model was used to verify the capacity of the floor acting as a deep beam (see figure II.8). Assuming an internal arm of 0.6 of the span, and 0.2 of the span as the linear tensile zone, with a tensile strength of 55kPa, the floor is capable of withstanding a distributed in-plane load adding up to 28kN; this is higher than what is required from the floor during the design earthquake.

Figure II.8 (4.47). Proposed analytical model for the deep-beam behaviour of the floor.

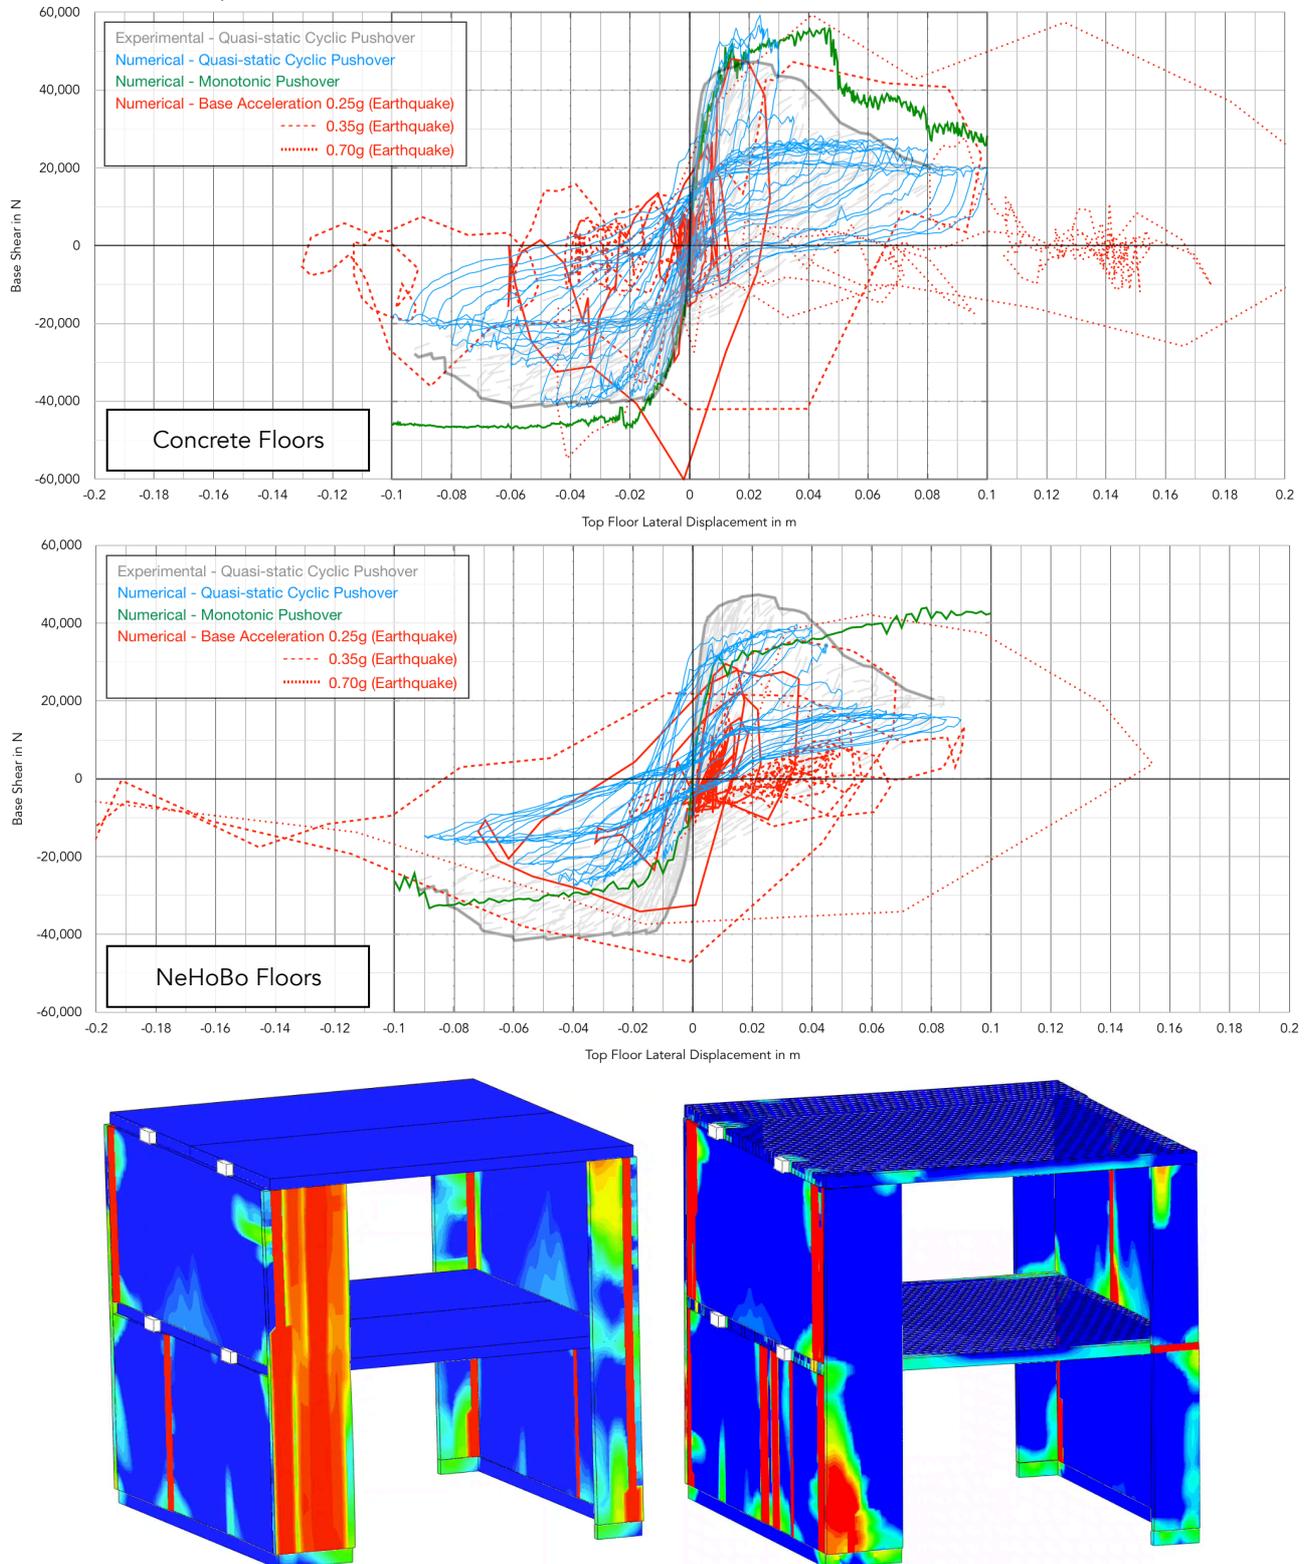
Figure II.9 (4.33 & 4.34). Force-displacement curves for the comparison of a terraced house with concrete floors or NeHoBo floors. The displacement is measured on the centroid of the floor. And bottom: model impressions showing crack areas (in red) for the concrete floor case (left) and the NeHoBo floor case (right) for the cyclic pushover to 100mm.

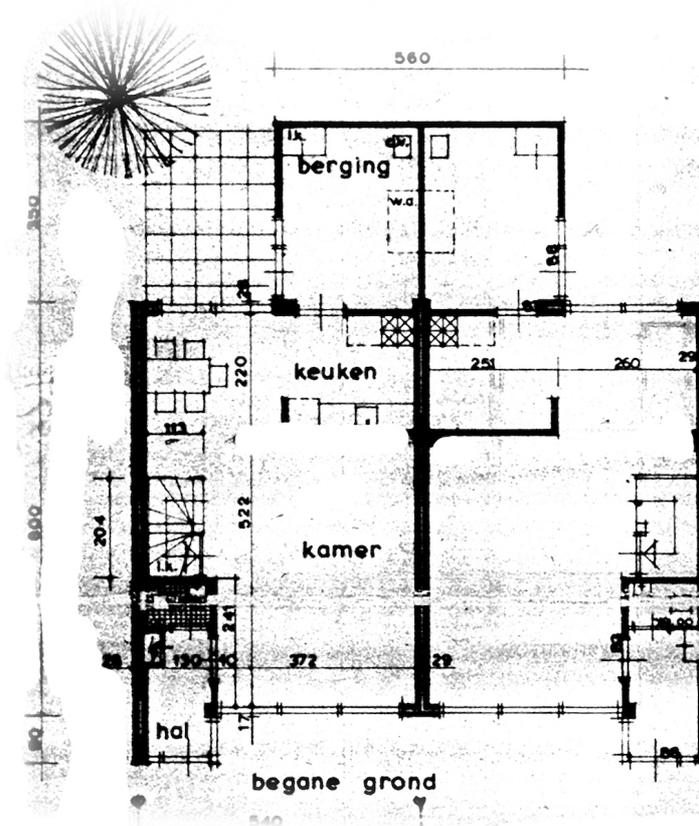
Figure 1.4. Architectural blueprint of the ground floor of one of the Zijlvest donor houses.

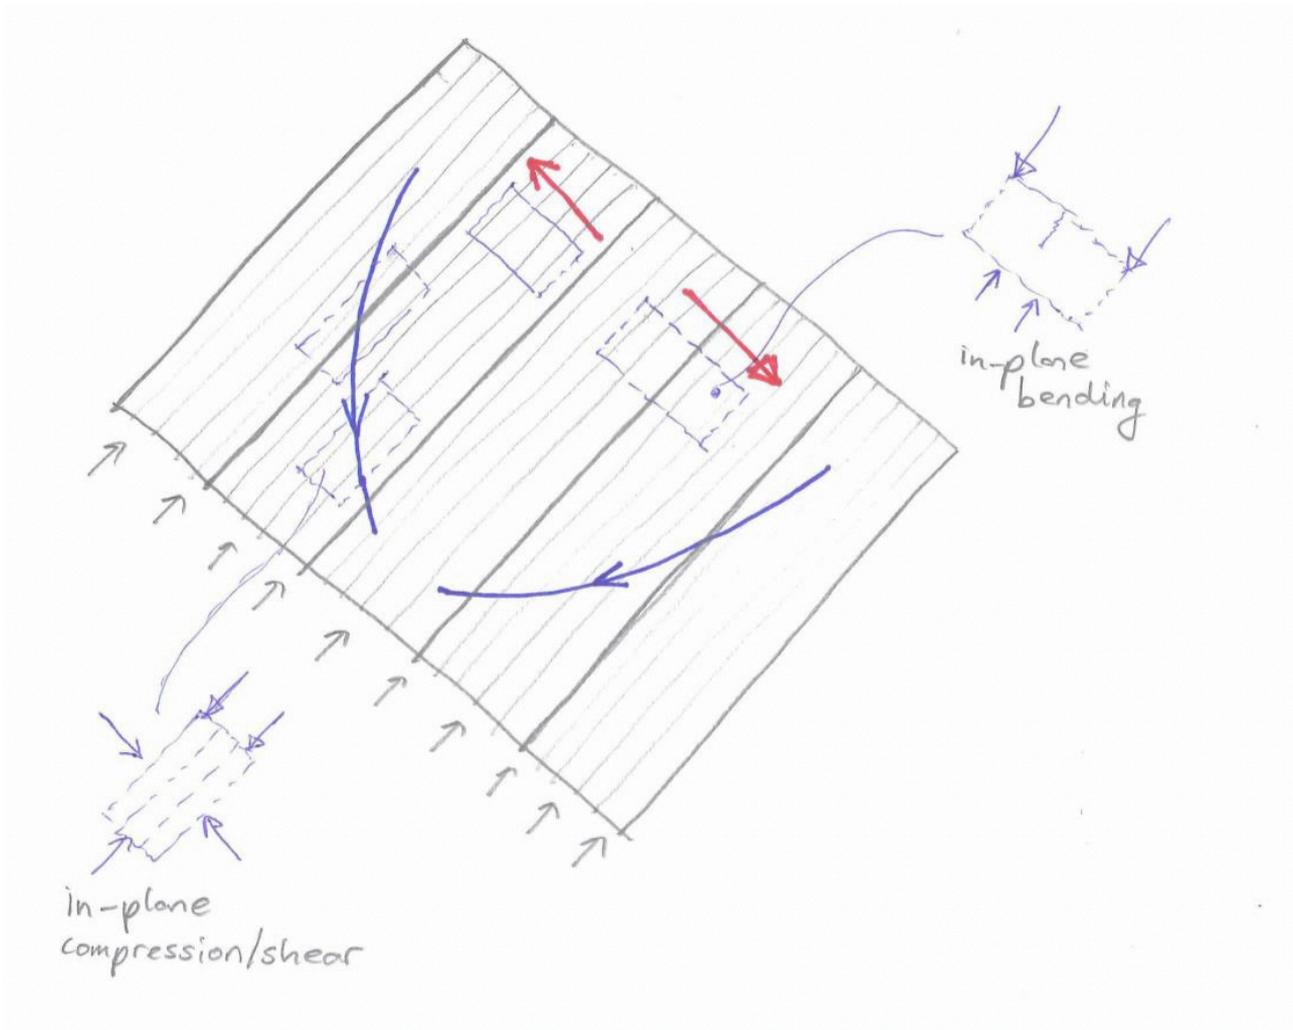
Figure 2.1. Illustration of in-plane stresses on the floor when subjected to lateral loading.

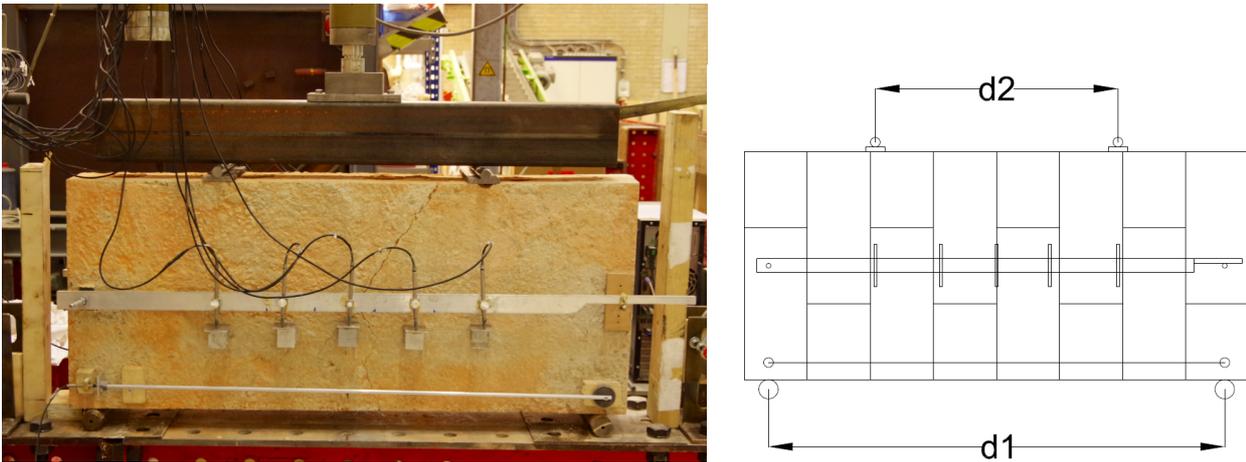
Figure 3.3. (left): four-point bending test set-up for in-plane bending of NeHoBo floor sample. (right): In-plane bending sample configuration.

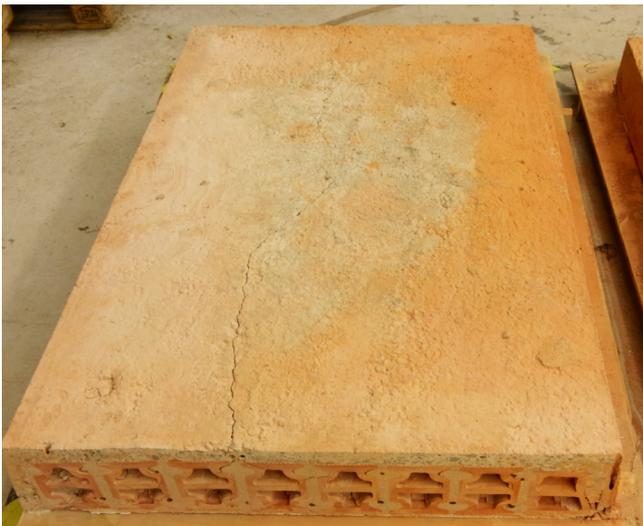
The first in-plane bending sample tested is a section from the NeHoBo panel shown in Figure 3.4. As can be seen, there is a significant crack in the top concrete layer. In Figure 3.5 of sample TUD_NEH-2-2 it can be seen that there is a tube for electrical wiring at the location of the crack. The same sample is shown in the test set-up in Figure 3.3. This figure is from before the test was performed, the diagonal crack where the tube is located is clearly visible. Figure 3.5 (right) and Figure 3.6 show the crack at final failure of the sample in bending from the concrete layer side and the plaster side.

Figure 3.4. NeHoBo floor panel number 2 showing a severe crack in the top concrete layer.

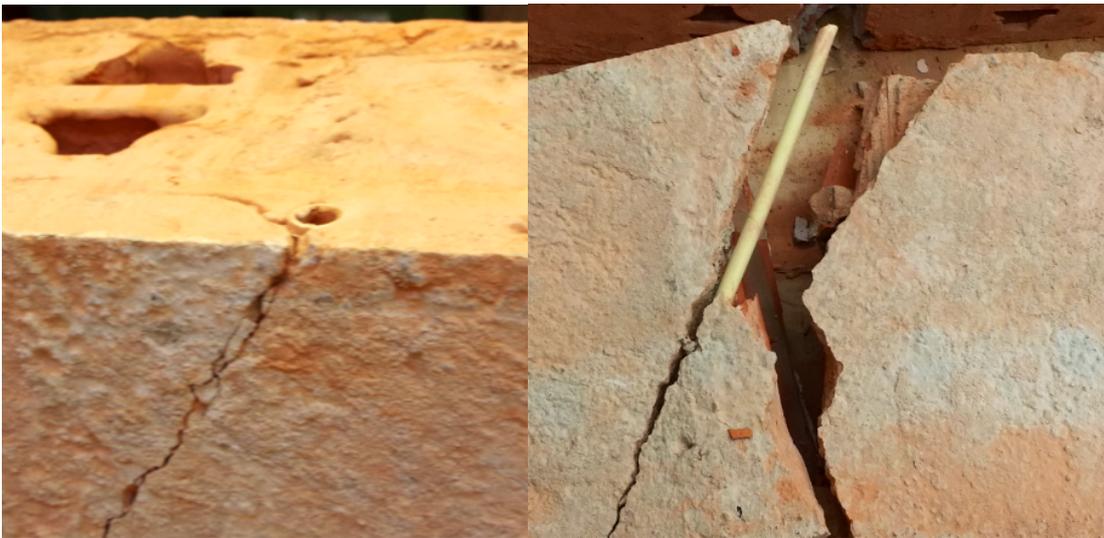
Figure 3.5. Sample TUD_NEH-2-2 (left): crack in concrete layer at location of tube for electrical wiring in the top concrete layer. (right): Cracking of the concrete layer along the initial crack in the concrete layer.

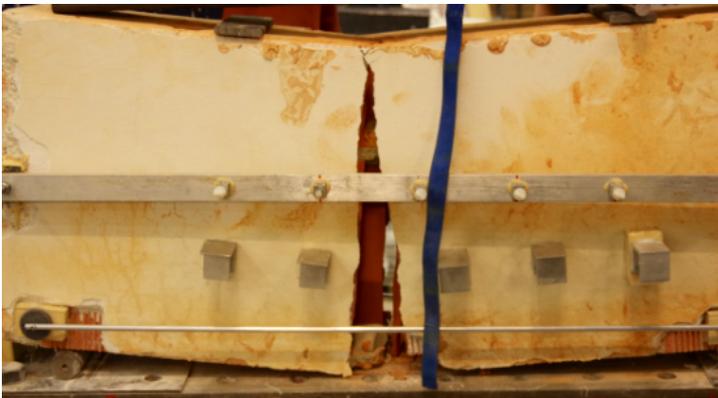
Figure 3.6. Sample TUD_NEH-2-2 back side view of crack at final failure of sample in bending

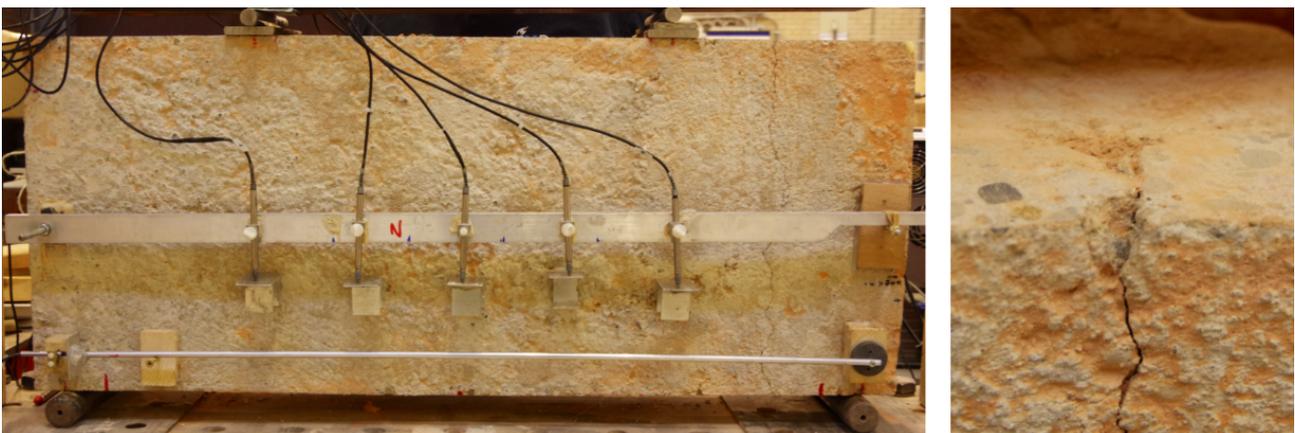
Sample TUD_NEH-4-1 has also a crack in the concrete layer (see Figure 3.7). Although there is no tube for electric wiring located at the crack.

Figure 3.7. Sample 4-1 (left): Crack in concrete layer visible on right side of the sample running from top to bottom. (right): Crack zoomed in on the top part of the sample, no tube for electrical wiring is visible.

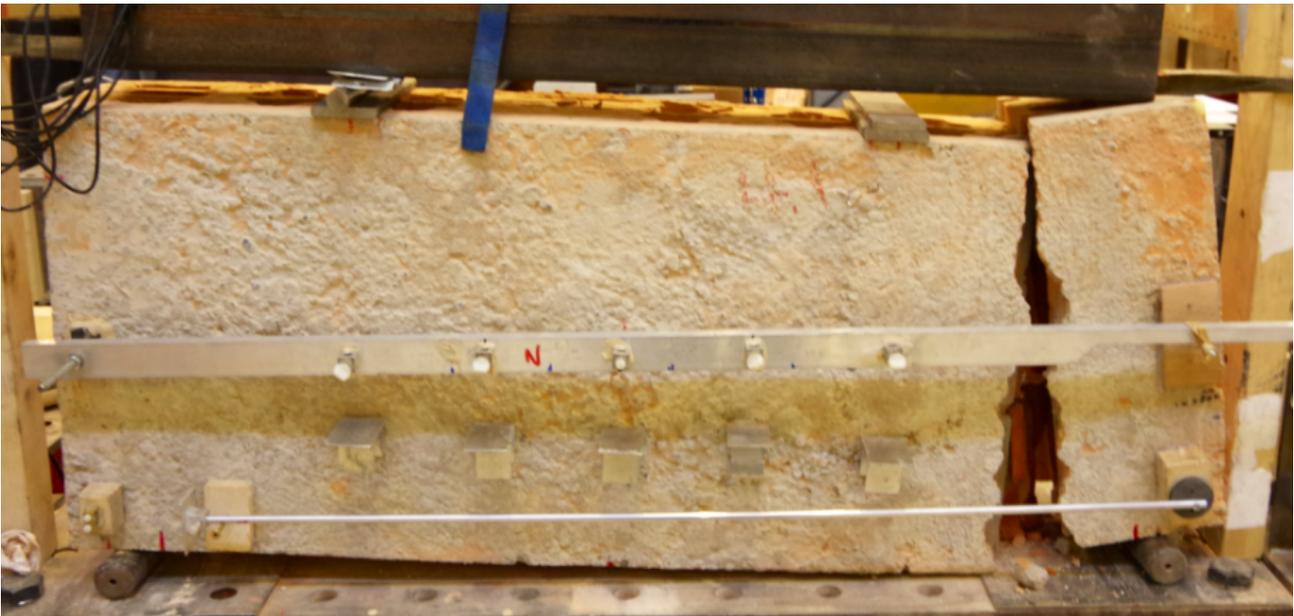
Figure 3.8. Sample TUD_NEH-4-1 failure due to in-plane bending.

Sample 4-1 shows failure due to bending at the location of the pre-test crack in the concrete layer. It appears that a crack in the concrete layer can more easily be increased or extended instead of forming another crack somewhere else in the concrete layer. The stress in the sample is focussed at the cross section where the crack is located. The crack went through the mortar interface and separated one brick row from the sample. The left part of the broken sample is re-tested (named Sample 4-1S) since it did not show any significant damage due to the test and does not have a severe crack in the concrete top layer like the previous samples (Figure 3.9). The sample is in this case 1/8 shorter than the other samples. Based on in-plane bending tests performed on masonry, with different height-length ratios, in the 2015 TUD test campaign (Esposito. 2016b.) it will not significantly change the flexural strength results that come out of this test.

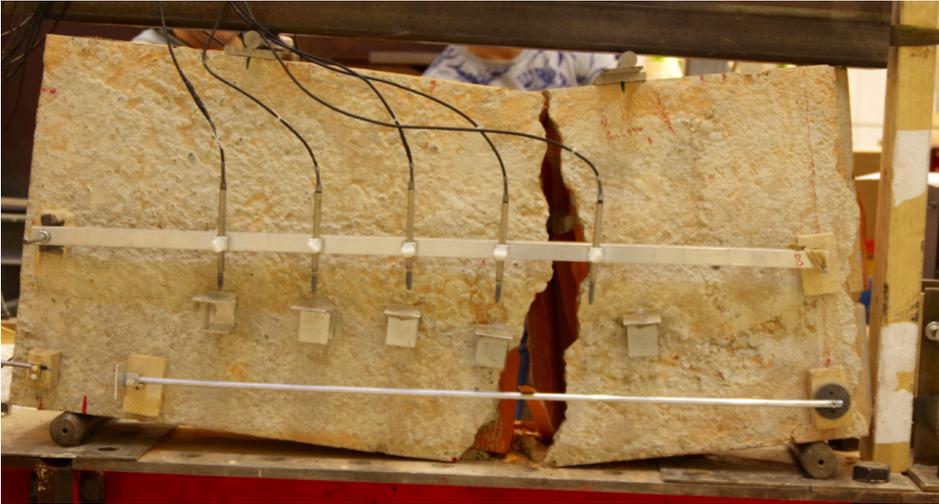
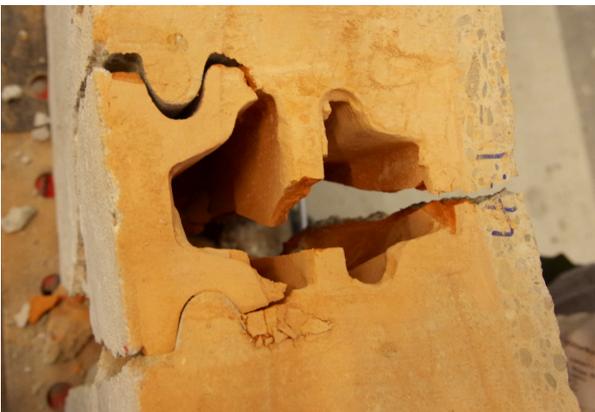
Figure 3.10. Sample TUD_NEH-4-1S

Figure 3.10 and Figure 3.11 show that the crack propagated partly through the bricks and partly through the brick-mortar interface. It is likely that the concrete layer cracks first due to its higher stiffness and then forces the crack through the thickness of the samples, where the crack propagates through the bricks or follows the brick-mortar interface.

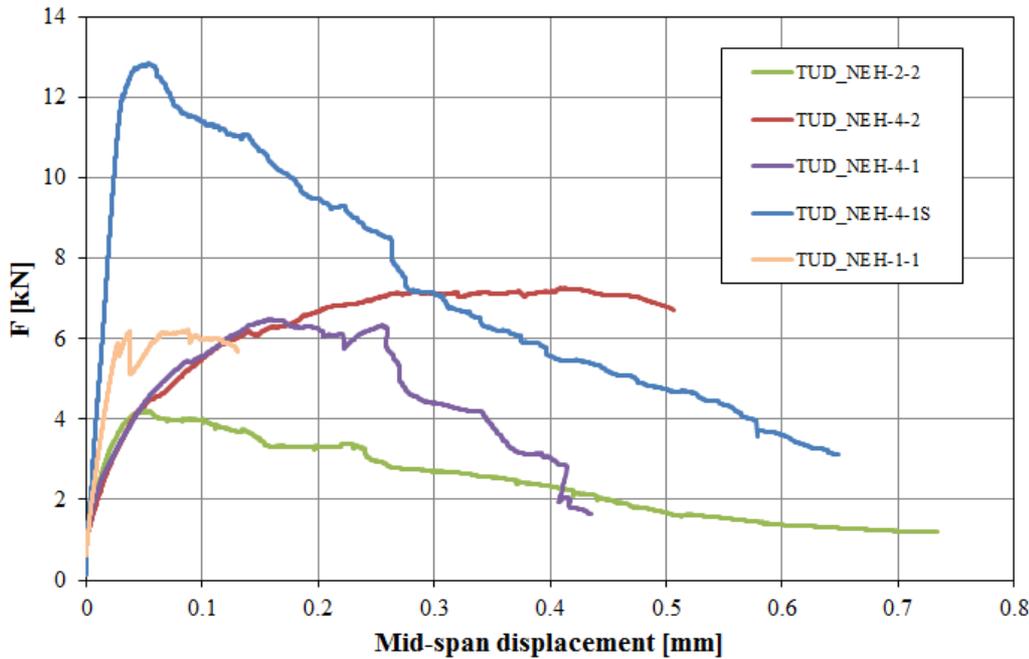
Figure 3.12 shows the force-displacement curves of the five in-plane bending test samples. It can be seen that sample TUD_NEH-4-1S has a significantly higher peak load compared to the other samples. This sample had no severe crack in the concrete layer, the other four samples did. Sample TUD_NEH-2-2 and TUD_NEH-4-2 showed similar cracking on the right side of the sample following a vertical crack in the concrete. In both cases the crack was outside the two loading points meaning that at the location of the crack the maximum bending moment is not present. The flexural strength for these two samples is determined at the location of the crack, based on the bending moment at that location. For the other samples the maximum bending moment is used to calculate the flexural strength described in the material test report of the TUD 2016 test campaign (Jafari. 2017).

Figure 3.12. (Left): Force-displacement curve of in-plane bending test samples.

Table 3.1 shows the flexural strength values from the tested NeHoBo in-plane bending sample. The average flexural strength found for all five tested samples is 0.13MPa. Only considering the pre-cracked concrete layer samples give an average of 0.11MPa. Sample TUD_NEH_4-1S, which has an undamaged (no severe crack) concrete layer, has a significantly higher flexural strength, 0.22MPa (Table 3.1). This makes sense since in that case the concrete layer also contributes to the in-plane bending capacity opposite to when the concrete layer is already pre-cracked. Note that for the case of the undamaged concrete layer only one sample has been tested so far.

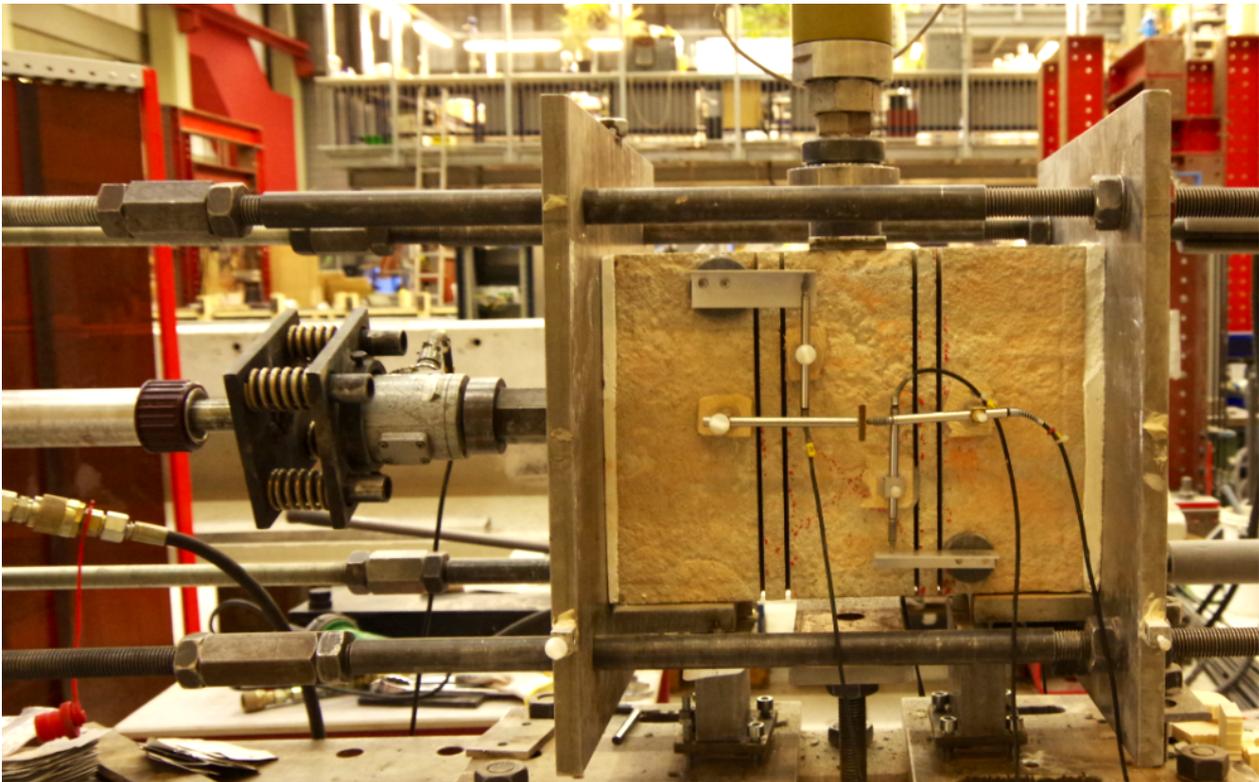
For the shear tests the same test set-up is used as in the 2016 TUD test campaign (Jafari, 2017) (Figure 3.15). By means of a horizontal, manually-controlled jack the pre-compression is applied to the shear sample. A computer-controlled vertical jack applies a displacement to the centre brick of the NeHoBo shear sample.

Figure 3.15. Shear test set-up with a horizontal jack (left side) and vertical jack (top side middle section) applying a load on the sample.

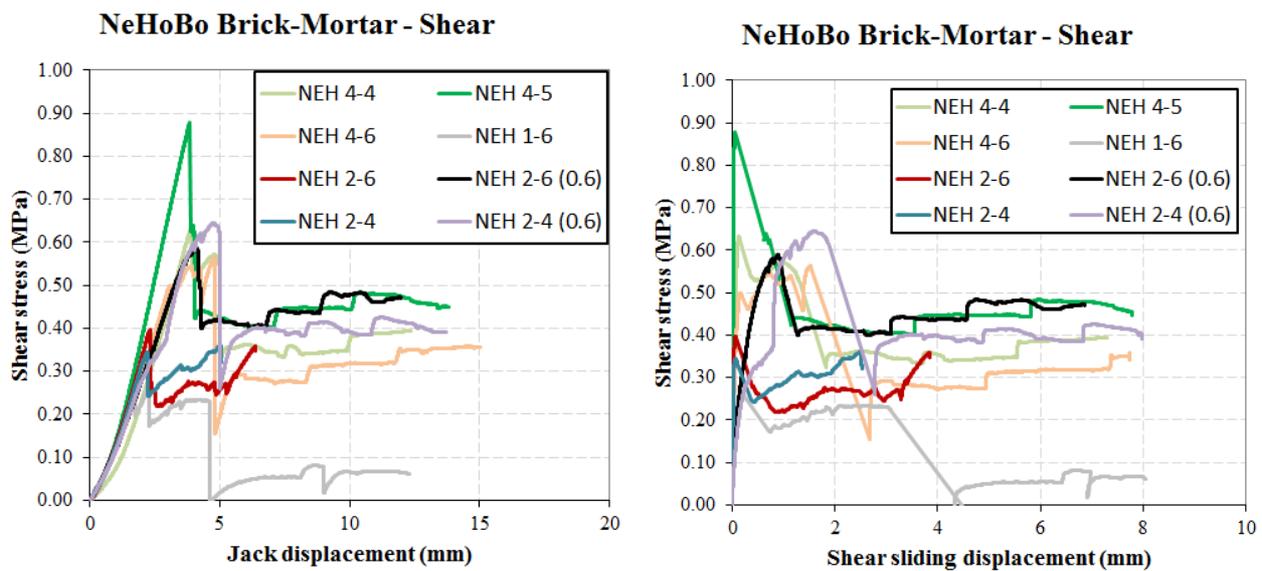
Figure 3.16. Shear stress-displacement : (Left) relative displacement of the jack; (right) relative displacement of the central brick from displacement sensor readings.

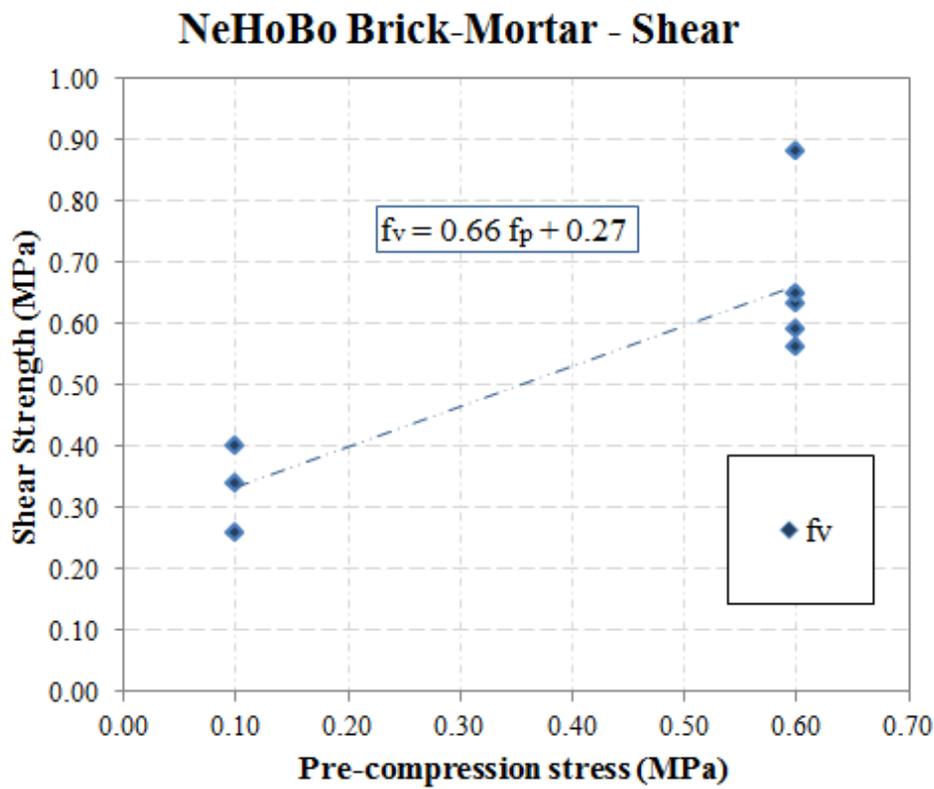
Figure 3.17. Pre-compression vs Shear strength resulting in a friction coefficient and cohesion value for the tested NeHoBo brick-mortar shear samples (f_v =shear strength, f_p =pre-compression stress).

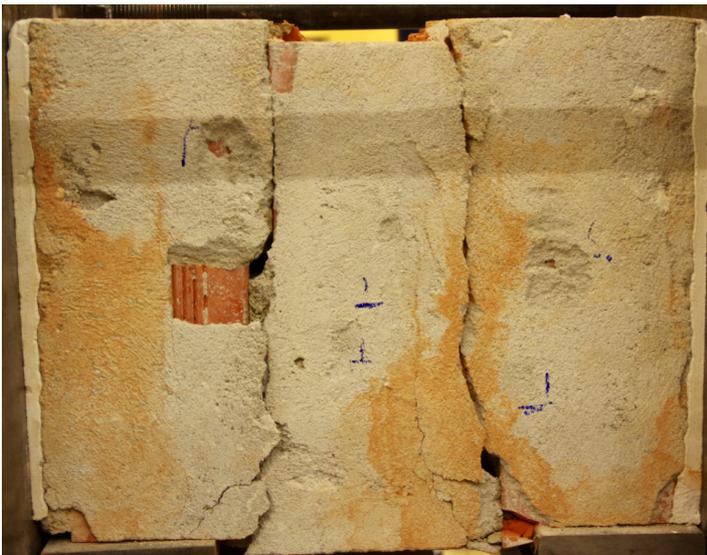
Figure 3.19. Sample 4-6

Figure 3.19 shows cracks on the plaster on the non-concrete side of the NeHoBo floor. It was noticed during the preparation of both in-plane bending and shear samples in the test set-up, that the plaster is very poorly bonded to the NeHoBo floor; it could usually be removed by hand. Therefore, it can be assumed that the plaster layer has no significant contribution to the load bearing capacity of the NeHoBo floor.

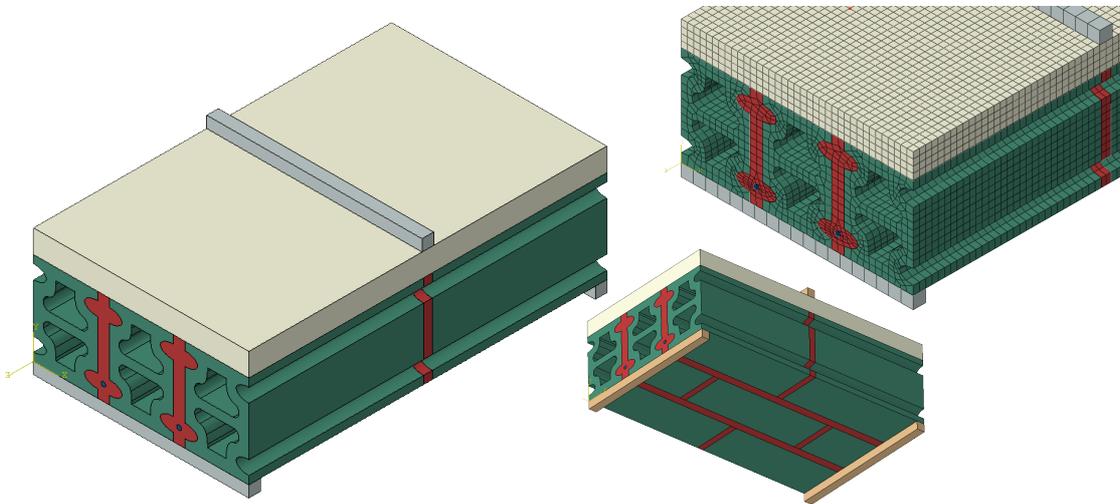
Figure 4.1. Detail available in the micro model; top right, model mesh.

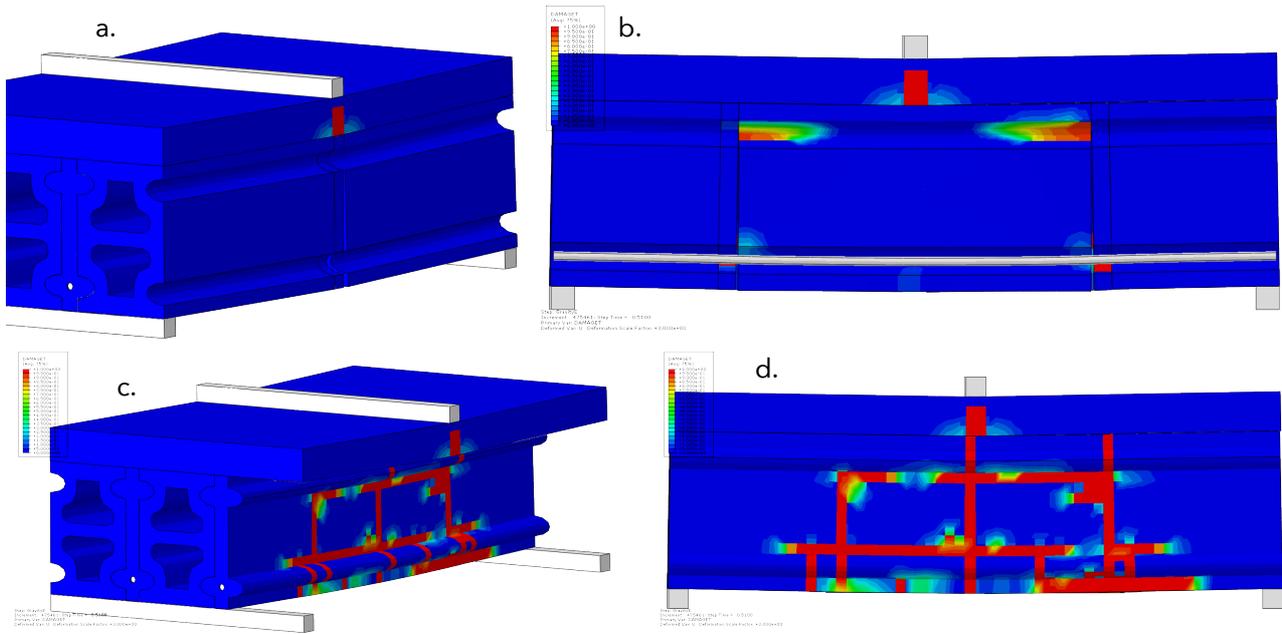
Figure 4.2. Failure mechanism of the out-of-plane, proof-of-concept model.

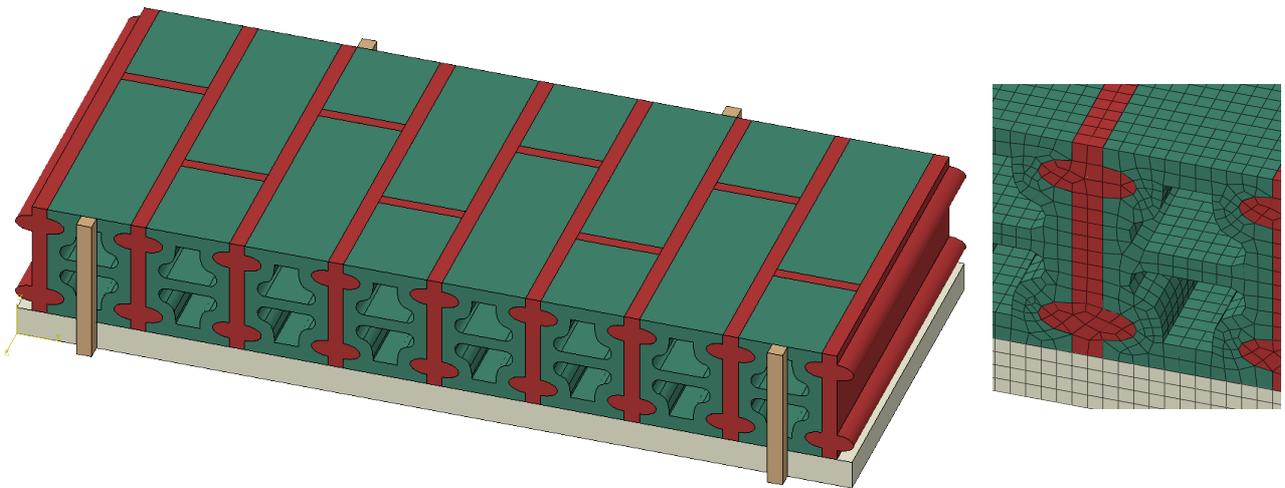
Figure 4.3. Micro model of in-plane bending test. Bottom view.

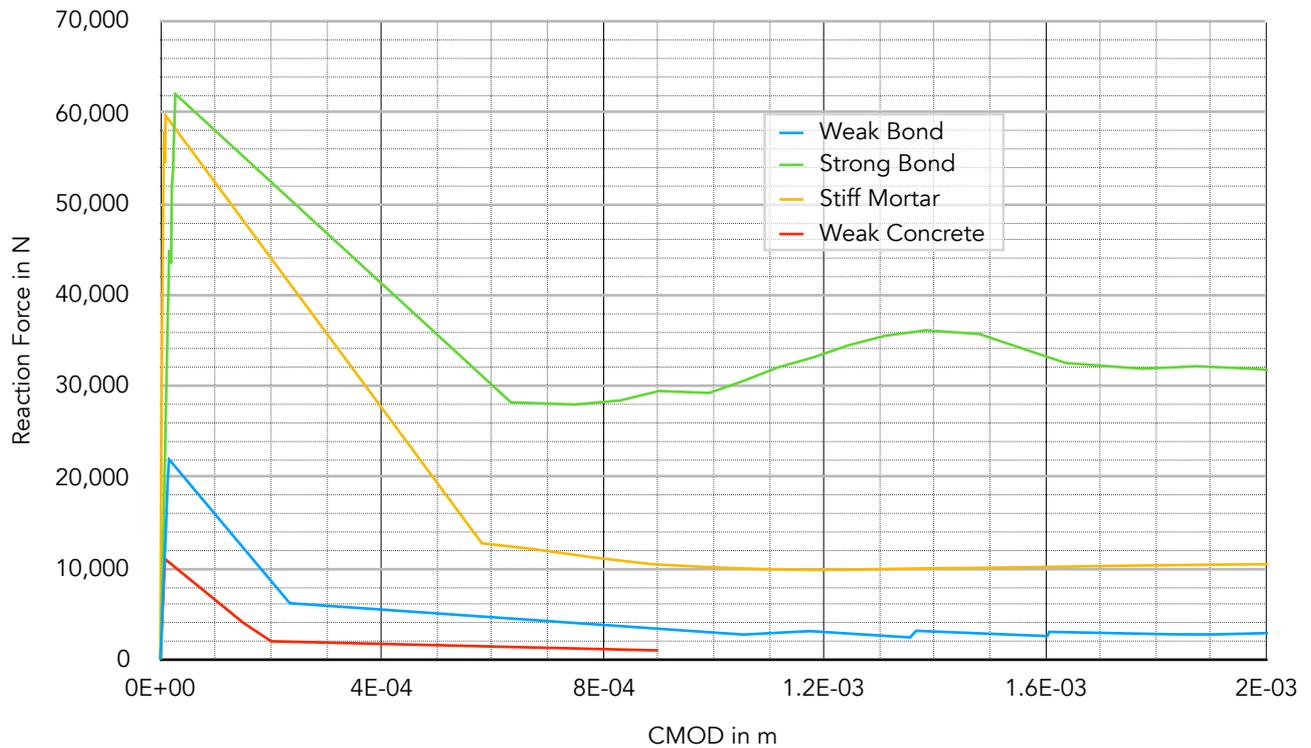
Figure 4.4. Force against crack mouth opening displacement for some variations of the in-plane micro model.

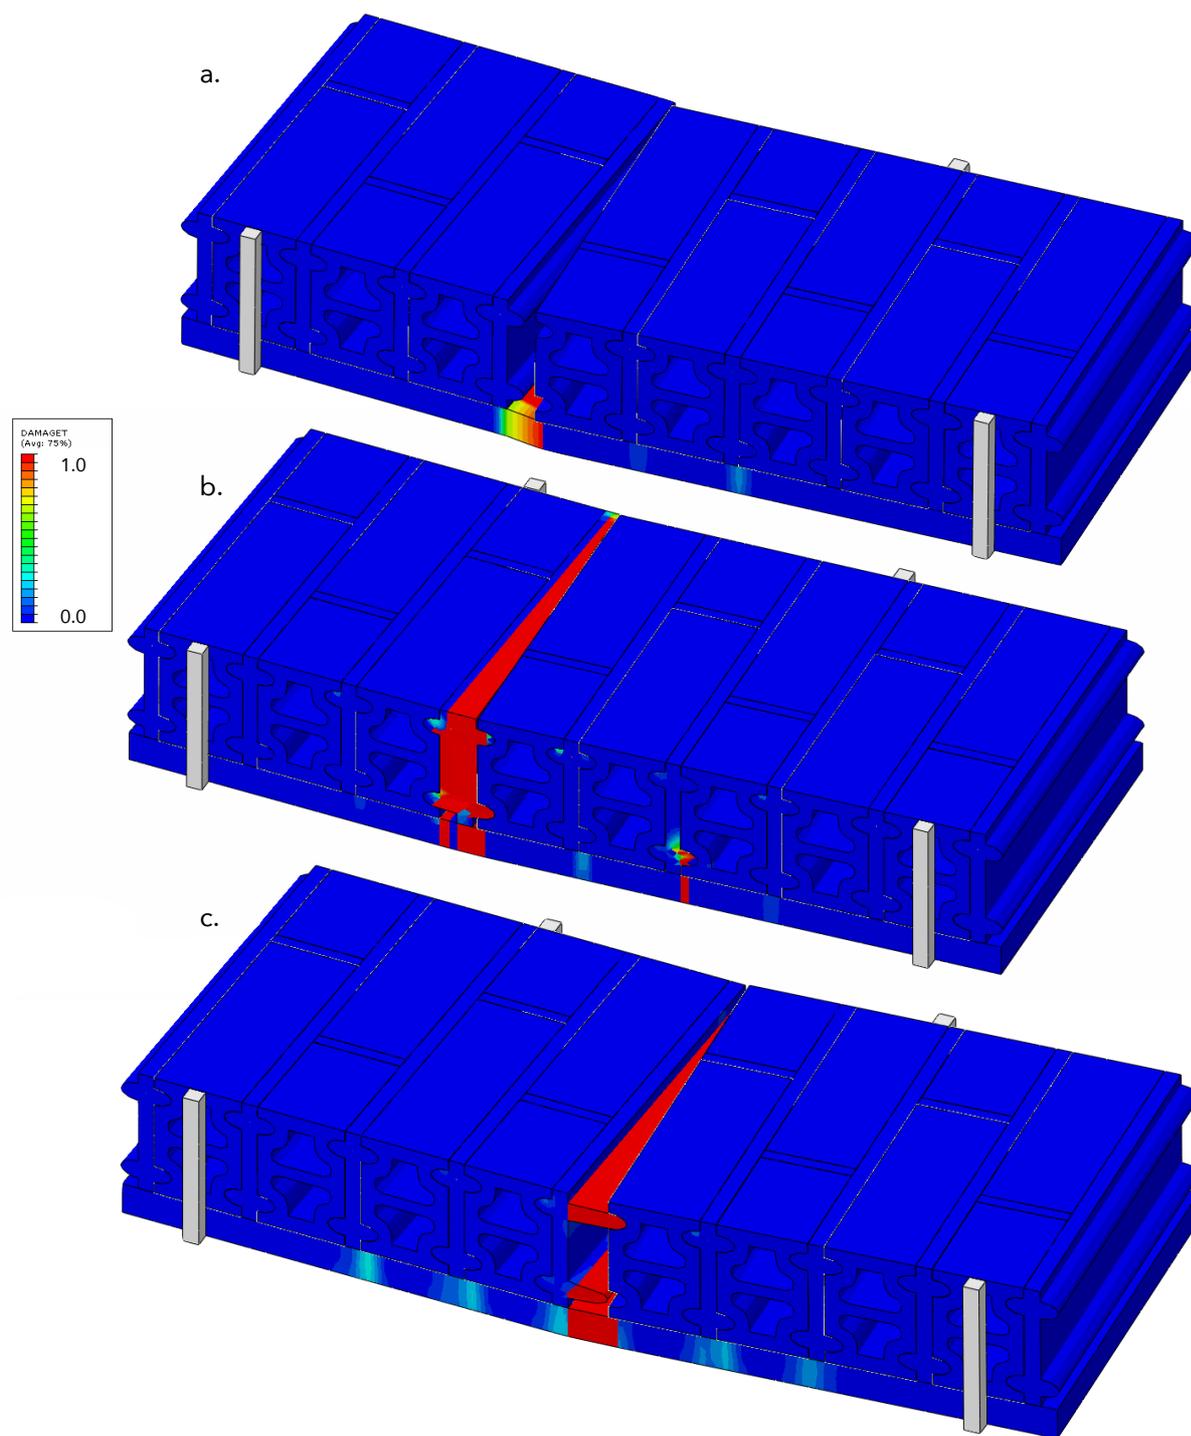
Figure 4.5. Similar failure mechanisms depending on various configurations of bond and mortar strength and stiffness.
