Testing, Characterisation, And Modelling Of Nehobo Floors For Groningen Seismic Assessment

Intermediate Report: Laboratory Tests and Numerical Models

Laboratory Tests and Numerical Models
INTERMEDIATE REPORT

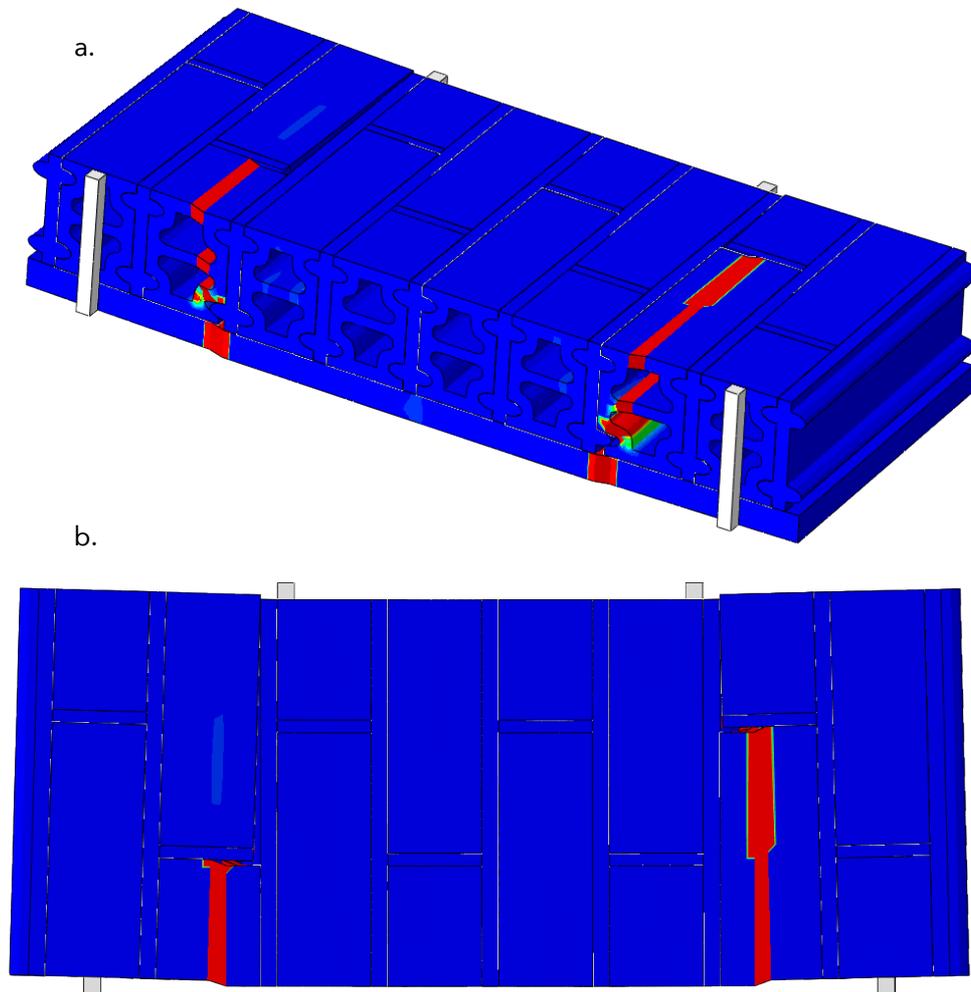
Figure 4.6. Fracture of the bricks when the brick material is weaker than the mortar material.

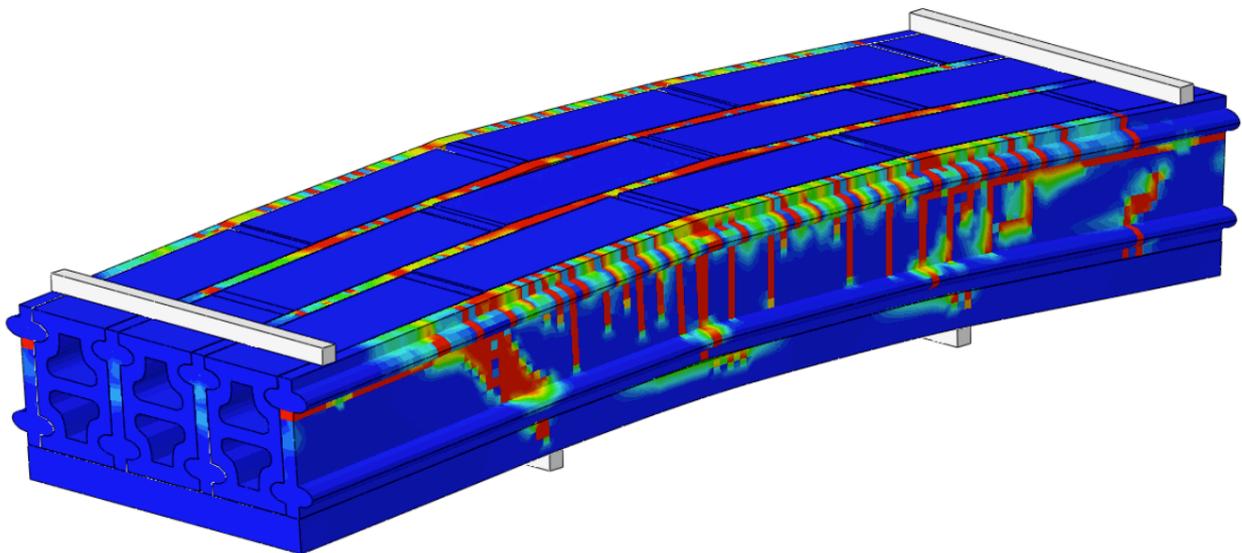
Figure 4.7. OOP bending test at peak load deformation. RC beam-like behaviour is observed.

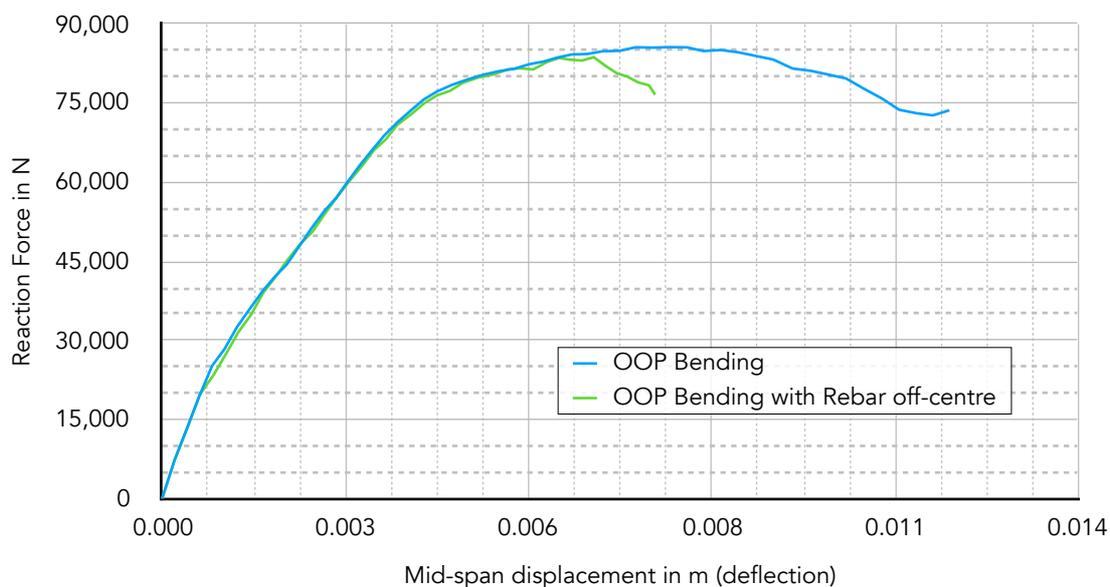
Figure 4.8. Force-displacement curve for the OOP bending test.

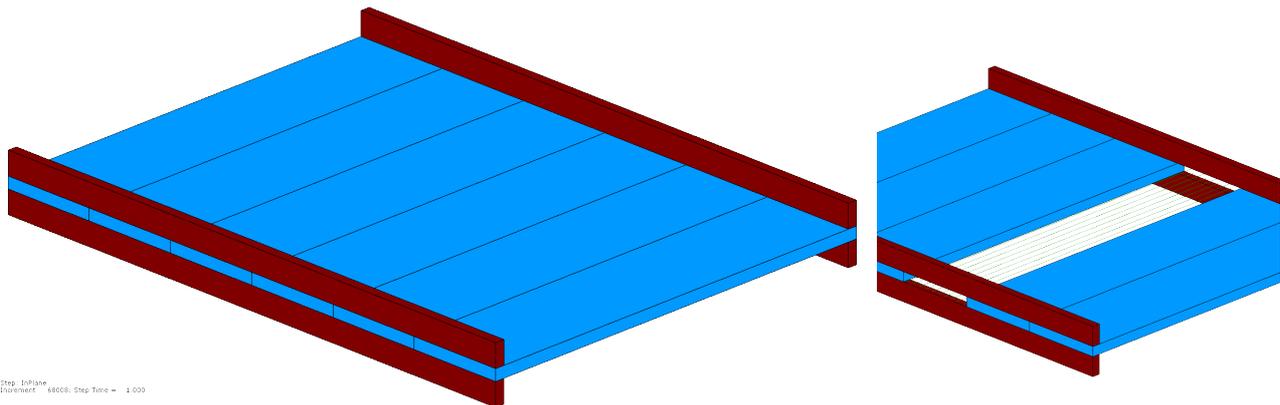
Figure 4.9. Meso model of the floor system with six plates (blue) and four wall stubs (brown). Right, one plate is hidden to show the direction of the embedded reinforcement.

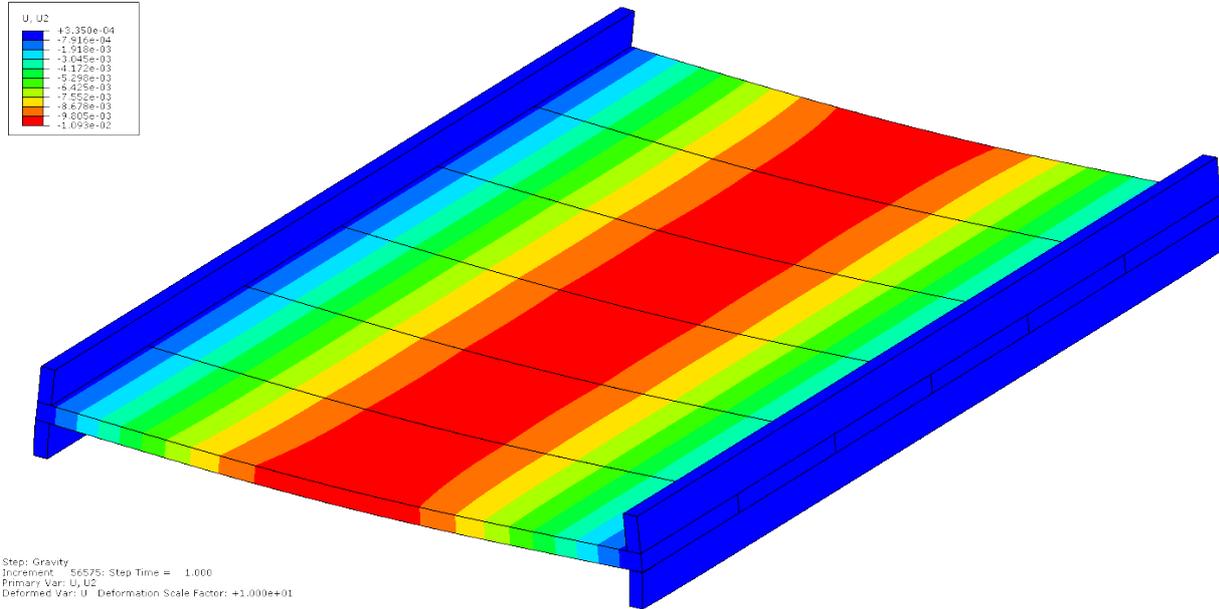
Figure 4.10. Deformation due to gravity loads. The maximum deflexion is 11mm (red, center). Deformed shape is magnified by 10.

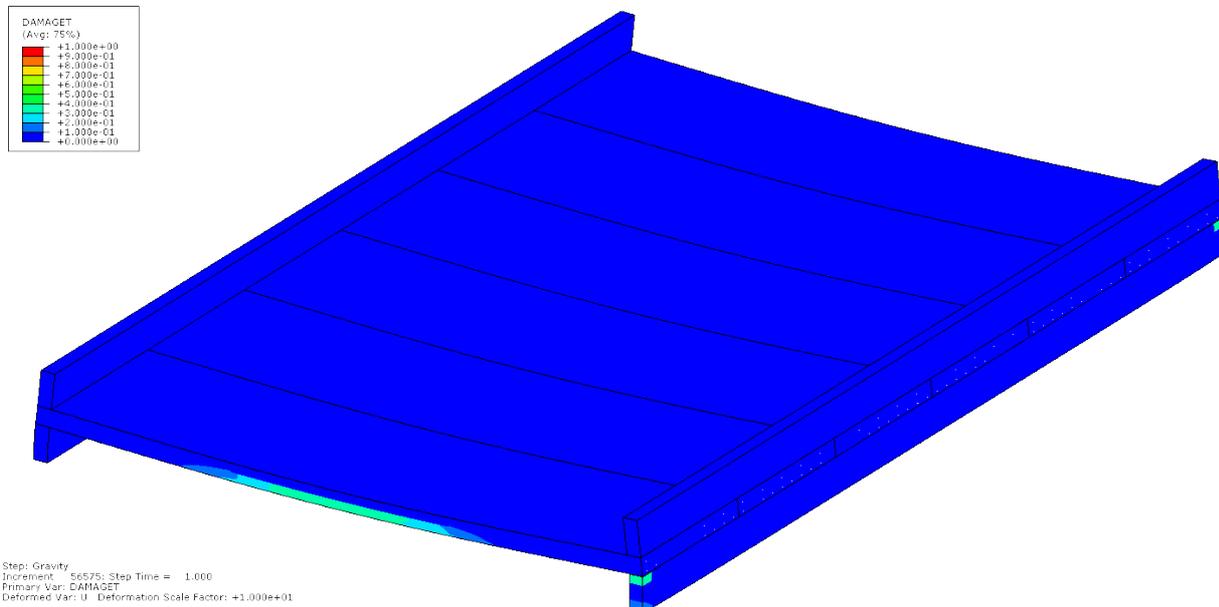
Figure 4.11. Zones with tensile cracks. Minor cracking is visible on the bottom side of the plates at the mid-span.

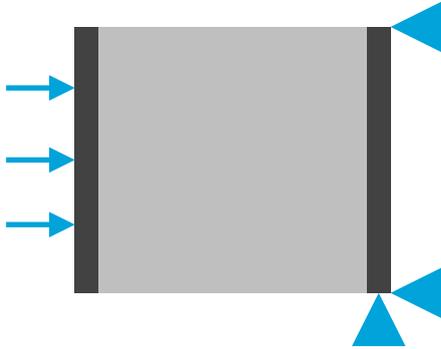
Figure 4.12. Sketch of in-plane loading.

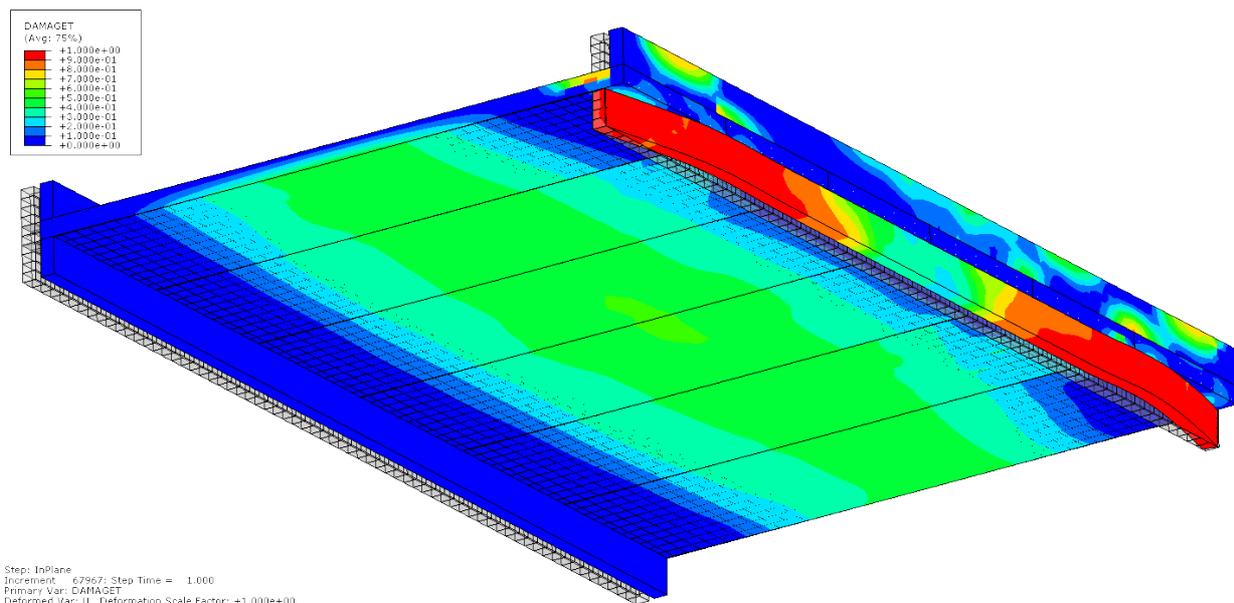
Figure 4.13. Bottom view. Sliding of the plates over the supporting wall, with out-of-plane movement of the wall.

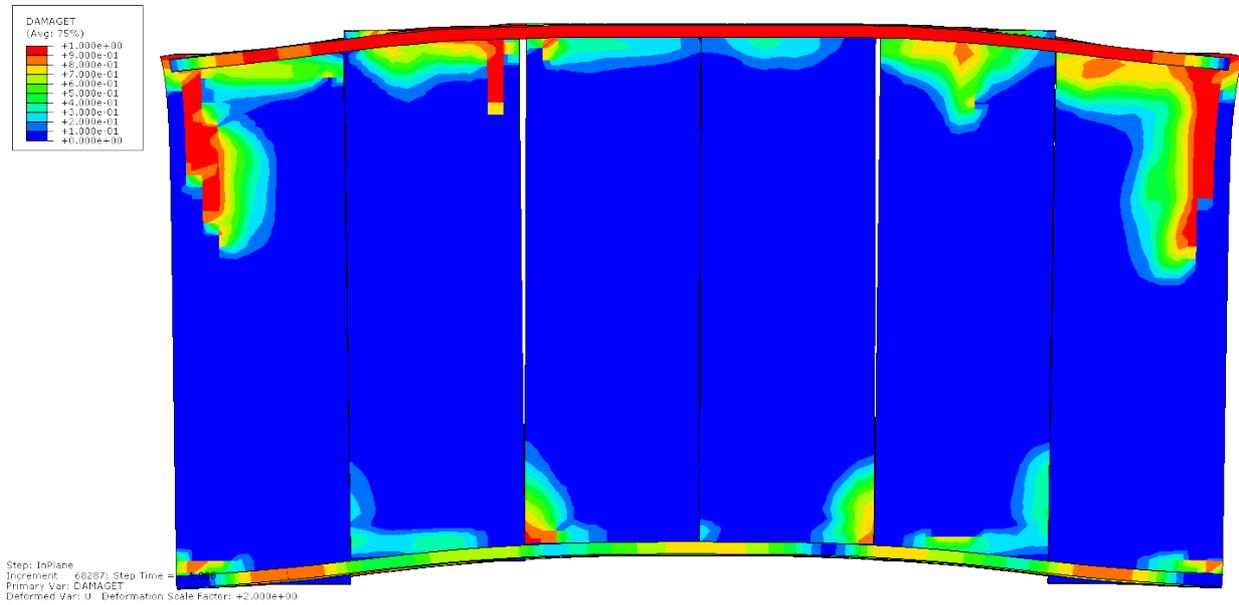
Figure 4.14. Top view of non-realistic restraint on the floors causing plate separation. Deformed shape magnified by two. Red shows zone with tensile cracks.

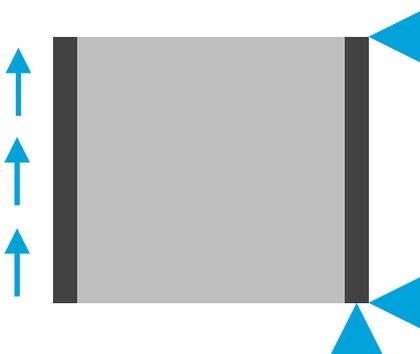
Figure 4.15. Sketch of in-plane, transversal loads.

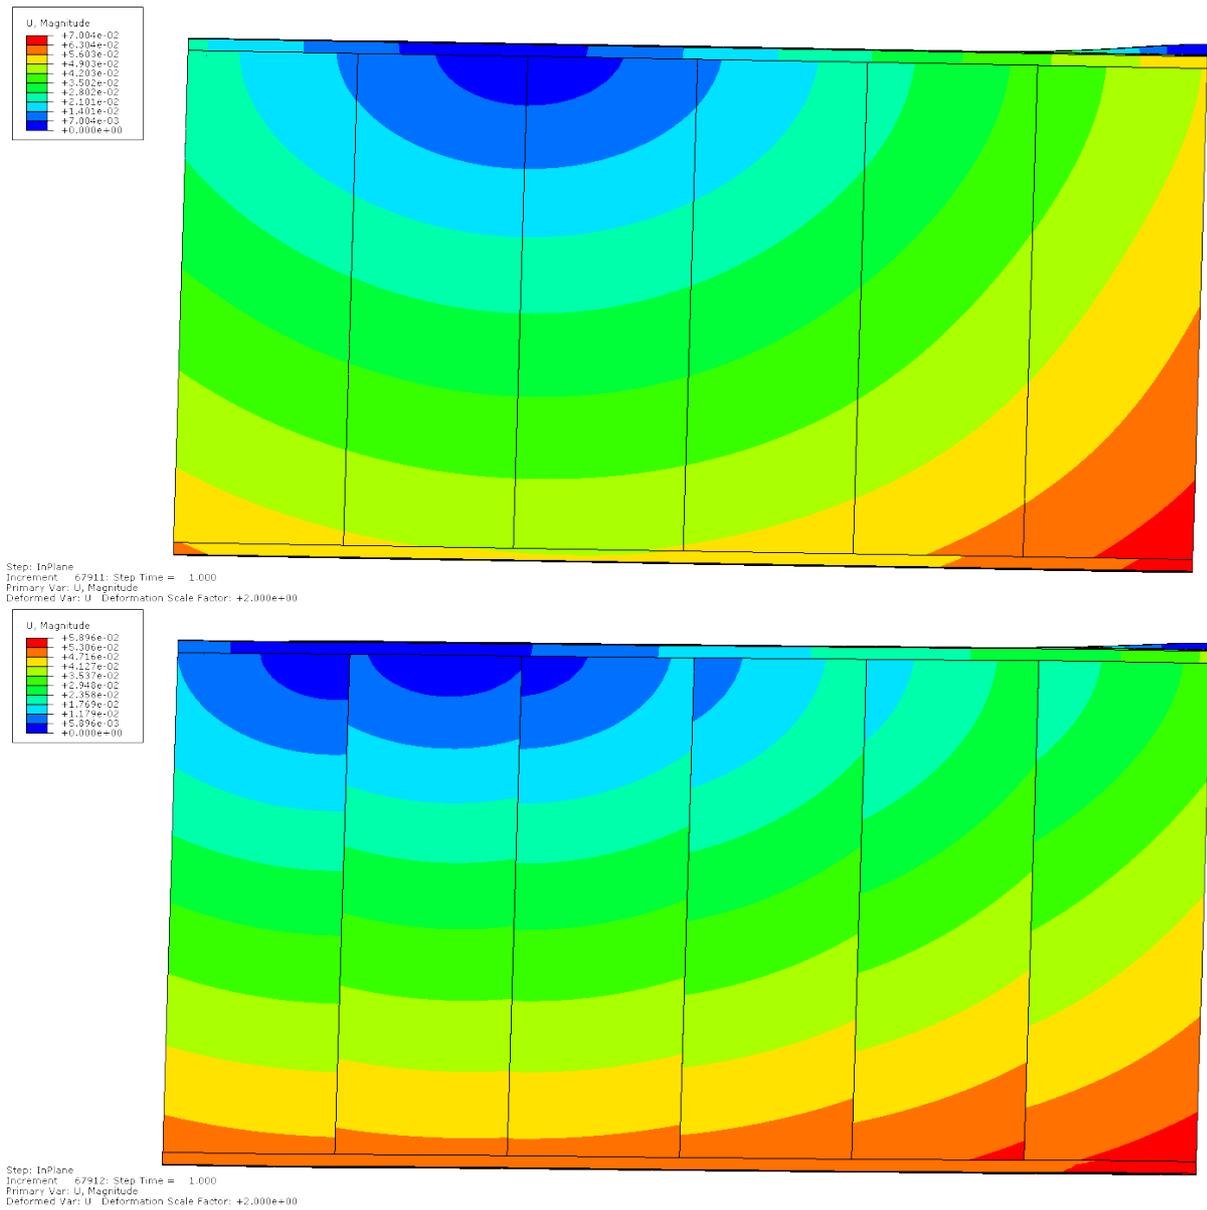
Figure 4.16. Deformation from shear load in-plane. Top, with cohesion between plates; bottom, without cohesion.

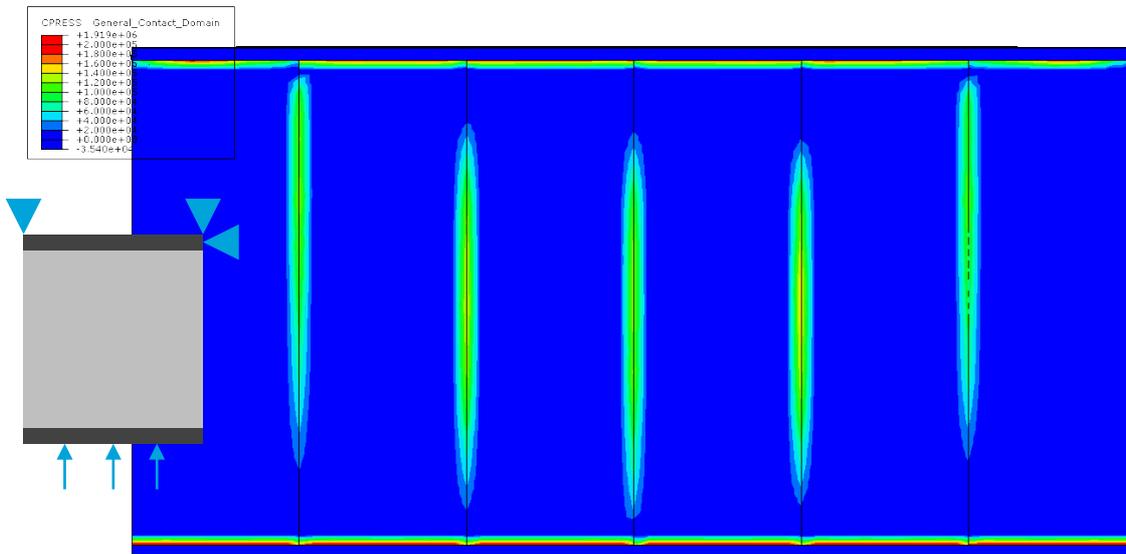
Figure 4.17. Contact stresses in between the plates reveal the expected compression arch.

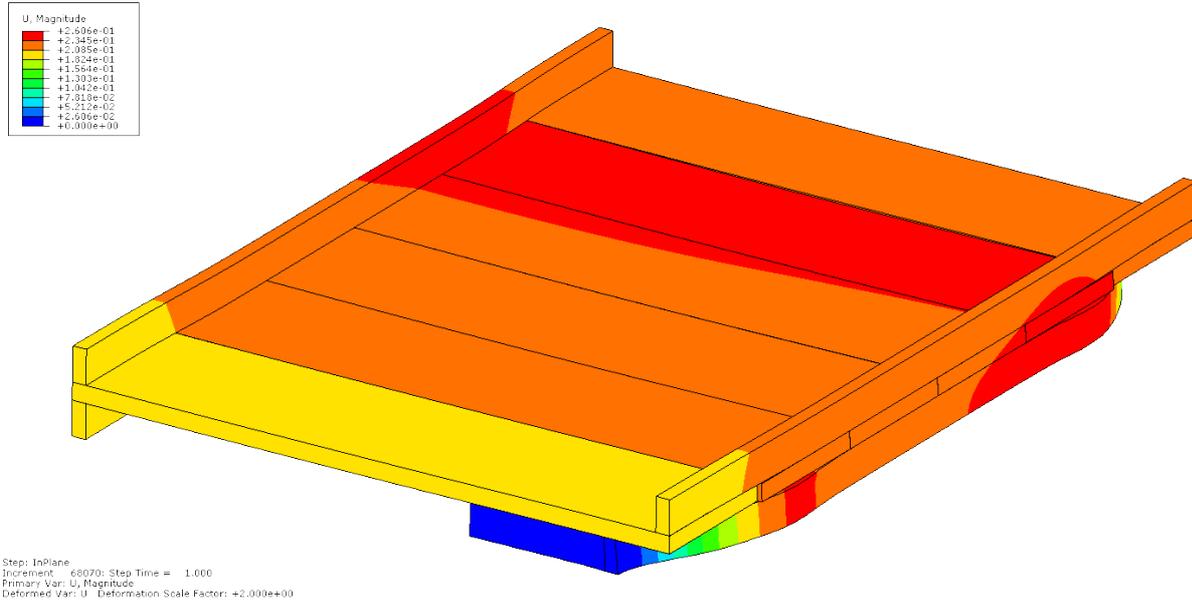
Figure 4.18. Deformation from in-plane push with lateral wall stubs. In this case, the plates at the extremes remain slightly behind, sliding against the other plates.

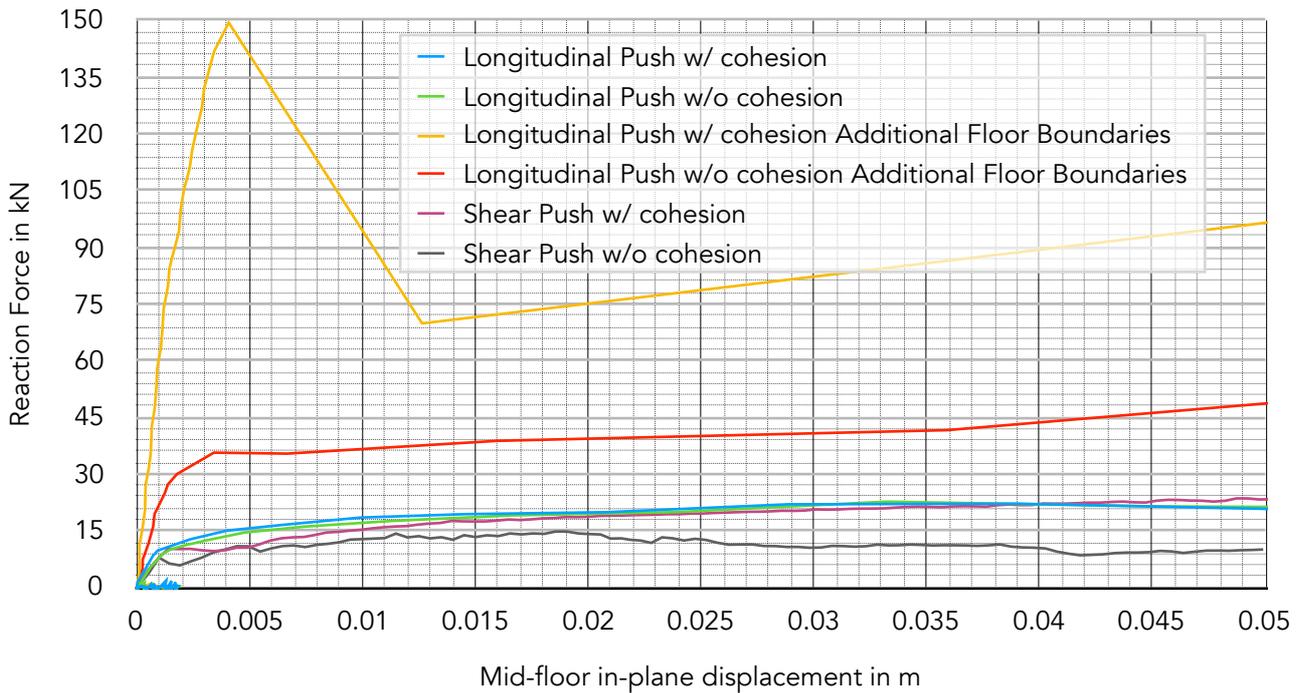
Figure 4.19. Reaction force against mid-floor (longitudinal) or floor-edge (transversal) displacement.

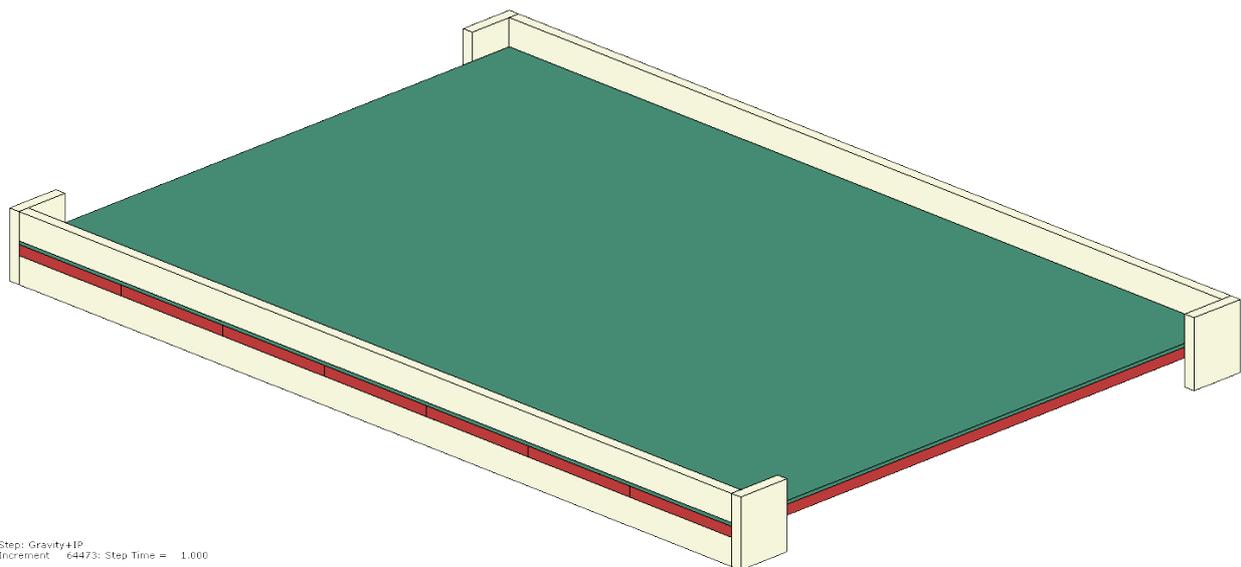
Figure 4.20. Model impression for the series of floor models 2.

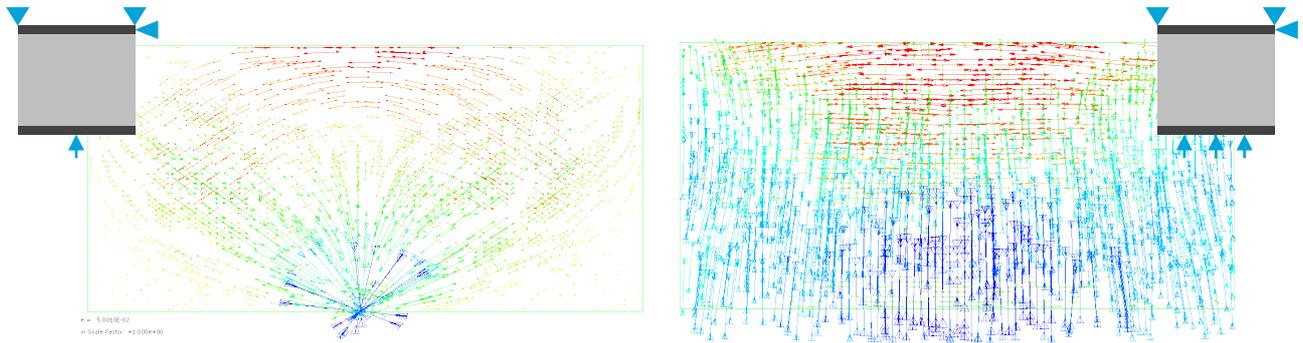
Figure 4.21. Travel direction of stresses through the floor.

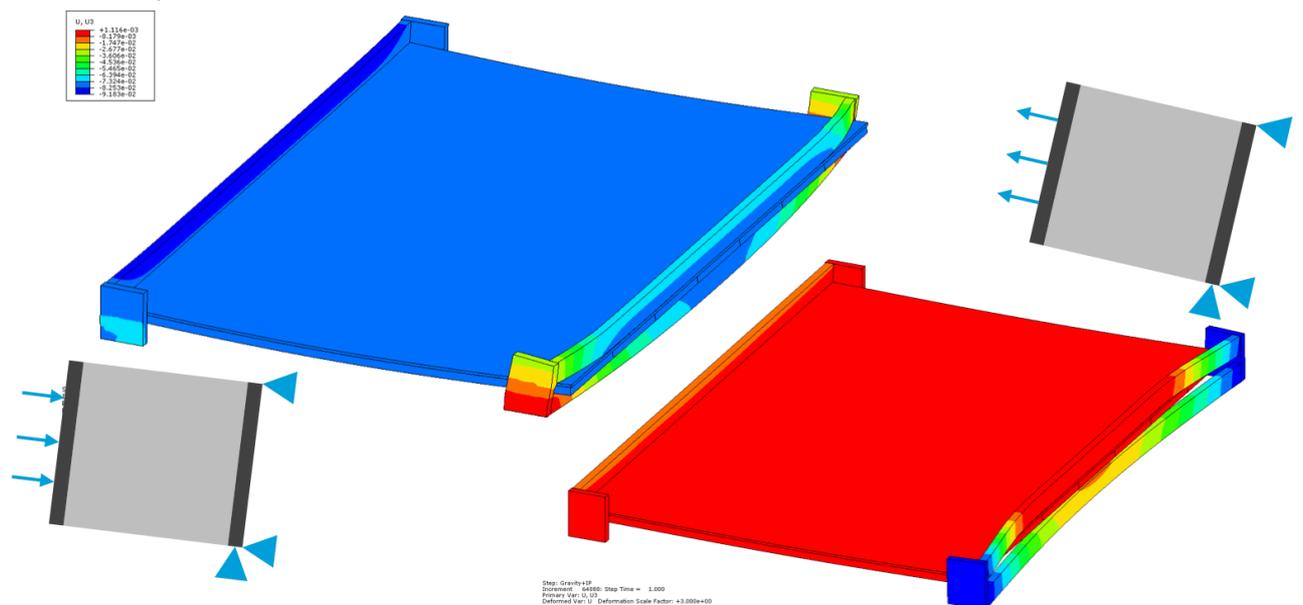
Figure 4.22. Longitudinal in-plane loading of the floor system. Slide-over of the floors at the connections with the wall stubs is observed.

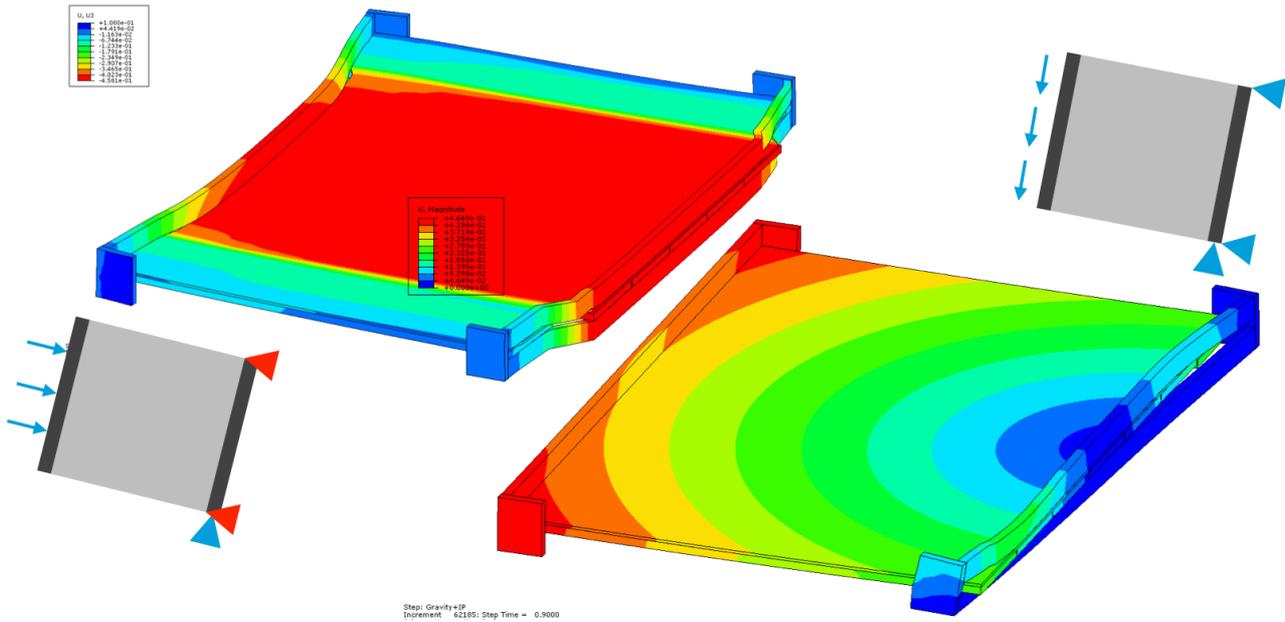
Figure 4.23. Over-constrained case and in-plane shear case for floor models 2.

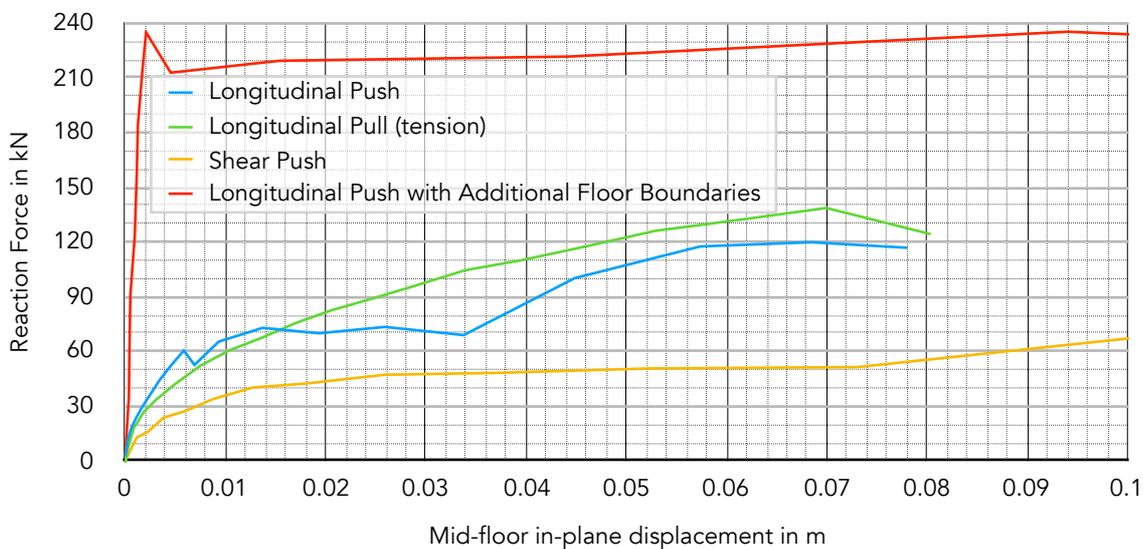
Figure 4.24. Force-displacement curve for floor models 2.

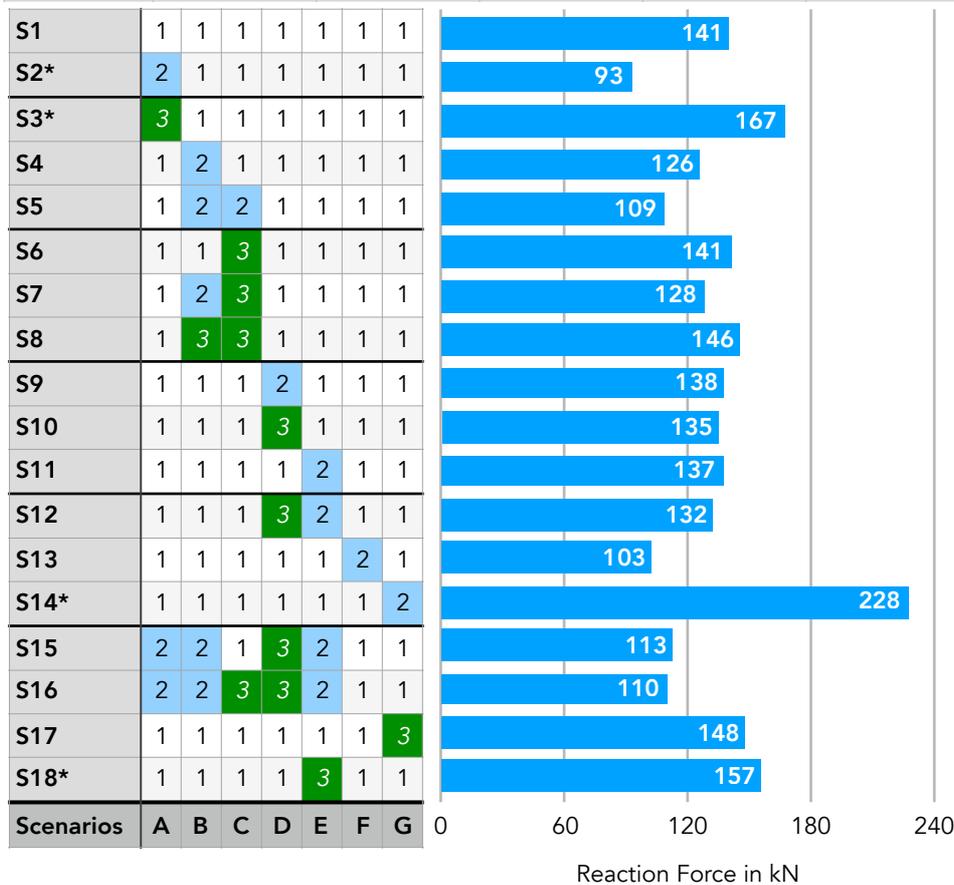
Figure 4.25. Results from the sensitivity analyses for longitudinal push in-plane.

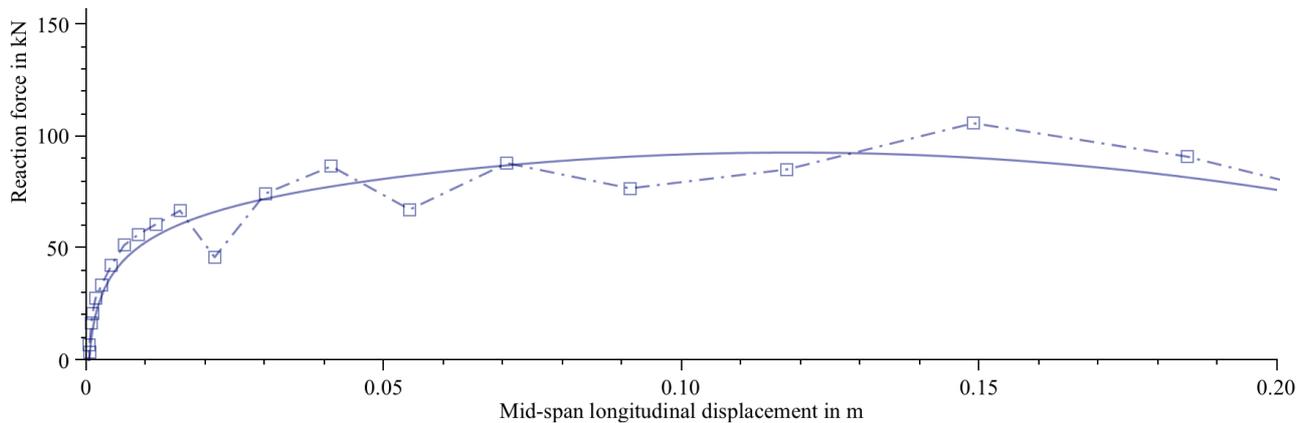
Figure 4.26 Example of log-parabolic fit to the force-displacement curves of the models.

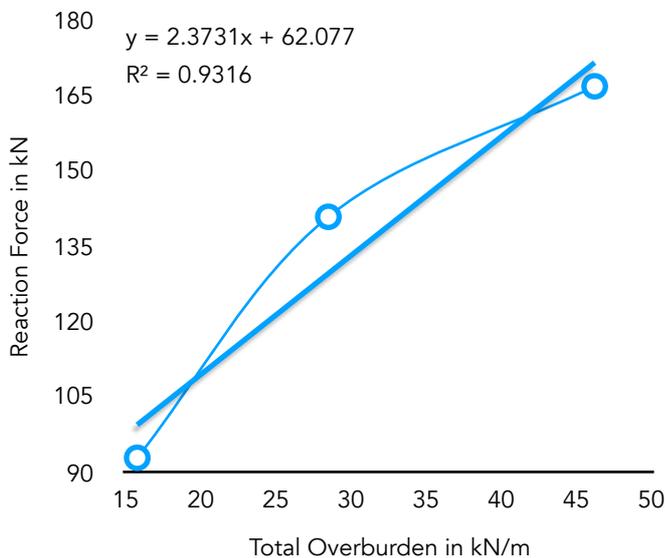
Figure 4.27. Example of regression for computed sensitivity values. Category A for overburden changes.

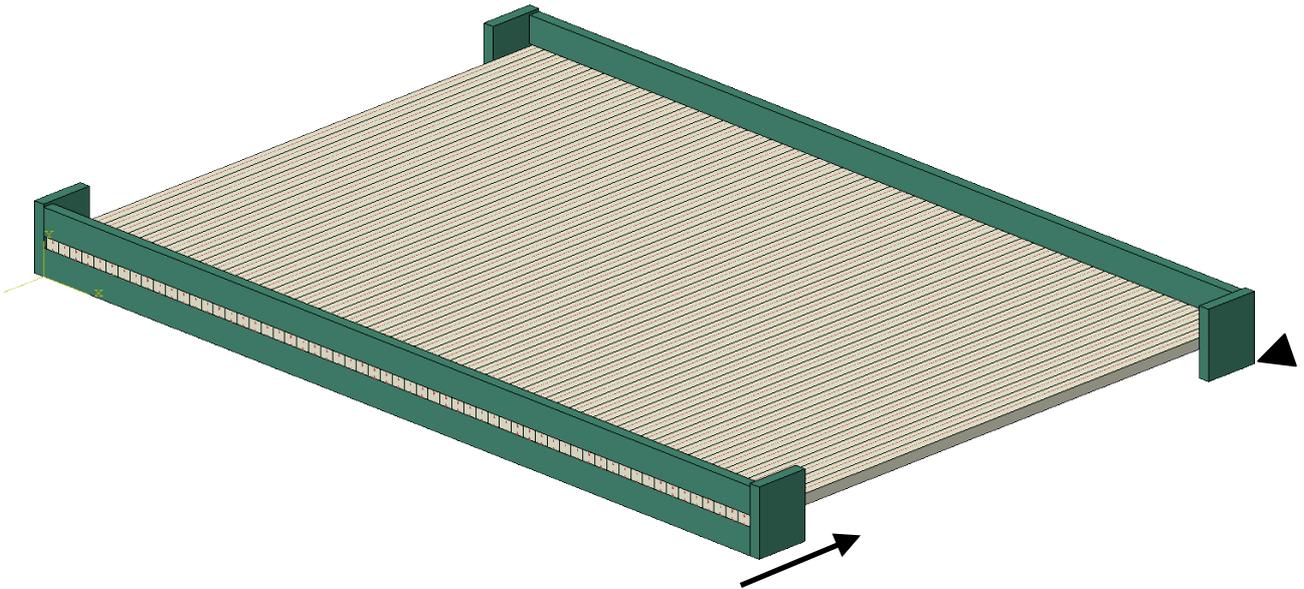
Figure 4.28. Impression of floor model 3 (strips).

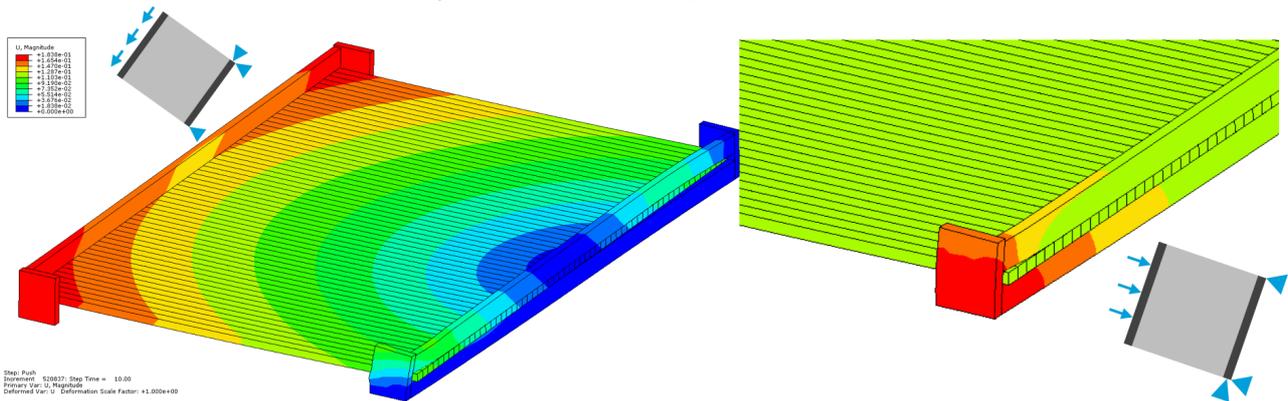
Figure 4.29. Failure mechanisms for the two principal in-plane loads for model 3.

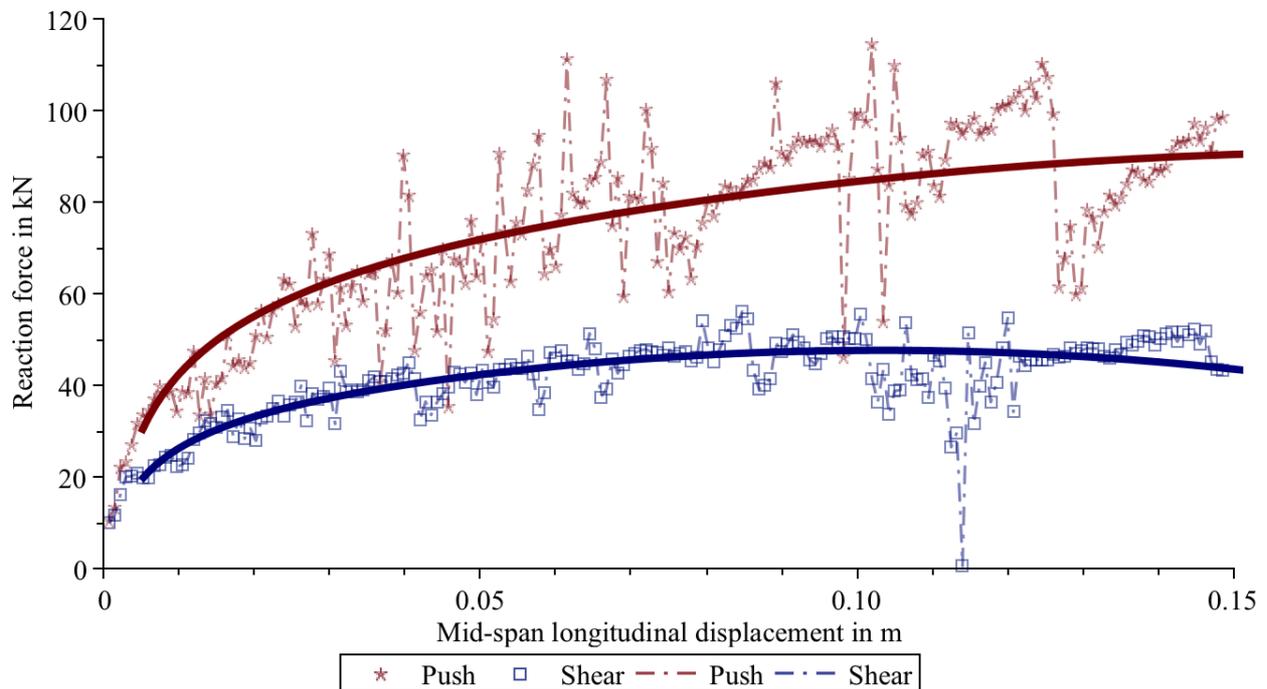
Figure 4.30. Log-parabolic fit to noisy data from floor models 3 (strips).

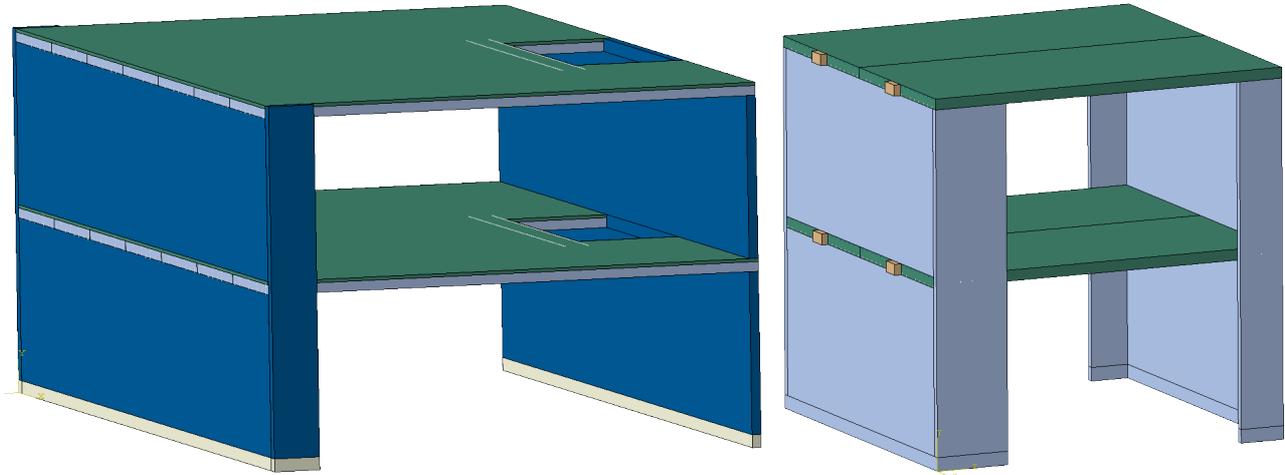
Figure 4.31. Left, approximate model of the Zijlvest donor house with two NeHoBo floors; right, model of the validated TU Delft laboratory house with solid concrete floors.

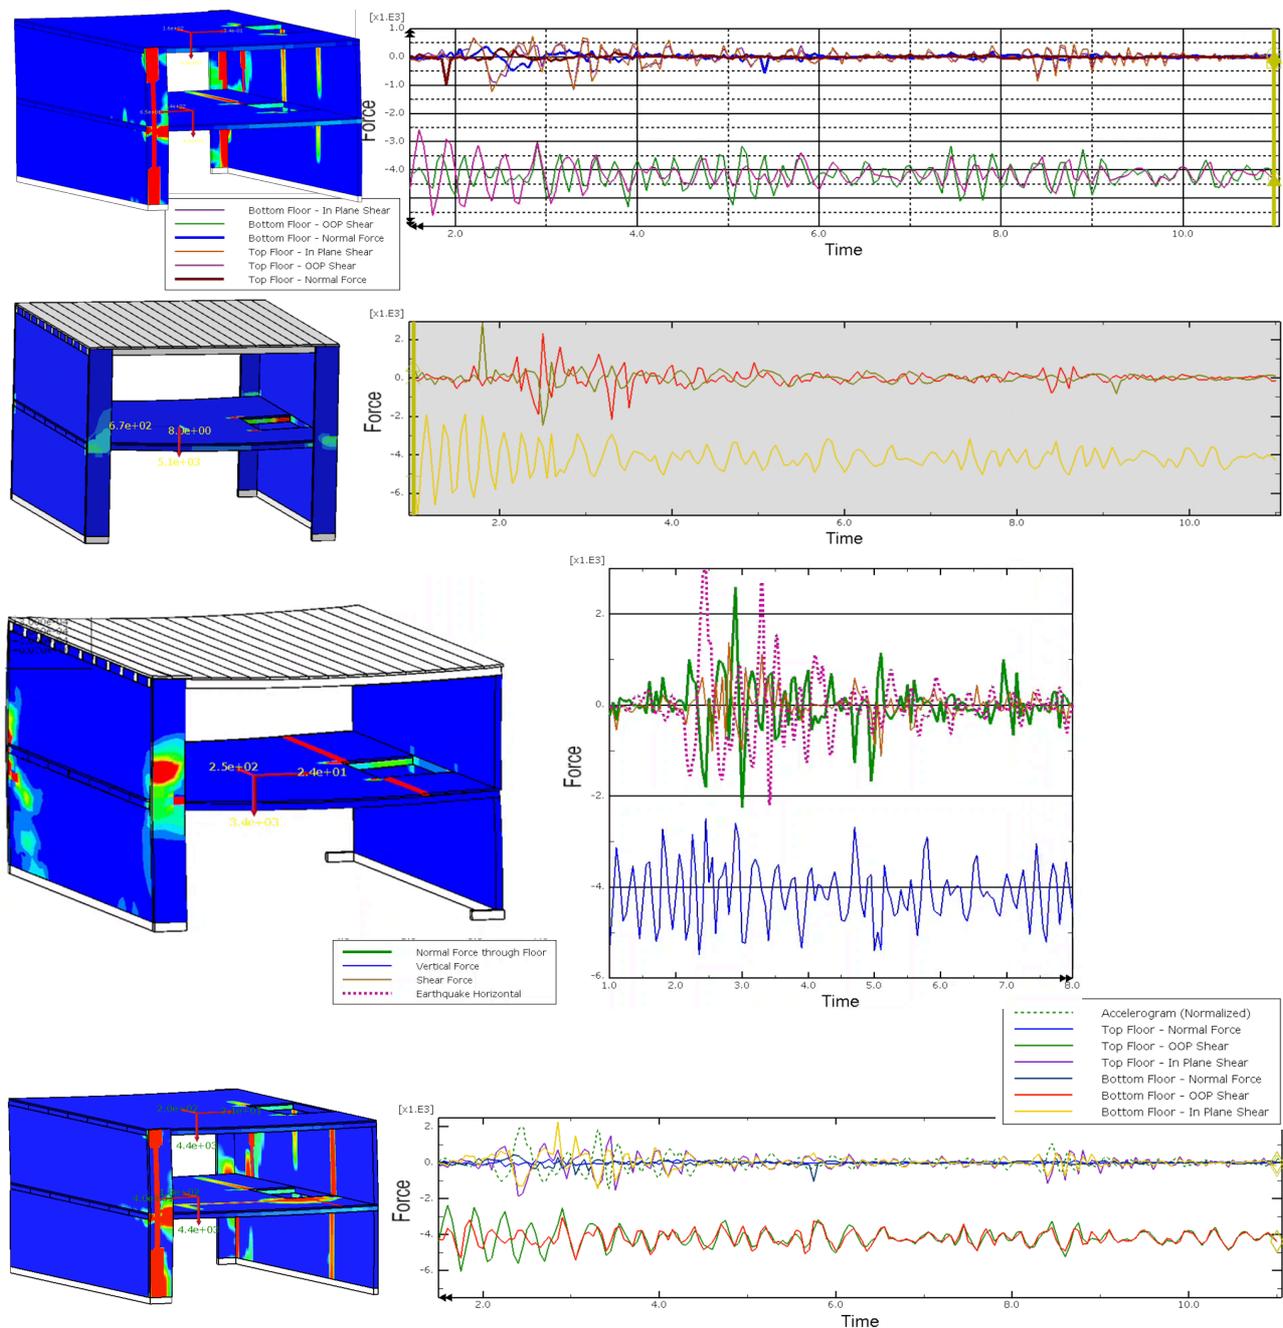
Figure 4.32. Examples of models for the Zijlvest donor house used to gain insight into the forces that need to be transmitted by the floor. From top to bottom: 2 NeHoBo floors at 0.25g, top timber floor at 0.35g with four piers, top timber floor at 0.35g with two piers, 2 NeHoBo floors at 0.35g with antisymmetric piers.

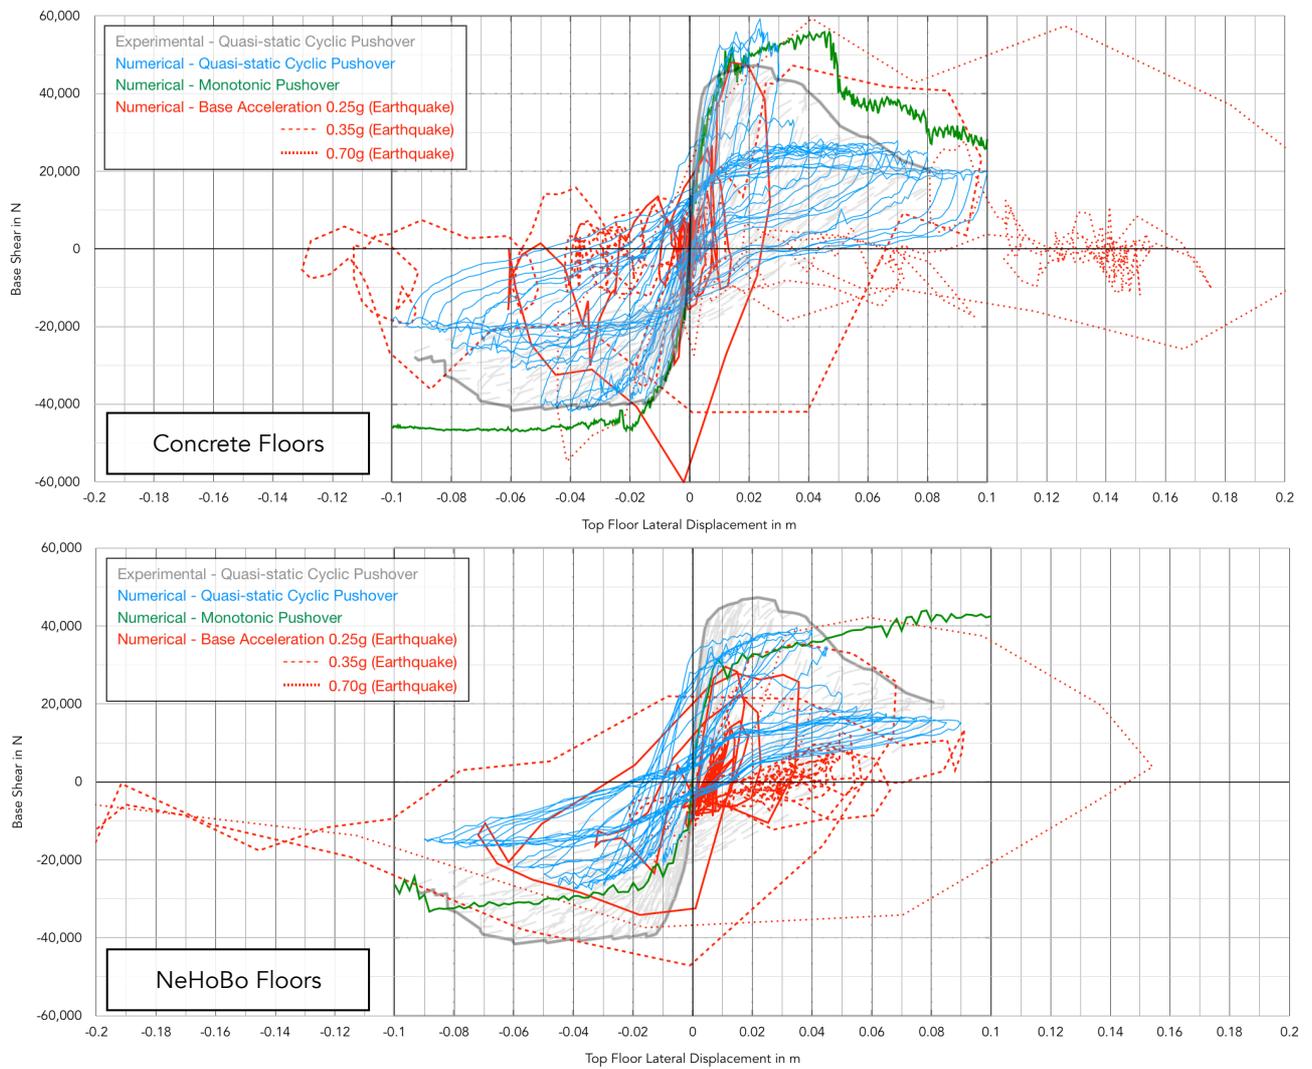
Figure 4.33. Force-displacement curves for the comparison of a terraced house with concrete floors or NeHoBo floors. The displacement is measured on the centroid of the floor.

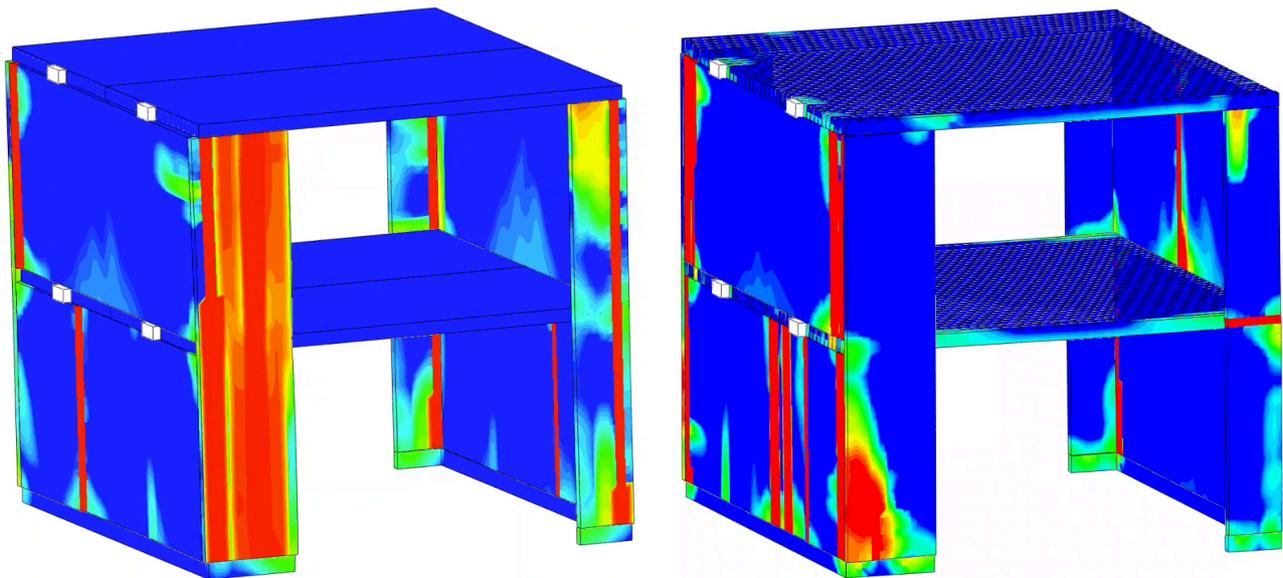
Figure 4.34. Model impressions showing crack areas (in red) for the concrete floor case (left) and the NeHoBo floor case (right) for the cyclic pushover to 100mm.
