Testing, Characterisation, And Modelling Of Nehobo Floors For Groningen Seismic Assessment

Intermediate Report: Laboratory Tests and Numerical Models

Laboratory Tests and Numerical Models
INTERMEDIATE REPORT

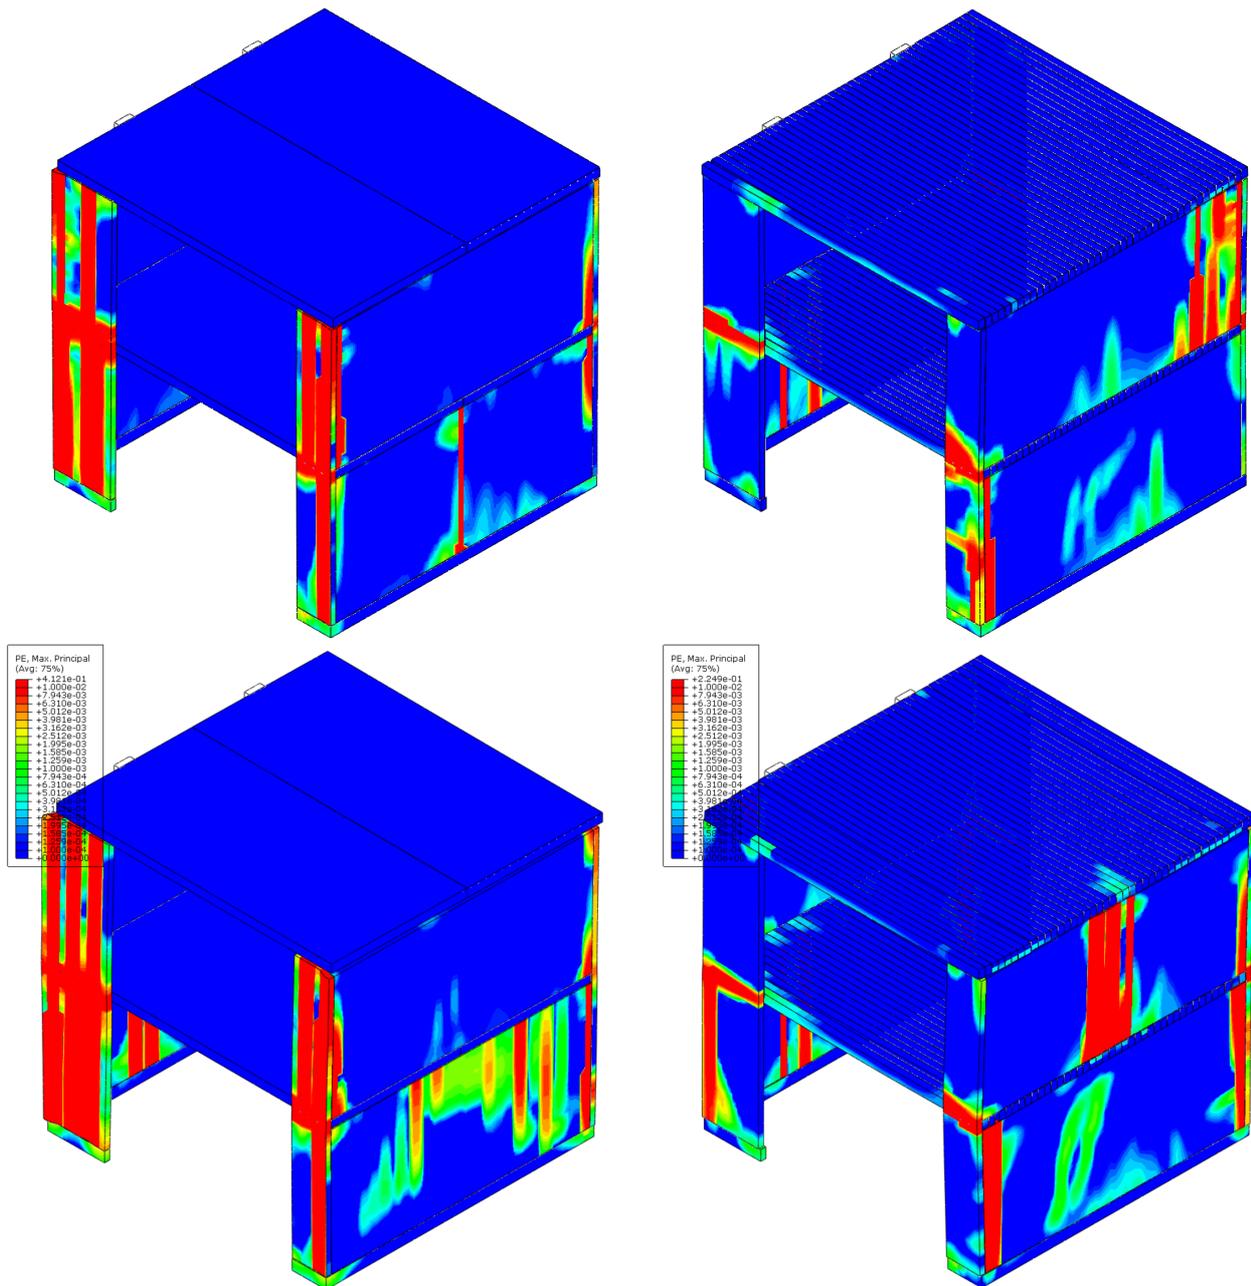
Figure 4.35. Top, earthquake at 0.25g (Resultant 0.35g); bottom, earthquake at 0.35g (Resultant 0.50g).

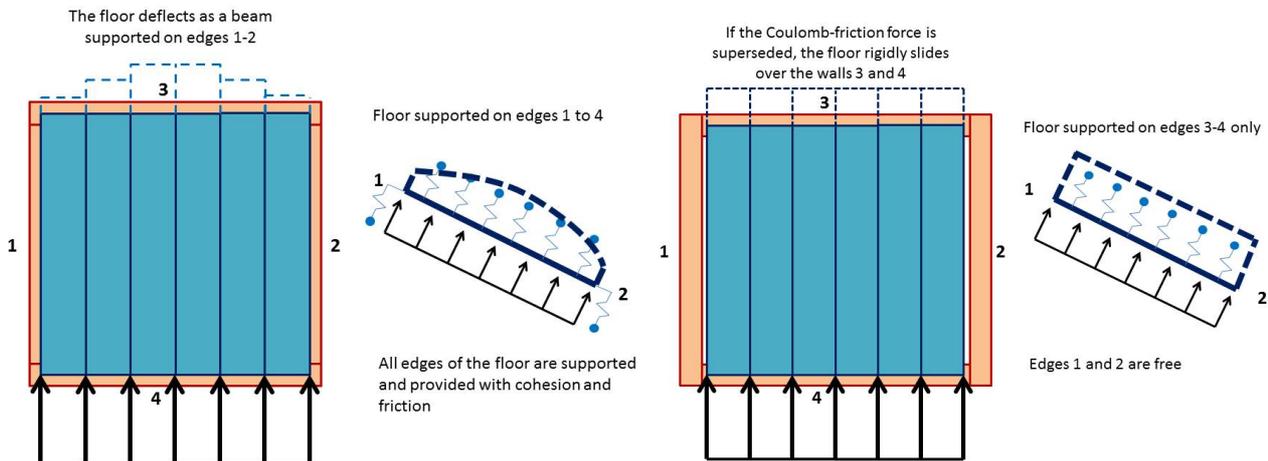
Figure 4.36. Qualitative deformation of the Nehobo floor subjected to lateral force: Left, floor supported on all the 4 lateral walls; and right, floor supported on two walls only.

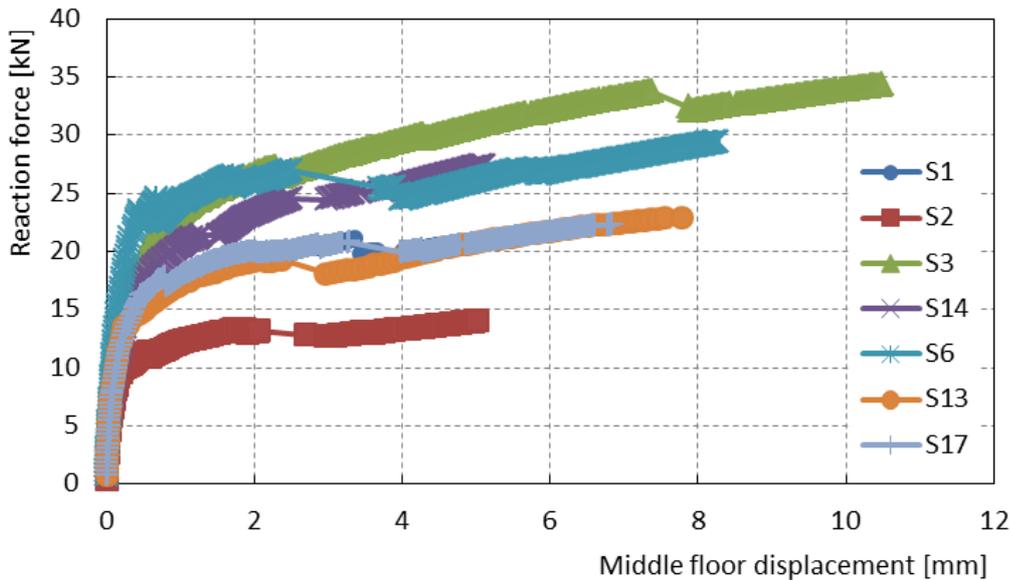
Figure 4.39. Envelope of the capacity curves obtained in the different sensitivity analyses.

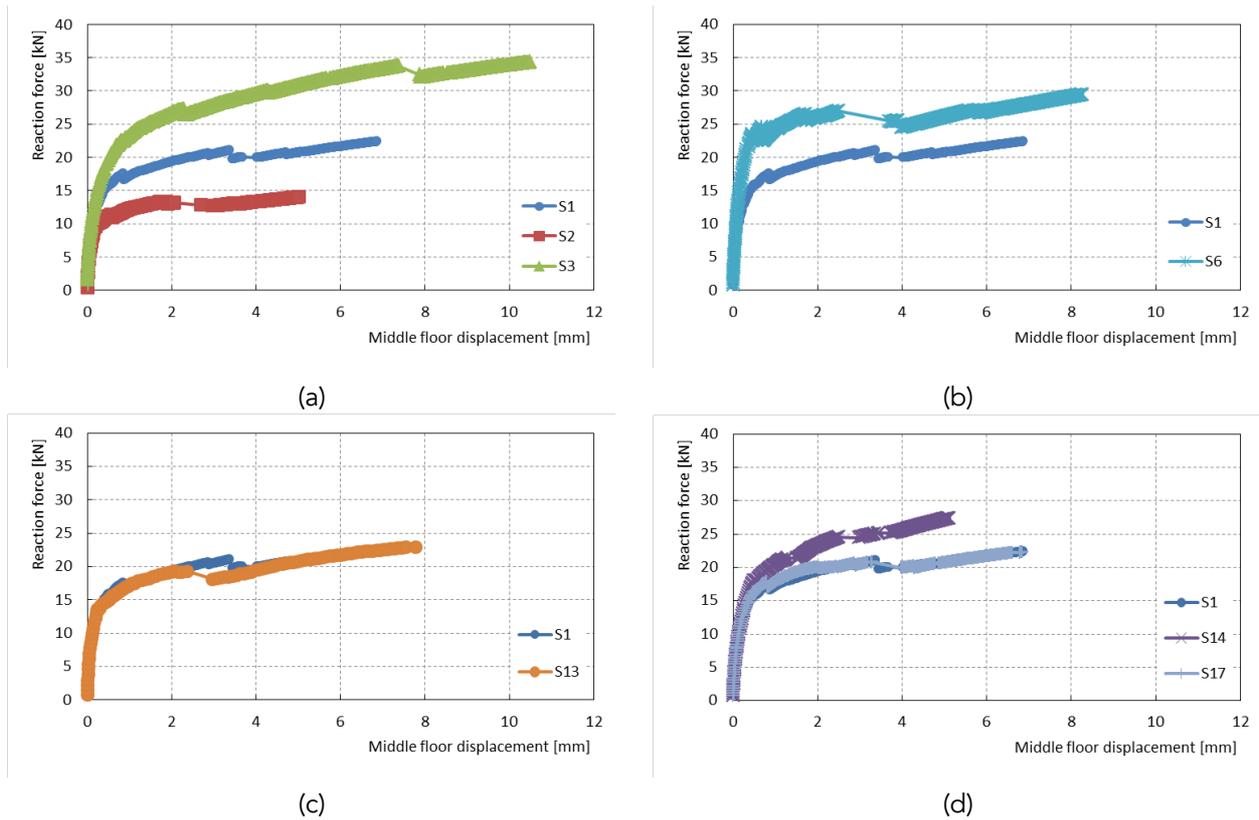
Figure 4.41. Effect of several parameters on the capacity curve: (a) overburden; (b) plate-to-wall interface properties; (c) plate stiffness; (d) walls material properties and linear/nonlinear behaviour.

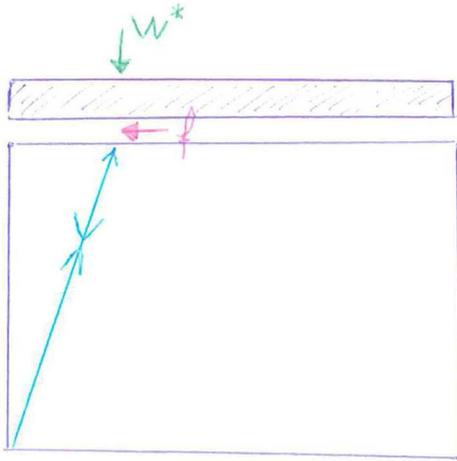
Figure 4.47. Sketch of strut model for maximum friction force between floors and walls.

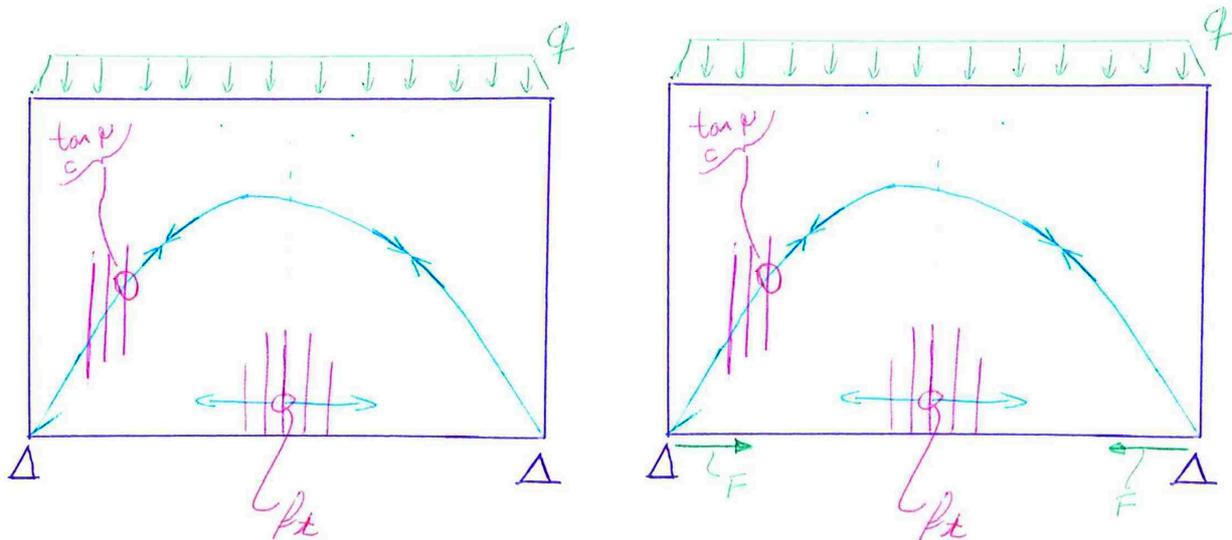
Figure 4.48. Proposed analytical model. Left, without contribution of the supporting walls; right, with their contribution.
