## Bio-Based Composite Footbridge: Design, Production and *In Situ* Monitoring

This paper deals with the design, production and monitoring of a bio-composite footbridge with a span of 14 m across the river Dommel in the city of Eindhoven, the Netherlands. The specific bio-composite material that was used for this research is a Natural Fibre Reinforced Bio-Polymer (NFRBP). The goal of the research is to prove that NFRBP can be applied as a load-bearing structure in an outdoor environment. For this purpose, a multidisciplinary team of academic researchers from two universities and from the Centre of Expertise Biobased Economy, together with a manufacturer from the NFRBP industry, have developed a feasible design that could be produced in a short period of time and within a limited budget. The footbridge was designed, built and installed within less than one year. In the two years after the installation of the footbridge, the structural behaviour of the bridge was monitored by means of optical fibre glass strands, integrated within the structure, with the purpose of measuring deformations and change in elasticity that occur over time.

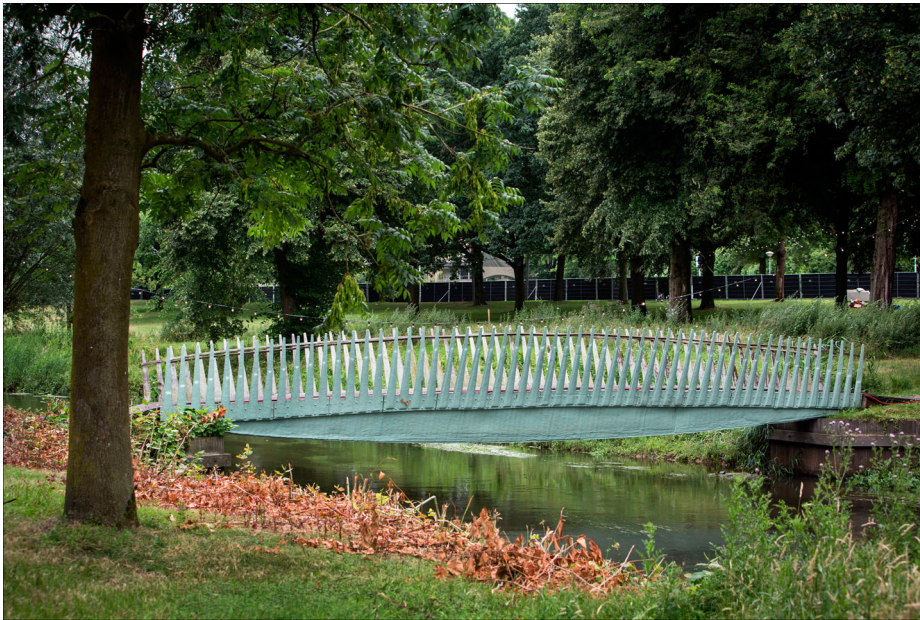
Fig. 1: The bio-composite footbridge, 18 months after the installation across the river Dommel

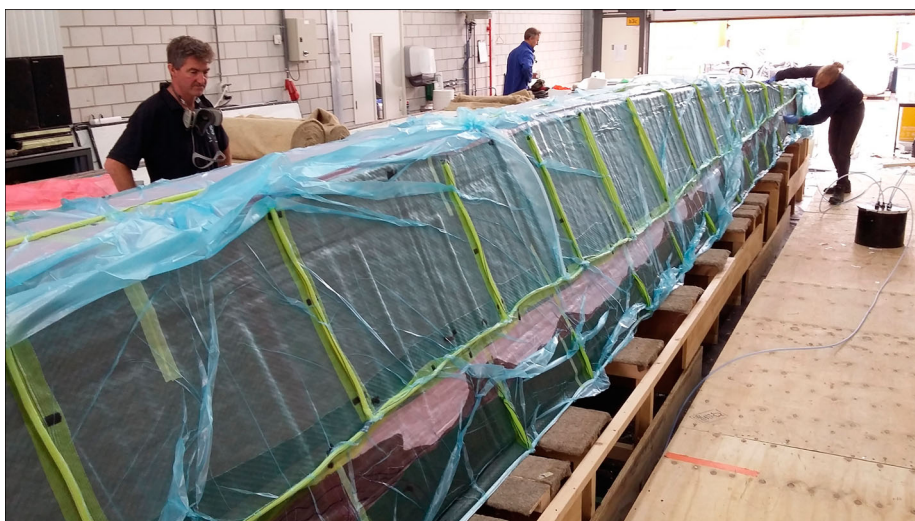
Fig. 4: Production of the 14m long bridge

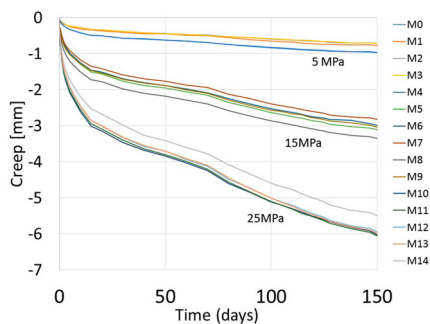
Fig. 8: Creep curves at three stress levels 5, 15 and 25 MPa in three-point bending tests

linear behaviour, creep test have been performed (Fig. 7). Three-point bending material creep tests on three different stress levels (5, 15 and 25 MPa) have been performed at TU/e. Figure 8 shows the results of these tests.

The creep slope of the samples under lower stress levels (indicated with 5 MPa) hardly show a decrease in time. The higher stress level (25 MPa) shows only a very small reduction in the creep slope. Therefore, the long-term deflection of the bridge can be estimated by a reduction in  $E$ -modulus approach, using with a reduction factor  $k_{def}$ :

Based on the creep curves for the low stress levels of 5 MPa (Fig. 8) and preliminary calculations, a  $k_{def}=0.8$  was found and applied in the design calculations.

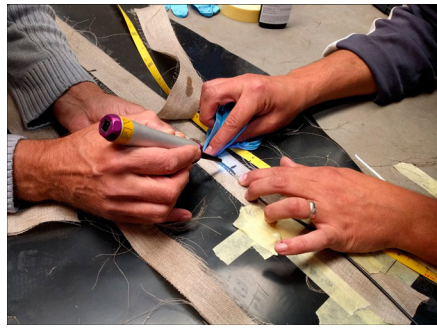
Fig. 9: Preparation of optical (glass) fibre bragg grating sensors

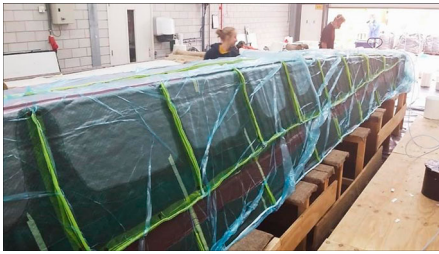
Fig. 14: Bridge beam during vacuum injection

Figure 14 shows the injection of the bridge beam (in top down position). In the dark green coloured areas, between the yellow injection canals, the resin has already penetrated the fibres. After the vacuum injection and the hardening, the bridge beam was turned 180 degrees and then cured at a temperature of approximate 50°C for a 36 h period using electrical air heaters. The bridge rail elements were then mounted and lastly, to prevent moisture accessing the structure over time, a coating system was applied.

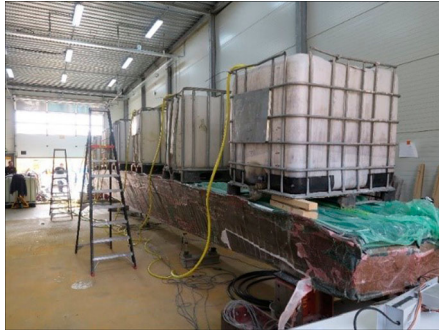
Fig. 15: Impression of the load test using seven water tanks

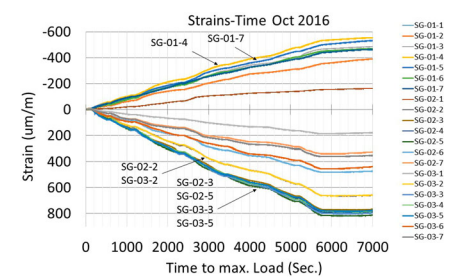
Fig. 19: Strain development versus time during loading; lines 2 and 3 are positive strains in tension (underside bridge beam) line 1 shows negative strains in compression (in bridge deck)

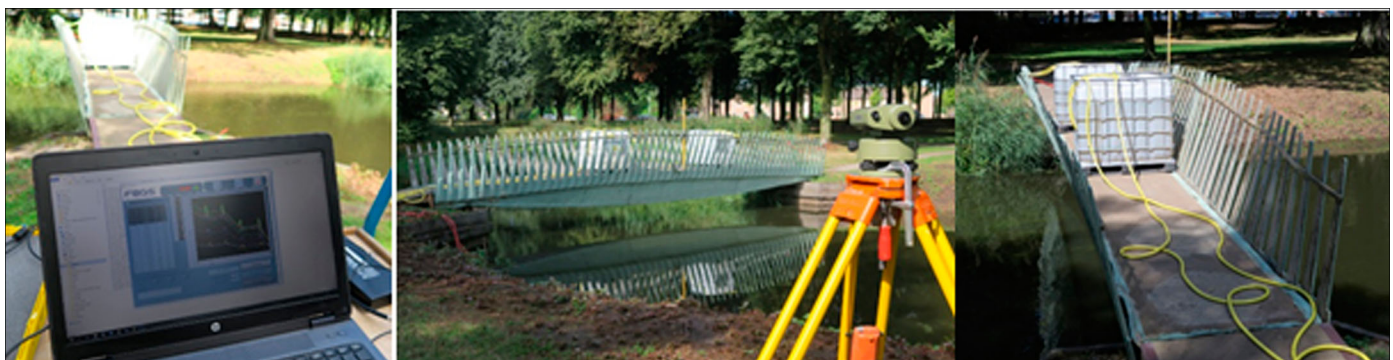
Fig. 21: Cyclic loading test performed one year and ten months after installation

The latest test thus far has been the test performed on 17 August 2018, 22 months after the installation. In this test, two water containers have been used to impose a load of a maximum of  $2 \times 10 \text{ kN}$  in a cyclic loading test (*Fig. 21*). Each load cycle step involved loading by filling the water tanks and unloading by releasing the water. The first load cycle has been performed in three steps to  $2 \times 6.0 \text{ kN}$ . After each load step of  $2.0 \text{ kN}$  a 5 min break was implemented during which time the load was kept constant in order to see if an increase in strains was measured. *Figure 22* shows the full three loading and unloading cycles versus time. Load cycle 2 was the reloading to  $2 \times 10 \text{ kN}$  and the full unloading and cycle 3 was the reloading once more to  $10 \text{ kN}$  and unloading to  $0 \text{ kN}$ .

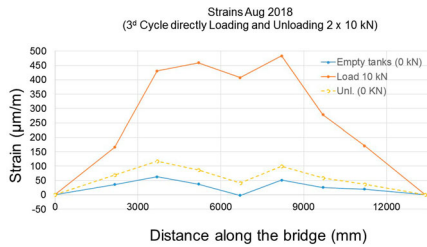
Fig. 25: Third load cycle; results of strains in tension sensors along the bridge (line 2), loading and unloading directly to 2x 10.0 kN. The dotted line shows the remaining strains

The green bandwidth shows the expected values of the strains calculated using an elastic calculation with a Young's modulus between 8000 and 10 000 MPa. While the strains in the middle of the bridge return to 0 there are small remaining strains on the left and right side of the bridge. The dotted line shows these remaining strains. This effect is increased after the third load cycle. Figure 25 shows the results of this third load cycle.

The second loading to the full 2x 10 kN load show almost 50 µm/m higher maximum strains near the middle of the bridge. Also, the unloading shows remaining overall strains of approximately 50 µm/m near the middle of the bridge. The sensors indicate a process of “yielding”, the increasing deformation under the constant load, not fully returning to the starting position of the sensors. The visual deflection measurements, however, do not show this yielding effect. Figure 26 shows the measured deflection in the middle of the bridge. The bridge shows a lasting upward deflection of initially almost 2 mm and at the third cycle an upward deformation of about 3 mm. A cause for this could be sought in small horizontal reactions at

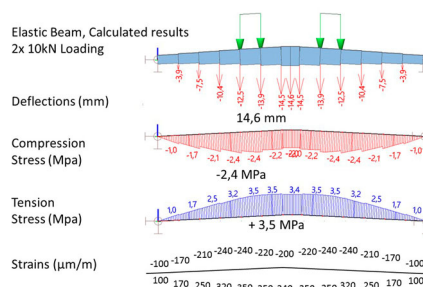
Fig. 27: Elastic model load test August 2018, calculated vertical deflections, the longitudinal compression and tension stresses and the strains

The elastic response to short time loads seems to show a more or less constant or only slightly decreasing material stiffness of approximately 10 000 MPa similar to the elastic beam model. The strains show a good correlation when the additional “yielding” strain is ignored. The calculated maximum strains in tension of 350 µm/m are also measured using the FBG's. Also the maximum strain of about 450 µm/m or 480 µm/m minus the remaining strains after unloading, 85 and 100 µm/m respectively (Fig. 27) show a difference of about 365–380 µm/m comparable to the calculated value of 350 µm/m. (Maximum reduced modulus of elasticity can be calculated as  $(350/380) \times 10\,000\text{ MPa} = 9200\text{ MPa}$ ) Also the measured deflections of about 16 mm (Fig. 26) compared to the calculated deflections (14.6 mm, Fig. 27) support this slight reduction in stiffness.

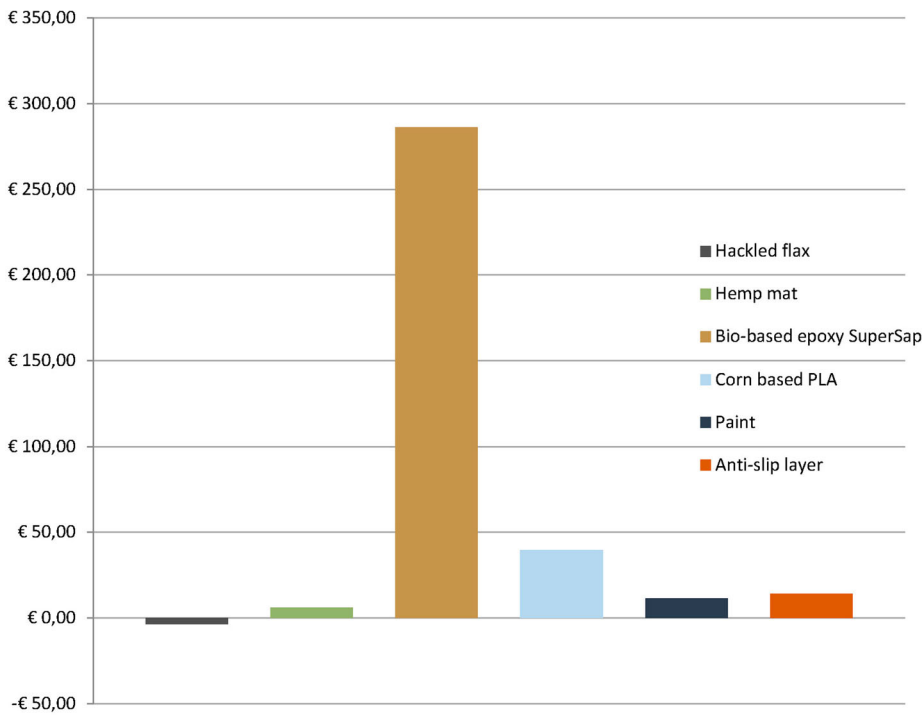
Fig. 29: Environmental cost impact for the total material used in to build the bridge

coating and the anti-slip layer. Calculating the material quantities used for constructing the bridge (Table 3) and linking them with the LCA data (Table 4), has revealed the actual degree of environmental impact for the total of materials used to build the bridge (Fig. 29).
