A second life for school buildings by atelier PRO architects

L M Oorschot¹

Abstract. Many educational buildings still do not have proper ventilation systems, are not sustainable in use, and contribute to the spread of Covid-19 viruses. The biggest challenge for the future is to provide attractive, useable, healthy, and sustainable educational buildings in the Netherlands. But is this challenge realistic? Old buildings are usually demolished and replaced by new ones because the government hardly gives any compensation for building renovation or transformation. This leads to the demolition of many school buildings even though the application of new raw materials is not circular and has an impact on our climate and environment. Furthermore, many pre-war buildings are heritage that have a positive impact on neighbourhoods. It is unclear who is responsible for educational buildings, renovation, and financing all the ambitions. The government, the municipality or the school foundation? Problems will soon be exacerbated. At this moment the environmental impact (MilieuPrestatieGebouwen MPG) has no legal base however, this will rapidly change in the age of a circular economy and the upcom

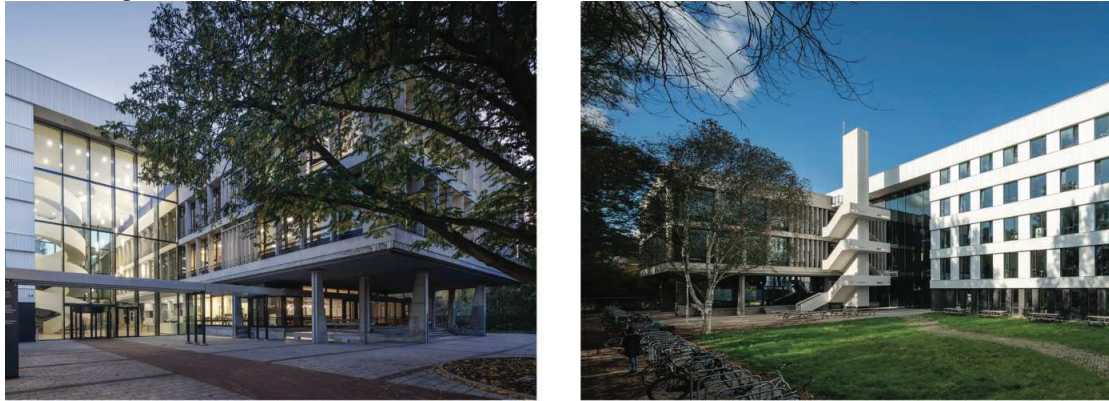
Figure 1. Lumion College Amsterdam after the renovation.
Source photos atelier PRO architects, photos by Jan Paul Mioulet

The design-tender for the Caland 2 Lyceum (later renamed to Lumion) started in 2013. A new secondary school and sport facility for 1,300 students with a completely new vision on education in accordance with the principles of personalised learning of Kunskapsskolan. In this concept the school is divided into small clusters for 160 students, each with an individual entrance and eight classrooms around an indoor square. The existing plot in the neighbourhood Sloten was a controversy between the school foundation, which wanted a new school on a new plot, and the municipality. The original building was created in 1973 by the architect Joh. Bernhard Ingwersen in béton brut architecture and it was listed by the municipality in 2008, see Figure 1. The foundation did not carry out building archaeological research because the building did not match with their educational vision about personalised learning, so they wanted it demolished. In order to gain an advantage, they decided to wait for the March 2014 elections. After that the municipality and foundation came to an agreement about which part would be demolished and which preserved. The design-bid-phase started early 2015. The school organisations in Amsterdam were reorganised and the name changed to ‘Stichting Openbaar Voortgezet Onderwijs Progreso’ (SOVOP). In the preliminary concept design in April, the preserved part was radically separated from two new building parts. The first preliminary design was ready on October 26, 2015. The process management was transferred from the school foundation to the Projectmanagementbureau (PMB) of Amsterdam in April 2016 and a second preliminary design was produced 9 March 2016. Yet the conflict between the municipality and the foundation had not ended there. They still discussed how much of the building should be allowed to be demolished and what had to be preserved in the interior. After a presentation by the architect a positive advice was received on May 25, 2016 from the commission ‘Welstand en Monumenten’ for the new building part. Moreover, even though the school foundation was still not convinced it was necessary, a building archaeological research on the historic part was completed on August 26, 2016 under pressure by the municipality. In the final design, completed back in July 2016, there was still discussion about the interior and the amount of preservation and advice from the commission on September 28, 2016 was negative about the renovation of the interior of the existing building. Finally, though, they gave a positive advice under certain conditions on October 19, 2016. All the conditions were discussed in a meeting with PMB and members of the department of Monuments & Archaeology (M&A) on November 18, 2016 and an agreement was reached. In the construction documents and bid specifications for contractors on December 2, 2016, the starting point was agreed upon. The historic building was compact with a good Form Factor. It had an open building structure with a centre core of staircases, toilets and auxiliary spaces. There were corridors around the core and classrooms along the façade. The infill was more or less flexible. This smart layout inspired atelier PRO to do the same with the new addition creating a spiral staircase in the middle of a central hall. There was a debate about the infill of the existing building. The window frames between classrooms and corridors with an architectural value had to be maintained. The municipality and foundation reached a compromise whereby some would be restored and others removed and adapted to the principles of the Kunskapsskolan. The removed window frames were reused as wood panelling elsewhere in the building. A glass-appliqué designed by artist Joop van den Broek in 1972 was restored. Eventually the school board plans to hide this piece of modern art behind a wall because it is not in line with their vision.

Under pressure by the municipality the new wall was removed. Construction started in August 2017 and the building was completed in May 2019.

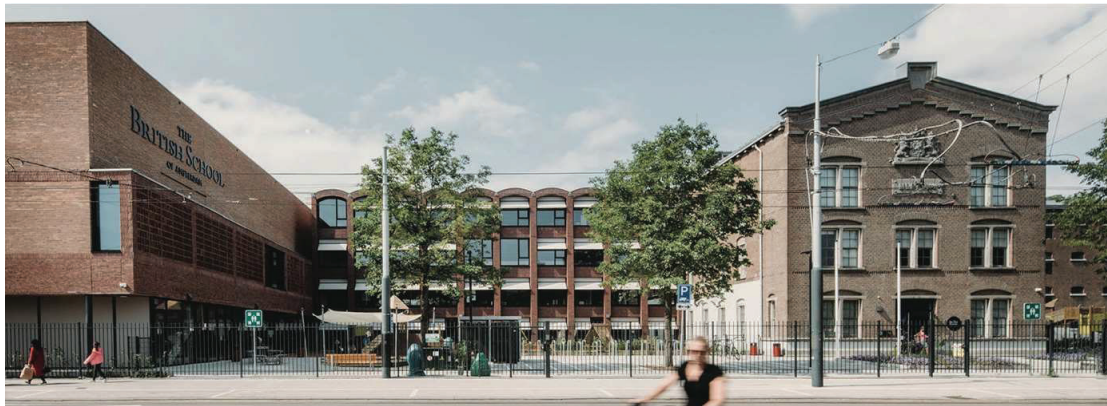
Figure 2. The British School of Amsterdam after the transformation.
Source photos atelier PRO architects, photos by Eva Bloem

In May of 2016 atelier PRO was invited to an architect selection for The British School of Amsterdam BSA that bought a nineteenth century prison at Havenstraat 6 in the Schinkelbuurt with support from the Amsterdam municipality, see Figure 2. The building was in a bad condition, brickwork was damaged and the roof was leaking. The prison was constructed in the period 1888 and 1891 and it was designed by government engineer W.C. Metzelaar. Many additions were added throughout the years. In fact, the ensemble was a chaos of buildings and additions. The BSA is a private school and foundation that wanted to incorporate three schools (primary, juniors, seniors) and amenities such as sport facilities, offices, and theatre. With the tender documents building archaeological research was already carried out by the department of M&A of Amsterdam on the possibilities for transformation of the prison. It was a challenge during the design process to convince users (teachers) that transformation could lead to a well-designed school. It was also going to be a challenge to integrate the balanced ventilation system into the existing structure. There were two important starting points. The old prison as an icon for the surrounding neighbourhoods had to be visible from the urban entrance road and secondly, the urban block around the prison had to be repaired. PRO helped BSA develop a program and used the building typology with circulation space of the prison and morphology of the building mass. The three cell blocks of the prison were transformed into schools with their own interiors and entrances. Every block was extended with a new building part for classrooms and the cells were transformed into an antechamber for more classrooms. Other cells were merged for additional and auxiliary spaces. The entrance and central hall with glass dome were renovated and became the heart of the building. The entrance wing with offices and church were transformed into a theatre and offices. Office space was added in a small extension at the back and a big extension on the front side was added for a sport hall and amenities. Inside the prison the paint on the brickwork was removed and a beautiful soft yellow stone appeared, so daylight from the glass dome above the space felt warm and intimate. Users of the BSA are calling this space The Globe, named after the Shakespeare theatre. The block of classrooms has a façade of brown red brickwork and a rhythm with vertical and horizontal bands and arches that refer to the cell structure. The two other new additions have a thin brick with thick joints. Close-up one experiences differences in the façade but from a distance the ensemble appears homogenous. In 2021 the building was delivered by the contractor. That year it was awarded best educational building of the year by Architectenweb and received the Geurst Brinkgreve Bokaal from the municipality of Amsterdam for best renovation or transformation of heritage. Users of the BSA are now convinced that transformation was the best way to have an iconic, attractive and functional educational building in the middle of the city.

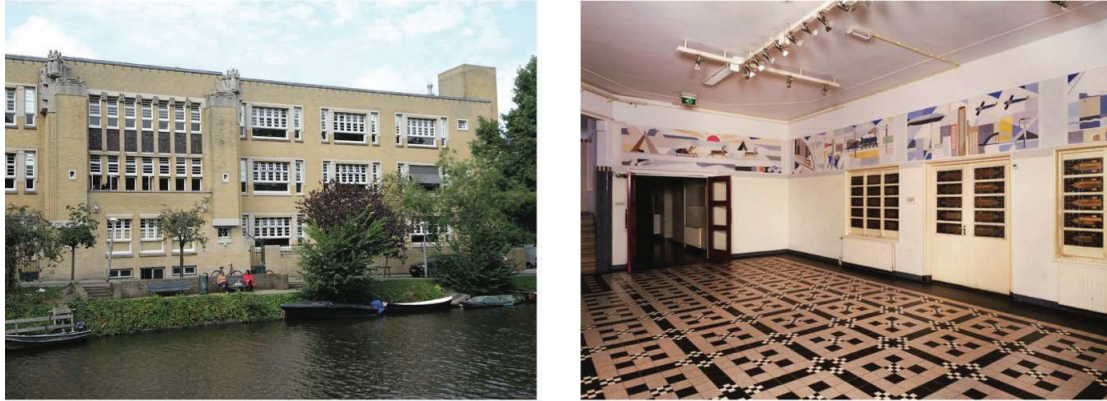
Figure 3. Berlage College Amsterdam.

The Berlage Lyceum has two buildings, both listed by the government in 2004 as heritage, see Figure 3. The school is Unesco-listed and international issues are important subjects in the education program. It is a school that pays a lot of attention to languages, globalisation, and international orientation. All education is offered in Dutch and English. The vwo concludes with an IB-English degree, havo with a Cambridge certificate, and mavo with an Anglia certificate. The school is located on the Pieter Lodewijk Takstraat 33/34 along the Amstel canal on the edge of Amsterdam-South and the Diamantbuurt. Both neighbourhoods are beautiful urban ensembles of Berlage with many Amsterdam School Architecture apartment buildings. The two schools were constructed between 1921 and 1924 and the municipality architect Arend Jan Westerman (1884-1966) designed both. The school has several statues by Hildo Krop outside and wall paintings inside by Peter Alma and Joop Sjollemma. The neighbourhood, buildings, and art all express the idea of *Gesamtkunst* and *Bildung* (*verheffing* in Dutch) for all users.^{14,15} In the beginning the vice principal of the school Joost Schoots was in doubt about renovation and preferred a new building at another location.¹⁶ After talks with the board of the school, the foundation ‘Esprit Scholen’ and the municipality of Amsterdam, Schoots was convinced that the school building and location were unique and that *Bildung* was a good argument for not moving away and respecting the existing structures. They decided that on the basis of pedagogic principle original qualities of the architecture of the buildings and art should be highlighted.

The old school was a corridor type building, long corridors lined with classrooms. This type of building has many possibilities to become very sustainable. A few years ago, the façades were renovated but inside it was outdated in many ways. It could not be adapted to the education vision and health was an issue. Architectural offices were asked to come up with some ideas and a tender was organised. In May 2016 PRO was invited for the tender by the foundation and a few months later selected. For every design phase there was a meeting with ICS, atelier PRO and the department of M&A from the municipality about the design, service systems, and materials. The walls of the buildings in circulation areas are plastered with pebbledash, which have been partially restored in the hall/staircase and in the corridor replaced by stucco. Wall tiles and terrazzo floors are being restored and after colour research and assessment, the original colours too. For example, the dark window frames in contrast to the light wall surfaces are brought back. Old Oregon pine and teak flooring (not original) in the classrooms removed to produce school furniture. The floor plan is changing to suit new education ideas. The circulation system in the central hall with its beautiful staircase split the building in left and right parts. On both sides of all the floors is a short corridor with classrooms on one side and small spaces (toilets) and rooms on the other. There are three staircases. A new elevator and three new shafts were created for all the new service systems. Separation walls between classrooms are being removed and replaced. The

old ones had about 48 square meters and the new ones have about 62 square meters in order to adapt to the new educational landscape and to accommodate 30 students per class. Furthermore, some windows were added between the classrooms and the corridor. The buildings will be delivered in 2023.
