Towards an International Levee Performance Database (ILPD) and Its Use for Macro-Scale Analysis of Levee Breaches and Failures

Ozer, Ece; van Damme, Myron; Jonkman, Sebastiaan N.

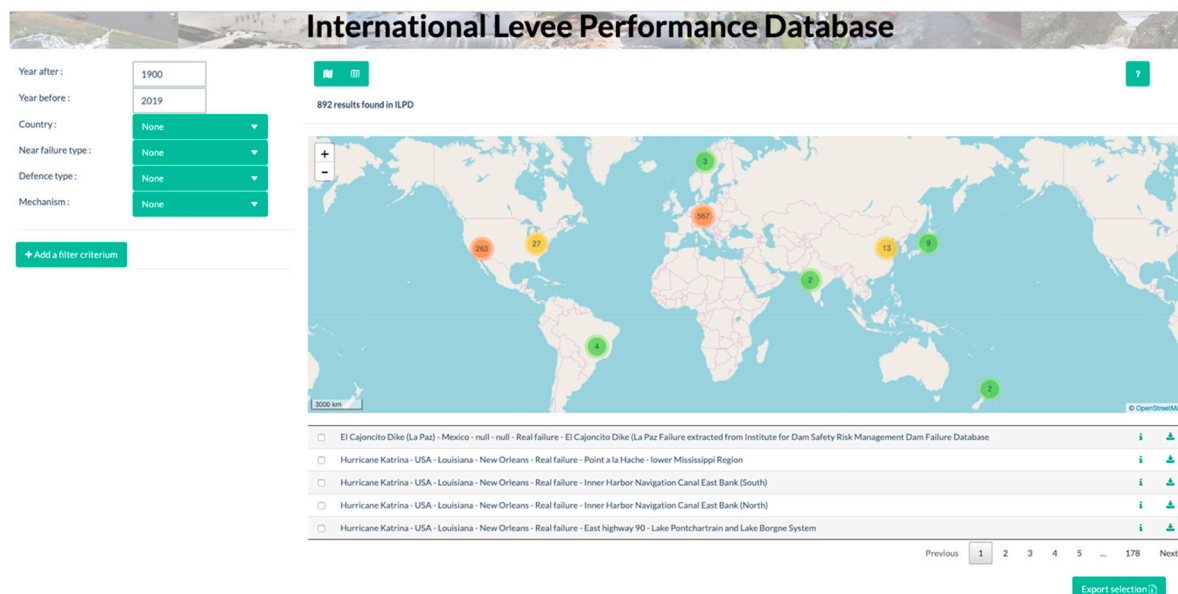
Figure 1. A screenshot of the opening page of the ILPD (leveefailures.tudelft.nl).

A screenshot of the opening page of the website is provided in Figure 1. The interactive map allows for navigation to all available failure cases. Each marker on the map represents the location of a failure case. Underneath, the cases pictured on the map are listed. When the case of interest is selected, basic information of the failure is presented and the media (if present) can be viewed. After selecting one or more cases, a click on the button 'Export selection' gives a pop-up window in which the type of data to be downloaded can be chosen. On the left side of the map, several filter criteria can be set. The database can be filtered based on time span, country, case study type, defence type or failure mechanism. Moreover, more filter criteria are available using the 'Add filter criterion' feature and a combination of different filter criteria can be made as well.

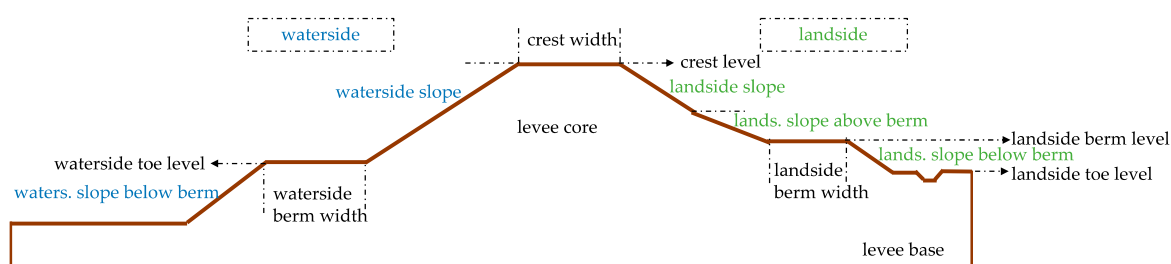
Figure 2. General levee cross section, showing the main elements of a levee included in the ILPD.

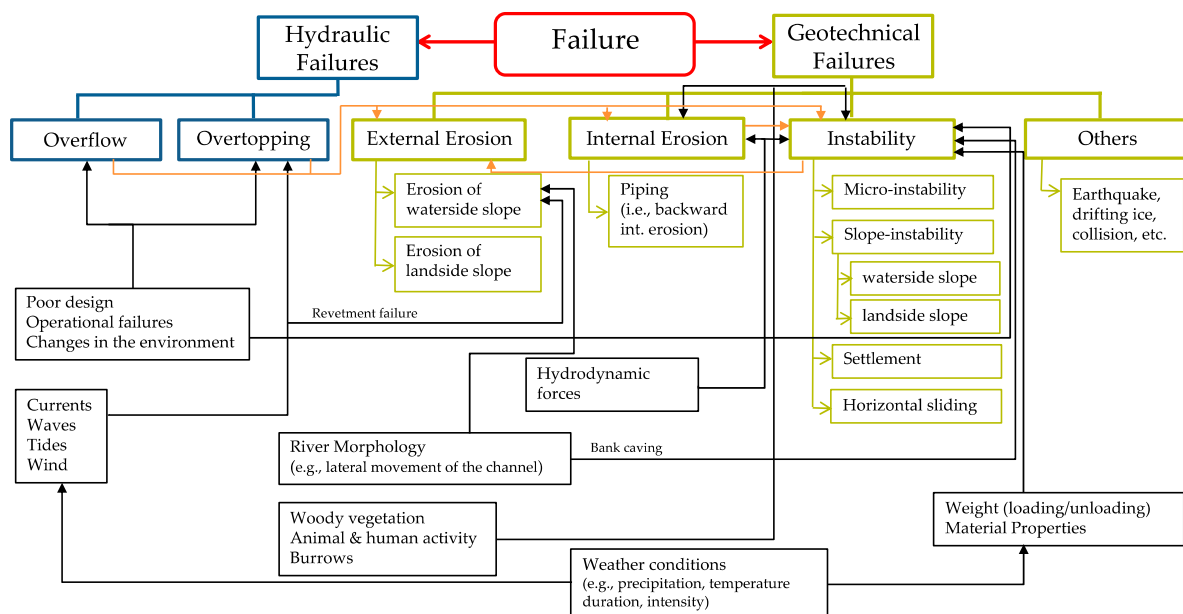
Figure 3. An overview of most relevant levee failure mechanisms and their most common contributing factors [9,31].

Levees can fail when their ultimate limit state is exceeded causing them no longer to fulfil their water retaining function [32]. The most commonly encountered levee failure mechanisms and their most common contributing factors are given in Figure 3 [31]. Hydraulic failures occur due to insufficient height, whereas insufficient strength leads to geotechnical failures [33]. Breaching of a levee refers to the loss of integrity or a major geometric change [32,34]. However, occurrence of a failure mechanism does not necessarily lead to a breach. For example, significant amount of overflow may cause severe floods without leading to a breach in the structure. Moreover, since the occurrence of the initial failure mechanism might trigger other mechanisms [33], a sequence of multiple failure mechanisms can be observed on the levee. For example, failures may be initiated with overtopping, followed by external erosion that causes a breach at the latter stage (Figure 3). All identified failure mechanisms are entered in the database in a chronological order.

- Overtopping and Overflow—Overflow occurs when still water level is higher than the crest level of the levee. Whereas, overtopping is observed when still water level remains below the crest level but waves run-up and pass the crest level.

- External erosion—External erosion occurs when the slope of the levee is not sufficiently resistant to the hydraulic loads, that is, when the shear stress induced by flows exceeds the critical value associated with the nature of the materials of the levee [31]. Currents and waves are the main aggravating factors of external erosion which can occur on the landside or waterside slope of the levee. Overtopping/overflow of a levee can induce major damages linked to external erosion, especially on the landside slope.

- Internal erosion—Internal erosion, which refers to a generic event, is initiated by hydrodynamic forces acting on soil particles within a levee foundation which are carried downstream by seepage flow [31]. In this process, migration of material particles induced by pore pressure and flow forms channels within the foundation soils. These pipes undermine the structure of the levee and lead to failure. Internal erosion related failure mechanisms consist of—concentrated leaks, backward erosion, contact erosion and suffusion [36]. Backward erosion, known as piping, is typically most relevant for levees. It occurs if uplift, seepage, heave and piping occur respectively. Seepage also

- Slope instability (i.e., instability)—Instability occurs when the forces (i.e., excess pore pressure) on a levee are higher than the shear resistance which is determined by the soil's shear strength. Landside slope instability occurs due to the infiltration of water into the levee body and its foundation, leading to forcing of the levee body and decreasing shear strength of the soil. Whereas, waterside slope instability occurs due to sudden drawdown of the outside water level after heavy saturation of the levee body. In this situation, the pore pressures at the base of the potential slide plane stay high, while the horizontal pressure or support from the river water is reduced.

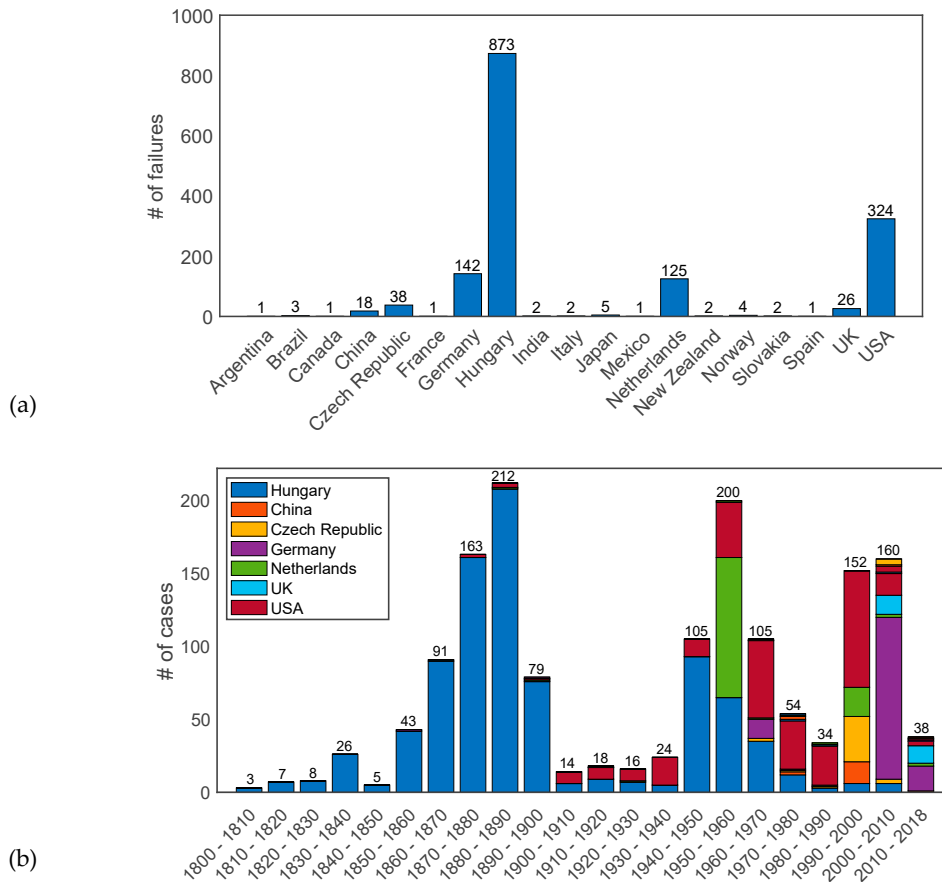
Figure 4. Statistics on the failures (a) per country, (b) per time period entered in ILPD.

A large number of failure cases are collected all around the world and their basic statistics are reported in this section to provide an overview of the characteristics of the database. Currently (October 2019), the ILPD includes 1572 failure cases of which 1538 are the failures of flood defences occurred in different time periods and 34 of them are full- and small-scale experiments collected from different countries (Figure 4a). The available information mainly concerns the failures of levees (1418 cases) and levee structure combinations (14 cases) occurred along rivers (89%), coasts (10%) and canals (1%) but also of some earthen dams (106 cases) due to their similar composition to levees. The majority of the levee failures before 1900s mostly occurred in the Carpathian Basin in Hungary, as reported by [25,37] but these only contain generic information. The other cases reported in the ILPD, occurred in the last 100 years, are mostly from Germany, The Netherlands, USA, UK and Czech Republic (Figure 4b). It is noted (and further discussed in Section 4) that the geographical and temporal distributions shown in Figure 4 only represent the data currently included in the database.

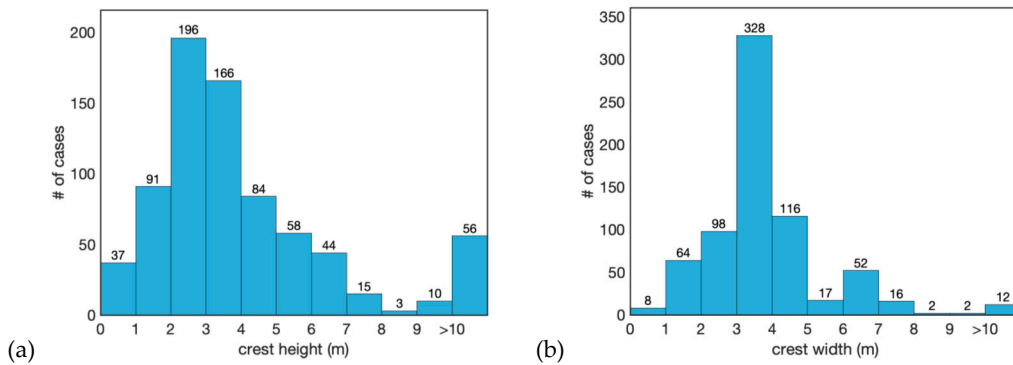
Figure 5. Statistics of the levee information (a) crest height, (b) crest width (m) per number of cases.

Most failure entries in the database contain general information (Level.1: 1498 cases), such as levee and breach characteristics. As an example, Figure 5 shows that the crest height of the failed levees, which is defined as the differences between the toe level and the crest level, varies mostly between 1–5 m, whereas the crest width is in the range of 2–5 m. The database also includes more detailed information on the Level.2 (59 cases) and the Level.3 (14 cases) data.

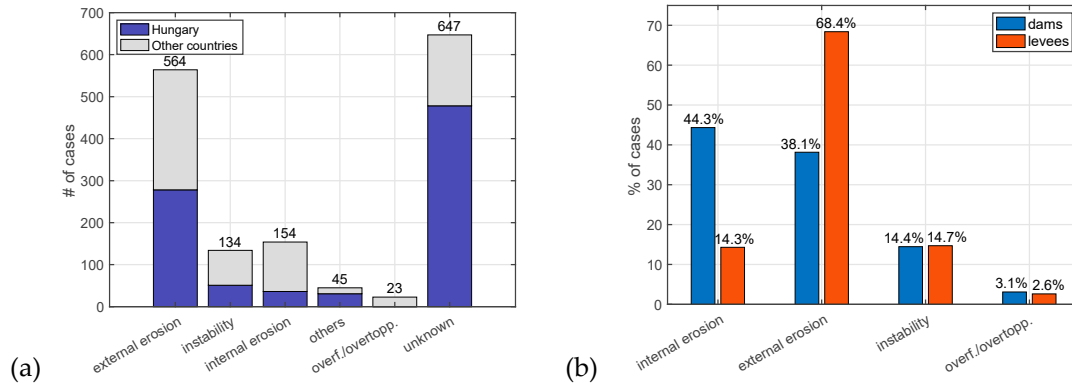
Figure 6. Statistics on (a) the observed failure mechanisms in ILPD (b) a comparison between earthen dams and levees for the most common failure mechanisms.

Analysis of the identified failure mechanisms within the collected cases in the database (Figure 6a) shows that more than half of the failures, of which their causes are known, occurred due to external erosion (61.5%), internal erosion (16.8%), instability (14.2%), overflow/overtopping (2.5%). Besides, the rest of the failures were due to other causes (4.7%), including man-made failures. It is noted that excluding the Hungary dataset [25], which forms the majority of the database, does not significantly affect this distribution (Figure 6a).

A comparison between observed failure mechanisms for levees and earthen dams (Figure 6b) reveals that external erosion of the slope is more likely to occur in levees. This can be explained by the fact that water level and discharge in rivers, as well as currents and waves in seas, are mostly affected by meteorological and hydrological conditions which are more uncertain than for dams. Whereas,

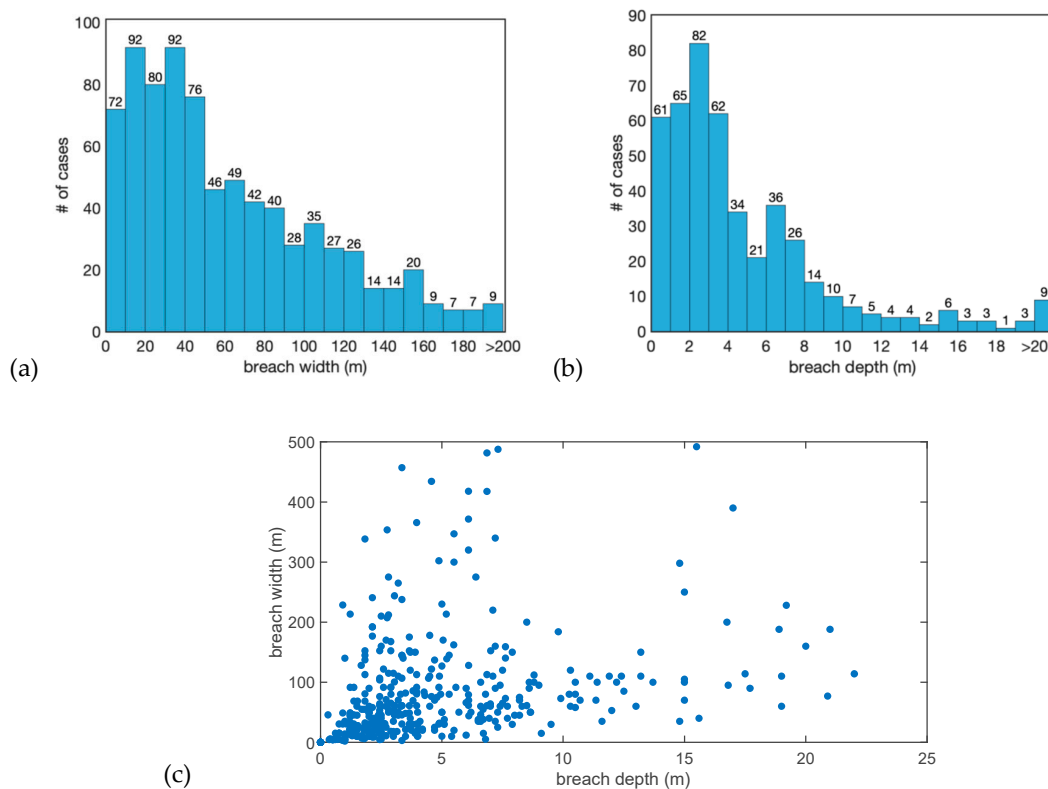
Figure 7. Statistics on (a) breach depth (450 cases), (b) breach width (785 cases) and (c) breach depth vs. width for (402 cases, Pearson coefficient, $r = 0.164$).

Levee breaching was observed for most of the failure cases that are entered in ILPD. Failures that did not lead to a breach at the later stage were mostly due to overflow/overtopping (23 cases). Information on the breach characteristics, given in Figure 7, shows that there is a considerable variation in breach depth and width values. Previous studies on breach models reveal that, under certain conditions, breach depth and width are correlated during some of the breach development stages [26,38]. However, breaching is a complex process that depends on many different factors (e.g., structure type, loading conditions, soil characteristics, etc.), thus the relation between breach depth and width may not always be explained by a simple relation model (Figure 7c).

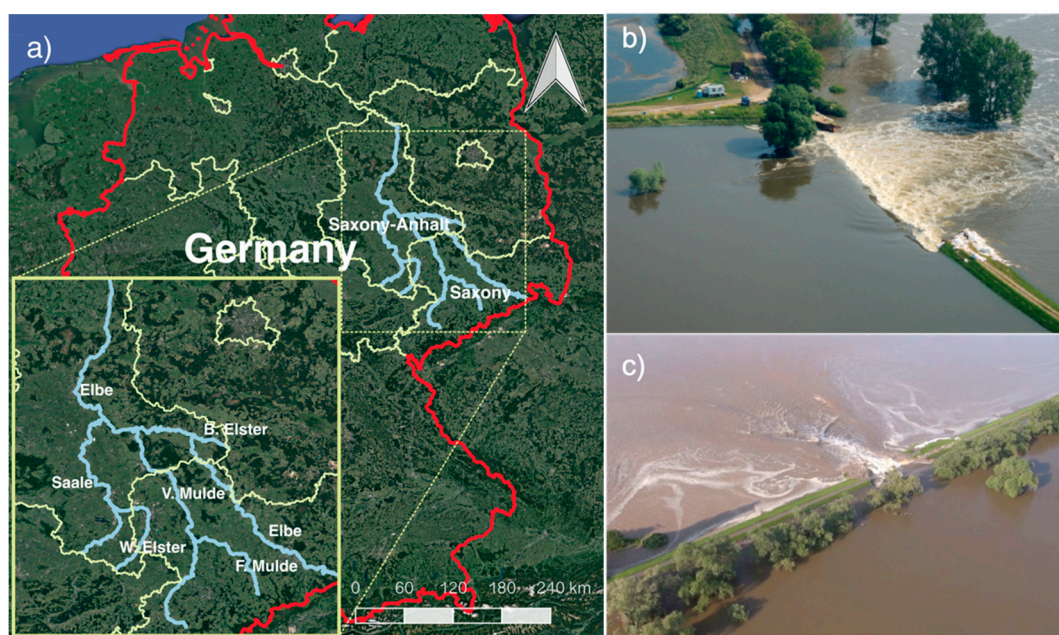
Figure 8. (a) Investigated rivers along the Elbe tributaries in Germany, which flooded in 2002 and 2013, (b) Fischbeck, 2013 (source: [42]), (c) Breitenhagen, 2013 (source: [43]).

and Fischbeck (Figure 8b,c). The first failure near Breitenhagen occurred due to instability of the landside slope which later resulted in a 150 m wide breach and inundated an area of 80 km² [44]. Simultaneously, the second failure near Fischbeck initiated with large cracks followed by settlement of the landside slope, resulting in a 100 m wide breach within hours. The main failure type is recorded as instability induced by internal erosion.

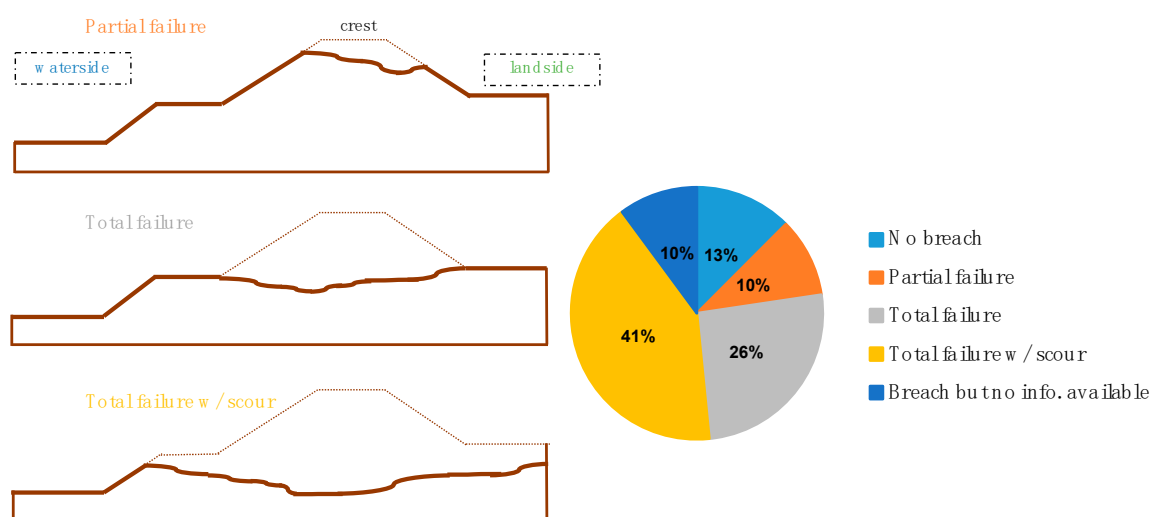
Figure 9. Damage degrees of the failed levees in Elbe region, Germany, 2002 and 2013 (adapted from [23]).

After these events, data was collected on levee failure cases, including location, geometry, levee structure, subsoil structure, vegetation, breach geometry and failure time. According to post-investigations [23,47], different degrees of damage have been observed on the levees. Based on the change in levee cross section, the breaches occurred in 2002 and 2013 are classified into three groups (Figure 9) as (a) partial failure (10%), where the breach depth was less than the crest height; (b) total failure (26%), when the crest was completely washed away; and (c) total failure with scour (41%), when, in addition to the crest, the soil beneath the toe level was also eroded. In most of the cases, the causes of levee failures were attributed to a combination of loads and local conditions (e.g., old breaches, tree roots, poor maintenance) [23].

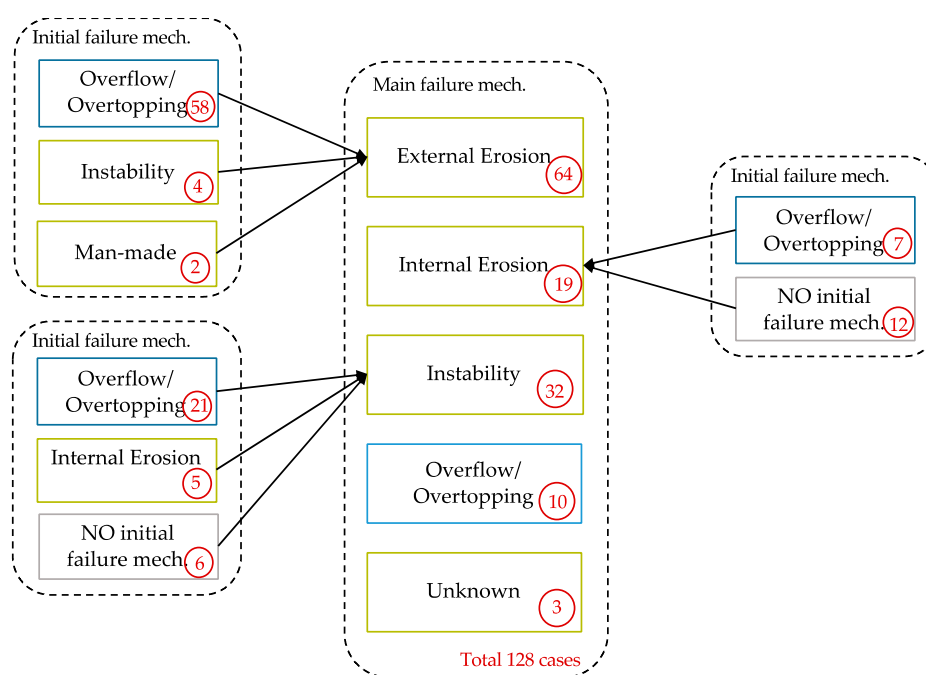
**Figure 10.** Initial and main failure mechanisms of the failed levees in the Elbe region, Germany, occurred in 2002 and 2013.

During the progress of these failures, multiple failure mechanisms were observed. In Figure 10, the occurrences of the different main failure mechanisms are associated with the initial mechanisms that have triggered them. Failure initiation mechanisms were mostly overtopping which was later followed by external erosion (58 cases), instability (21 cases) and internal erosion (7 cases). At some locations, overflow/overtopping (10 cases) occurred but did not lead to a levee breach. For example, four different levee breaches during the 2002 event have initiated with an instability of the landside slope which slipped away partially and the remaining part continued to be eroded gradually by overflowing water (external erosion).

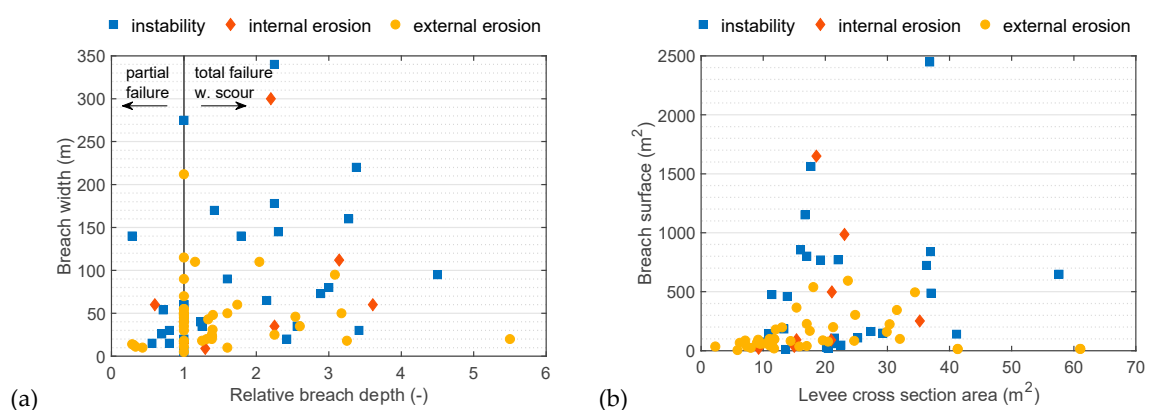
Figure 11. Relation between (a) relative breach depth and breach width per failure mechanism; (b) breach surface and geometry of the levees per failure mechanism.

In order to further analyse the breach characteristics of the failures, the relation between breach parameters and failure mechanisms is assessed. First, the ratios between breach depth and crest level (i.e., relative breach depth) are compared with the breach width per main failure mechanisms (Figure 11a). It can be observed that, by normalizing the breach depth (as breach depth/crest level), the breach width is also larger for the failures with total scour. Moreover, the main failure mechanisms of most of the large breaches are observed as instability or internal erosion. Second, a comparison between breach surface (as breach depth \times breach width) and geometry of the levees (i.e., cross section area) is given in Figure 11b per failure mechanisms. The levee surface could affect the breaching in different ways. A larger levee is associated with a larger hydraulic head (more forcing) but would also require more erosion during breaching (more resistance). Figure 11b shows that levees with large cross sections tend to have larger breach surfaces. Furthermore, the failures with large breaches ($>500 \text{ m}^2$) are due to instability, with only a few failures caused by internal erosion. Variations in breach surface for similar levee geometry might be explained by the differences in hydraulic head conditions. Moreover, recent studies show that even if the hydraulic load is the same, the duration of the load is also an important parameter in development of breach surfaces [54].

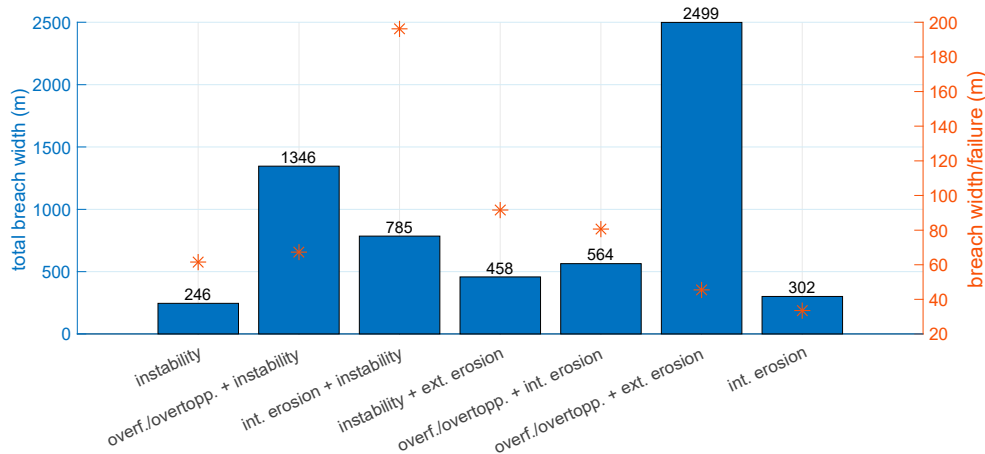
Figure 12. Breach width analysis per failure mechanism occurred during the flooding event in Germany, 2002 and 2013.

The understanding of failure patterns could be further deepened by checking how the failure initiated. Thus, the following analysis of the levee failures considers both their initial and main mechanisms. In Figure 12, the total and average breach width per failure mechanisms are compared.

For instance, it can be seen that, if an external erosion case is initiated by instability, it is more likely to have a wider breach per failure than for an external erosion case that is triggered by overflow/overtopping. This can be explained as follows. When an instability occurs, most of the times a relatively large part of the crest is pushed away by internal forces with the following sequence of external erosion making the damage larger. Whereas, if the failure starts with overflow/overtopping which by time erodes the crest externally (external erosion), the levee is most likely to have smaller damages compared to the previous case. Another interesting observation is that some types of failure occur more often (e.g., external erosion triggered by overflow/overtopping) but with a relatively smaller average breach width per failure (i.e., smaller damage).

It is also noticed in Figure 12 that when an instability failure mechanism is initiated by internal erosion (e.g., piping), it is more likely to have wider breaches, whereas if it is initiated by overflow/overtopping, the size of the breach is smaller than the previous case but still larger than an instability failure without any initial mechanism. Figure 13 gives a schematization of these three cases. This trend can be explained by the fact that internal erosion, occurring directly in the subsoil, creates an extra hydraulic pressure below the crest. By time, the piping disconnects the upper part of the levee from its foundation, undermining the stability of a large section of the levee. In general, this analysis shows that the underlying failure mechanisms are of importance in the breach development.

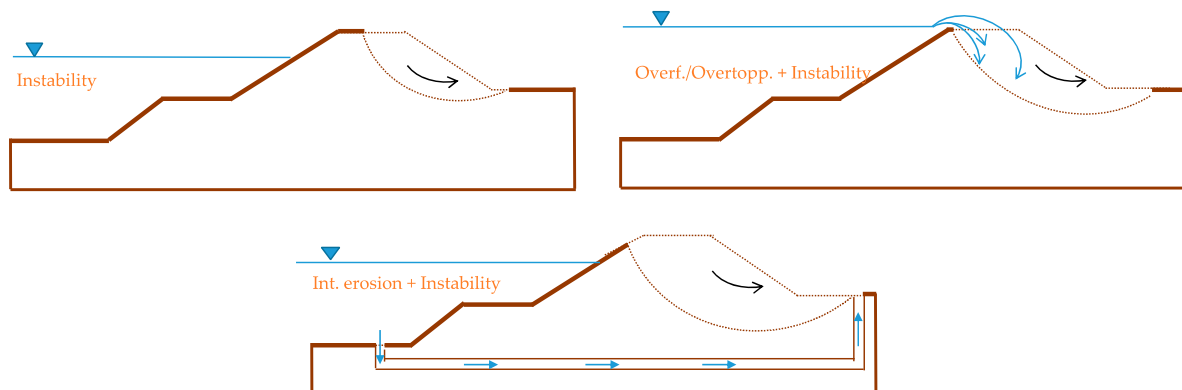
Figure 13. A schematization of an instability failure with three possible initiation mechanisms.

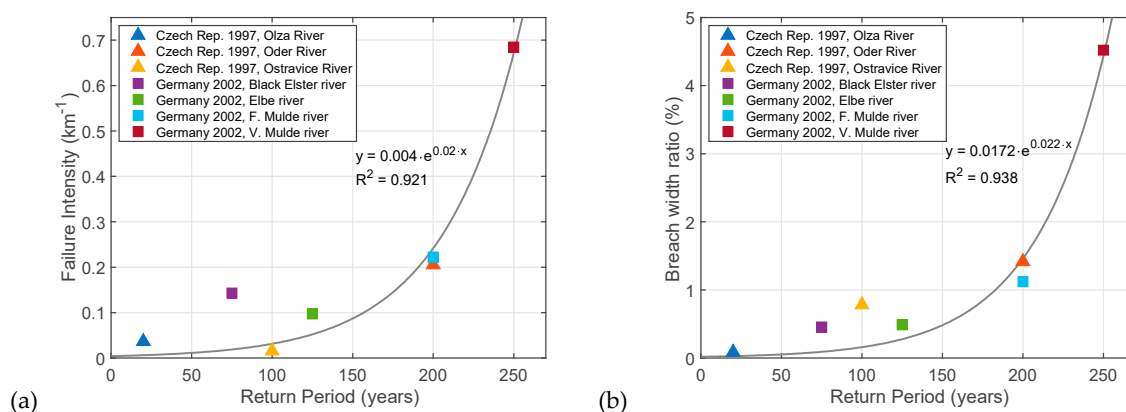
Figure 14. (a) Failure intensity (km^{-1}) and (b) Breach width ratio (-) along the rivers investigated during Germany, 2002 and Czech Republic, 1997 events.

The calculated parameters for the 1997 and 2002 events range between 0.02 and 0.68 km^{-1} for the failure intensity and between 0.08% and 4.5% for the breach width ratio, as shown in Figure 14. For the 2013 event, the values of the calculated breach width ratio (between 0.1%–0.4%) and failure intensity (between 0.03–0.1 km^{-1}) are smaller than for the 2002 event, which can be explained by the strengthening of the levees after 2002, as explained in Section 3.2. However, although the conditions during the 2013 event was more severe, return periods found in the literature were either assessed with smaller values than for the 2002 event [58] or defined too general, that is “>100 years” [59,60]. Thus, the values for the 2013 event were not included in the rest of the analysis.

Considering the events of Germany 2002 and Czech Republic, it is noticed that when the return period (T) increases, the failure intensity and the breach width ratio also increase. For the seven rivers considered, a non-linear regression analysis using an exponential fitting function has been performed on the available data for both breach density parameters (trust-region optimization algorithm available in the MATLAB *fit* function). The resulting functional relations and the corresponding R^2 values

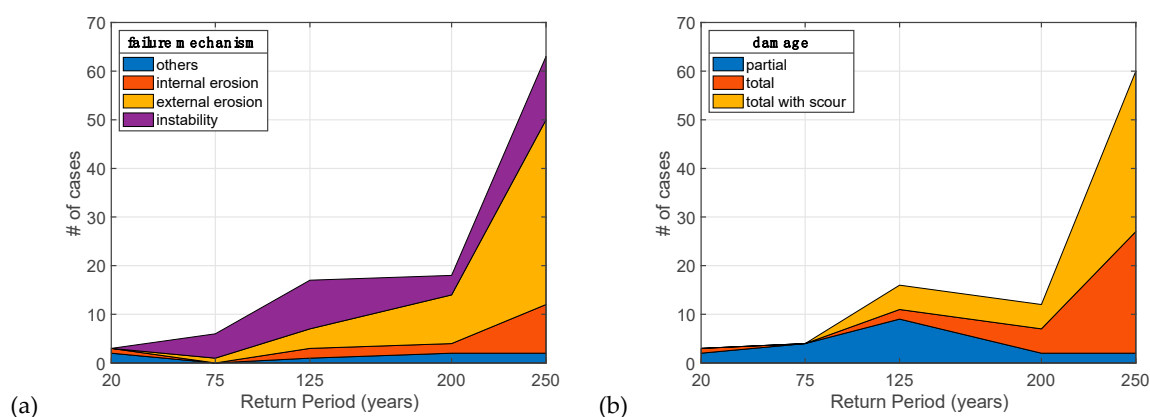
Figure 15. Distribution of (a) failure mechanisms and (b) degree of damage for different return periods (T) along the rivers investigated during Germany, 2002 and Czech Republic, 1997 events.

For the same events investigated above, we also explore the occurrences of different failure mechanisms and the degree of damage for different return periods (Figure 15a). In general, the total number of failures increases with the change in the return period. However, as it is given the Figure, external erosion is more likely to occur for high return periods. This can be explained by the fact that a high return period is related to high water levels and river discharges, which in turn leads to overtopping/overflow followed by an external erosion. Moreover, it is shown in Figure 15b that higher return periods lead to larger degrees of damage on the levees.
