4th International Conference on Service Life Design for Infrastructures

# A METHOD FOR DETERMINING THE REMAINING TIME TO CHLORIDE INDUCED CORROSION INITIATION OF EXISTING CONCRETE STRUCTURES

**Keywords:** service life; reinforcement corrosion; existing structures; reliability; asset management

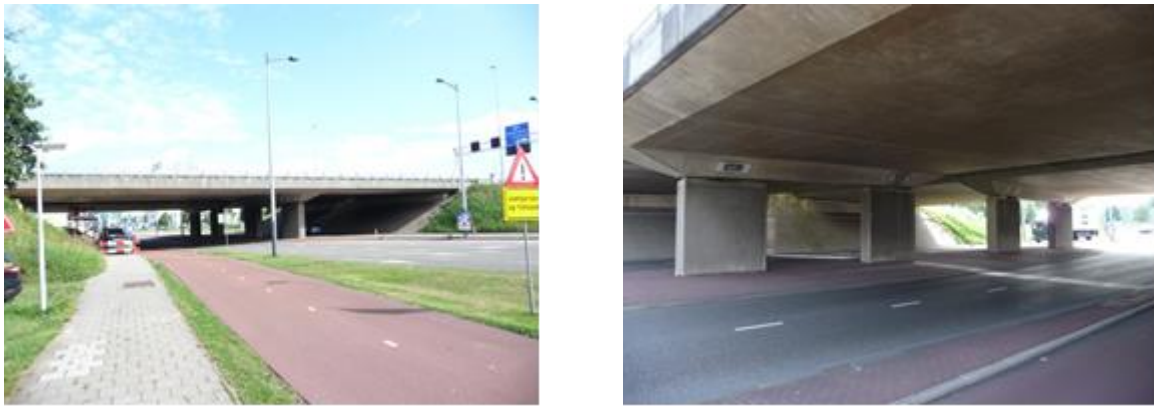
Figure 1 Side view (left) of investigated bridge and columns supporting the decks (right)

The structure (KW15) consists of a northern and a southern bridge. The decks consist of one post-tensioned concrete slab each with a total length of 45 m in two spans. Each deck is supported by two abutments and two piers with two columns each, see Figures 1 and 2.

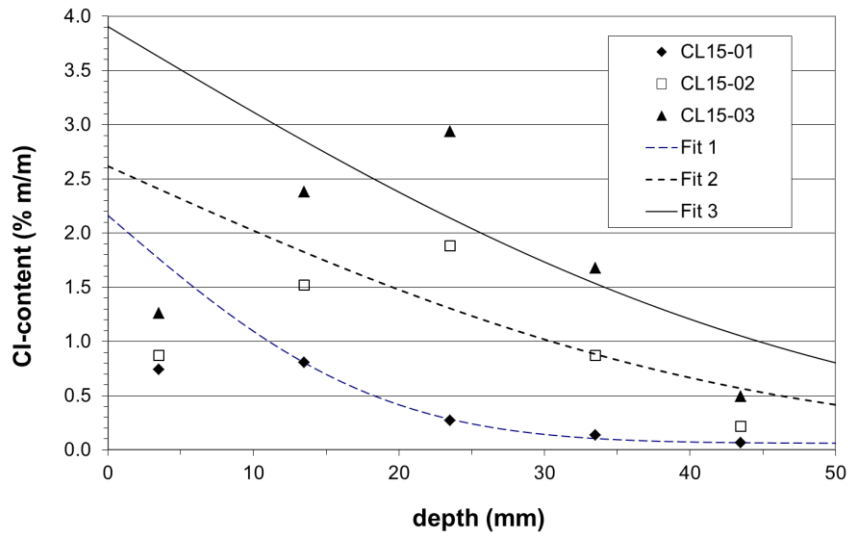
Figure 2 Measured chloride profiles (symbols) and best fits (curves), Northern abutment

Cores for chloride profiles were drilled from the front vertical side of the abutments and from the top side of the bridge decks (through the asphalt). The decks have a slight inclination for water discharge and the cores were drilled at the low side. Examples of the obtained chloride profiles and fitted curves are shown in Figures 2 and 3. The complete chloride profiles from the top of the deck could be well described by the diffusion equation. In the profiles of the abutments the first one or two points needed to be discarded in the fit.

The  $t_R$  values from the bridge decks are all  $>30$  years except one. The  $t_R$  values from the abutments are much lower and even negative for four cores from the northern viaduct. The  $t_m$  values are also negative in these cases. This implies that corrosion should have been initiated in the past. Nevertheless, damage by corrosion has not (yet) been observed. Possibly, the critical chloride content is higher than 0.50% for this concrete, or this is due to the relatively poor fit of the profiles (Figure 2 left), or it is related to the relatively high carbonation depths (see below).

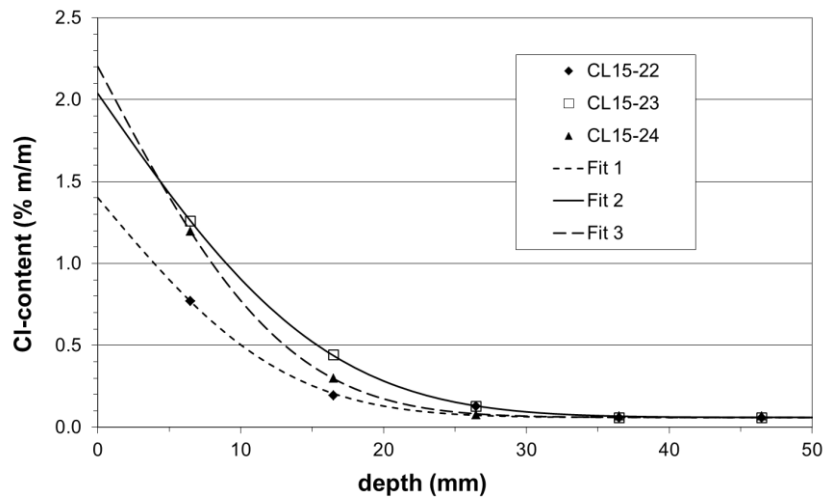
Figure 3 Measured chloride profiles (symbols) and best fits (curves), top side of deck
