**Investigation of compression after impact failure in carbon fiber reinforced polymers using acoustic emission**

Biagini, Davide; Pascoe, John Alan; Alderliesten, René

Journal of Composite Materials

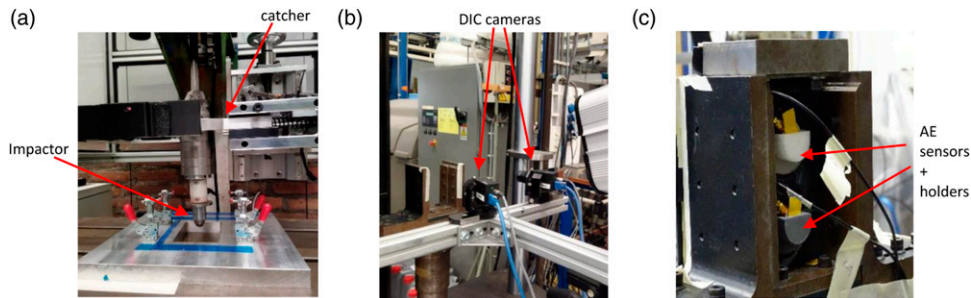
**Figure 1.** (a) Impact test setup with catcher to avoid bounce-back of the impactor; (b) ‘Front’ view showing two DIC cameras pointed at the CAI setup; (c) ‘Back-side’ view of the CAI setup with the two AE sensors positioned inside their holders.

Impact testing was conducted using a drop-weight tower according to ASTM D7136.<sup>22</sup> The test set up is shown in Figure 1(a). The support fixture has a cut-out of  $125 \pm 1$  mm in the length direction and  $75 \pm 1$  mm in the width direction. To prevent the occurrence of multiple impacts, the impact tower was equipped with a catcher triggered by optical sensors. A hemi-spherical impactor with a diameter of 16 mm and a mass of 4.8 kg was used. A target impact energy of 34 J was used in all the impacts. This condition can be classified as LVI and produced a dent depth  $< 2$  mm (BVID). After the impact, the size of delamination was measured by ultrasound inspection.

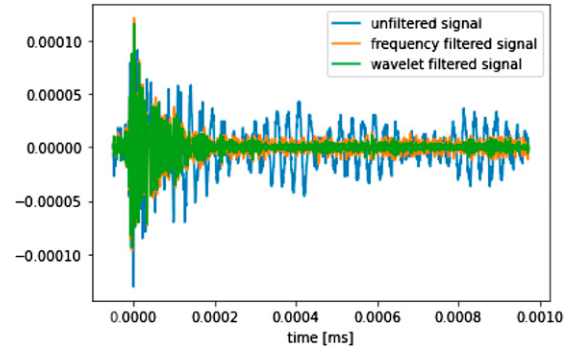
Figure 2. Comparison of different filtering strategies.

Considering the above, a filtering strategy composed of three stages was adopted. First, a maximum amplitude threshold for the acquisition was set to 45 dB. This threshold was selected due to a relatively high noise level during the test. It must be considered however that adopting a 45 dB filter could cut out some micro cracking events, which could affect the reported repartition between damage modes. The analysis of the waveforms recorded with this setting, revealed a low frequency (60 kHz) continuous-type signal (Figure 2), which we associated with friction. Considering this, a high pass filter allowing only frequencies >70 kHz was applied. Then, a four level discrete wavelet packet filter was applied using Daubechies 32 wavelets, setting a hard threshold at 10% of the maximum coefficient. As can be seen in Figure 2, thanks to the application of the two consecutive filters, it was possible to effectively remove acoustic energy that was not related to damage from the recorded signals.

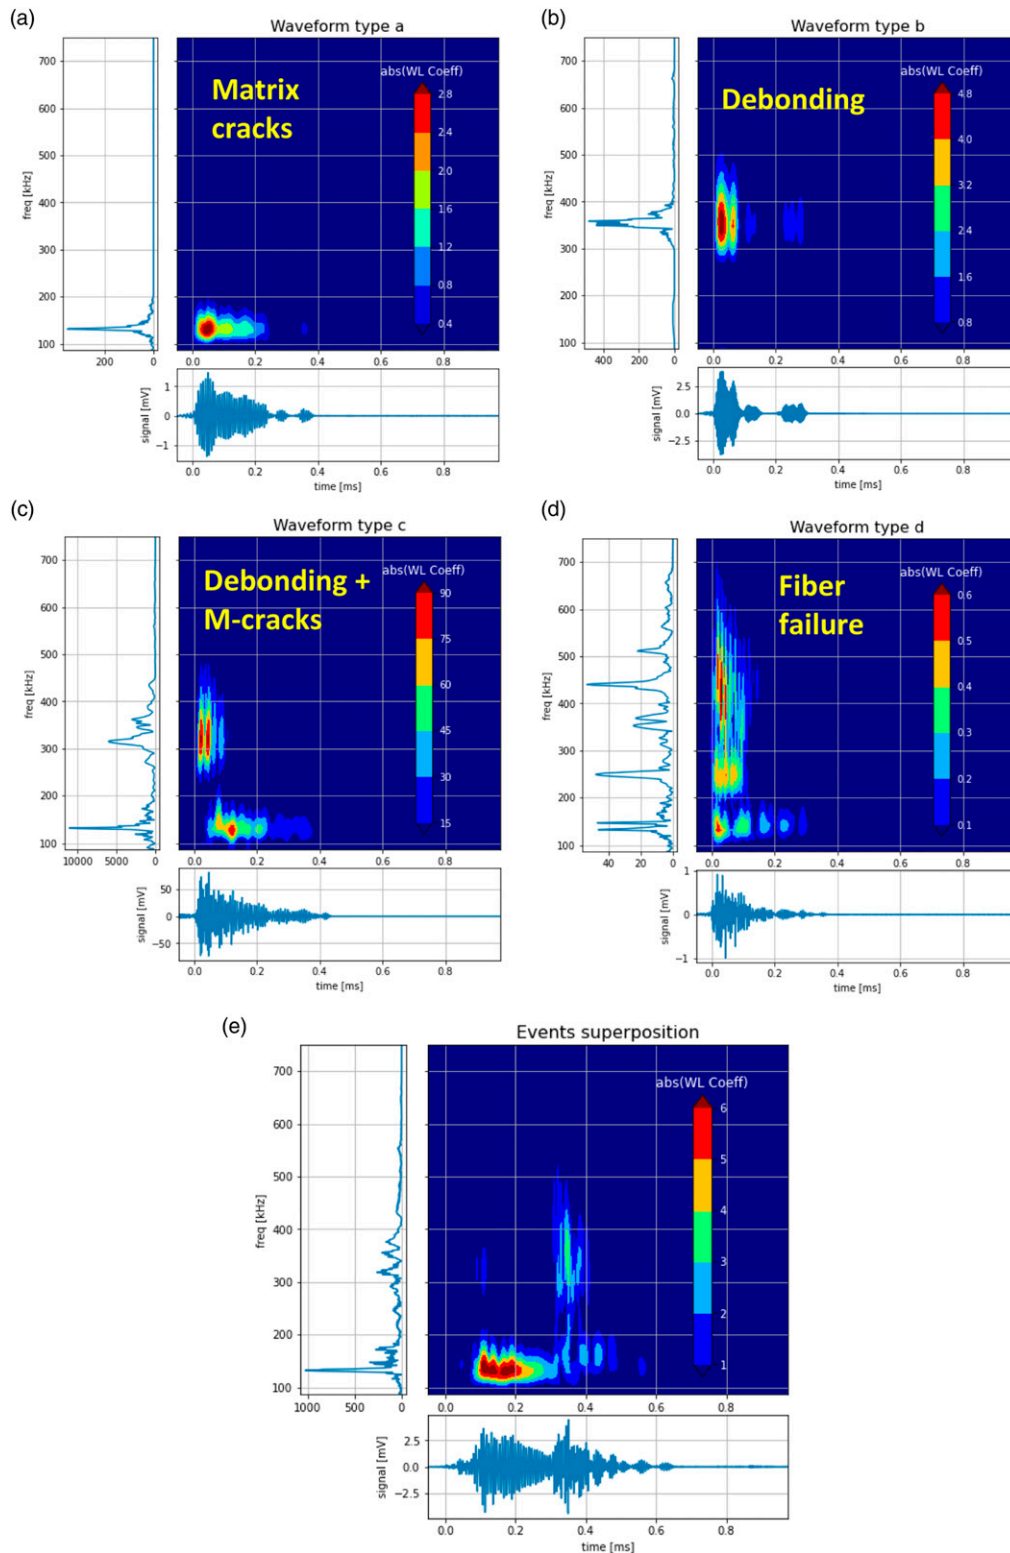
**Figure 3.** Continuum wavelet transforms of different types of waveforms ((a)-(b)-(c)-(d)) and an example of event superposition in CAI failure (e). In the colour plots, absolute value of continuous Morlet WL coefficients are plotted in time–frequency scale. Horizontal sub-plots are the original signals aligned in the time domain. Vertical sub-plots are the Fourier spectrum of the signals aligned in frequency domain.

- Type a) is characterized by low frequency (100–200 kHz) and long duration. It was present in tests [0], [90] and Teflon, but was predominant in [90] test. For this reason we associated this waveform with pure matrix cracking. A different tensile campaign also associated matrix cracking with low frequency events,<sup>26</sup> and numerical modeling of AE sources<sup>12</sup> confirms this assumption.

- Type c) appears to be a combination of waveform type a and b. It was the predominant signal in [0] test and Teflon-test, especially close to final failure, and less frequent in [90] test.

- Type d) spectrum is characterized by several local peaks, some of them at high frequencies (450–600 kHz). This waveform was totally absent in the [90] test. In [0] test and Teflon-test, it appeared only at relatively high stress. Considering this, we associated waveform type-d with fiber failure. A previous tensile campaign associated fiber failure with high frequency events,<sup>26</sup> and numerical modeling of AE source<sup>12</sup> seems to confirm this assumption.

There was good agreement between the damage modes identified in the preliminary tests and those observed in the CAI tests. In Figure 3(e) a typical signal recorded close to CAI failure is shown. It is evident that in this case, multiple burst-signals are reaching the sensor almost simultaneously. Unsupervised clustering and supervised classification of acoustic events are based on the assumption that each waveform represents a single damage mode. Figure 3(e) shows that this assumption does not hold close to final CAI failure. This makes both unsupervised clustering and supervised classification of damage modes unsuitable for separating different damage modes close to failure, which is the region we were most interested in investigating.

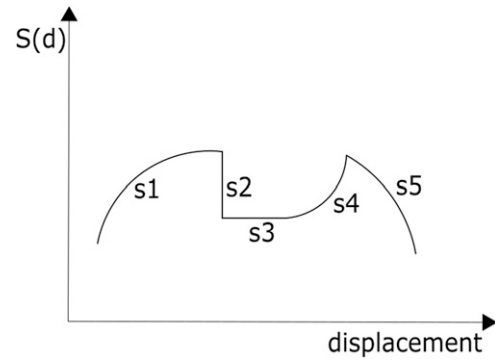
**Figure 4.** Sentry function/displacement plot. The possible trends that can be found in actual test are shown.

As the applied compression displacement increases linearly, different trends can be expected in the sentry function (Figure 4): *increasing trend* (s1) corresponds to a strain energy storing phase where mostly micro-damage is formed, this means that the capability to store strain energy is higher than the acoustic activity; *sudden drop* (s2) corresponds to a fast release of acoustic energy and possibly a drop in stiffness, this was associated with coalescence of micro damage leading to macro damage<sup>19</sup>; *constant trend* (s3) is a state of equilibrium between the storage of mechanical energy and the AEs activity; *increasing after drop* (s4) suggests that the previous event didn't cancel the capability of the material to store mechanical energy; *decreasing trend* (s5) the capability to store strain energy is now less than the acoustic activity. It is important to remark that the sentry function depends both on acoustic activity and mechanical energy. For example a sudden drop (s2) could be due to an increased acoustic activity and/or a stiffness drop.

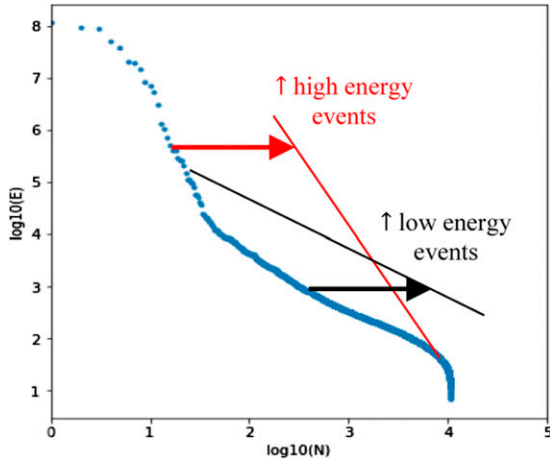
**Figure 5.** AE event occurrence versus event energy plot. In red a relative increase of high energy events is represented while in black a relative increase of low energy events is represented.

Where  $N_{\bar{E}}$  is the number of events with energy  $\leq \bar{E}$  and  $\bar{E}$  is the acoustic signal energy value. As in case of seismic events, in a log-log scale a linear relationship well fits the results for AE data. The value of the slope  $b$  can be seen as an indication of how frequent high energy acoustic events are compared to low energy events (Figure 5). As the compression displacement is increased during the test, an increasing number of AE hits are recorded and different trends can be expected in the b value (Figure 6). In case of *decreasing trend* (b1) AE activity has the form of accumulation of a large number of low energy events. In case of

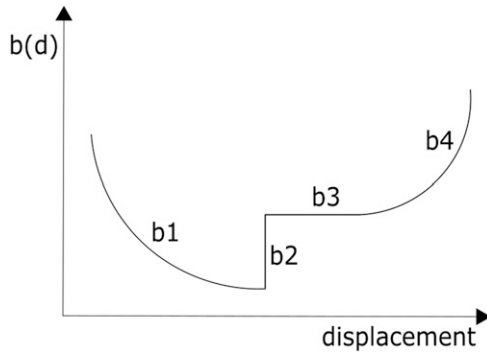
**Figure 6.** b-value/displacement plot. The possible trends that can be found in actual test are shown.

a *sudden increment* (b2) there is a fast release of great amount of acoustic energy in the form of high energy hits. If a *constant trend* (b3) is observed as acoustic activity continues, an equilibrium is present between the occurrence of high energy hits and of low energy hits. Finally, a *gradual increasing trend* (b4), suggests an AE activity gradually shifting towards high energy events. It is important to remark that the b value is a ‘cumulative’ quantity, which takes into account all the previous acoustic events and that the relationship is expressed in a log scale. A constant value of b does *not* mean that high and low energy events are added at the same rate. It means that new events occur following the frequency of occurrence that characterized the test until that point.

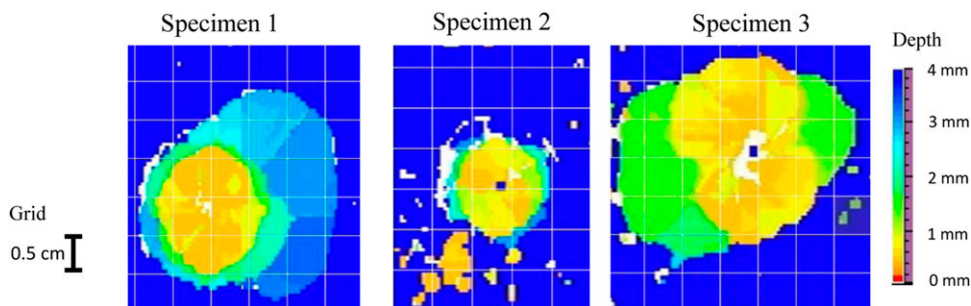
**Figure 7.** Close up C-scan images of the impacted specimens, showing multiple delaminations at different depths. The images are cropped to show the full delamination; the impact contact point was always in the centre of the specimen, in accordance with ASTM D7136.

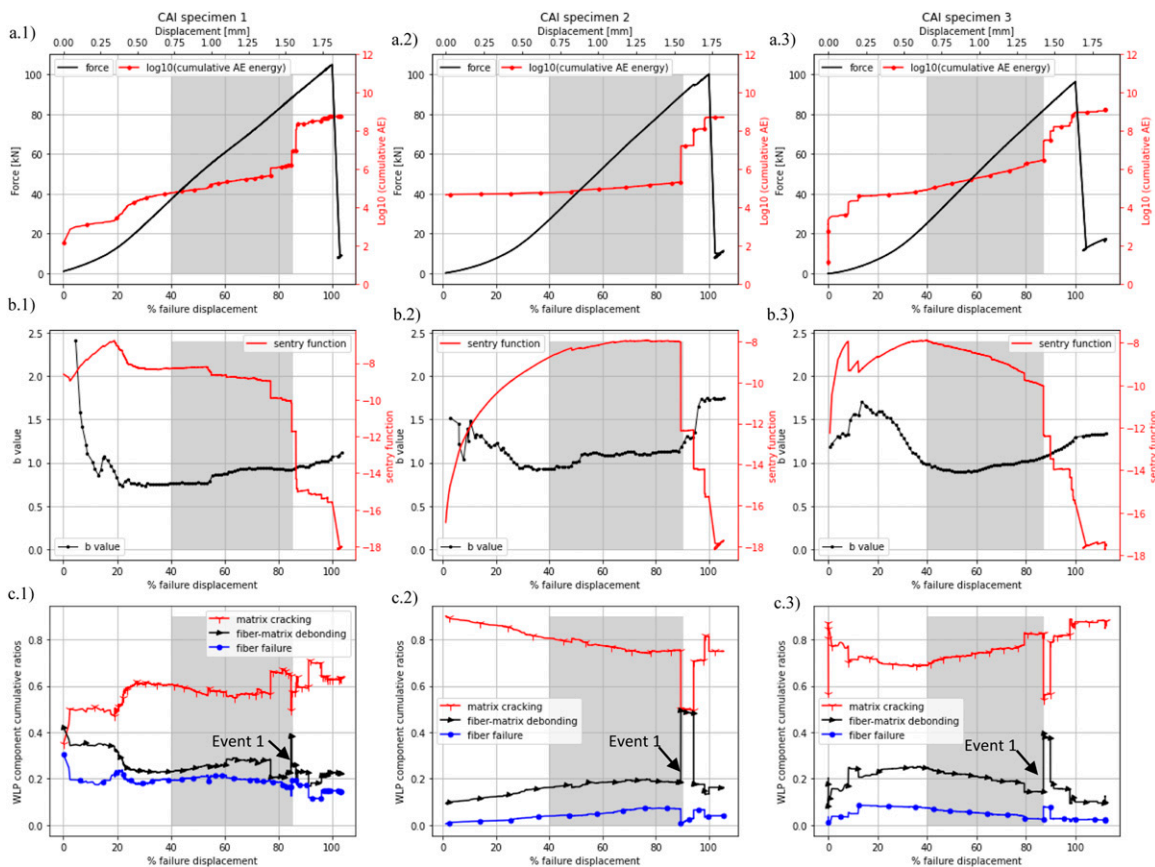
**Figure 8.** CAI tests of specimens 1-2-3. Images (a1)-(a2)-(a3) show the load displacement curve and the  $\log_{10}$  of cumulative acoustic energy. Images (b1)-(b2)-(b3) show the sentry function and b-value. Images (c1)-(c2)-(c3) show damage modes repartition. The grey area indicates the stable damage accumulation zone.

There is good agreement in load displacement curves between the three CAI tests (Figures 8(a1)–(a3)). The specimens showed a constant stiffness until final failure. Only in specimen two, a small drop in force is observed before failure.

Acoustic energy (measured in attoJoule) was released from the beginning of the test (Figures 8(a1)–(a3)). This early release of acoustic energy can be explained by the presence of a large impact damage, causing high local stress at the geometrical discontinuities, even at relatively low applied stress. In all three specimens there is a phase of steady accumulation of damage, where the cumulative AE energy appears to be linear in the logarithmic scale. After that, all tests show a sudden increase of cumulative AE energy, starting after 80% of CAI failure displacement, suggesting that an unstable mechanism could be triggering the increase of acoustic energy released (Figures 8(a1)–(a3)). It is noteworthy that this event was not accompanied by a noticeable drop of stiffness in any of the specimens.

**Damage stabilization.** In all the specimens, a first phase of increase of Sentry function is observed (Figures 8(b1)–

(b3)). This can be attributed to a phase of strain energy storing and relatively low acoustic activity. Although damage is accumulated, as proven by the cumulative acoustic energy (Figures 8(a1)–(a3)), it does not degrade the capability to store mechanical energy, since no change in the global stiffness is observed. During this phase a decrease of the b-value is observed (Figures 8(b1)–(b3)). This suggests that mostly micro-damage is propagating during this phase, since AE energy is released in the form of many low energy events. During this phase, damage mode fractions are chaotic and there is no good agreement between the different specimens (Figures 8(c1)–(c3)). To explain this, it must be considered that wavelet ratios are cumulative quantities (equations (4) and (5)). A single fiber fracture happening at the beginning of the test, has more effect on the wavelet cumulative ratios compared to the same event happening at the end of the test. At the beginning of the test, all damage modes can potentially happen in weak areas of impact damage. Due to the stochastic nature of initial impact damage, no good agreement is found between the different tests. However, as the test goes on, the results converge towards a similar repartition between damage modes in different specimens.

During this phase, no drops are observed in the load displacement curve, suggesting that the material is still efficiently storing strain energy. An overall increase of the acoustic activity is observed during this phase and cumulative acoustic energy has a linear trend in the logarithmic plot (Figures 8(a1)–(a3) grey area).

In all the specimens a constant trend is observed in the b-value (Figures 8(b1)–(b3)). This means that the relative frequency of occurrence of the high energy peaks and low energy peaks does not change during the test as acoustic energy is progressively released.

The damage modes repartition evaluated with cumulative ratios of wavelet packet components, remains stable and assumes similar values in the different tests (Figures 8(c1)–(c3)). It can be observed that during this phase matrix cracking is the predominant damage mode but debonding is still not negligible in terms of energy dissipation.

*Unstable damage accumulation.* In all the specimens, the end of the stable damage accumulation is determined by a significant and sudden increase of the released acoustic energy (Figures 8(a1)–(a3)). It is interesting to observe how

During this phase an increase in b value is observed in all the specimens, meaning that new hits come in the form of relatively high energy events (Figures 8(b1)–(b3)). This indicates that larger scale damage is now formed, compared to the previous phase of the tests.

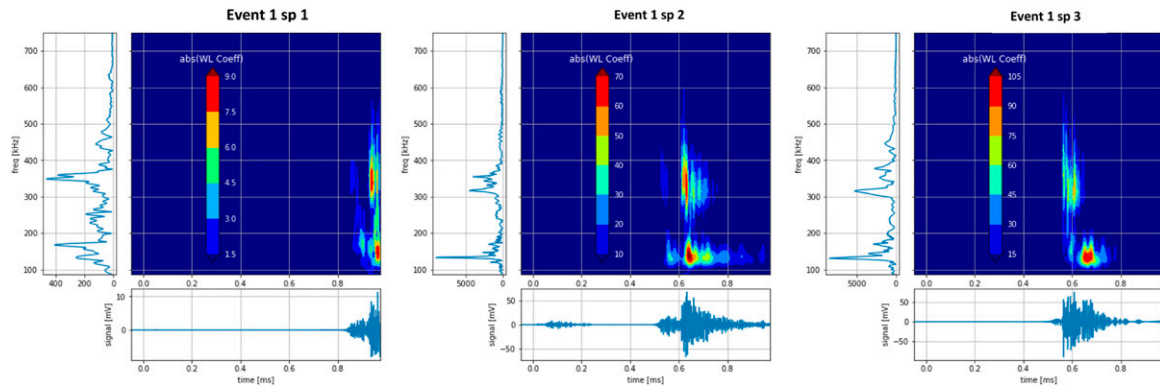
**Figure 9.** Continuous Morlet wavelet plot of event one in the three specimens.

debonding (intermediate frequency event). The event causing this change is called here ‘event 1’ and was studied in more detail using a continuum wavelet analysis (Figure 9). By looking at the scalogram in Figure 9, it is evident that the event one in all three tests looks very similar and can be classified as waveform type c (cf. Figure 3(c)), which we attributed to a combination of debonding and matrix cracking. In all tests a second event was observed, releasing a large amount of energy in the matrix cracking frequency range. After these events, the damage mode fraction evolution (as a function of displacement) largely differs in the different specimens. It must be considered that wavelet packet ratios must not be taken as an exact repartition between damage modes, since there are overlaps in the spectrum of the different waveform type (Figure 3) but they can be useful to analyze trends in the damage accumulation.

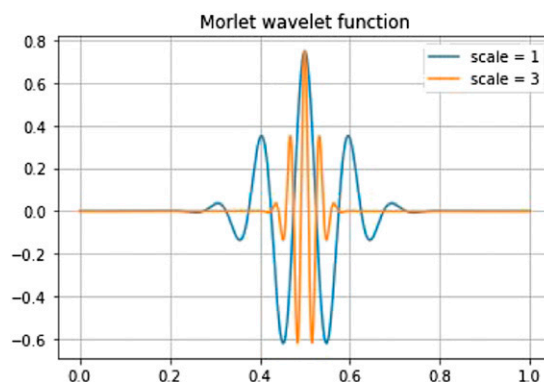
Figure 10. Example of Morlet wavelet function at different scales.

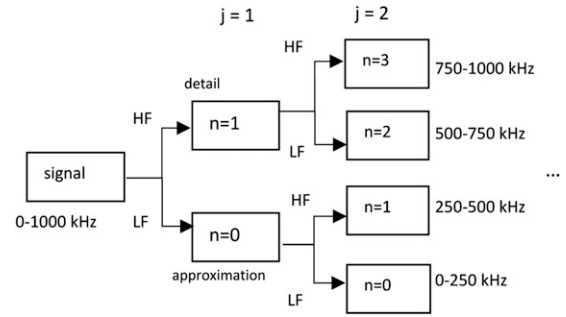
**Figure 11.** Example of wavelet packet decomposition tree;  $j$  are decomposition levels and  $n$  are components. HF stands for high pass frequency filtering while LF stands for low pass frequency filtering.

Wavelet packet transforms (WPT), are discrete wavelet transforms allowing to decompose the signal into wavelet packet components covering equal frequency sub-bands. This is achieved by decomposing the original signal into a low frequency component (approximation) and high frequency component (detail). This operation is repeated multiple times until reaching the desired decomposition level (Figure 11). Given a decomposition tree like the one showed in Figure 11, the frequency range  $f_{range}$  covered by each component can be determined knowing the level of decomposition  $j$ , the component number  $n$  and the sampling frequency of the original signal  $fs$ .
