Damage sensitivity of Groningen masonry structures – Experimental and computational studies

STREAM 1 - REPORT

Cite as: Korswagen, P., Longo, M., Meulman, E., Van Hoogdalem, C. (2017). Damage sensitivity of Groningen masonry structures – Experimental and computational studies. Report number C31B69WP0-12, Final report, version 1.2, 30th of December of 2017.

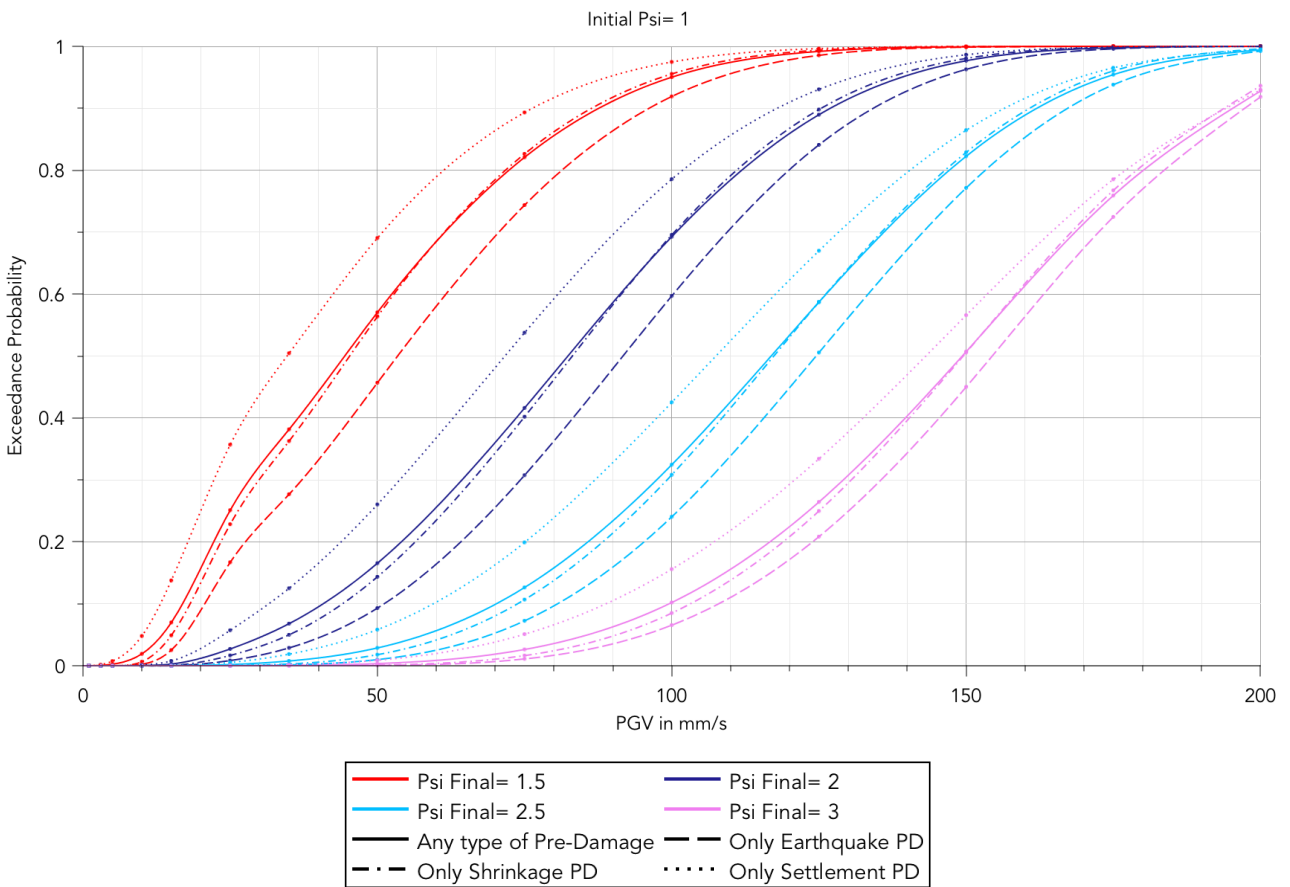
Figure I.12. (7.22) Indicative resistivity curves for computational wall results for some initial pre-damage $\Psi_0=1.0$ against PGV. Showing also the difference between pre-damage types.

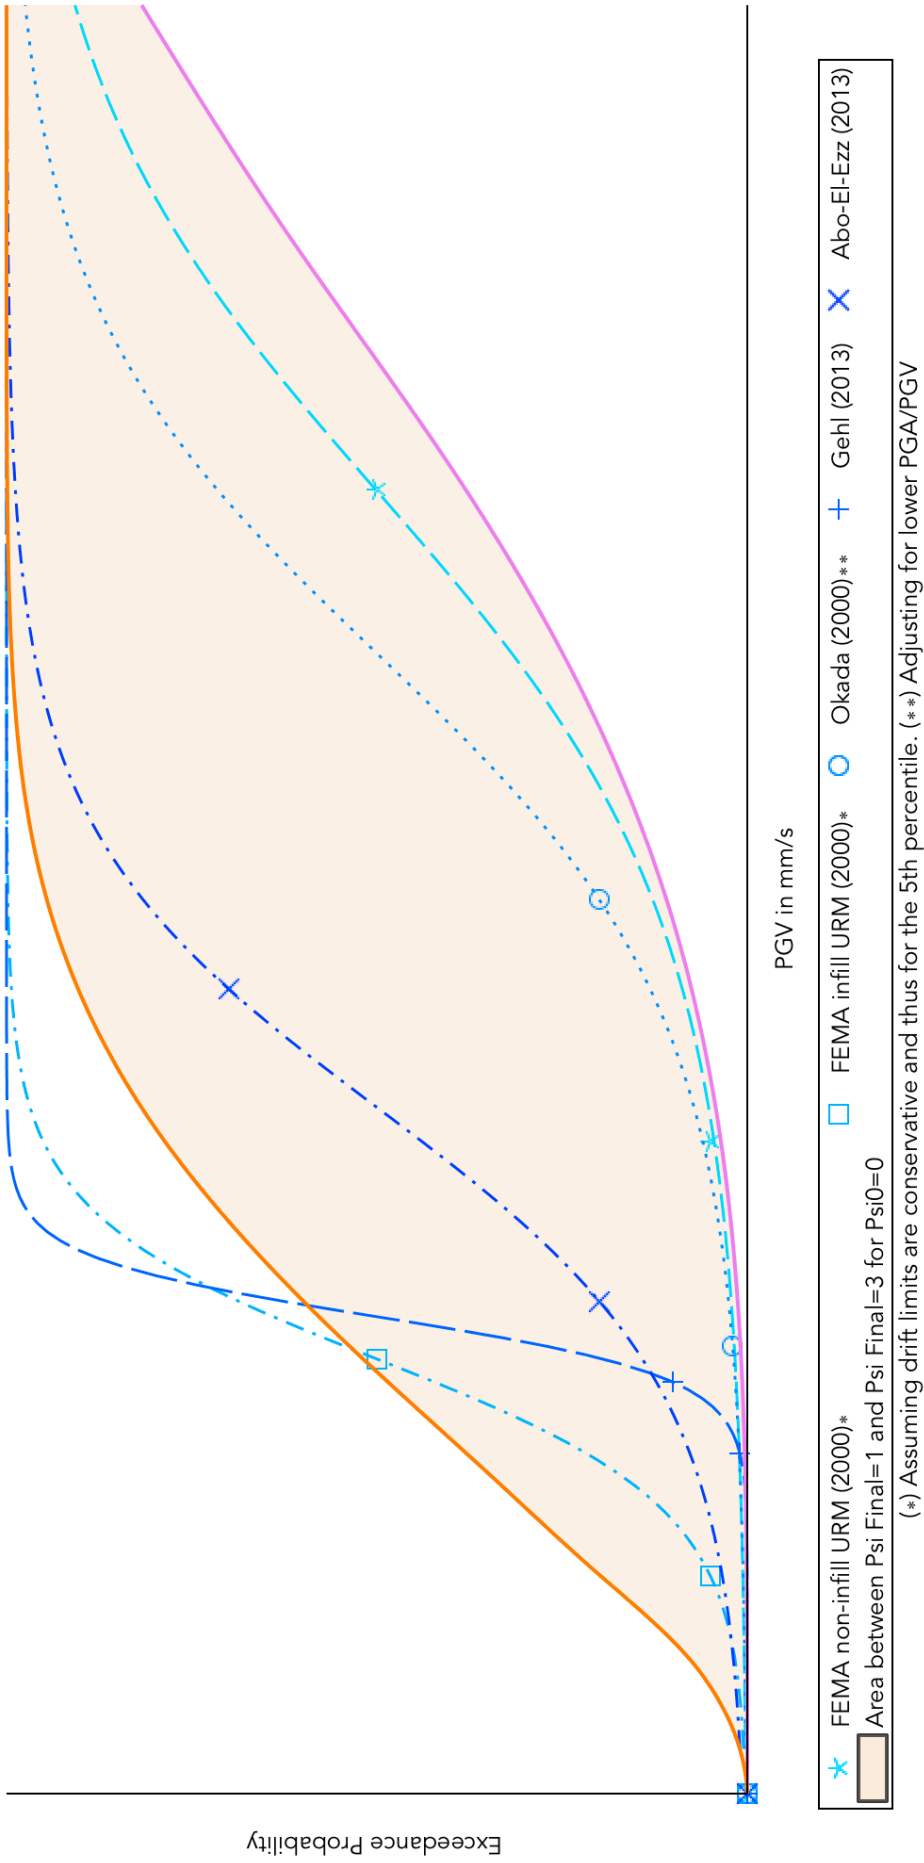
Figure 1.13. (7.25) Comparison with curves and points for DS1 from various authors. According to the definition for the damage level of this study, depending on the structure, DS1 starts between $\Psi=1$ and $\Psi=3$: the shaded area. Indicative Resistivity curves for computational results for $\Psi_0=0$ against PGV for these two values are shown. Note that the comparison curves are log-normal S-curve fits to a few available points and that their behaviour away from the marked points may differ.

Curves developed for DS1 by other authors appear to fit well in the range of $1 < \Psi < 3$ (Figure I.13).

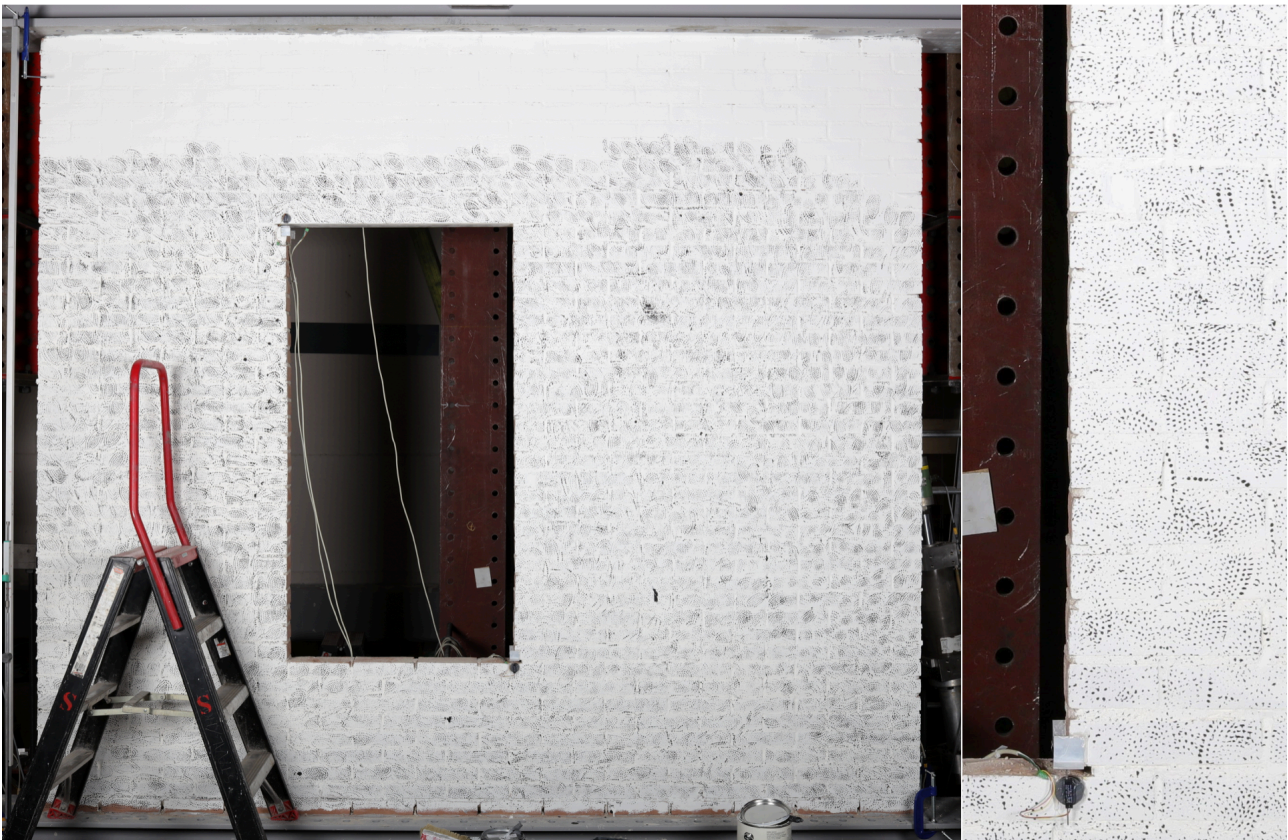
Figure 2.9. Patterns being applied to the wall.

Digital Image Correlation (DIC) analyses the relative displacements between clusters of patterns in different photographs. The patterns are obtained by analysing areas of contrast and shape in the pictures; therefore, the samples are painted with a random array of dots or patterns which are sized to be picked up clearly by a camera, see Figure 2.9.

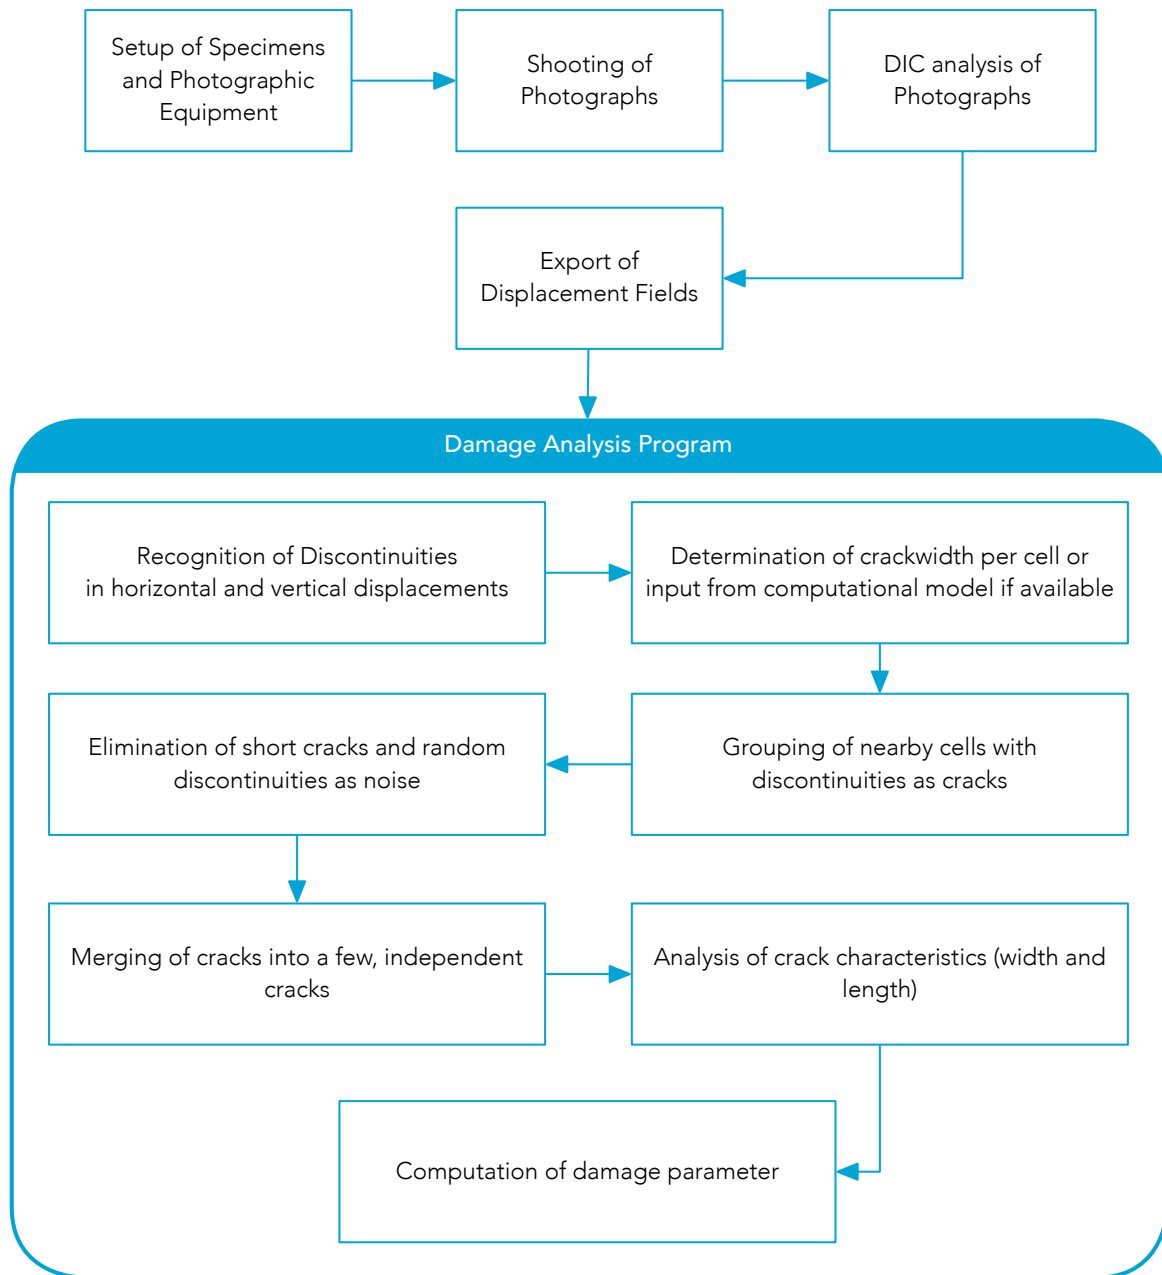
Figure 2.12. Flowchart for the process of computing the damage parameter from DIC or computational results.

Since the primary output of the DIC analysis and computational models can be matrices of displacements as has been shown, a program was written to analyse these automatically and determine the damage value. The flowchart in Figure 2.12 gives an overview of the sequence of analysis which is elaborated upon next.

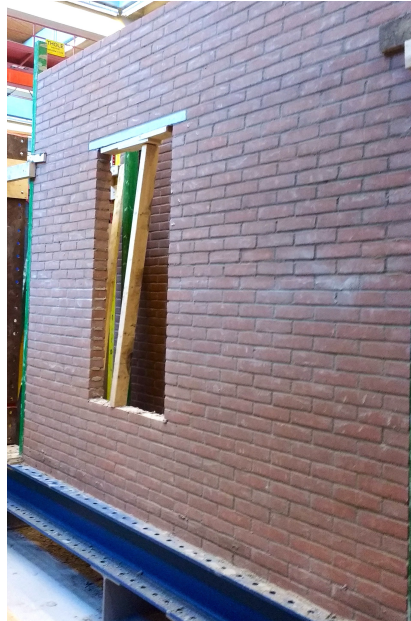
Figure 4.2. IP wall test sample.

Five single-wythe clay brick masonry walls with a window opening have been constructed in the TU Delft's Stevin lab II, all with the same type of material and identical geometry (Figure 4.2). Two notches with a dimension of 10x50mm are located in the bottom right and in the top left window corner. The specimens have a thickness of 100mm. An overburden of 0.12MPa is applied during the tests. Different loading schemes have been chosen (see Table 4.1). More details about the samples and tests are provided in the test protocol (Meulman et al., 2017). For the tests, pulling is associated with the positive direction, while pushing is associated with the negative direction (see Figure 4.1).

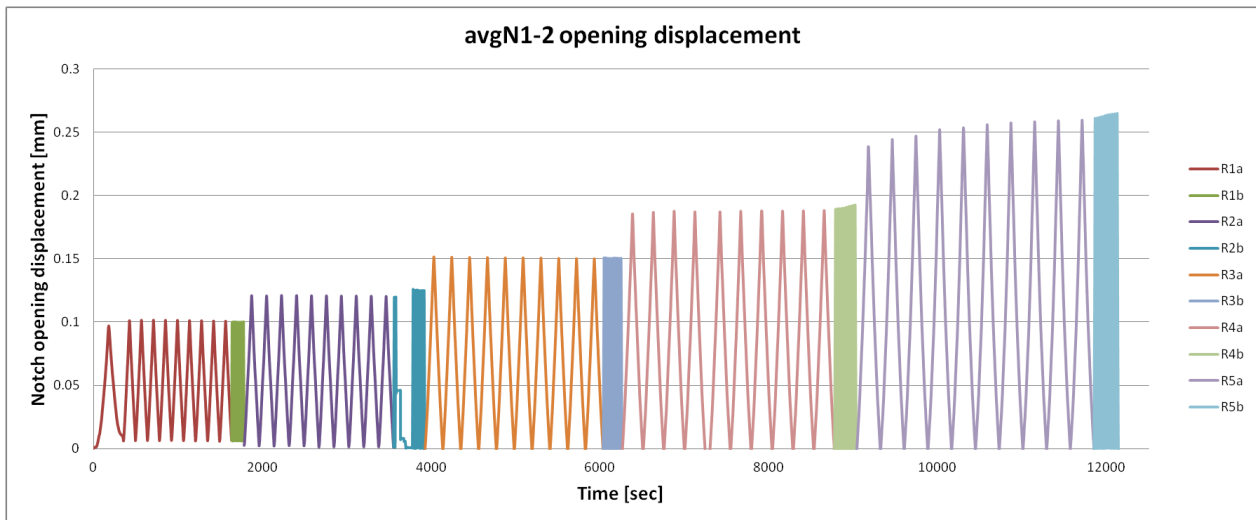
Figure 4.41. Average opening displacement of notch 1 and 2.

During the out-of-plane instability fix, the top beam had to be pushed by hand slightly to the back side to be able to fill the space between the vertical column and top beam. This push is visible in the notch sensors in Figure 4.41 and Figure 4.42 as a small increase in opening of the notch displacement after the test is continued.

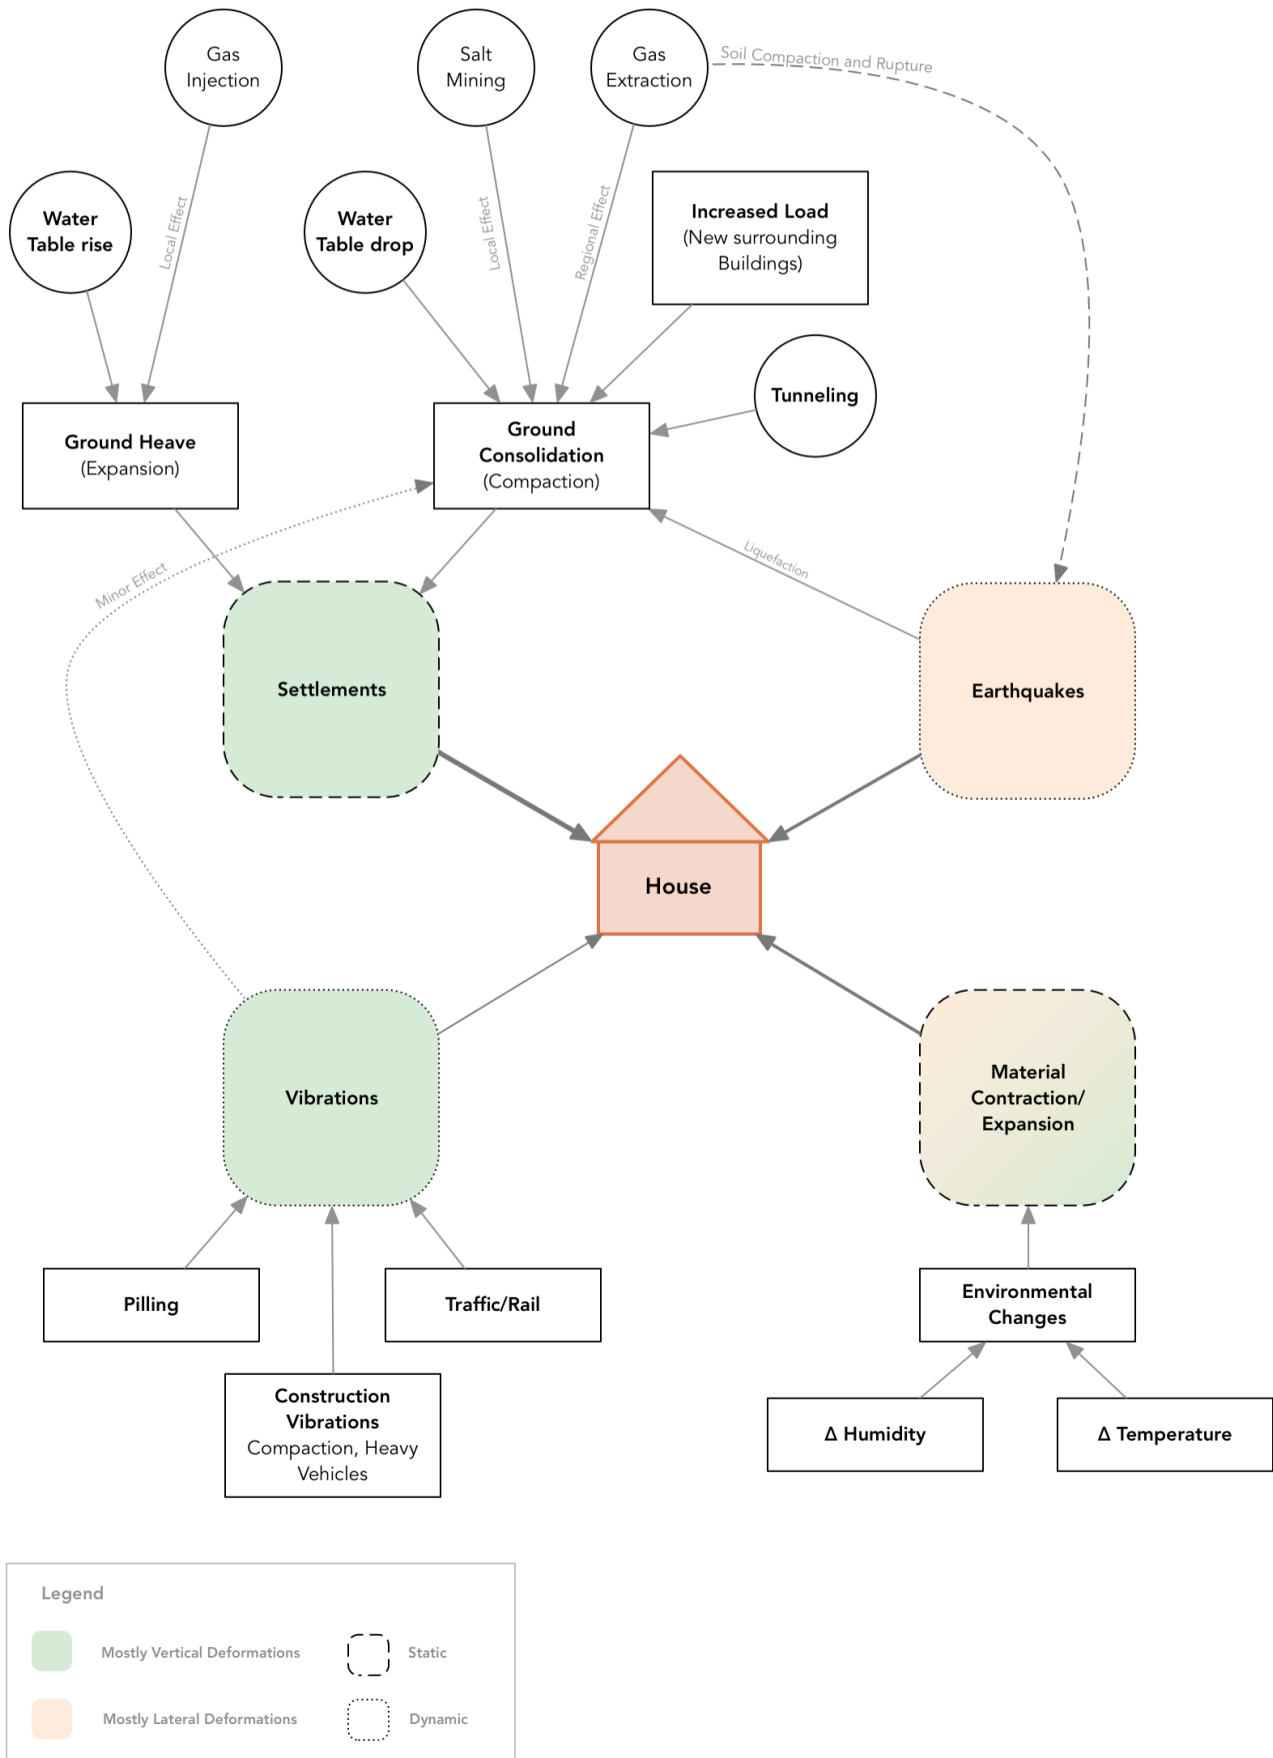
Figure 7.6. Overview of external actions that may lead or contribute to damage.

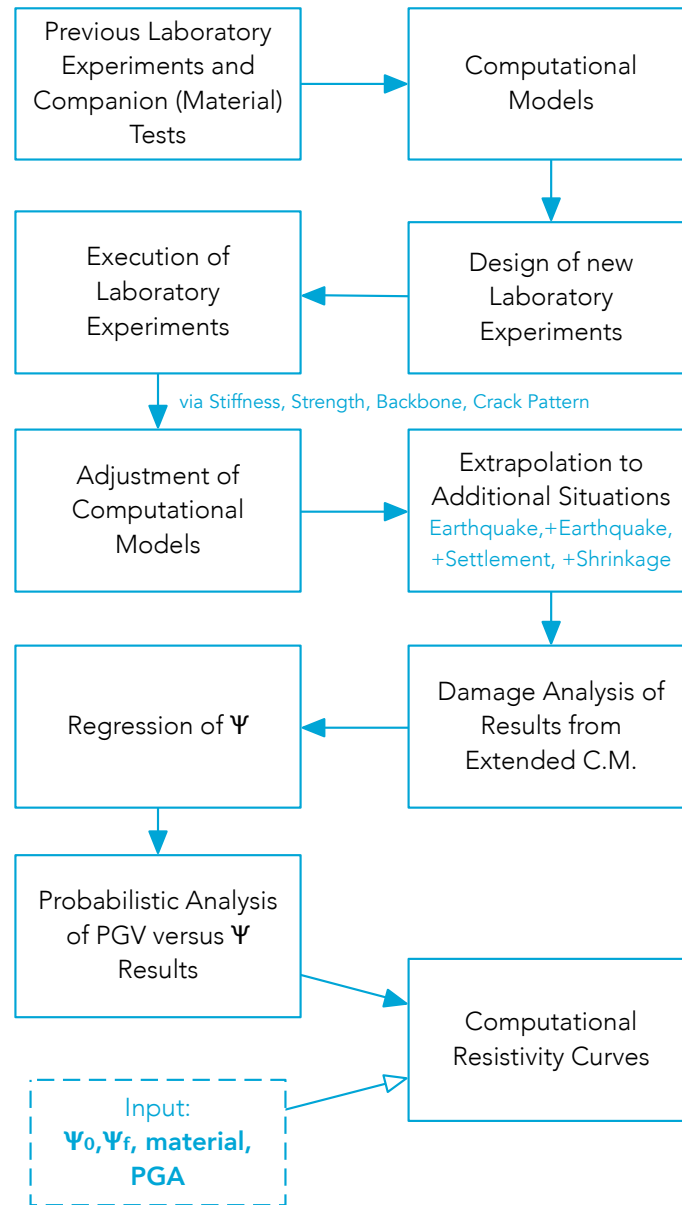
Figure 7.11. Work flow for producing resistivity curves from computational models.

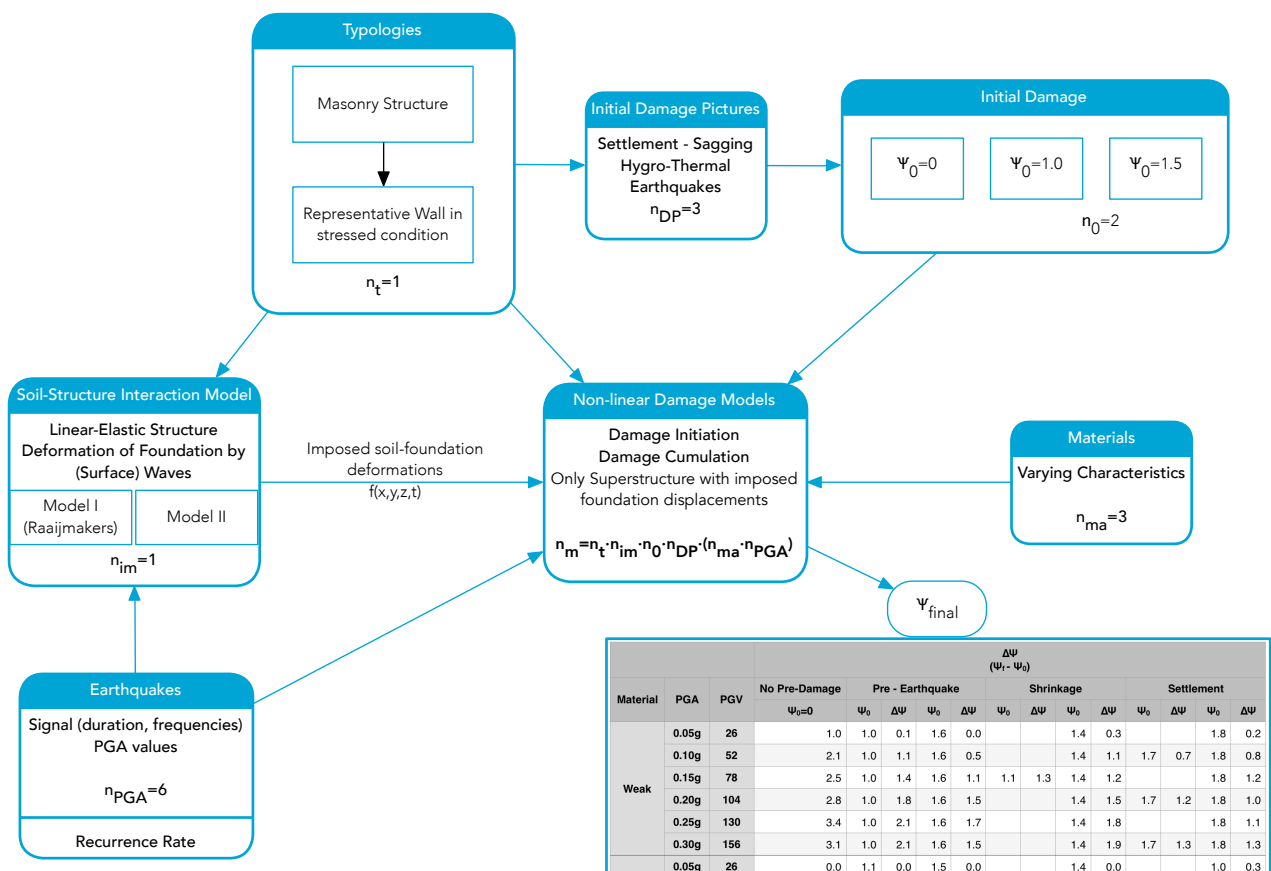
Figure 7.12. Number of computational models to run.

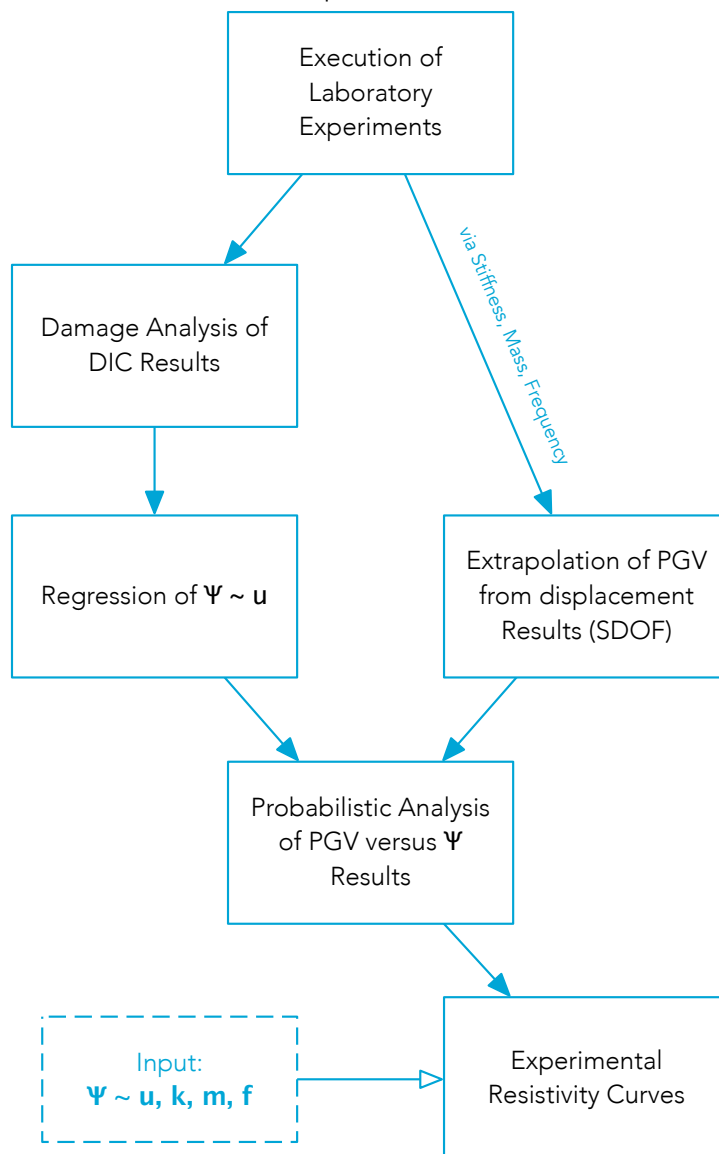
Figure 7.26. Workflow for producing resistivity curves based on the laboratory experiments.
