On the necessity of new hydrophobic treatment after repointing of water repellent masonry

Nijland, Timo G.; Lubelli, Barbara; van Zundert, Kim; van Hunen, Michiel

Construction and Building Materials

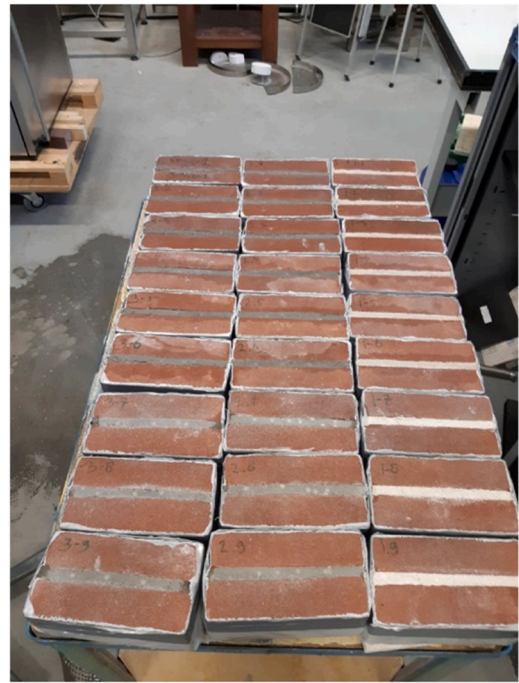
Fig. 1. Example of sealed and pointed test specimens.

Test specimens are composed by two bricks with a bedding and pointing mortar in between (Fig. 1). The size of the specimens is about $215 \times 112 \times 102$ mm (l x h x b).

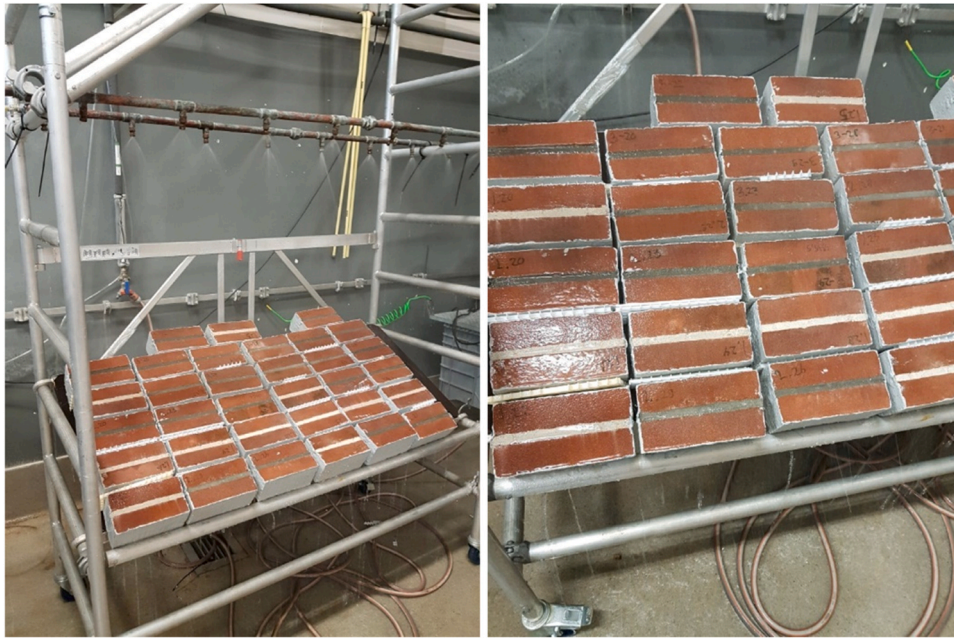
Fig. 3. Rain test.

A rain test has been performed to determine the different saturation degree of HH (treated, pointed and not retreated) and HHH (treated, pointed and retreated). A purpose made test setup has been built (Fig. 3): the specimens were laid on a metal grid, positioned at an angle of approximately 30° , to obtain an even thin water film on the surface; 10 water sprinklers were positioned in two rows, at a distance of 150–200 cm from the specimens top surface, depending on the position of the specimen (Fig. 3). The test involved continuous raining for 8 h a day for four days; this period was enough for the untreated specimens (O) to reach the saturation degree corresponding to moderate saturation as pre-conditioning for the freeze-thaw test (see above). The test was performed under laboratory conditions, i.e. about 20°C , no (artificial) sunning nor wind. To prevent evaporation from the test specimens in periods without rain, the surface of the specimens was covered with a plastic foil. The specimens were weighted after the first, second and fourth 8 h rain period. At the fourth day, the moisture distribution in brick and mortar was determined gravimetrically, on powder samples collected at different depths from the surface.

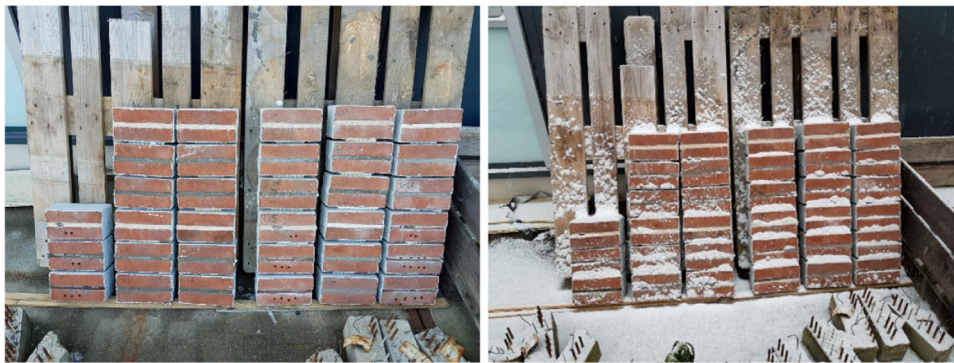
Fig. 4. Test specimens in outdoors exposition. Left October 11, 2018, right January 21, 2019.

After the end of the rain test, specimens were exposed outdoors at the premises of the TNO laboratory in Delft, the Netherlands, from October 11, 2018 til April 8, 2021 (Fig. 4). Relevant climate data are given in Fig. 5. The masonry walls faced east and were placed under angle to enhance exposure to precipitation. The masonry walls were periodically inspected visually; after 2.5 years exposure, the state of the pointing, the hydrophobicity (including penetration depth of the treatment) and moisture contents of brick and mortar were determined.
