Ground floor : before

Ground floor : after

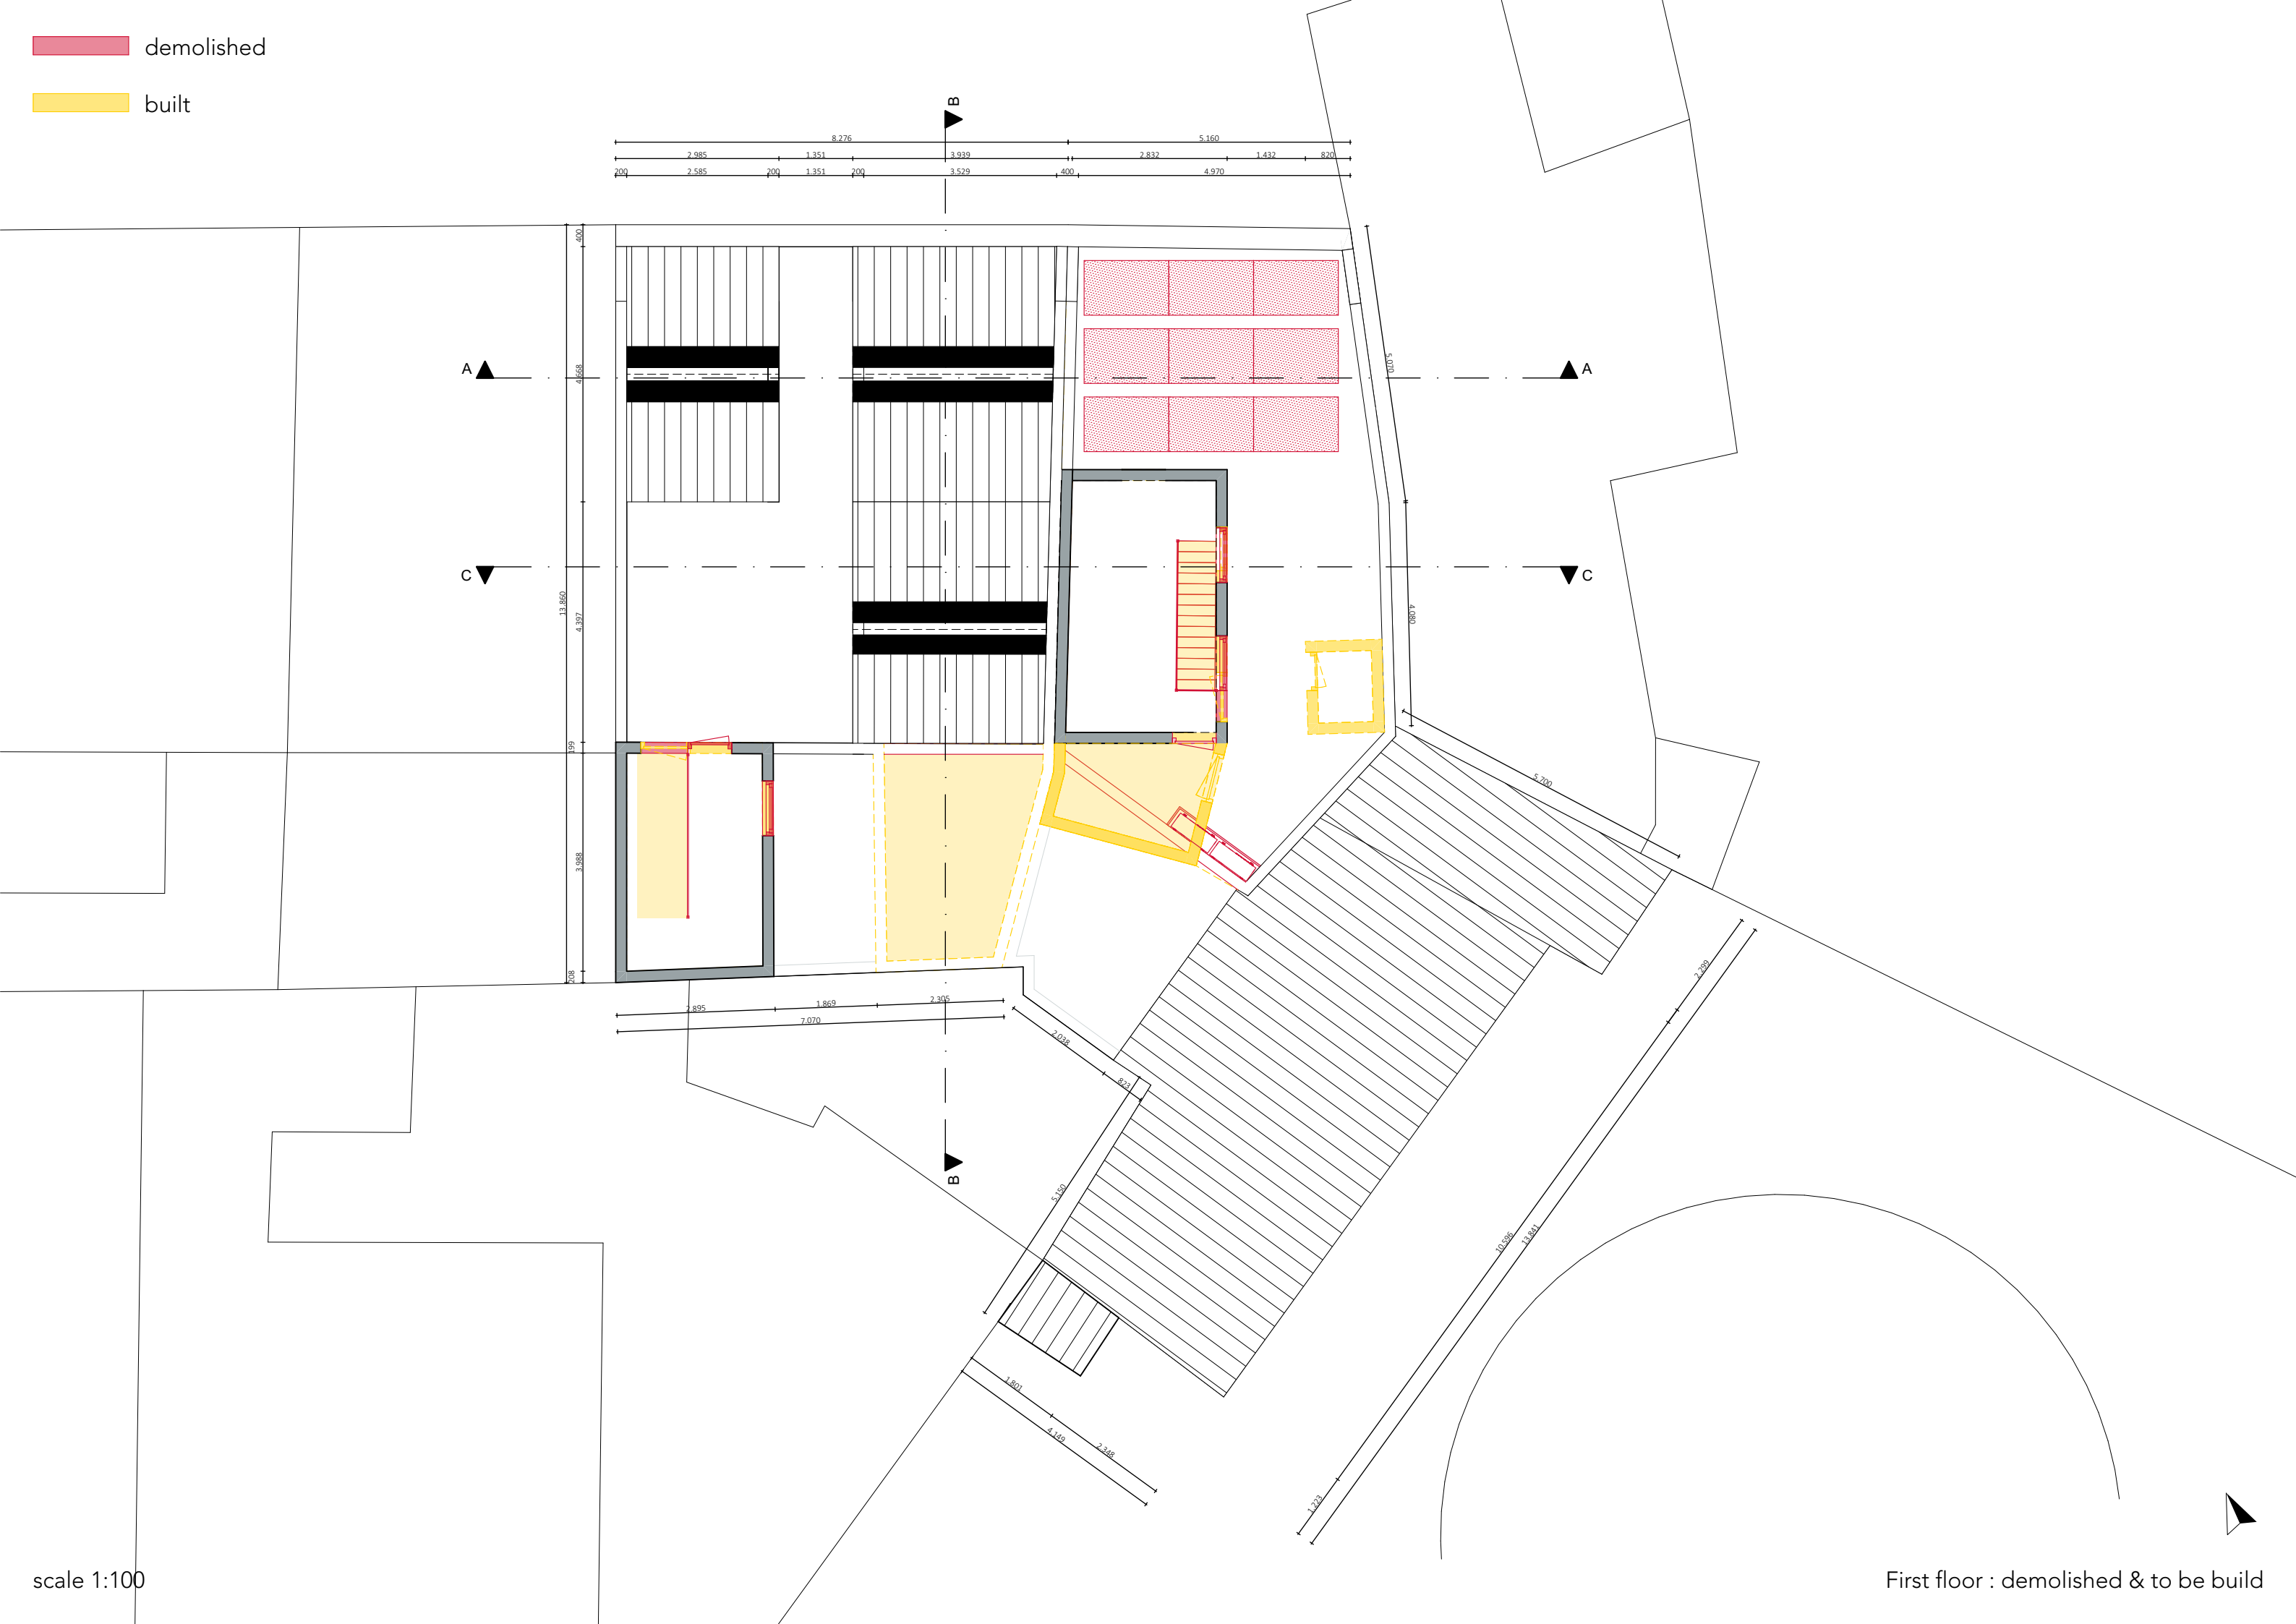
First floor : demolished & to be build

demolished

built

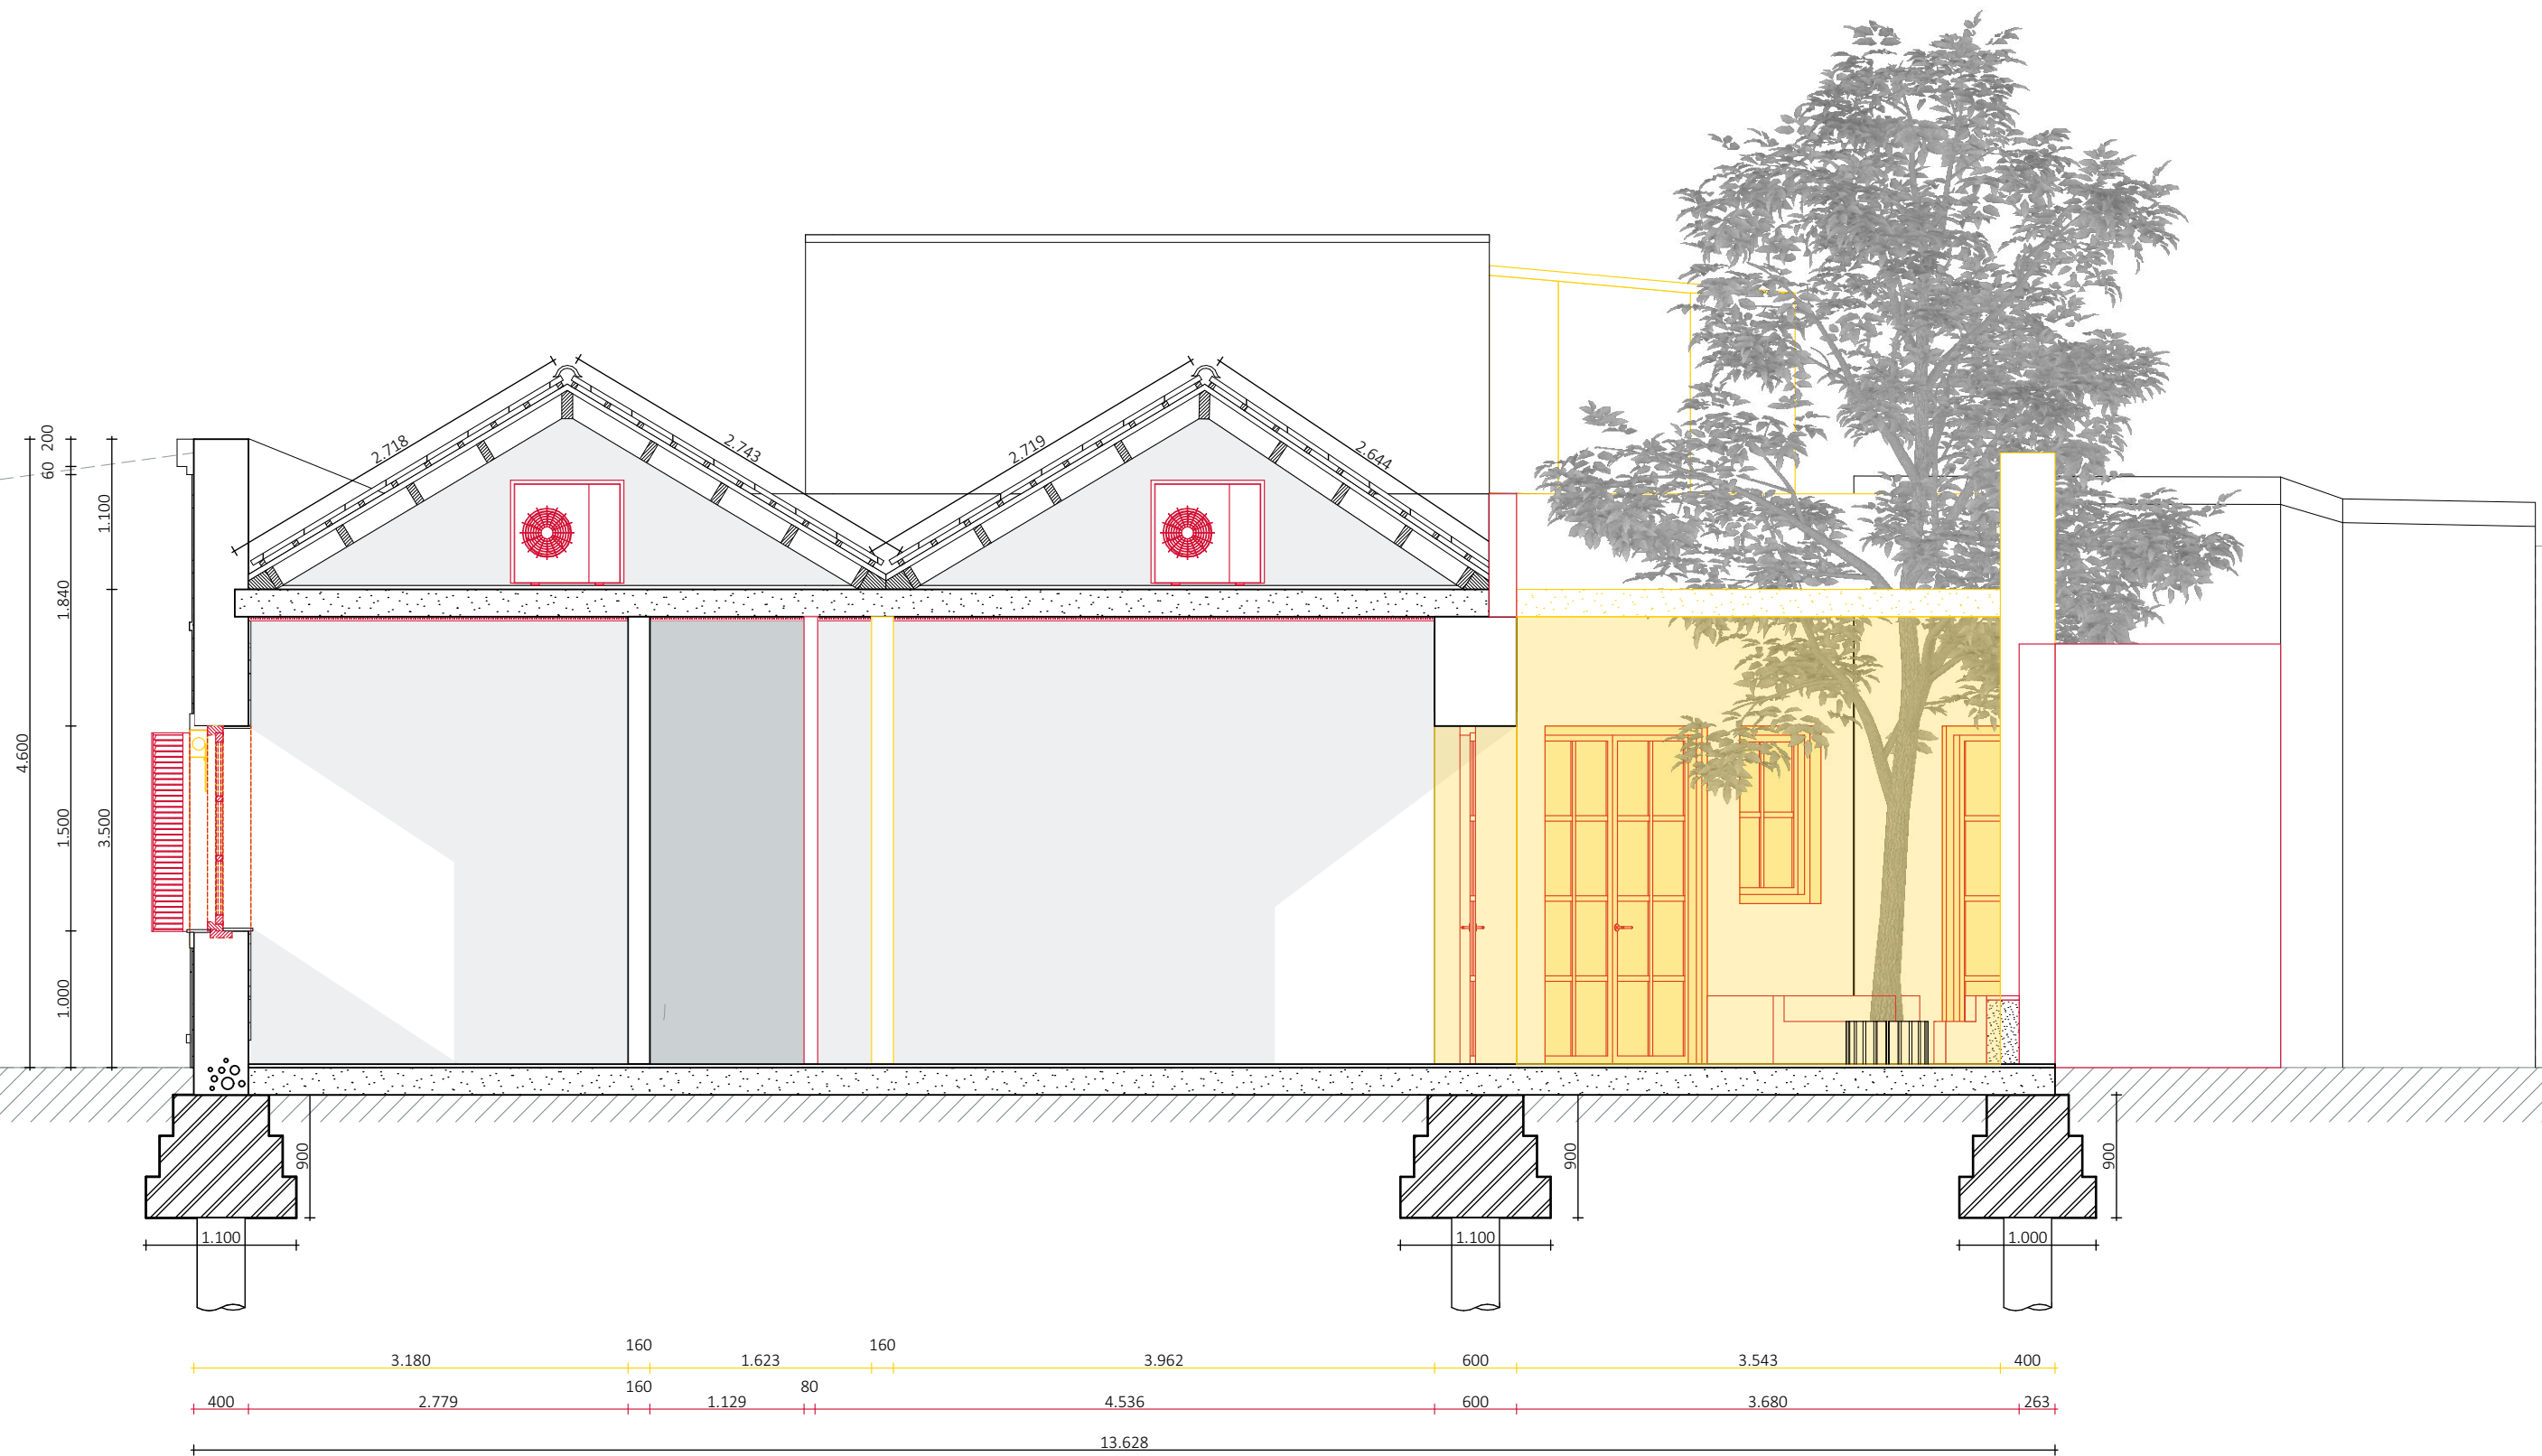
Section B - B : demolished & to be build

demolished

built

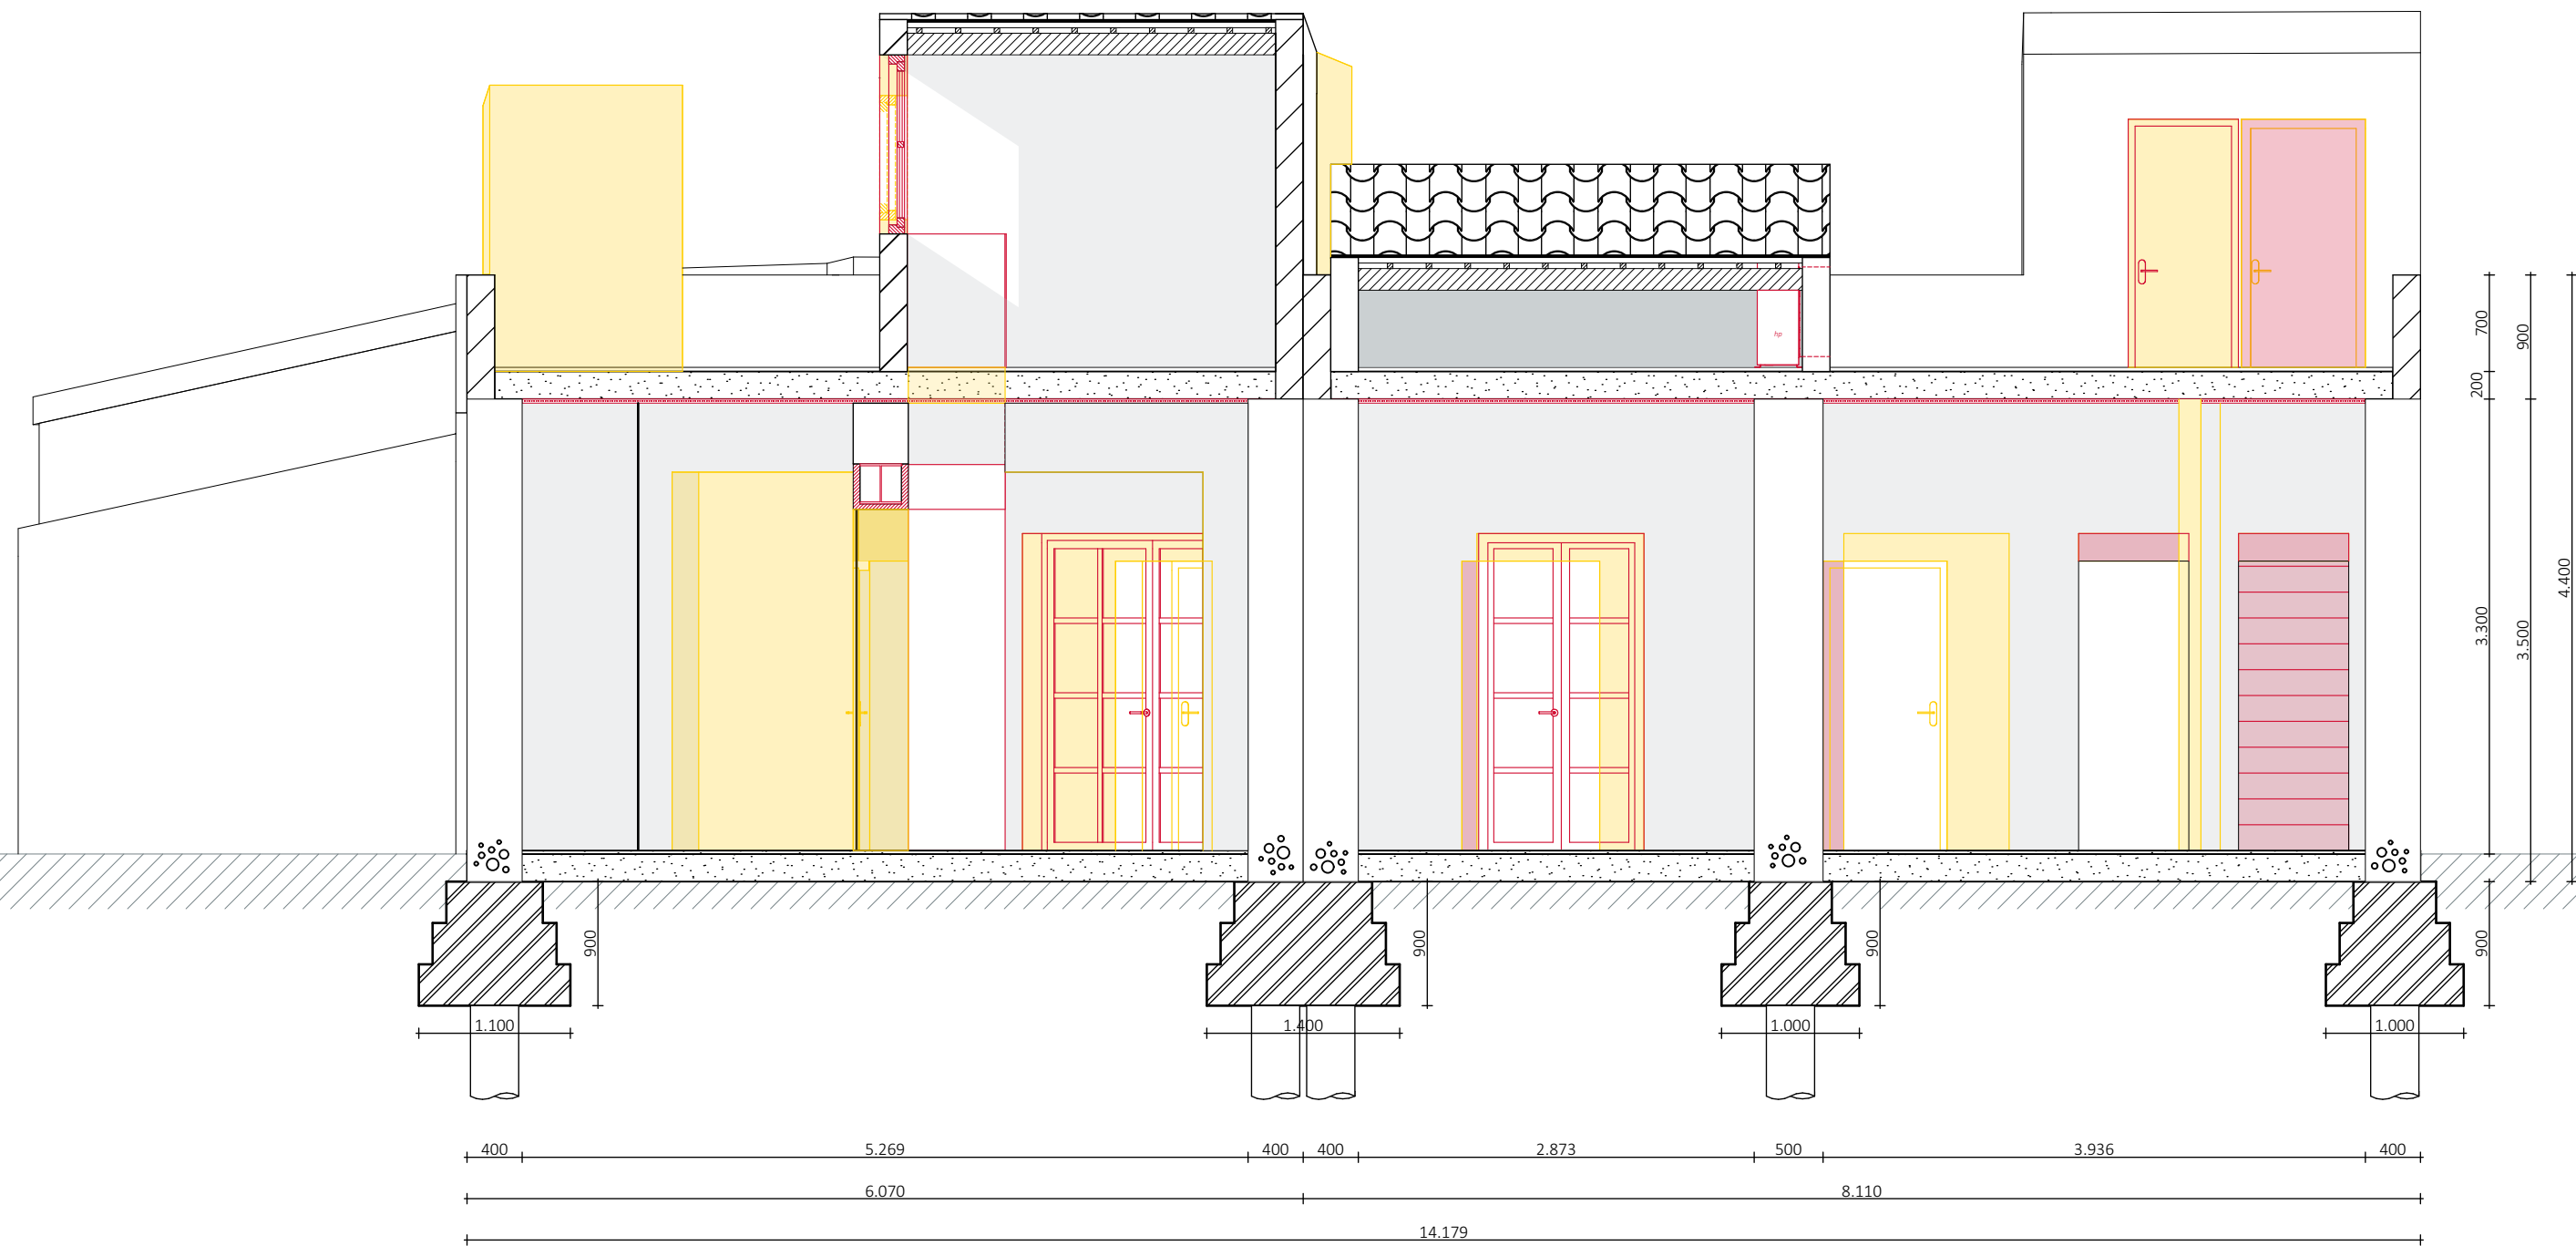
Section C - C : demolished & to be build

demolished

built

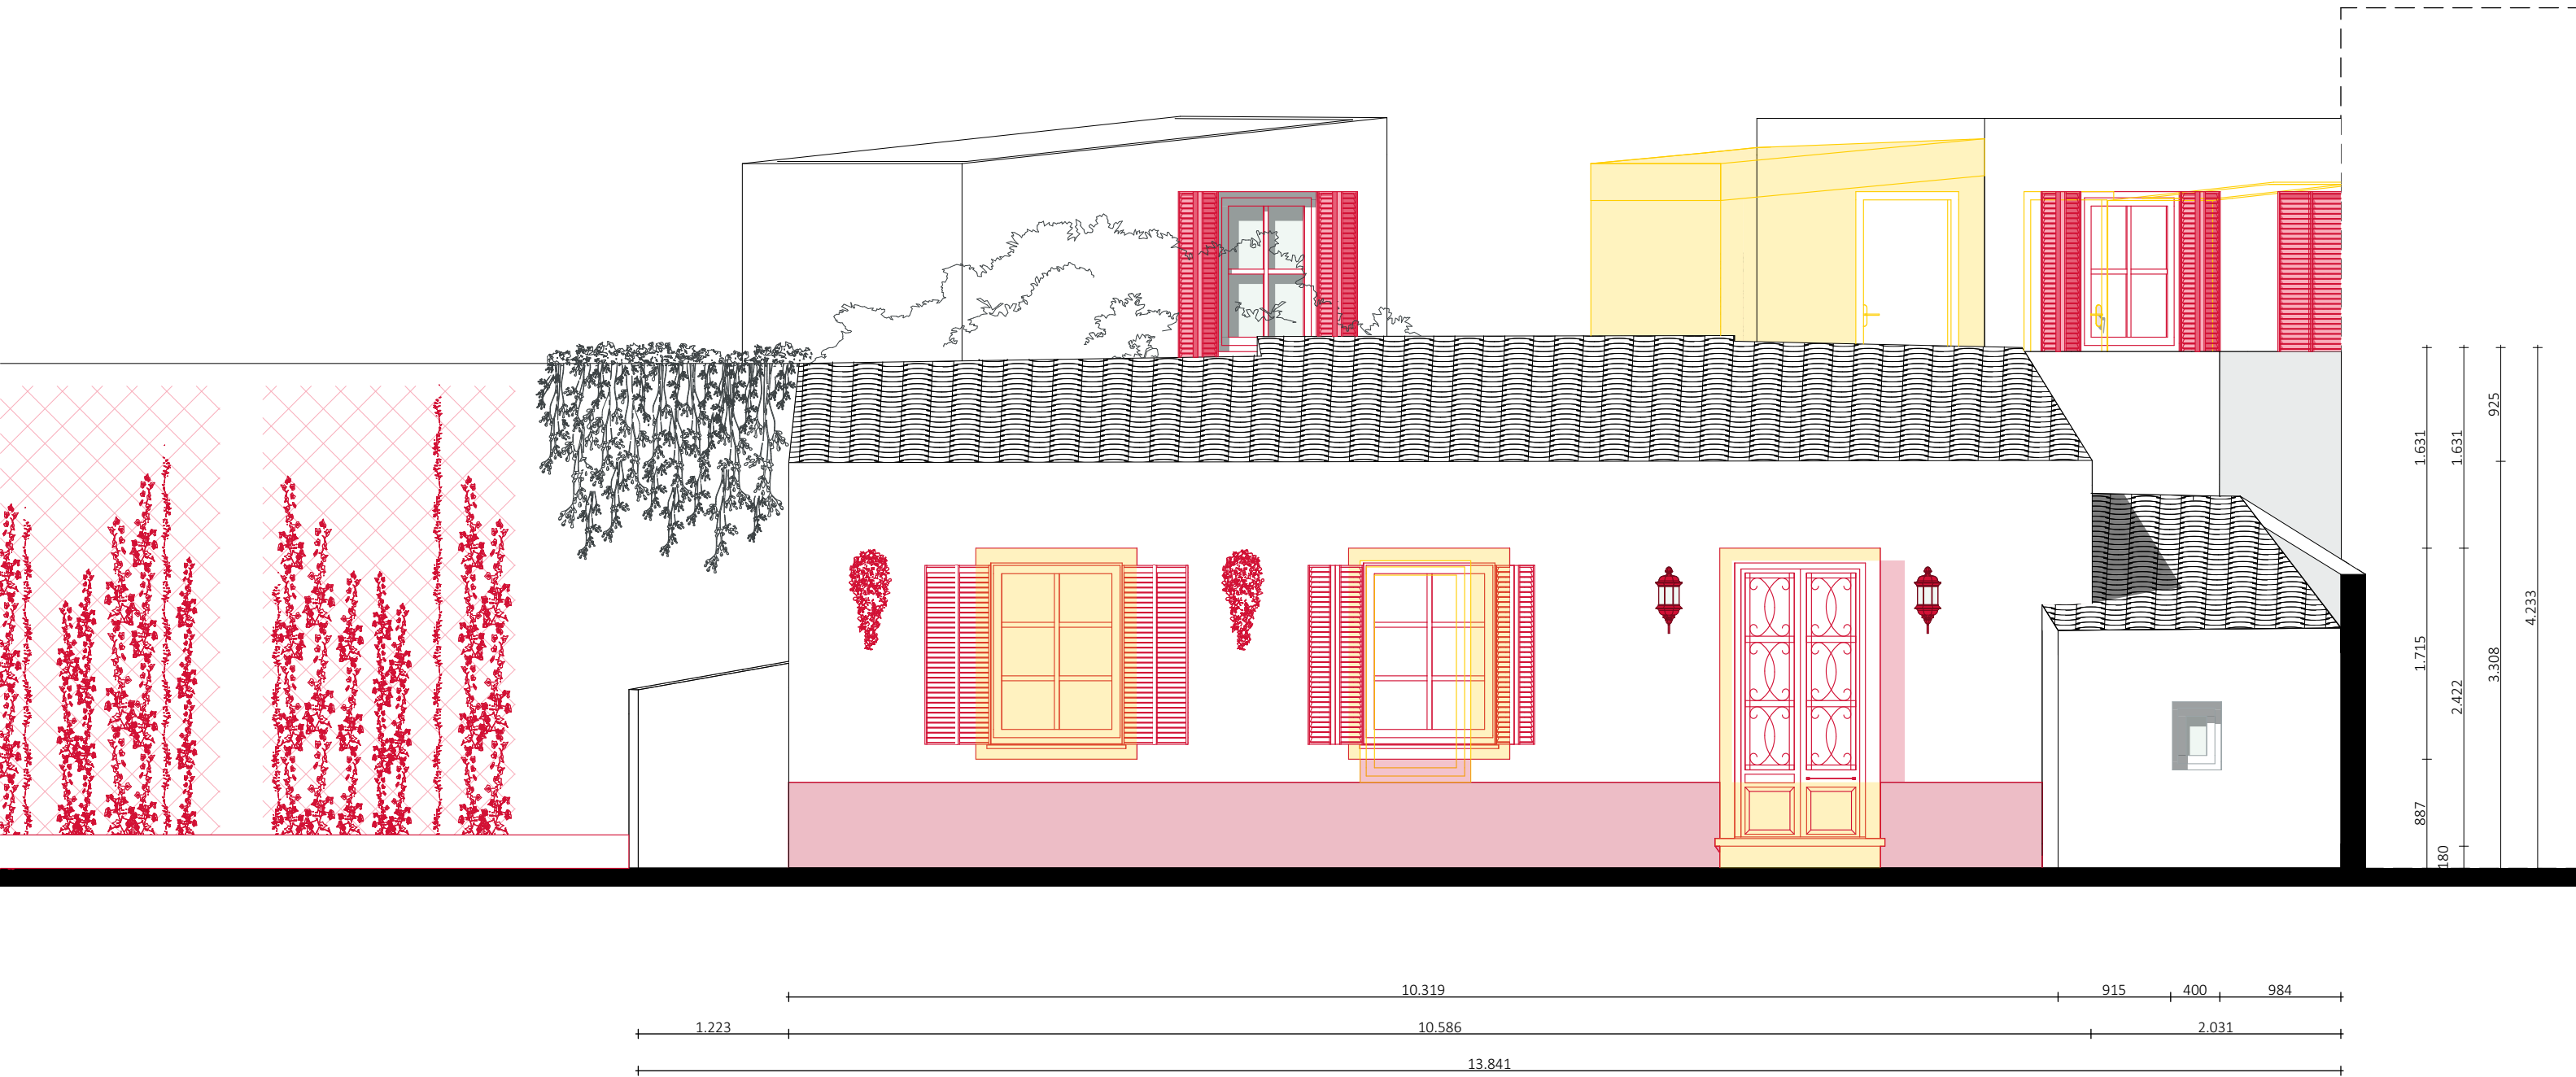
original rear facade : to be build & demolished

demolished

built

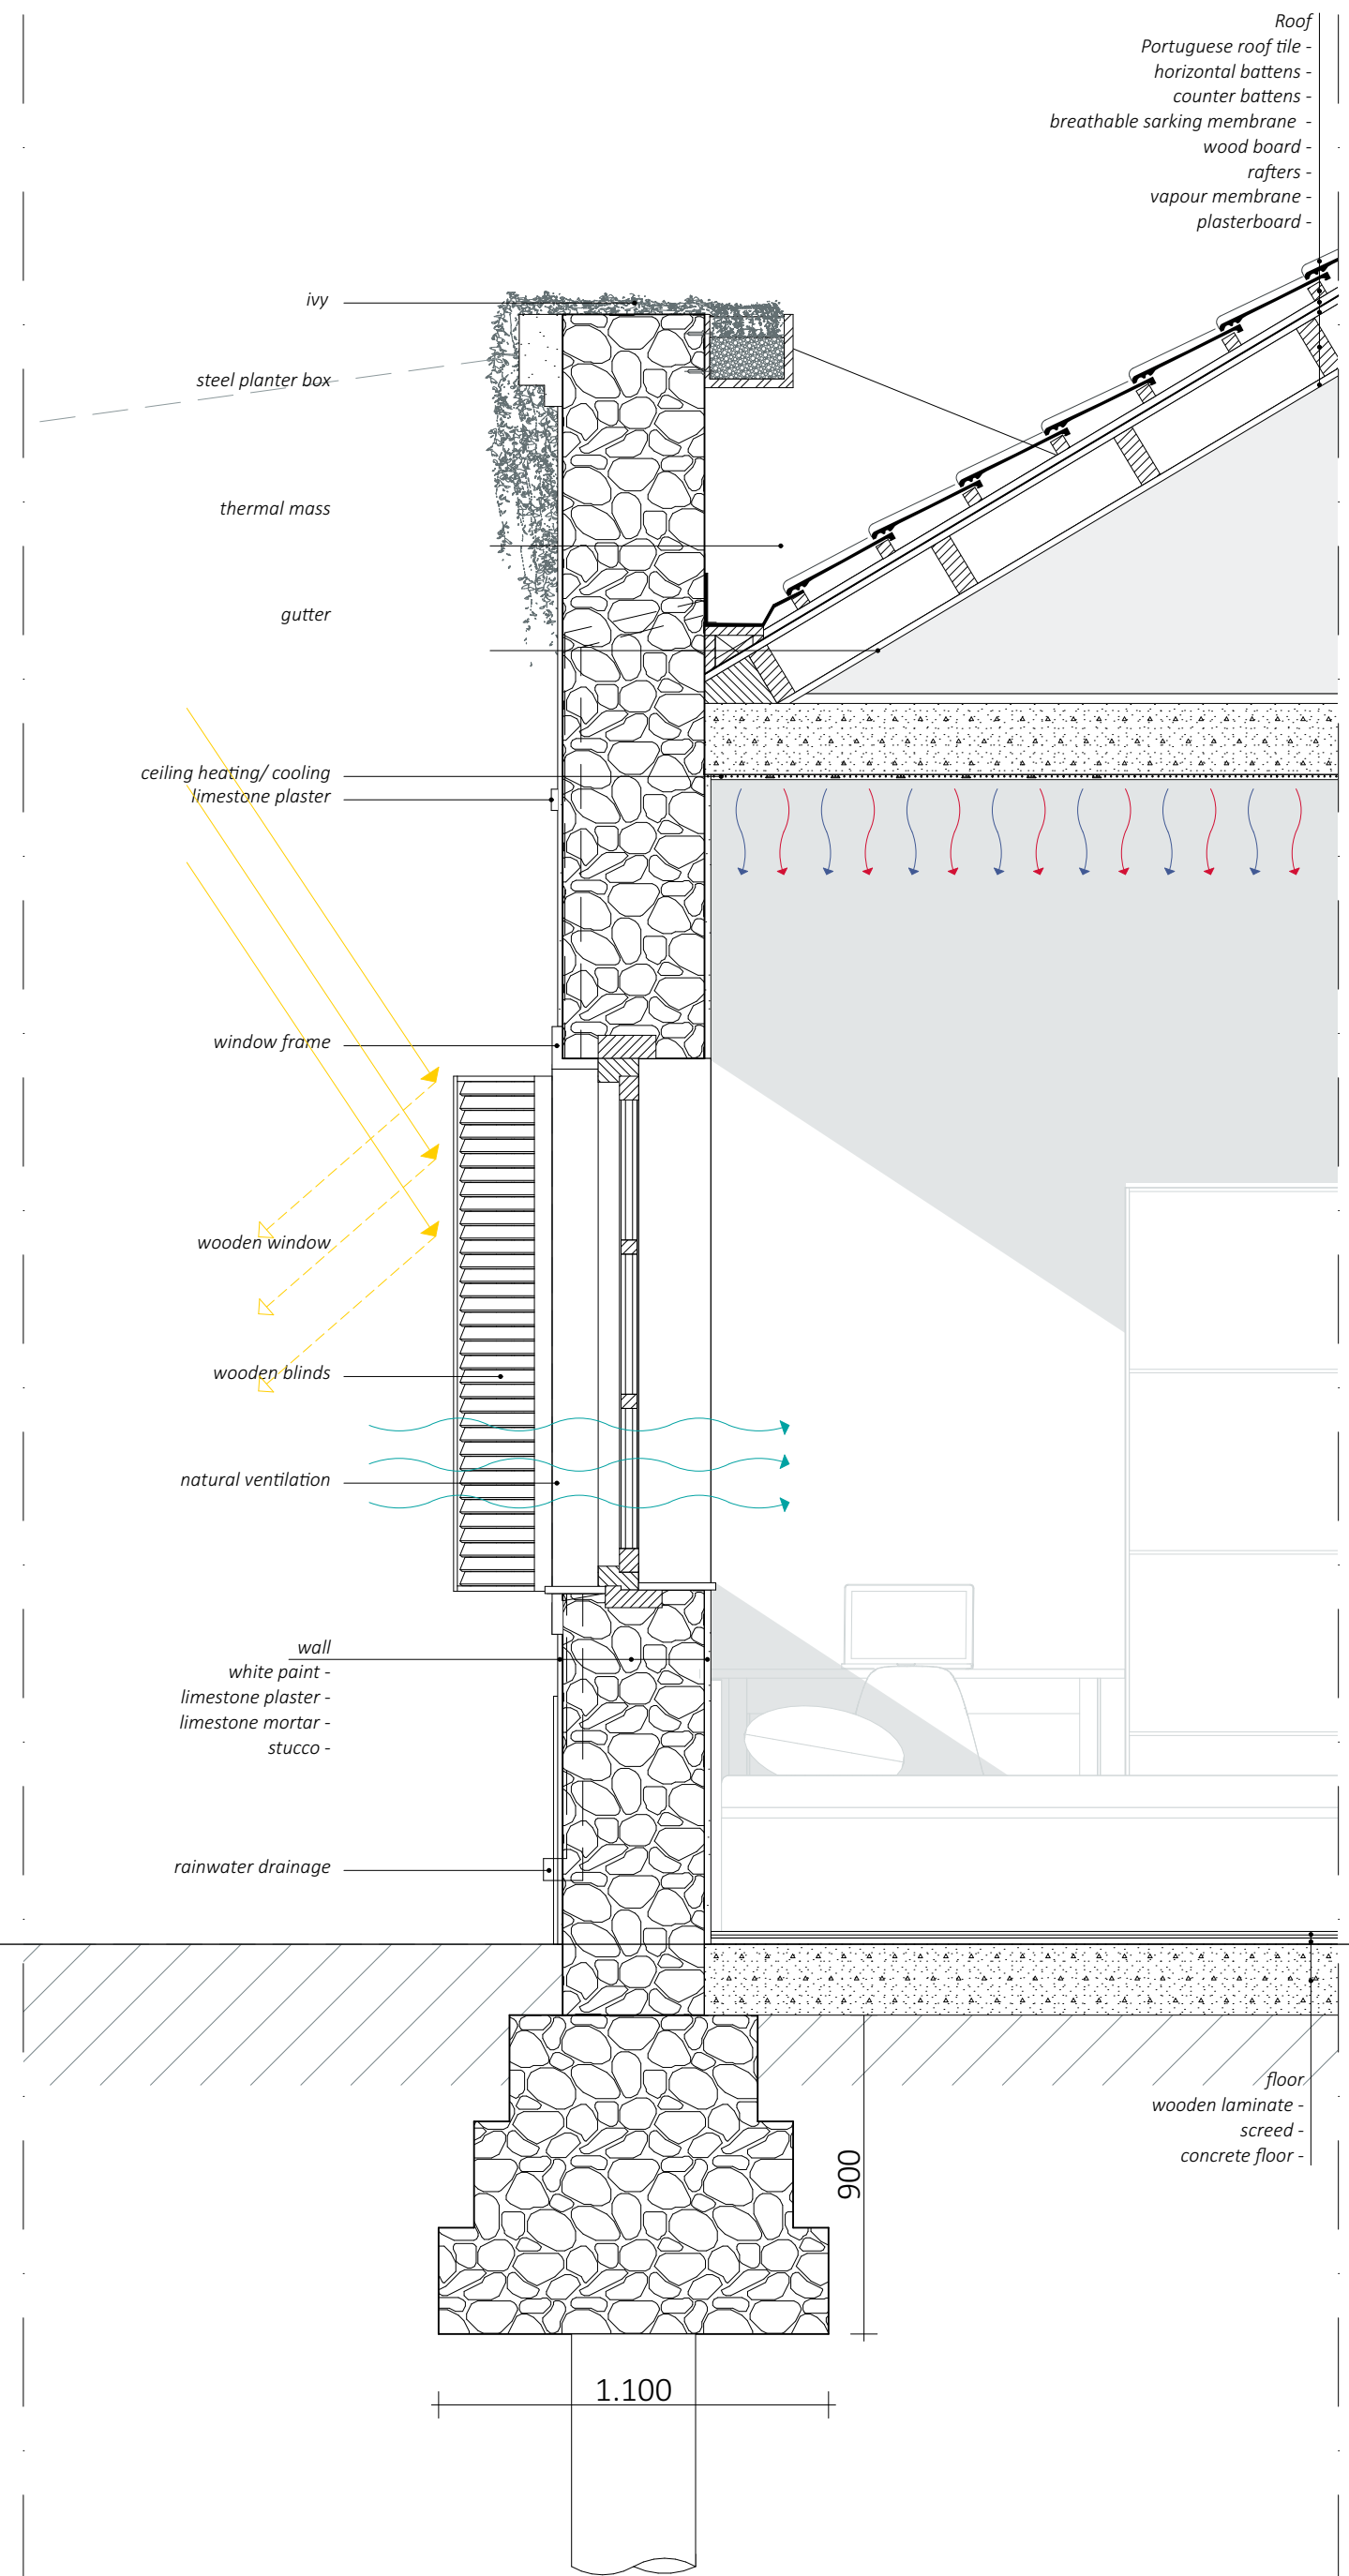
Roof
Portuguese roof tile -
horizontal battens -
counter battens -
breathable sarking membrane -
wood board -
rafters -
vapour membrane -
plasterboard -

ivy
steel planter box
thermal mass
gutter
ceiling heating/cooling
limestone plaster
window frame
wooden window
wooden blinds
natural ventilation
wall
white paint -
limestone plaster -
limestone mortar -
stucco -
rainwater drainage

floor
wooden laminate -
screed -
concrete floor -
