Effect of moisture on the adhesion of CFRP-to-steel bonded joints using peel tests

Moreira Arouche, M.; Budhe, S.; Alves, L. A.; Teixeira de Freitas, S.; Banea, M.D.; de Barros, S.

Brazilian Society of Mechanical Sciences and Engineering. Journal

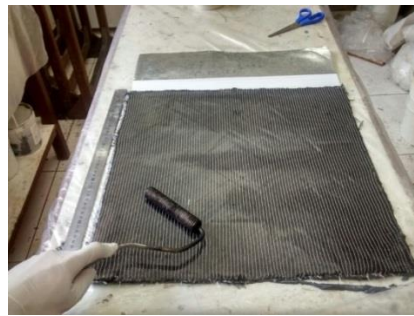
The composite-to-metal bonded joint test specimens were manufactured by the same process used in composite patch repairs of oil and gas production platforms [29-30]. The carbon steel plate was blasted with G-40 steel shot and then degreased using acetone. The final surface roughness measured was 12.26 μm root mean square deviation (Rq) and 76.12 μm total height of the roughness profile (Rt). The epoxy resin NVT201E® was then applied over the treated steel plate surface. Afterwards, the lamination process started by alternating application of carbon fiber fabric layers and the impregnation resin PIPEFIX®, as shown in Figure 1. Six plies of carbon fiber were used to produce the composite with a

Fig. 1 Carbon fiber lamination process

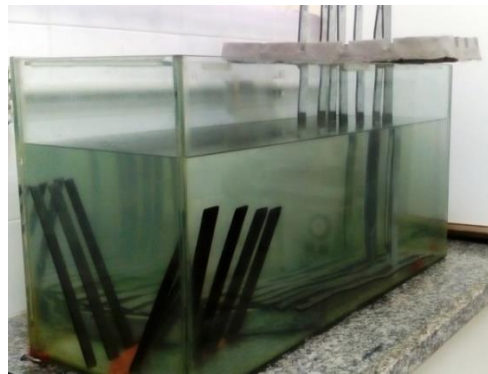
The salt water ageing process was employed in order to evaluate the long-term effect of environmental exposure on the joint. The specimens were kept inside the salt water

1 tank (5% NaCl) at room temperature for 40 days and 150 days. The ageing process
2 simulates the effect of environmental conditions wherein the bonded repairs are exposed
3 to marine environment. Specimens were exposed to ageing in two different conditions:
4 partially immersed in salt water, i.e. 50% of bonding length was in salt water and
5 remaining in atmospheric conditions; and fully immersed in salt water. Some reference
6 specimens were tested without any ageing. Figure 3 shows the specimens in the salt water
7 tank and Table 1 provides the ageing conditions tested and the number of specimens for
8 each condition.
9
10
11
12
13
14
15
16
17
18
19
20
21
22
23
24
25
26
27
28
29
30
31

32 **Fig. 3** Specimens in salt water tank

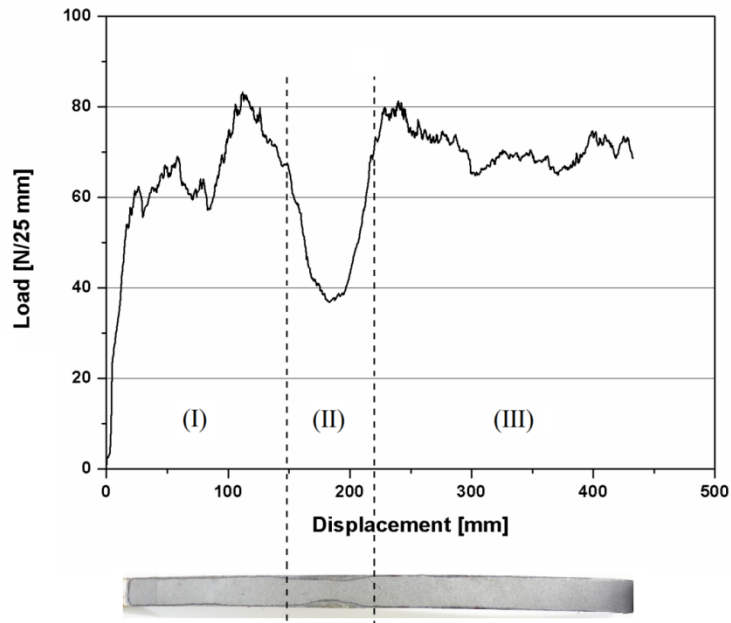
31 In order to obtain a better understanding of the ageing effects on the adhesion
32 performance, peel loads were related to fracture surfaces of 150 days aged joints, as they
33 presented a more significant influence of moisture on the adhesive layer. Figure 10 shows
34 a comparison between load-displacement curve and fractured surface of the flexible
35 substrate in a partially aged tested specimen.
36
37
38
39
40
41
42
43
44
45
46
47
48
49
50
51
52
53
54
55
56
57
58
59
60
61
62
63
64
65

Fig. 10 Comparison between peel load and fracture surface of a 150 days partially aged specimen

Three different regions can be identified by visual inspection along the curve: I, II and III. Regions I and II correspond to the aged part of the specimen while region III is the non-aged part. The moisture penetration at the fracture surface is small and reasonably uniform in the region I (between 25 and 145 mm of displacement) and corresponds to an average peel load of 62.6 ± 12.1 N. This value is close to the average peel load of 150 days fully immersed specimens showed in Table 2. Region II presents a considerable increase of moisture penetration, which is followed by a decrease in peel loads until 36.8 N. Region III (from 220 mm to the end) presents an average peel load of 71.1 ± 3.8 N. This value is close to the average peel load of non-aged specimens (Table 1). There is a 12% reduction in the average peel load between regions I and III. In addition, the minimum peel load occurred in region II is about 48% lower than the average peel load of the non-aged region. These percentages are proportional to the penetration of moisture in

the fracture surface. This reveals the relationship between ageing effect and reduction of adhesion quality.

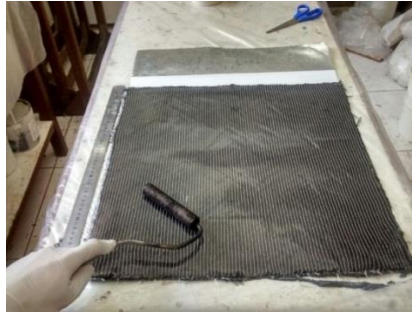
Fig. 1 Carbon fiber lamination process

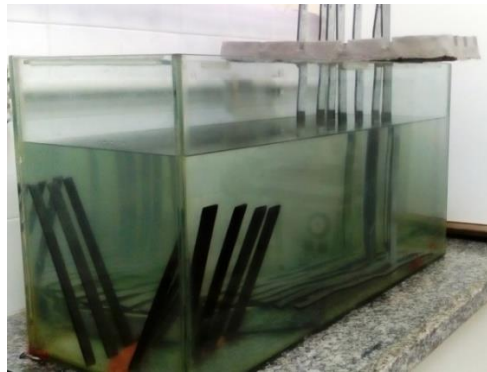
Fig. 3 Specimens in salt water tank

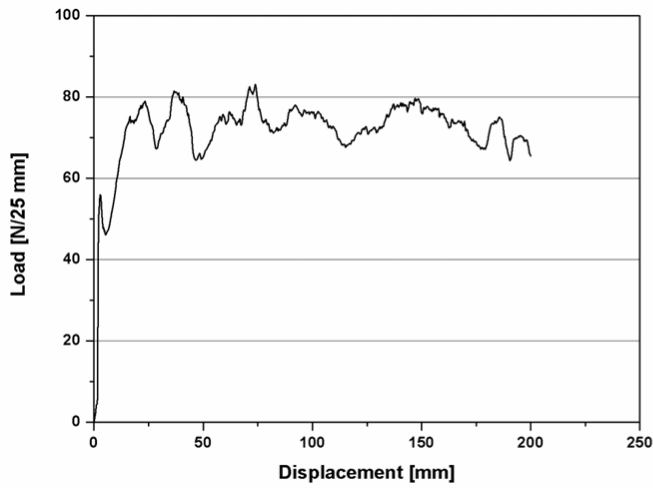
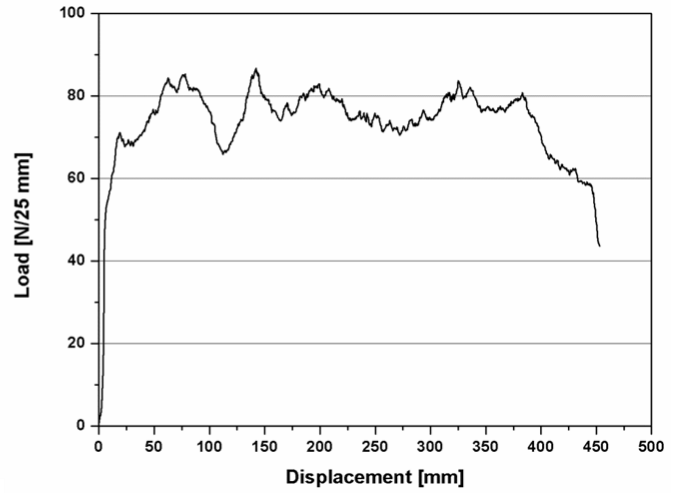
Fig. 7 Representative curves of dry specimens with: a) 250 mm length; and b) 500 mm length
