## Morphodynamic trends of the Ribb River, Ethiopia, prior to dam construction

Geosciences (Switzerland)

# Morphodynamic Trends of the Ribb River, Ethiopia, Prior to Dam Construction

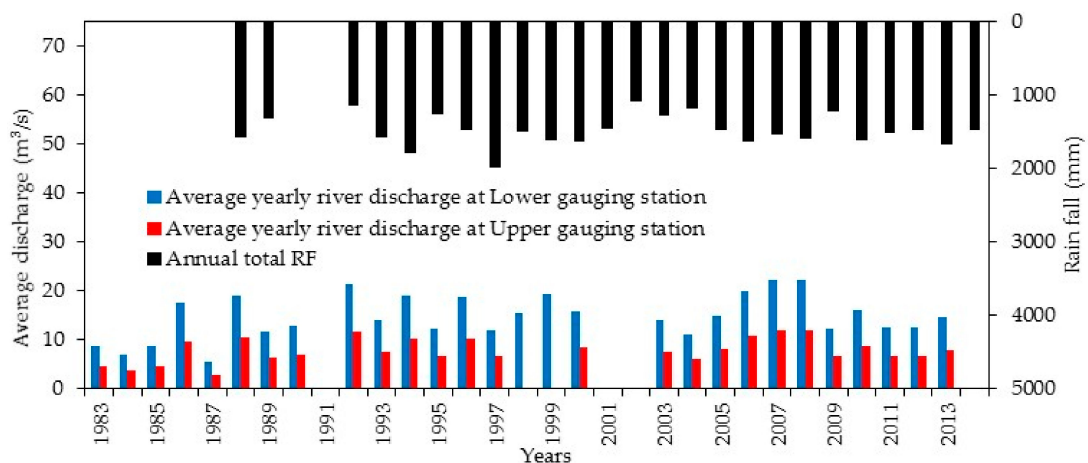
**Figure 2.** Yearly rainfall from the year 1988 to 2014 and average Ribb River discharges from the year 1983 to 2013 for the Lower and Upper gauging stations. The graph does not show any increasing or decreasing trends. Data source: National Meteorological Agency and Ministry of Water, Irrigation and Energy, Ethiopia.

The average annual maximum temperature in the upper part of the Ribb River basin is 27 °C, while the minimum falls below 0 °C in December (Debre Tabor meteorological station). The temperature increases near Lake Tana, where the average annual maximum and minimum values become 35 and 11 °C, respectively (Addis Zemen meteorological station). The Ribb River flow depends mainly on rainfall. The catchment receives a yearly rainfall of 1300 mm (data from the period 1988–2015), of which 80% occurs between the months of June and September. The annual rainfall at Debre Tabor meteorological station, assumed here representative for the Ribb basin, does not show any increasing or decreasing trends in the last three decades (Figure 2), although there are considerable

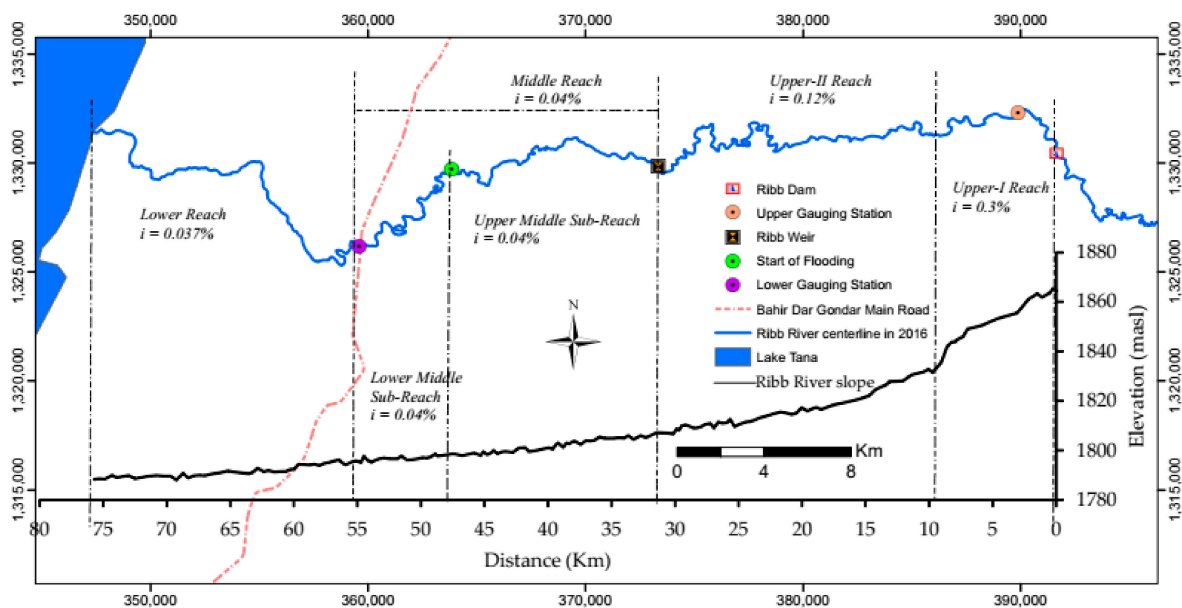
**Figure 3.** Ribb River study reach, sub-reaches and riverbed profile from the dam site to Lake Tana. The river alignment is derived from Google Earth images of 2016. The slope is obtained from 30 m resolution Digital Elevation Models (DEM) of Advanced Spaceborne Thermal Emission and Reflection Radiometer (ASTER) satellite images of 2014.

The study river reach has a length of 77 km, starting at the Ribb Dam site to Lake Tana. This reach is here sub-divided into four parts: Upper-I, Upper-II, Middle and Lower reaches (Figure 3). The presence of riverbed fixation (rock outcrops and weir), the junction of major tributaries, the longitudinal slope, the channel width and the presence of anthropogenic interventions (sand mining, embankment construction and water extraction) are the basis of this sub-division.

The Middle reach (sub-divided in Upper Middle and Lower Middle) is 25 km long, from the weir site to the Ribb Bridge (Figure 3). The reach is sub-divided based on the existence of embankments for flood protection. The Upper Middle sub-reach is 15 km long and extends from the weir site to the start of the embankment, while the Lower Middle sub-reach forms the remaining 10 km where embankments are present. This part of the reach experiences flooding due to reduced channel conveyance capacity [23]. The Middle reaches have a relatively gentle slope of 0.04% and a sandy bed.

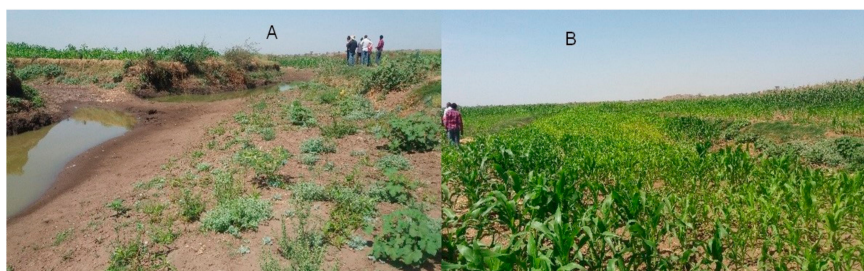
**Figure 5.** Lower Ribb River reach. (A) the point where the river loses its channel; (B) maize plantation using residual moisture along the river channel downstream of location A.

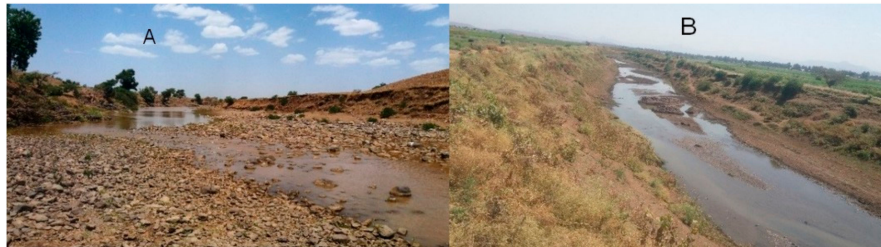
**Figure 6.** River bed and bank material in the Upper-I (A) and the Lower Middle (B) River reaches (March 2016).

The Ribb River channel has a meandering planform with sporadic central bars in the Upper-I reach where the channel is wider. Point bars inside river bends and alternate bars are observed in the Upper-II, Middle and Lower River reaches. Figure 6 shows the riverbed and banks in the Upper-I reach and Lower Middle sub-reach.

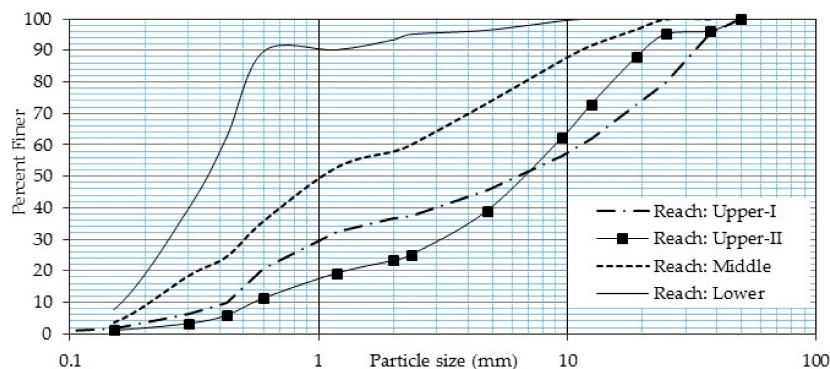
**Figure 7.** Grain size distribution of Ribb River bed material downstream of the Ribb Dam site, upstream and downstream of the weir site and upstream of the Ribb Bridge, at Universal Transverse Mercator (UTM) coordinates 37P 0388475, 1332080, 1872 m a.s.l.; 37P 0373692, 1329576, 1819 m a.s.l.; 37P 0368803, 1330762, 1804 m a.s.l. and 37P 0359808, 1326196, 1795 m a.s.l., respectively (Samples were collected in March 2016).

The granulometric curves of the bed material (Figure 7) show that the Ribb River sediment becomes finer in the downstream direction [13,24].

The riverbed near the dam site is dominated by a mixture of gravel (65%) and sand (35%). The bed material gradually changes to sand near the weir site (60% sand and 40% gravel). Further downstream, the riverbed is composed of 90% sand. The median grain size,  $D_{50}$ , is 7 mm in the Upper I and Upper II reaches and decreases to 0.65 mm in the Middle (the Upper and the Lower) reaches and 0.35 mm in the Lower reaches. Historical data on sediment grain size are lacking and this does not allow for assessing their temporal evolution.

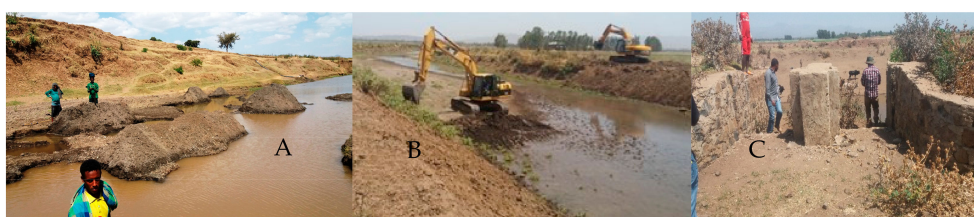
**Figure 8.** (A) excavated sand accumulation by sand miners in the Middle River reach; (B) river channel enlargement and deepening to increase flow conveyance. The contractor used the material for embankment construction at the Lower reach; (C) flood outlet structure to the farmlands as low height weir (April 2016).

The Ribb River has been subject to long years of sand mining (Figure 8A) and water extraction for irrigation during the dry season (Figure 9A). The prolonged sand mining activity in the Middle and Lower River reaches has clearly affected the natural riverbed topography. Sand miners extract sand from bar tops during low flow conditions, altering the shape and height of sand bars, as well as the sediment balance of the river. This activity has steadily increased in the last 30 years.

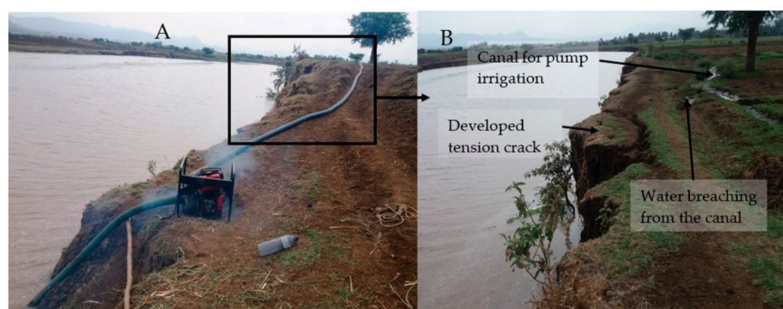
**Figure 9.** (A) water extraction with a diesel pump for irrigation; (B) irrigation canal to transport extracted water, which has been breached, and adjacent failing banks. The photos were taken immediately upstream of the under-construction Ribb weir in April 2017.

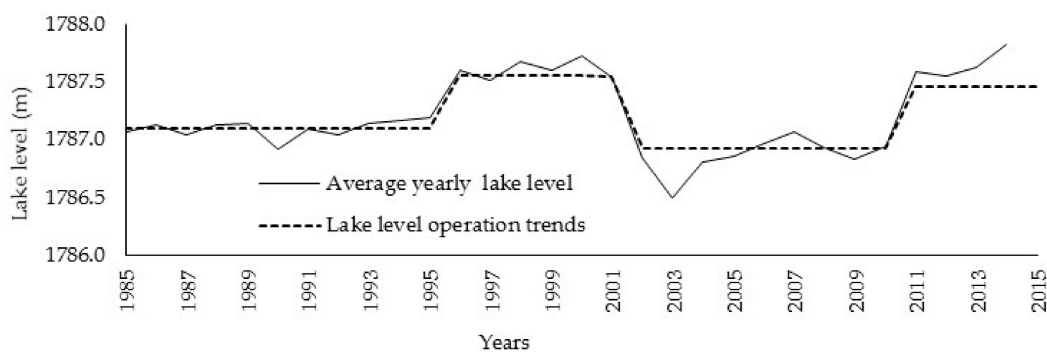
**Figure 10.** Mean annual Lake Tana level since 1985 (data source: Ministry of Water, Irrigation and Energy, Ethiopia).

The Ribb River debouches in Lake Tana, which had a regulated level for hydropower production since 1995. It shows three distinct operation periods: (1) a rise by 45 cm in the period 1995–2001, (2) a drop by 53 cm in the period 2001–2010, and (3) a rise by 62 cm in the period 2010–2015 (Figure 10). Increased flooding and the recent channel avulsion of 2008 have been often attributed to past lake level regulation.

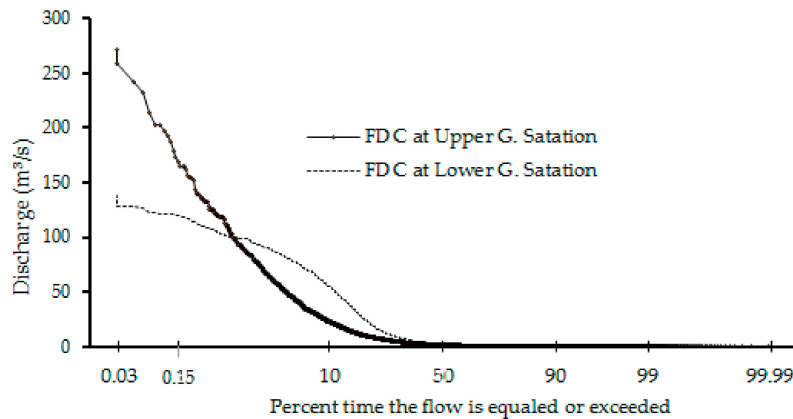
**Figure 11.** Flow duration curves at the Lower and Upper gauging stations (data source: Ministry of Water, Irrigation and Energy).

The FDCs derived for the gauging stations are shown in Figure 11. It is evident that the peak discharge at the Upper gauging station is substantially greater than the one at the Lower gauging station. This is likely due to overbank flow reducing the discharge exceeding the bankfull by as much as 71% at the Lower gauging station [21].

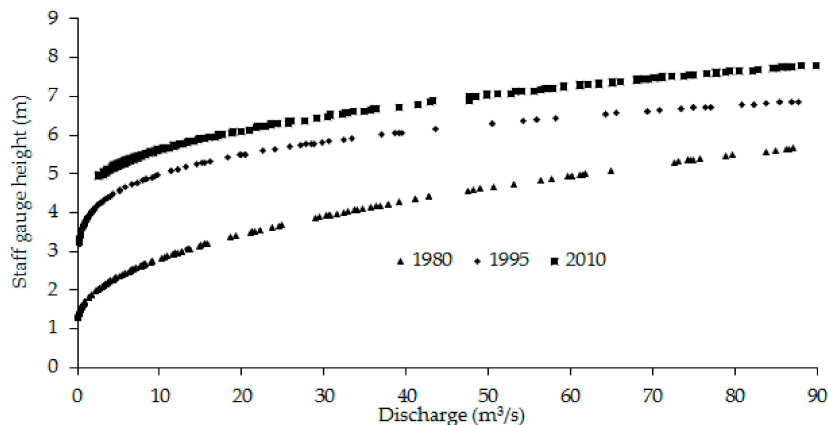
**Figure 12.** Ribb River staff level at the Lower gauging station with corresponding discharges (Data source: Ministry of Water, Irrigation and Energy, Ethiopia).

The time-series of daily water levels at the Lower gauging station shows that the riverbed rose by 2.2 m (14.7 cm/year) and 0.7 m (4.4 cm/year) between 1980 and 1995 and between 1995 and 2010, respectively, which is 2.9 m in 30 years (1980 to 2010) (Figure 12). Similarly, the nearby Gumara River bed rose by 2.91 m (6.3 cm/year) between 1963 and 2009 [18]. The adjacent Megech River to the north has similarly experienced sedimentation of the old channel downstream of a bifurcation since 1998 [23]. This means that sedimentation is observed in practically all rivers debouching in the Lake Tana from the Fogera plain.

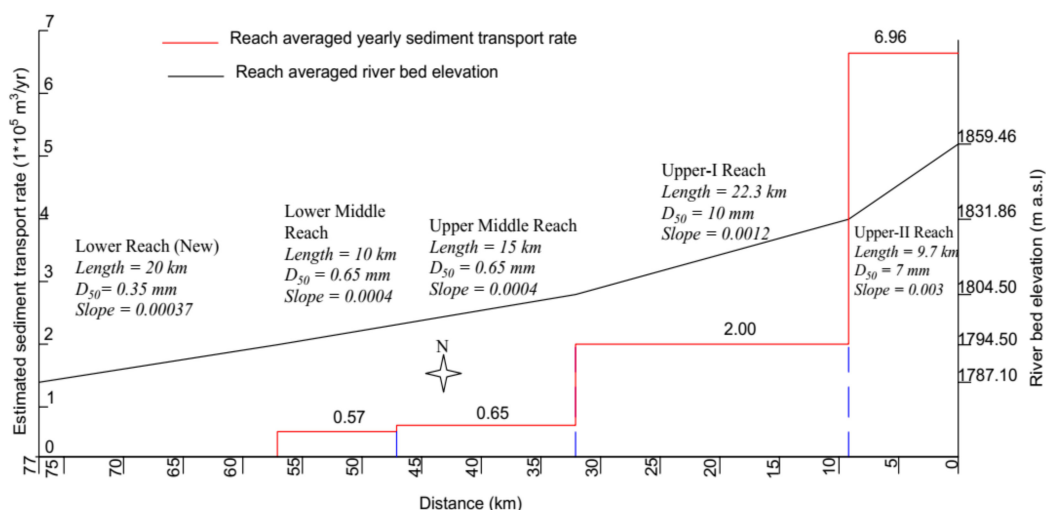
**Figure 13.** Sedimentation trend along the Ribb River based on estimated sediment transport rates. Distance of 0 km corresponds for dam site while 77 km is Lake Tana.

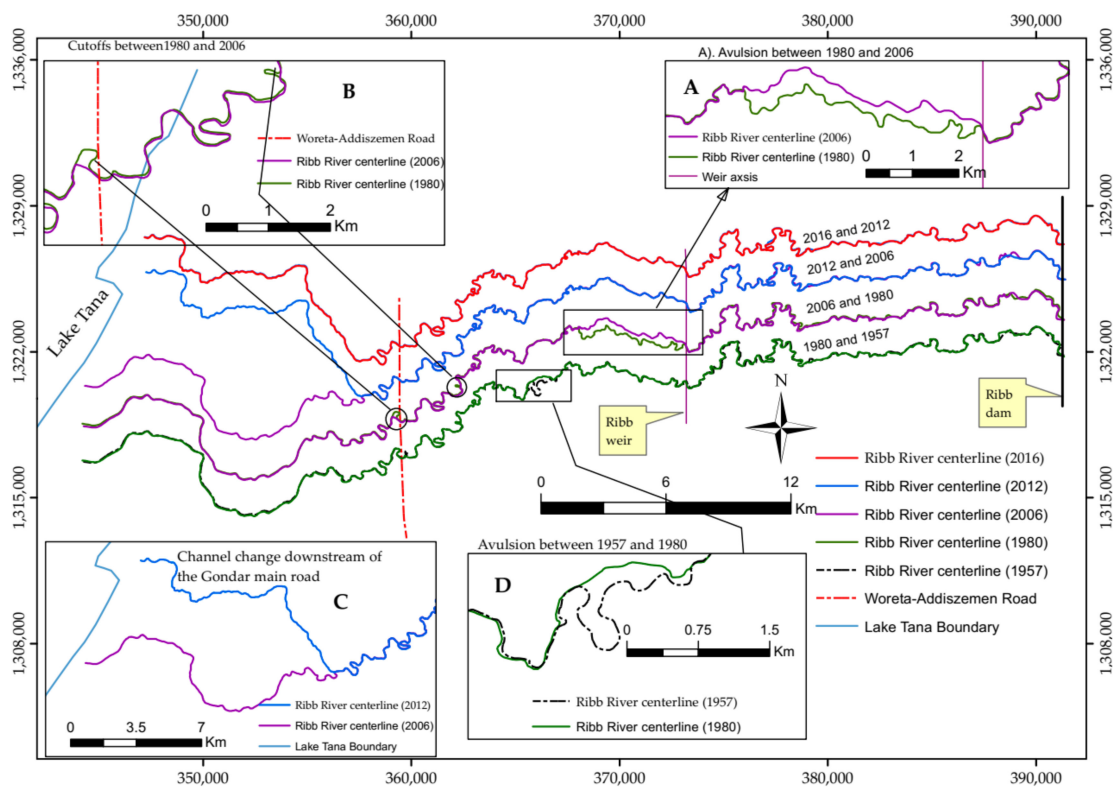
**Figure 14.** Successive Ribb River centerlines. (A) avulsion developed between the years 1980 and 2006; (B) cut-off developed between the years 1980 and 2006; (C) complete channel change between the years 2006 and 2012; (D) cut-off developed between the years 1957 and 1980.

The river reach-scale characteristics in 1957, 1980, 2006, 2012 and 2016 are presented in Table 2, where negative values for sinuosity changes indicate length reduction. The river planform changes caused by bank retreat, cut-off formation, channel avulsion, and complete channel blockage between 1957 and 2016 are shown in Figure 14.

The analysis of aerial photographs and satellite images shows that the study reach of the Ribb River reduced its length from 81 to 77 km since 1957. In the Upper-I and Upper-II reaches, the river has experienced only little planform changes, with  $-4.08\%$  and  $11.28\%$  sinuosity changes resulting in 0.2 km length reduction and 1.5 km length increment between 1957 and 2016, respectively. The rocky nature of the channel bed and banks in the Upper-I reach controls channel shape and width. The Middle reach reduced in length by 2.4 km, resulting in a sinuosity reduction of 16.9%. This was due to a channel avulsion event (Figure 14A) and a cut-off (Figure 14B), which occurred in the period 1980–2006. Another cut-off event (Figure 14D) occurred in the period 1957–1980. The small avulsion in Figure 14A reduced

the channel length from 7.4 to 6.3 km and the sinuosity from 1.41 to 1.20, while the cut-off in Figure 14D reduced the river channel length from 3.0 to 1.4 km and the local sinuosity from 2.51 to 1.11. Generally, channel cut-offs and avulsions immediately increase the energy slope and the bed shear stress and may coarsen the riverbed materials [42]. However, in the absence of further changes, the channel tends to restore its characteristics (slope, width, etc.) as before the shortening, with channel incision as a result. Embankments have been built in the Lower Middle sub-reach to reduce flooding. These embankments have also drastically reduced local channel migration. In the Lower reach, the channel experienced sedimentation, which resulted in complete river channel blockage starting 4 km downstream of the bridge in 2008 followed by channel avulsion (Figure 14C). The length of the new river channel is 2.6 km larger than that of the old river reach, but has similar sinuosity (Table 2).

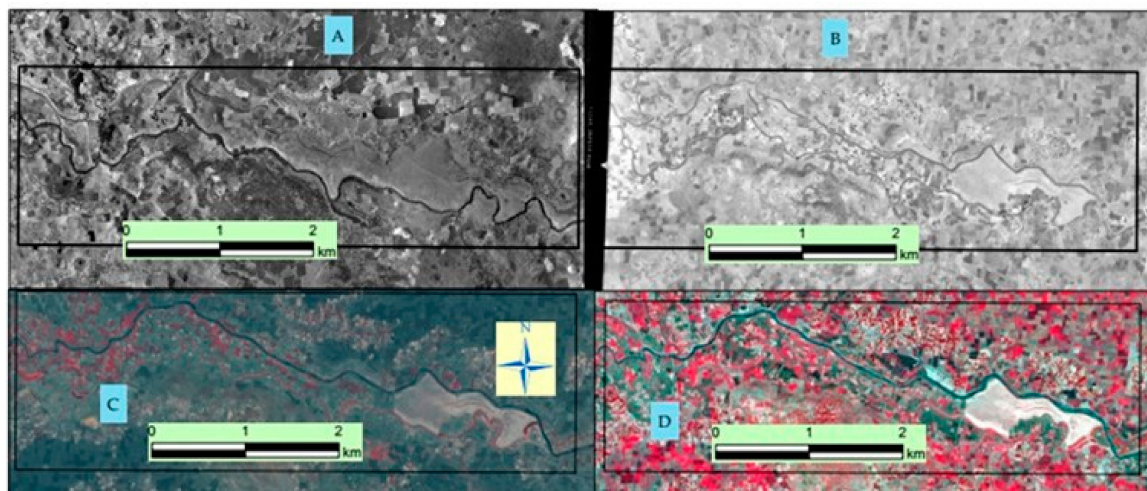
**Figure 15.** Aerial photographs and SPOT satellite images of the Middle river section downstream of the weir. (A,B) aerial photograph and river pattern of the year 1957 and 1980, respectively, and (C,D) SPOT satellite image and river pattern of the year 2006 and 2012, respectively.

The temporal river planform changes occurred in the Middle reach in the period between 1980 and 2006 are shown using the aerial photographs 1957 and 1980 and the SPOT satellite images 2006 and 2016 (Figure 15).
