A second life for school buildings by atelier PRO architects

L M Oorschot¹

¹ atelier PRO architecten, Kerkhoflaan 11a, 2585 JB Den Haag, Nederland

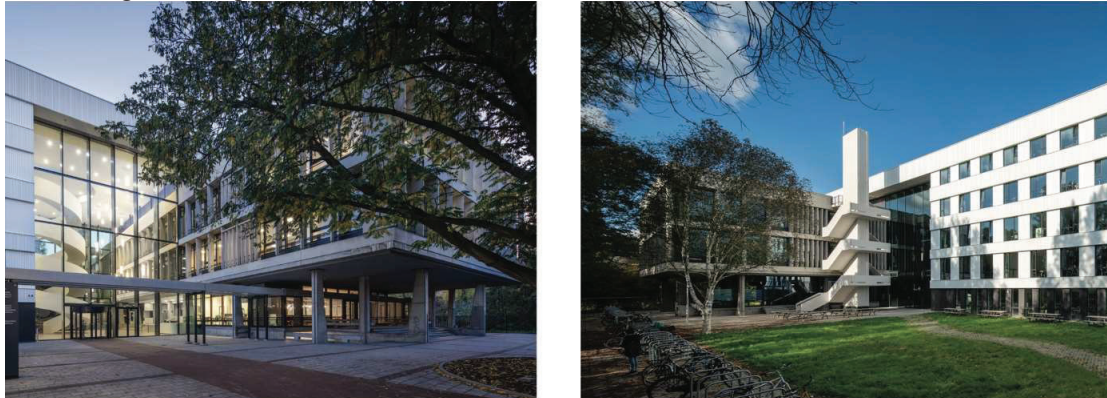
Figure 1. Lumion College Amsterdam after the renovation.
Source photos atelier PRO architects, photos by Jan Paul Mioulet

The design-tender for the Caland 2 Lyceum (later renamed to Lumion) started in 2013. A new secondary school and sport facility for 1,300 students with a completely new vision on education in accordance with the principles of personalised learning of Kunskapsskolan. In this concept the school is divided into small clusters for 160 students, each with an individual entrance and eight classrooms around an indoor square. The existing plot in the neighbourhood Sloten was a controversy between the school foundation, which wanted a new school on a new plot, and the municipality. The original building was created in 1973 by the architect Joh. Bernhard Ingwersen in béton brut architecture and it was listed by the municipality in 2008, see Figure 1. The foundation did not carry out building archaeological research because the building did not match with their educational vision about personalised learning, so they wanted it demolished. In order to gain an advantage, they decided to wait for the March 2014 elections. After that the municipality and foundation came to an agreement about which part would be demolished and which preserved. The design-bid-phase started early 2015. The school organisations in Amsterdam were reorganised and the name changed to ‘Stichting Openbaar Voortgezet Onderwijs Progreso’ (SOVOP). In the preliminary concept design in April, the preserved part was radically separated from two new building parts. The first preliminary design was ready on October 26, 2015. The process management was transferred from the school foundation to the Projectmanagementbureau (PMB) of Amsterdam in April 2016 and a second preliminary design was produced 9 March 2016. Yet the conflict between the municipality and the foundation had not ended there. They still discussed how much of the building should be allowed to be demolished and what had to be preserved in the interior. After a presentation by the architect a positive advice was received on May 25, 2016 from the commission ‘Welstand en Monumenten’ for the new building part. Moreover, even though the school foundation was still not convinced it was necessary, a building archaeological research on the historic part was completed on August 26, 2016 under pressure by the municipality. In the final design, completed back in July 2016, there was still discussion about the interior and the amount of preservation and advice from the commission on September 28, 2016 was negative about the renovation of the interior of the existing building. Finally, though, they gave a positive advice under certain conditions on October 19, 2016. All the conditions were discussed in a meeting with PMB and members of the department of Monuments & Archaeology (M&A) on November 18, 2016 and an agreement was reached. In the construction documents and bid specifications for contractors on December 2, 2016, the starting point was agreed upon. The historic building was compact with a good Form Factor. It had an open building structure with a centre core of staircases, toilets and auxiliary spaces. There were corridors around the core and classrooms along the façade. The infill was more or less flexible. This smart layout inspired atelier PRO to do the same with the new addition creating a spiral staircase in the middle of a central hall. There was a debate about the infill of the existing building. The window frames between classrooms and corridors with an architectural value had to be maintained. The municipality and foundation reached a compromise whereby some would be restored and others removed and adapted to the principles of the Kunskapsskolan. The removed window frames were reused as wood panelling elsewhere in the building. A glass-appliqué designed by artist Joop van den Broek in 1972 was restored. Eventually the school board plans to hide this piece of modern art behind a wall because it is not in line with their vision.

Under pressure by the municipality the new wall was removed. Construction started in August 2017 and the building was completed in May 2019.
