Development of fragility curves for railway embankment and ballast scour due to overtopping flood flow

Natural Hazards and Earth System Sciences

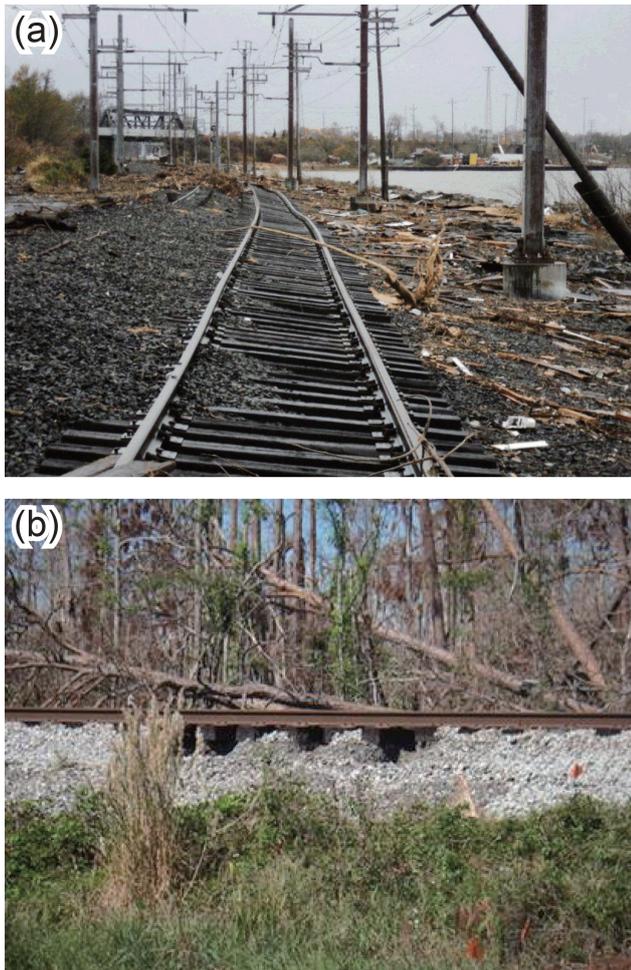
Figure 1. Railway ballast scour failures: (a) New Jersey Transit tracks in New Jersey, USA, after Hurricane Sandy in 2012; (b) CSX railroad tracks in Mississippi, USA, after Hurricane Katrina in 2005 (photo credits: New Jersey Transit, a).

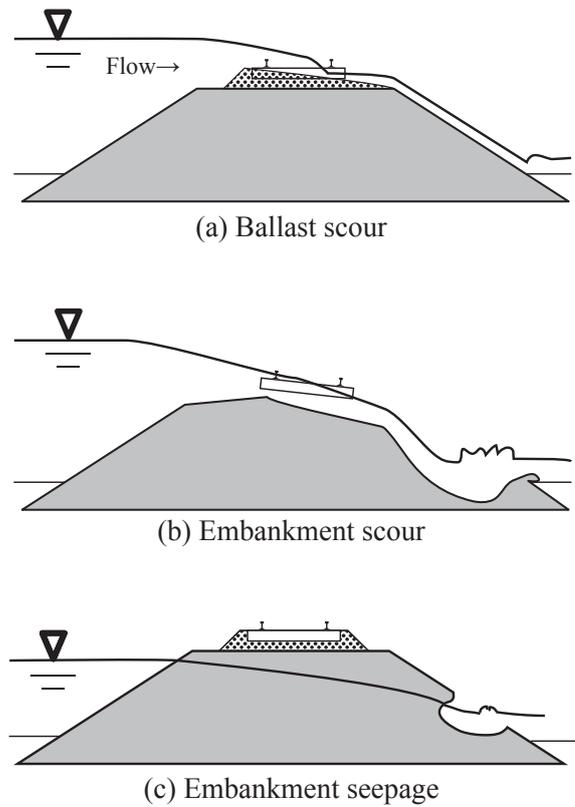
Figure 2. Railway embankment damage types.

ometrically similar to roadway embankments and levees, the structures atop railway embankments are very different from those atop these other embankments, as are the mechanisms by which overtopping can cause damage. As Fig. 2 shows, floods can cause damage to railway embankments via three processes: (a) scour of ballast induced by overtopping, (b) scour of both ballast and embankment fill by overtopping, and (c) piping/seepage failure of embankment fill. Though piping/seepage failure of fill is more likely to occur in high (and wide) embankments, most railway embankments are relatively low, and most observed railway embankment failures appear to have been the result of overtopping-induced scour of embankment fill and/or ballast (Kaneko, 2010; Tsubaki et al., 2012a; Onoda and Hayano, 2015). Ballast scour is a damage mode unique to railway embankments. In the cases of ballast scour only, repair of the ballast layer is relatively straightforward, but in cases of embankment fill scour, repairs can be costly and take a long time. Repair of damage to an embankment is less expensive than repair of damage to bridges and other facilities (see Table 1), but ballast and embankment damage occurs much more frequently than bridge damage. Furthermore, river floods or tsunamis large enough to damage bridges usually also cause extensive flooding which leads very long sections of an embankment to wash out (e.g., Shimozono and Sato, 2016). Therefore, the development of fragility curves for scour of railway ballast and embankments is crucial for the assessment of railway vulnerability and resilience.

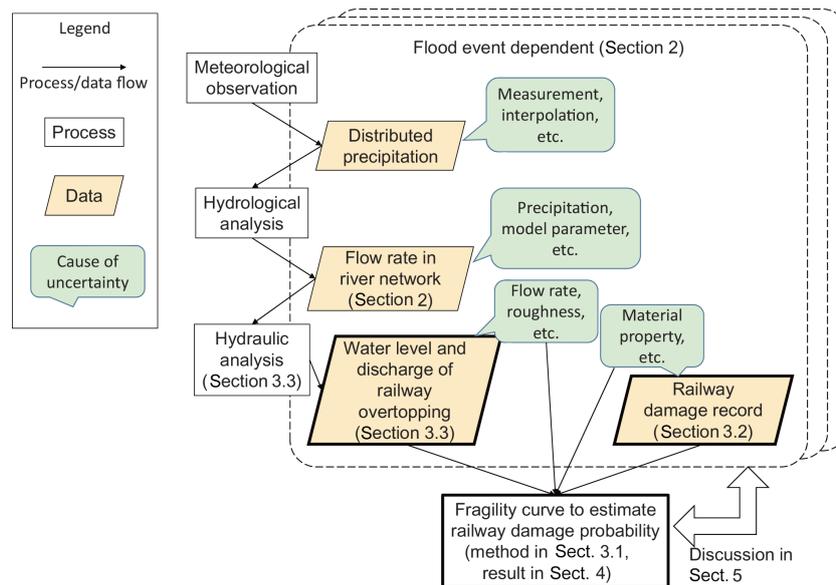
Figure 3. Relationship between processes and data within the structure of this paper.

Figure 3 shows the relationship between the processes and data used in this study. The two flood events for which damage records exist, as well as the estimated flow rates in the river networks during these events, are described in Sect. 2. Section 3 is devoted to the methods used in this study. Fragility curves are introduced in Sect. 3.1. Railway damage recorded for the two flood events is described in Sect. 3.2. The method of hydraulic analysis and uncertainty in the estimated water depth are both described in Sect. 3.3. Based on the results of Sects. 3.2 and 3.3, the fragility curves are developed in Sect. 4. Discussions including the comparison between the estimated damage probability and recorded damage types are reported in Sect. 5. Section 6 highlights the conclusions of this study.

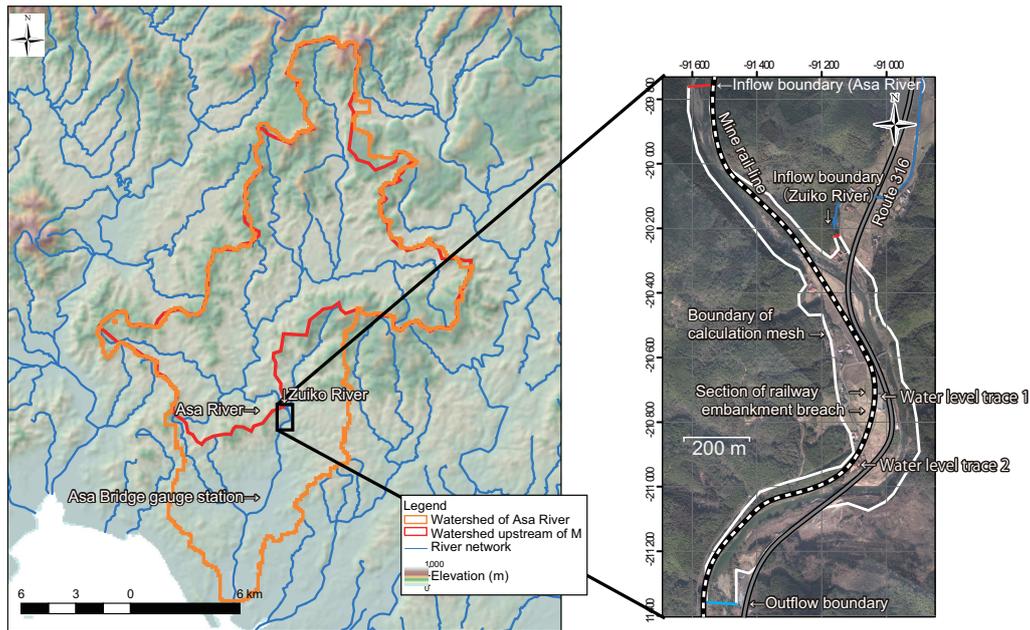
Figure 4. Watershed of the Asa River (left) and aerial photo taken in 2011 of section M (right). (Source: National Land Numerical Information download service, Ministry of Land, Infrastructure, Transport and Tourism, Japan, for digital elevation model, watersheds, and river network.)

In June 2010, a large flood occurred along section M (see Fig. 4) of the Asa River and caused inundation of homes and a factory, as well as washout of a railway embankment (Yamasaki et al., 2010; Tsubaki et al., 2014). The left-hand map in Fig. 4 outlines the watershed upstream of section M of the Asa River in red, while the watershed of the entire reach of the Asa River is outlined in orange. A storage function model, with parameters calibrated to previous major events, was used to calculate an event-dependent model parameter R_{sa} (a saturation criterion to start runoff), which was determined via best fit to the discharge hydrograph measured at the Asa Bridge gauge station (location indicated in the left panel of Fig. 4) based on four error criteria (Ube Construction Office, 2012). The estimated maximum flow rate in the Asa River was $811 \text{ m}^3 \text{ s}^{-1}$ (Ube Construction Office, 2012), while the inflow from the Zuiko River was $110 \text{ m}^3 \text{ s}^{-1}$. Though it is possible that the peak flow in each river would reach their confluence at slightly different times, the same hydrologic model showed that the maximum flow at a point 3 km downstream of the confluence was

Water levels hindcast by the flood simulation are compared with measured water level traces from two locations depicted in the right panel of Fig. 4. Steady flow boundary conditions were used for model inflow and outflow, though the presence of vortices (circulatory flow) over the floodplain and near the riverbanks caused a complex velocity field and prevented perfectly steady flow from forming (Tsubaki and Kawahara, 2013). Due to these fluctuations, modeled water levels were assessed via both 20 min running averages representing each minute of model output, as well as maximum water levels during these same intervals. Flood elevation trace no. 1, on the inner wall of the factory, was measured to be 25.98 m (in Tokyo datum, hereafter). The average modeled flood elevation here was 25.79 m, and the maximum modeled flood elevation at this location was 25.90 m. At location no. 2,

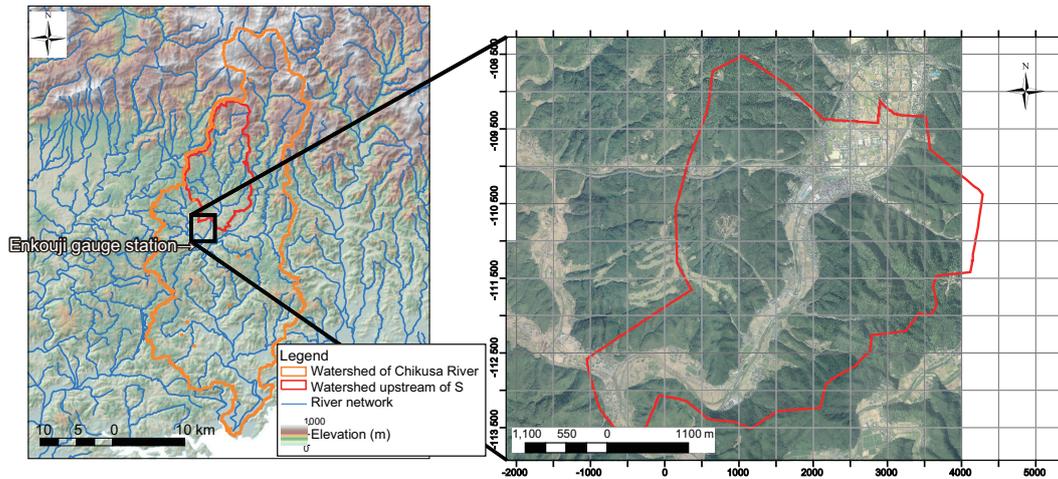
Figure 5. Watershed of Chikusa River (left) and hydraulic flood model domain in section S of Sayo River (right). (Source: National Land Numerical Information download service, Ministry of Land, Infrastructure, Transport and Tourism, Japan, for digital elevation model, watersheds, and river network and Kinki Regional Development Bureau, Ministry of Land, Infrastructure, Transport and Tourism Japan for the aerial photo taken in 2010.)

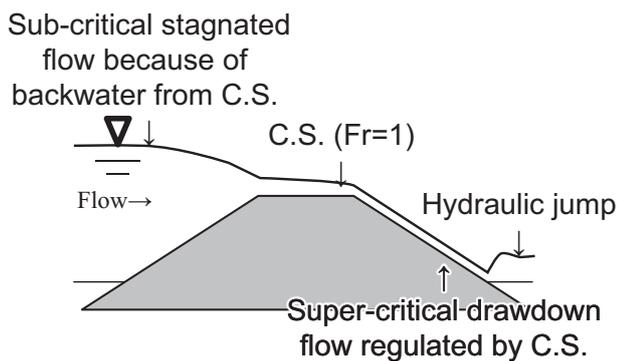
Figure 6. Schematic diagram of one-dimensional flow over embankment. C.S. in figure corresponds to the critical section where the flow is critical.

In this paper, we use upstream flood water level (overtopping surcharge) as a variable explanatory for railway overtopping failures. As schematically depicted in Fig. 6, under the situation of water overtopping an embankment, critical flow occurs on the embankment (C.S. in Fig. 6) and the upstream water level correlates almost directly to the overtopping discharge (Chow, 1959; Dawson et al., 2005; Apel et al., 2009). The upstream water has less velocity head and the surface is relatively flat, whereas the overtopping flow atop the embankment is rapidly varied flow and quite sensitive to small differences and uncertainty in the local elevation of the em-

bankment crest. The flow on the lee side of embankment is supercritical and the water level is regulated by the C.S. The local flow rate over the embankment crest estimated by the embankment-resolving fine-resolution inundation simulation (e.g., Tsubaki and Kawahara, 2013) has non-negligible uncertainty because of high sensitivity to the embankment shape and height represented by the undulation of the calculation grid based on the digital elevation model and land cover data. This is because exchange between kinetic and potential energies is actively occurring in this area (Chow, 1959), leading to a two-dimensionally undulating water surface profile and inhomogeneous velocity distribution (Tsubaki and Kawahara, 2013). For these reasons we use the upstream water level as a hazard level to explain the probability of railway failure.

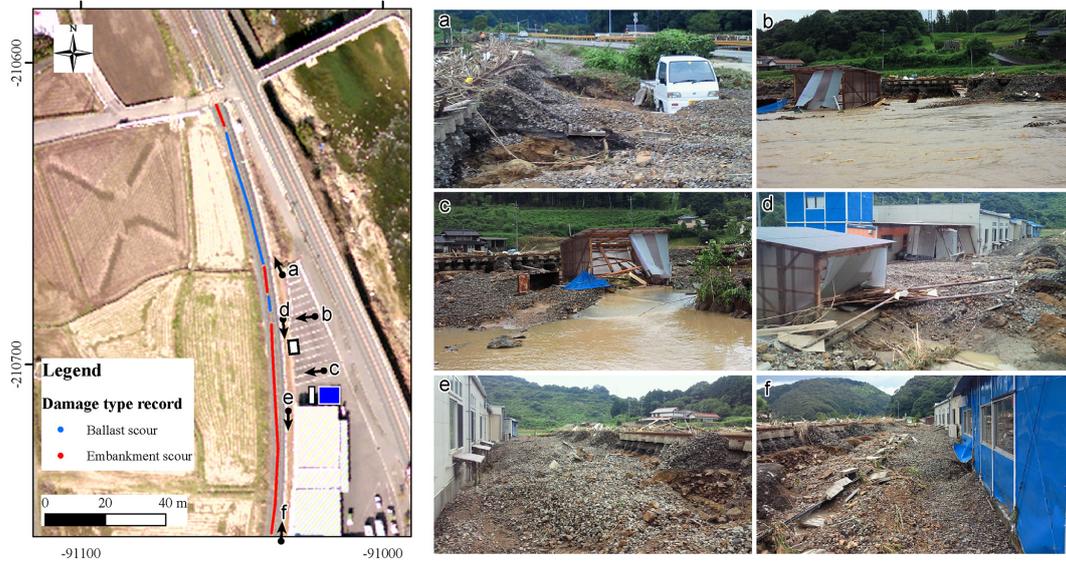
Figure 7. Example of the photos showing the status of the railway ballast–embankment scour just after the flood. Shooting location and direction of each photo are both plotted in the left orthorectified aerial photo taken in February 2012 (photo source: M. Kikunaga).

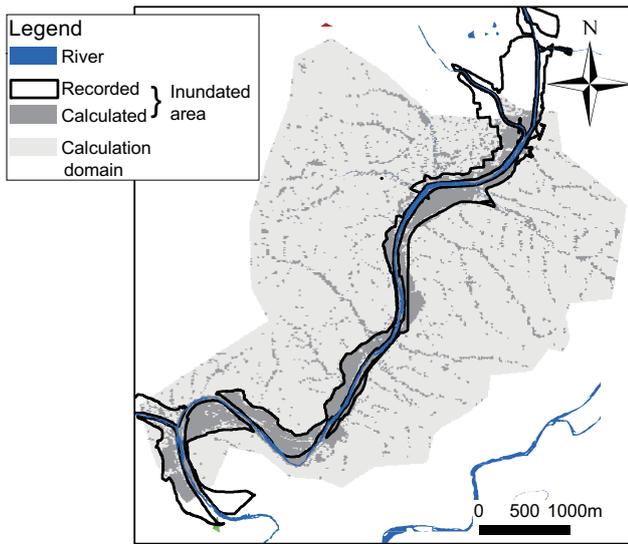
Figure 8. Comparison of calculated and recorded inundation areas (Tsubaki et al., 2012a).

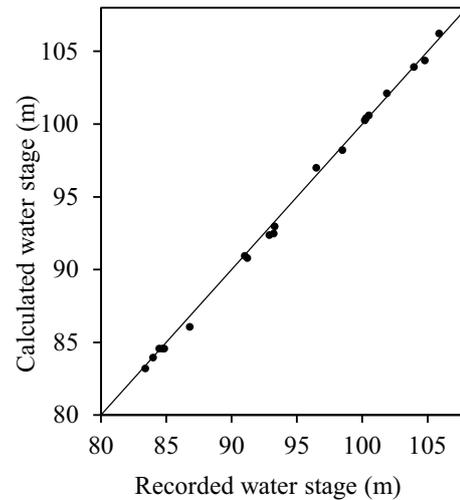
Figure 9. Comparison of calculated and recorded flood stages in Tokyo datum. The straight line shows the perfect-agreement line, i.e., recorded water stage = calculated water stage (Tsubaki et al., 2012a).

cover on the embankment slope. Moreover, there is a difference in the definitions of calculated and recorded water depths, namely the calculated water depth is a cell-averaged quantity but the recorded water depth denotes the local water depth around obstacles; this caused an underestimation of the calculated water depth as reported in Sect. 3.3.2a for the Asa River and shown in Fig. 9 for the Sayo River.

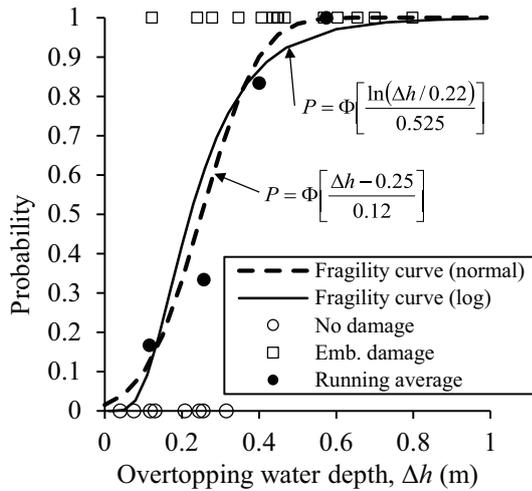
Figure 10. Fragility curves for embankment scour damage described by normal and log-normal distributions.

Figure 10 displays the fragility curves for the embankment scour using the normal distribution (depicted by the dashed line with log-likelihood $\ln(L) = -7.3$) and the log-normal distribution (the solid line with log-likelihood $= -7.9$) resulting from data points at which either no damage (the number of samples was $n = 8$) or embankment scour ($n = 16$) was observed at two flood events. In Fig. 10, open symbols represent individual data points, while filled figures represent overtopping water depth and damage data which have been put through a five-point running average after ordering by overtopping water depth. Though both normal and log-normal distribution models (solid and dashed lines, respectively) represent well the trend of damage probability based on the field record (filled circles), the normal distribution has a slightly better fit.

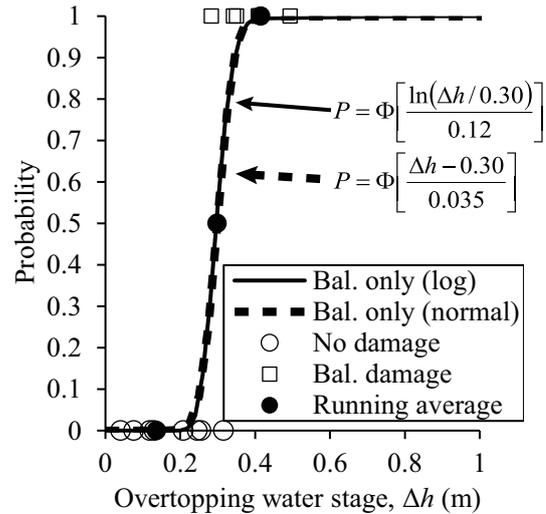
Figure 11. Fragility curves for ballast scour damage described by normal and log-normal distributions.

Figure 11 shows the fragility curves for the ballast scour using the normal distribution (depicted by the dashed line with log-likelihood $= -2.6$) and the log-normal distribution (the solid line with log-likelihood $= -2.6$) resulting from data points at which either no damage (the number of samples was $n = 8$) or ballast scour ($n = 7$) were observed during the two flood events. The normal and log-normal curves were almost identical.

In Fig. 11, the fragility curve for ballast scour has a median overtopping water depth of $\Delta h = 0.30 \text{ m}$, and its variance $\sigma = 0.035 \text{ m}$ is smaller than those of the fragility curves for the embankment scour and combined ballast and embankment scour. It must be kept in mind that the lidar topography used in the flood model has an RMSE on the order of 0.1 m , and the uncertainty in hindcast flood levels was on the order of 0.2 m , so the standard deviation $\sigma = 0.035 \text{ m}$ of the ballast scour model is very small compared with expected uncertainty in the estimated overtopping water level. The experiment of Tsubaki et al. (2012b) showed ballast scour to begin at $q_c = 0.045 \text{ m}^2 \text{ s}^{-1}$, which is an order of magnitude smaller than the median ($q = 0.4 \text{ m}^2 \text{ s}^{-1}$) or lower limit ($q = 0.25 \text{ m}^2 \text{ s}^{-1}$) of the fragility curve for ballast scour shown in Fig. 13. Therefore, it appears the calculated fragility curve for ballast scour in this study may overestimate the condition experimentally evaluated in Tsubaki et al. (2012b). This

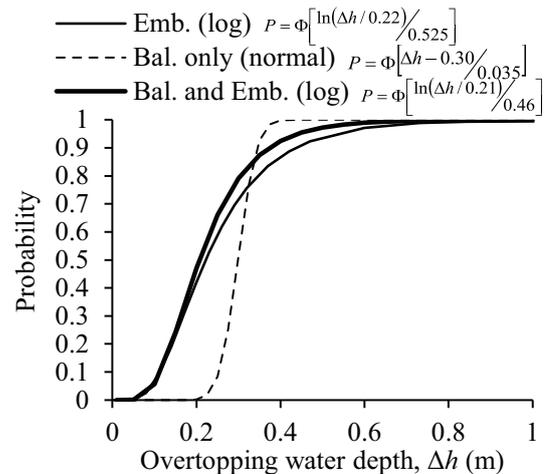
Figure 12. Fragility curves for ballast scour (Bal. only), embankment scour (Emb.), and ballast and embankment scour (Bal. and Emb.).

Figure 12 compares the normal fragility curve for ballast scour (dashed line) and a log-normal curve for the combination of ballast scour and embankment scour (thick line, log-likelihood $= -8.9$). The fragility curve for ballast scour has a larger mean and smaller standard deviation compared with the curve for embankment scour and the curve for combined ballast scour and embankment scour. The damage probability at medium overtopping water depth $0.2 \text{ m} < \Delta h < 0.6 \text{ m}$ for the combined ballast and embankment scour is slightly larger than the probability for embankment scour only.

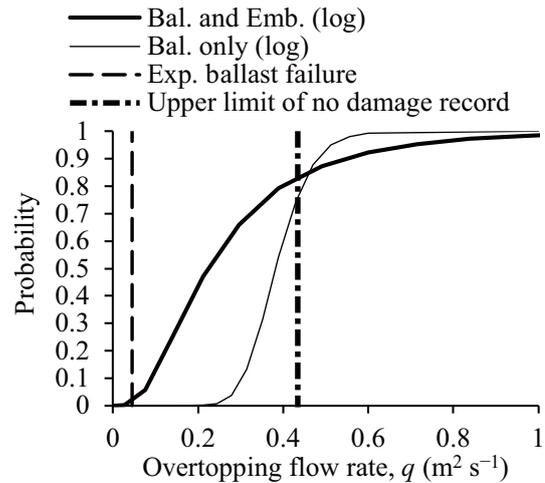
Figure 13. Fragility curve for ballast failure using overtopping flow rate per unit length. The dashed line indicates the experimental bound at which the onset of ballast scour occurs (Tsubaki et al., 2012b). The double line corresponds to the upper limit of the flow condition where no damage was observed.

The largest overtopping flow rate at which no damage was observed at the point s1 (Table A2, $\Delta h = 0.31 \text{ m}$ and $q = 0.43 \text{ m}^2 \text{ s}^{-1}$) and damage probability for this hazard level was 0.6–0.8 for all developed fragility curves (Figs. 13, 9, 10, 11, 12). The damage probabilities converge to unity for larger hazard level and convergent rate with increase of hazard level differs depending on the types of fragility curve. The fastest convergence of the damage probability to unity was observed in the ballast scour model and followed by the ballast and embankment scour model. The embankment scour model showed the slowest convergence to unity. The log-normal models also showed relatively slow convergence

to unity compared with the corresponding normal models. An overtopping flow rate of $0.5 \text{ m}^2 \text{ s}^{-1}$ (corresponding to an overtopping water depth of 0.4 m) is quite an intense flow from the viewpoint of earthen embankment overtopping (Apel et al., 2004) and it is very unlikely that no scour will occur during such an intense flow. The damage probability of the ballast scour model was almost unity but the damage probability of the embankment scour model and embankment and ballast scour model was about 0.9 and 0.95 for this range ($q = 0.5 \text{ m}^2 \text{ s}^{-1}$ and $\Delta h = 0.4 \text{ m}$). Thus, the log-normal models and the embankment scour models may underestimate the damage probability for large hazard level.

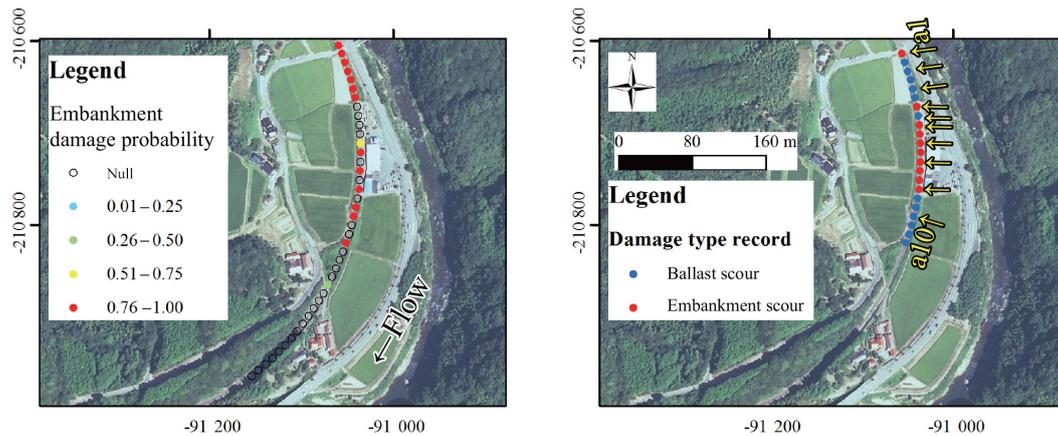
Figure 14. Estimated damage probability (left) and damage type record (right) at Asa River section M. The yellow symbols in the right map depict data points listed in Table A1.

A validation of the combined damage fragility curve, of which feasibility was discussed above, was conducted by comparing its calculated probabilities to the actual damage record. The normal distribution for combined ballast and embankment scour was determined to be the most feasible model based on the discussion in Sects. 5.1–5.3. Via the model, the damage probability along the rail track in the Asa River floodplain at 10 m intervals was calculated and plotted in Fig. 14 (left). Thirty-one of the data points, used in Sect. 4 and listed in Tables A1 and A2 to obtain the fragility curves, were selected where the damage type record was confident (e.g., not marginally at the border of two damage types), but a point array at 10 m intervals was used for the validation here. Damage probability in Fig. 14 (left) is calculated without regard to the types of failure (ballast or embankment scour), but it is calculated with the fragility curve for ballast and embankment scour; however, the actual damage record of the right figure distinguishes the type of damage. In Fig. 14, there is variability in the calculated result, but the area where the

ballast and embankment scours were observed is predicted as a high damage probability area. The points at which no damage was calculated are points at which the flood model calculated either a very shallow overtopping water depth, or no overtopping at all. The railway crest in this section is almost horizontal. Since the crest of the railway embankment consists of both rail and railway ties (sleepers), the 1 m^2 resolution lidar data cannot resolve this, and the 1.7 m^2 triangular mesh carries forward this variation, leading to an unavoidable difference between modeled and actual topography. Since actual railway crest elevation does not experience spurious variations at 10 m intervals, topography based on lidar data of limited resolution and accuracy might be improved by application of a spatial filter along the railway.

Table A1. Point-wise estimated overtopping water depth Δh and damage types for the Asa River flood. In damage types row, emb. is embankment scour, bal. is ballast scour, and no is no damage. Location of each point is indicated in Fig. 14.

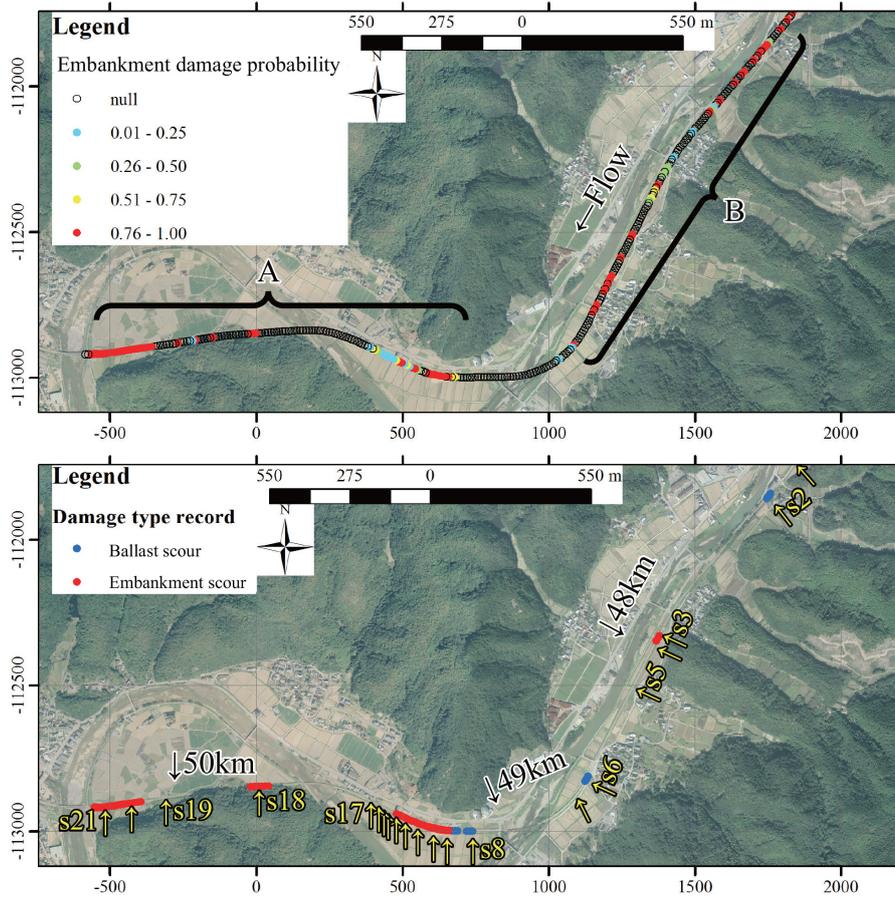
Figure 15. Estimated damage probability (top) and damage type record (bottom) at Sayo River section S. The yellow symbols in the bottom figure depict data points listed in Table A2. (Source: Kinki Regional Development Bureau, Ministry of Land, Infrastructure, Transport and Tourism Japan for the aerial photo taken in 2010.)

Figure 15 shows calculated and observed damage to the railway along the Sayo River. The domain is decomposed into two segments (A and B) in the discussion below. Continuous damage was recorded along a portion of Segment A, and this damage was reproduced well in the fragility curve calculation. In this segment, damage occurred in locations at which relatively steep slopes existed in the railway crest elevation profile (Fig. 16). Since the locations of railway embankment overtopping were governed by a longitudinal slope of the railway and large-scale topography in this segment A, the flood model was able to simulate actual overtopping location and flow rate with higher accuracy, and damage probability resulting from the fragility curve matched recorded damage well. In Segment B, estimated damage probability was high at points that experienced actual damage, but many other points estimated to have high damage probability experienced no actual damage. In regions such as this, where spatially sporadic damage is calculated, fragility curves are still useful for predicting whether damage will occur, but they cannot predict the specific locations at which the damage should be expected. In this segment, elevation of the railway embankment crest was very smooth, with no steep slopes in

Table A2. Point-wise estimated overtopping water depth Δh and damage types for the Sayo River flood. Location of each point is indicated in Fig. 15.

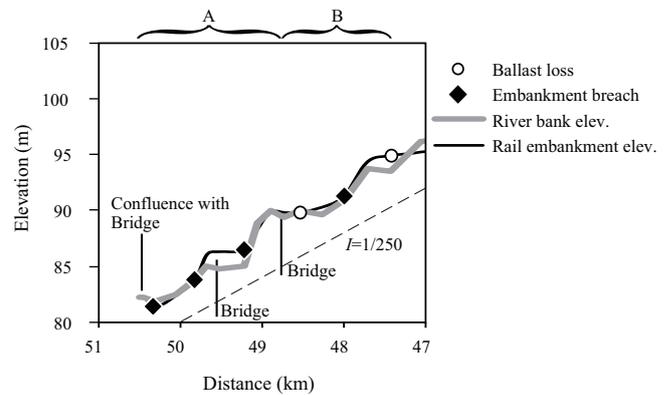
Figure 16. Longitudinal profiles of railway and riverbank elevation. The cross sections where the river and railway intersect are indicated as “bridge” (Tsubaki et al., 2012a).

crest elevation (Fig. 16). Therefore, the entire segment was overtopped with shallow surcharge. However, small errors in topography at the size of each model grid cell caused large difference in the overtopping water depth, resulting in erroneous damage probabilities at the 10 m intervals at which damage was assessed. The fragility curve concept can also account for uncertainty in hazard level (overtopping water depth in this paper) by adjusting the deviation parameters σ or ζ in Eq. (1) or (2) (Mander, 1999); in segments within which sporadic damage is predicted, the level of damage can be estimated by averaging the damage predicted for points within the segment. However, the reason damage in Segment B of Fig. 15 was not evaluated as such an average is that the error in grid-scale model topography was too large to just cause variations in overtopping water depth; rather, the error caused many points within the segment to not experience any overtopping at all. Therefore, the model predicted scattered damage for Segment B.
