Mechanical behaviour of thermoplastic composites spot-welded and mechanically fastened joints

A preliminary comparison

Composites Part B: Engineering

Mechanical Behaviour of Thermoplastic Composites Spot-Welded and Mechanically Fastened Joints: A Preliminary Comparison

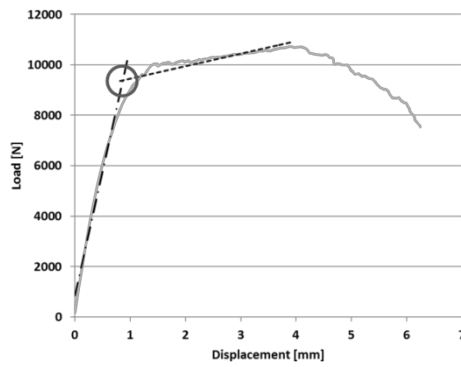
Fig. 3. Bilinear approximation (dashed lines) for the OFL of mechanically fastened joints in DLS (a) and PT (b) tests. OFL is indicated by the circles on the intersection of two fitting lines.

Load-displacement (L-D) curves recorded during the tests were utilized to characterize the mechanical behaviour of both types of joints. As illustrated in [20, 23, 27], the loading process of the mechanically fastened specimens normally shows two failure points, namely onset failure and ultimate failure. In this study, both of the load values on these two points were noted, hereafter mentioned as onset failure load (OFL) and ultimate failure load (UFL), to evaluate the load-carrying capability of the joints. The OFL was calculated by the bilinear approximation method, which is commonly used in

numerical modelling to characterize the structural failure and proved to provide good fits to the experimental L-D curves [28, 29]. An example is shown on representative DLS (a) and PT (b) L-D curves for mechanically fastened joints in Fig. 3. Linear fitting was performed on the stages before and after the stiffness reduction and the OFL was located at the intersection of two fitting lines. According to the statement in ASTM D7332 [26], OFL of specimens in PT tests is regarded as the first peak load during the loading process in correspondence with a significant load drop (more than 10%). However, the first obvious load drop for all mechanically fastened specimens was found to be lower than 10%, which will be mentioned in Section 3.2. Therefore, to keep consistent with the results in DLS tests, the OFL of the mechanically fastened joint is also calculated by using the bilinear approximation method. The UFL is recorded by the maximum load point on the L-D curves. Additionally, the linear fitting of the initially elastic stage of L-D curves corresponds to the joint stiffness (JS), which is another interesting mechanical property for the comparison between the welded and the mechanically fastened joints in this study.

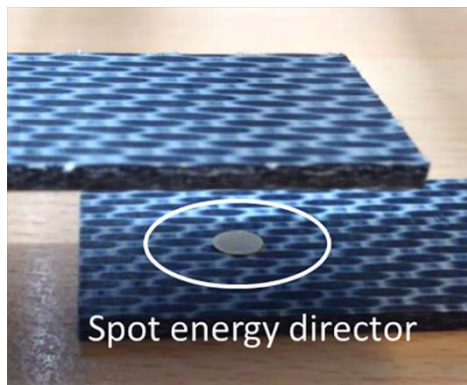
Fig. 5. Spot energy director fixed on composite adherend prior to welding process.

Spot flat energy directors, made of a neat resin film, were used to create the spot-welded joints in this study, as shown in Fig. 5. To keep consistent with the pin diameter of the mechanical fasteners, 4 mm-diameter-circular energy directors (EDs) were used, as cut from the PEEK film with a nominal thickness of 0.25 mm. Prior to the welding process, the spot EDs were manually fixed on the bottom adherend with a Rinco handheld ultrasonic welder. The ED melted, flowed and created a bigger spot-welded joint (approximately 10mm in diameter) during the welding process, which will be illustrated in detail in Section 3.1.

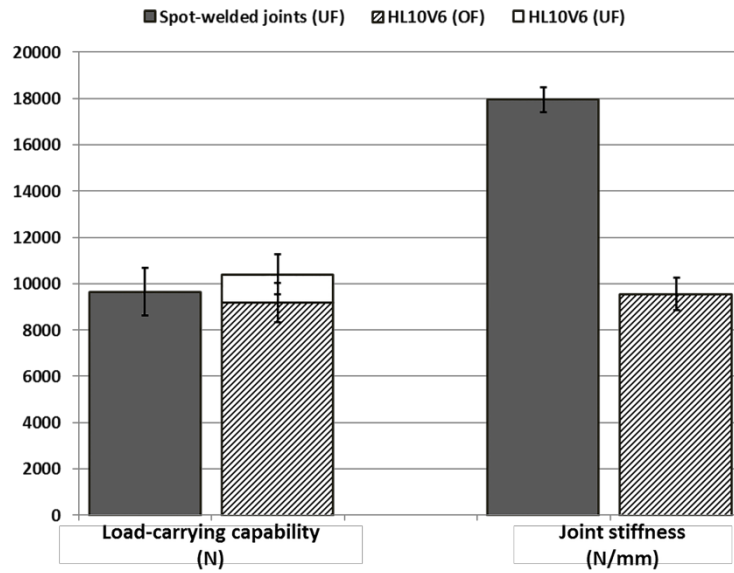
Fig. 8. Comparison of in-plane mechanical (shear) performance for both types of joints in DLS tests. (OF: onset failure, UF: ultimate failure) The error bars indicate the standard deviation.

Table 1 lists the average OFL, UFL and JS of both types of joints, accompanied by the corresponding coefficient of variation (COV) in the parentheses. Since the welded specimens failed immediately after the maximum load was reached, only UFL was represented. As mentioned in Section

2.1, the OFL of mechanically fastened joints, which is more important in the structural design rather than the UFL [23], was calculated by using bilinear approximation. It is notable that the OFL of both types of joints in DLS tests are within the same range, which is also indicated by the bar graph in Fig. 8. The variation of the load-carrying capability of both types of joints are within standard deviation, which is displayed by the error bars. In contrast, the averaged stiffness of spot-welded joints is reported to be substantially higher, by 88%, than the mechanically fastened specimens. In addition, the COV is lower for the spot-welded joints.

Fig. 8. Comparison of in-plane mechanical (shear) performance for both types of joints in DLS tests. (OF: onset failure, UF: ultimate failure) The error bars indicate the standard deviation.

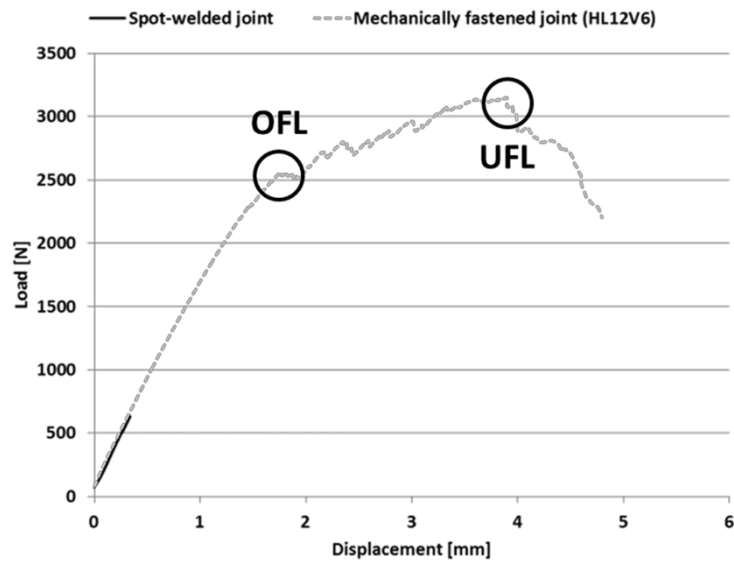
Fig. 12. Comparison of representative load-displacement curves between spot-welded (solid line) and mechanically fastened (dashed line) joints in PT tests. The left and right circles indicate the onset and ultimate failure, respectively. The data are adopted from [31].

Fig. 12 shows representative L-D curves for both spot-welded and mechanically fastened joints in PT tests. Similar to the DLS tests, spot-welded specimens exhibit a linear behaviour during the loading process without stiffness reduction. The averaged UFL is recorded at approximately 600 N, which is listed in Table 2, and is found to be much lower (by 82%) than the UFL of the specimens joined with HL12V6 fasteners. The OFL of mechanically fastened specimens are calculated by using the bilinear approximation method and the average value is shown in Table 2 and Fig. 13. The lower UFL of the welded joints is because the mechanically fastened joints relies on the titanium fastener (head) under peel loading, while the resistance to pull-through force of welded joints comes from the interlaminar strength of the composite adherends. As it is known that composite laminates have low transverse properties [22, 23], the observation that load-carrying capability on peel loading of welded specimens is not comparable to the mechanically fastened counterparts is as expected.

Fig. 12. Comparison of representative load-displacement curves between spot-welded (solid line) and mechanically fastened (dashed line) joints in PT tests. The left and right circles indicate the onset and ultimate failure, respectively. The data are adopted from [31].

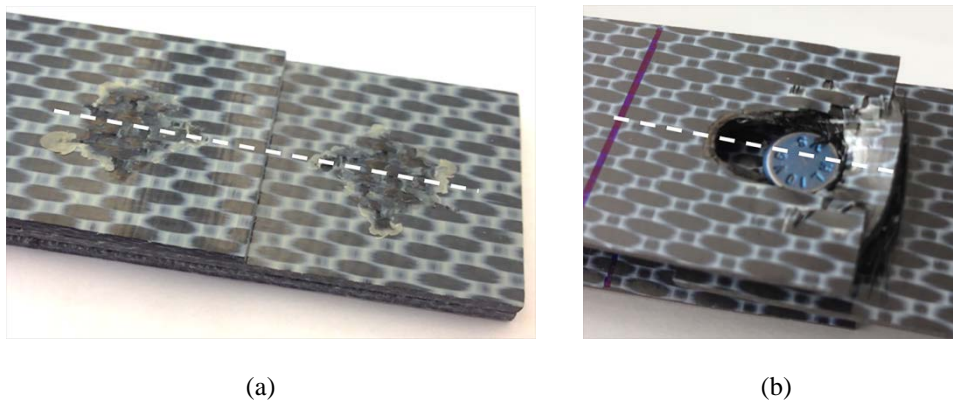
Fig. 17. Central-cut of both welded (a) and mechanically fastened (b) specimens along the dashed lines for the cross-sectional microscopy.

A combination of ultrasonic C-scan and cross-sectional microscopy was used to assess the internal damage in both the welded and the mechanically fastened joints. To characterize the through-the-thickness damage utilizing a microscope, some selected specimens were cross-sectioned through the central line of the overlap, parallel to the apparent fibre orientation, as indicated in Fig. 17. Afterwards, the sectioned specimens were embedded in epoxy and polished. The experimental results are separately shown based on DLS and PT tests.
