Bacteria-based self-healing agent for masonry repair: applicability to cement-lime mortars

Maria B. Gaggero^{1*}, Paul A. Korswagen¹, Rita Esposito¹ and Jan G. Rots¹

Abstract. In the pursuit of introducing bacteria-based self-healing mortar for masonry repair, this study examined the potential of incorporating a poly-lactic acid (PLA) agent—already established in concrete repair—into cement-lime mortars, typical of historical constructions. Testing prisms constructed with varying lime/cement ratios revealed decreased flexural and compressive strength in high-cement-concentration mortars upon the addition of the agent; for mortars with high lime concentration, however, the agent led to an increase in both strengths. Furthermore, the agent's potential to self-repair was confirmed by allowing the remaining portions of tested samples to heal under humid conditions. Irrespective of mortar composition, cracks were resealed thus confirming the aesthetic, and potentially watertightness, restoration.

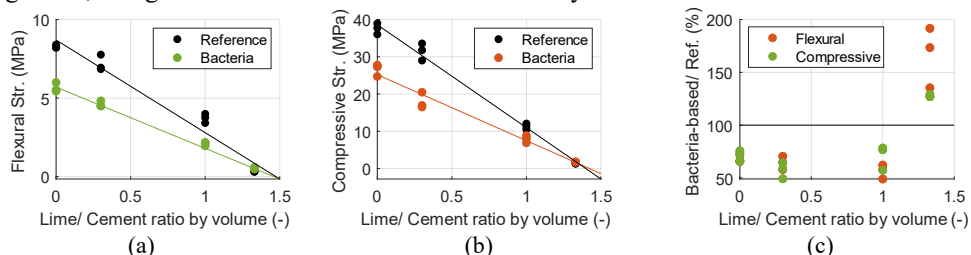
Fig. 1. Effect of the agent on (a) flexural strength, (b) compressive strength, and (c) ratio of bacteria-based to reference specimens for both mechanical properties.

Experimental results showed that the added agent influences the flexural and compressive strength of mortar after a 46-day hardening period (Fig 1). Up to a lime/cement ratio of 1, the addition of the agent resulted in [44% - 29%] decreased strength. Conversely, in samples with higher lime content (lime/cement ratio above 1), the addition of the agent yielded strength enhancements of 66% and 28% for flexural and compressive strength, respectively. Furthermore, the agent's potential was confirmed by exposing the remaining portions of the samples to healing under humid conditions (Fig.2). Notably, cracks in bacteria-based samples were effectively filled, nearly disappearing visually, regardless of mortar composition. Post-healing imaging displayed enhanced behavior in bacteria-based samples with higher lime concentrations, characterized by substantial precipitation.

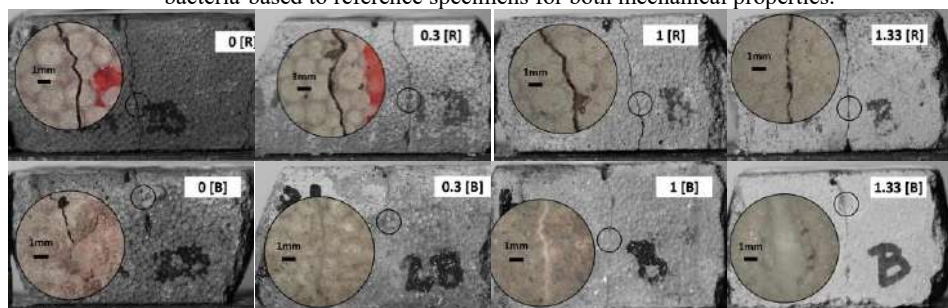
Fig. 2. Aesthetic recovery and crack filling observed in Reference[R] and Bacteria-based [B] specimens after 115 days of healing. Microscope magnification: x30.

40x40x40 mm³ tested portion (which constitutes half of the compression-tested sample and a quarter of the original sample) crumbled and detached from the sample. The parts remaining from the two tested halves were reassembled with an elastic band and left to heal under humid conditions (20 ± 2 °C, 95 ± 5 % RH) for 115 days. Subsequently, samples were examined using a Keyence VHX 6000 digital microscope to observe aesthetic recovery.
