HANAMI

reimagining vacations for special needs families:
a healing escape

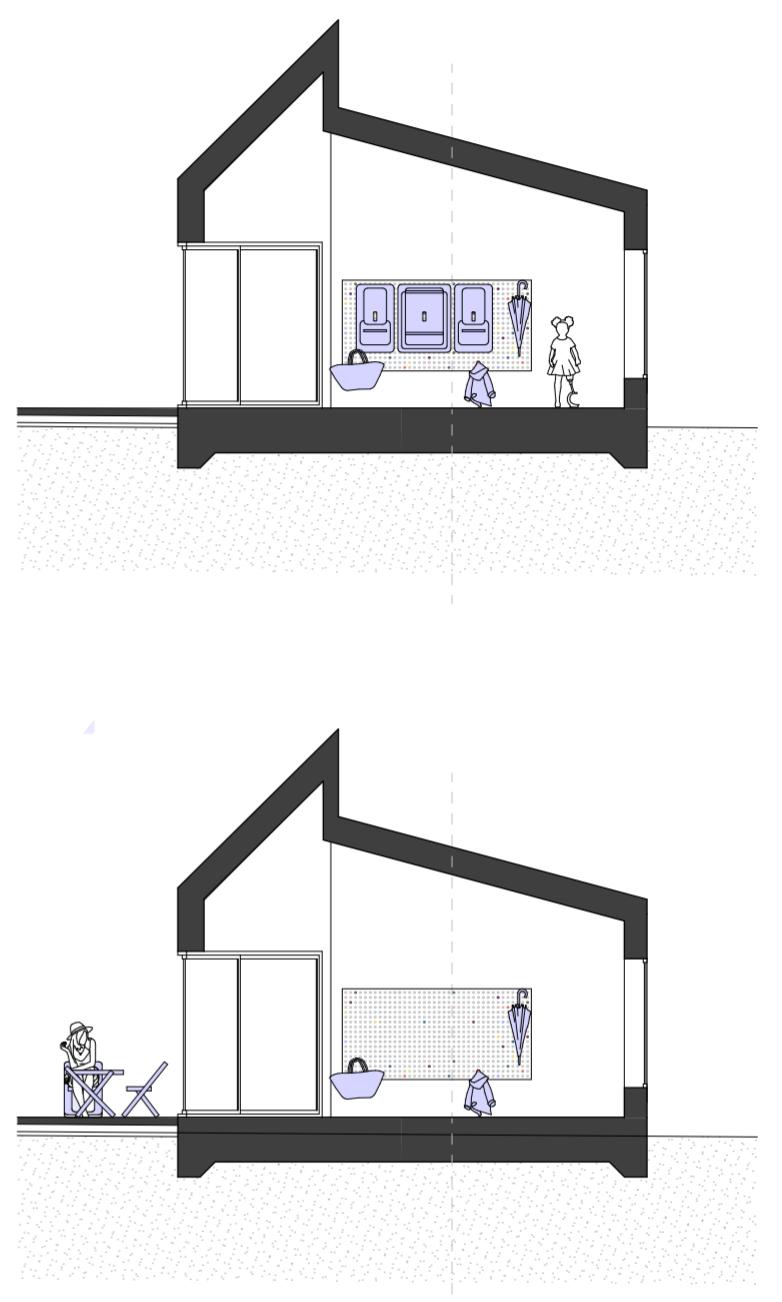
pegboard &
foldable furniture

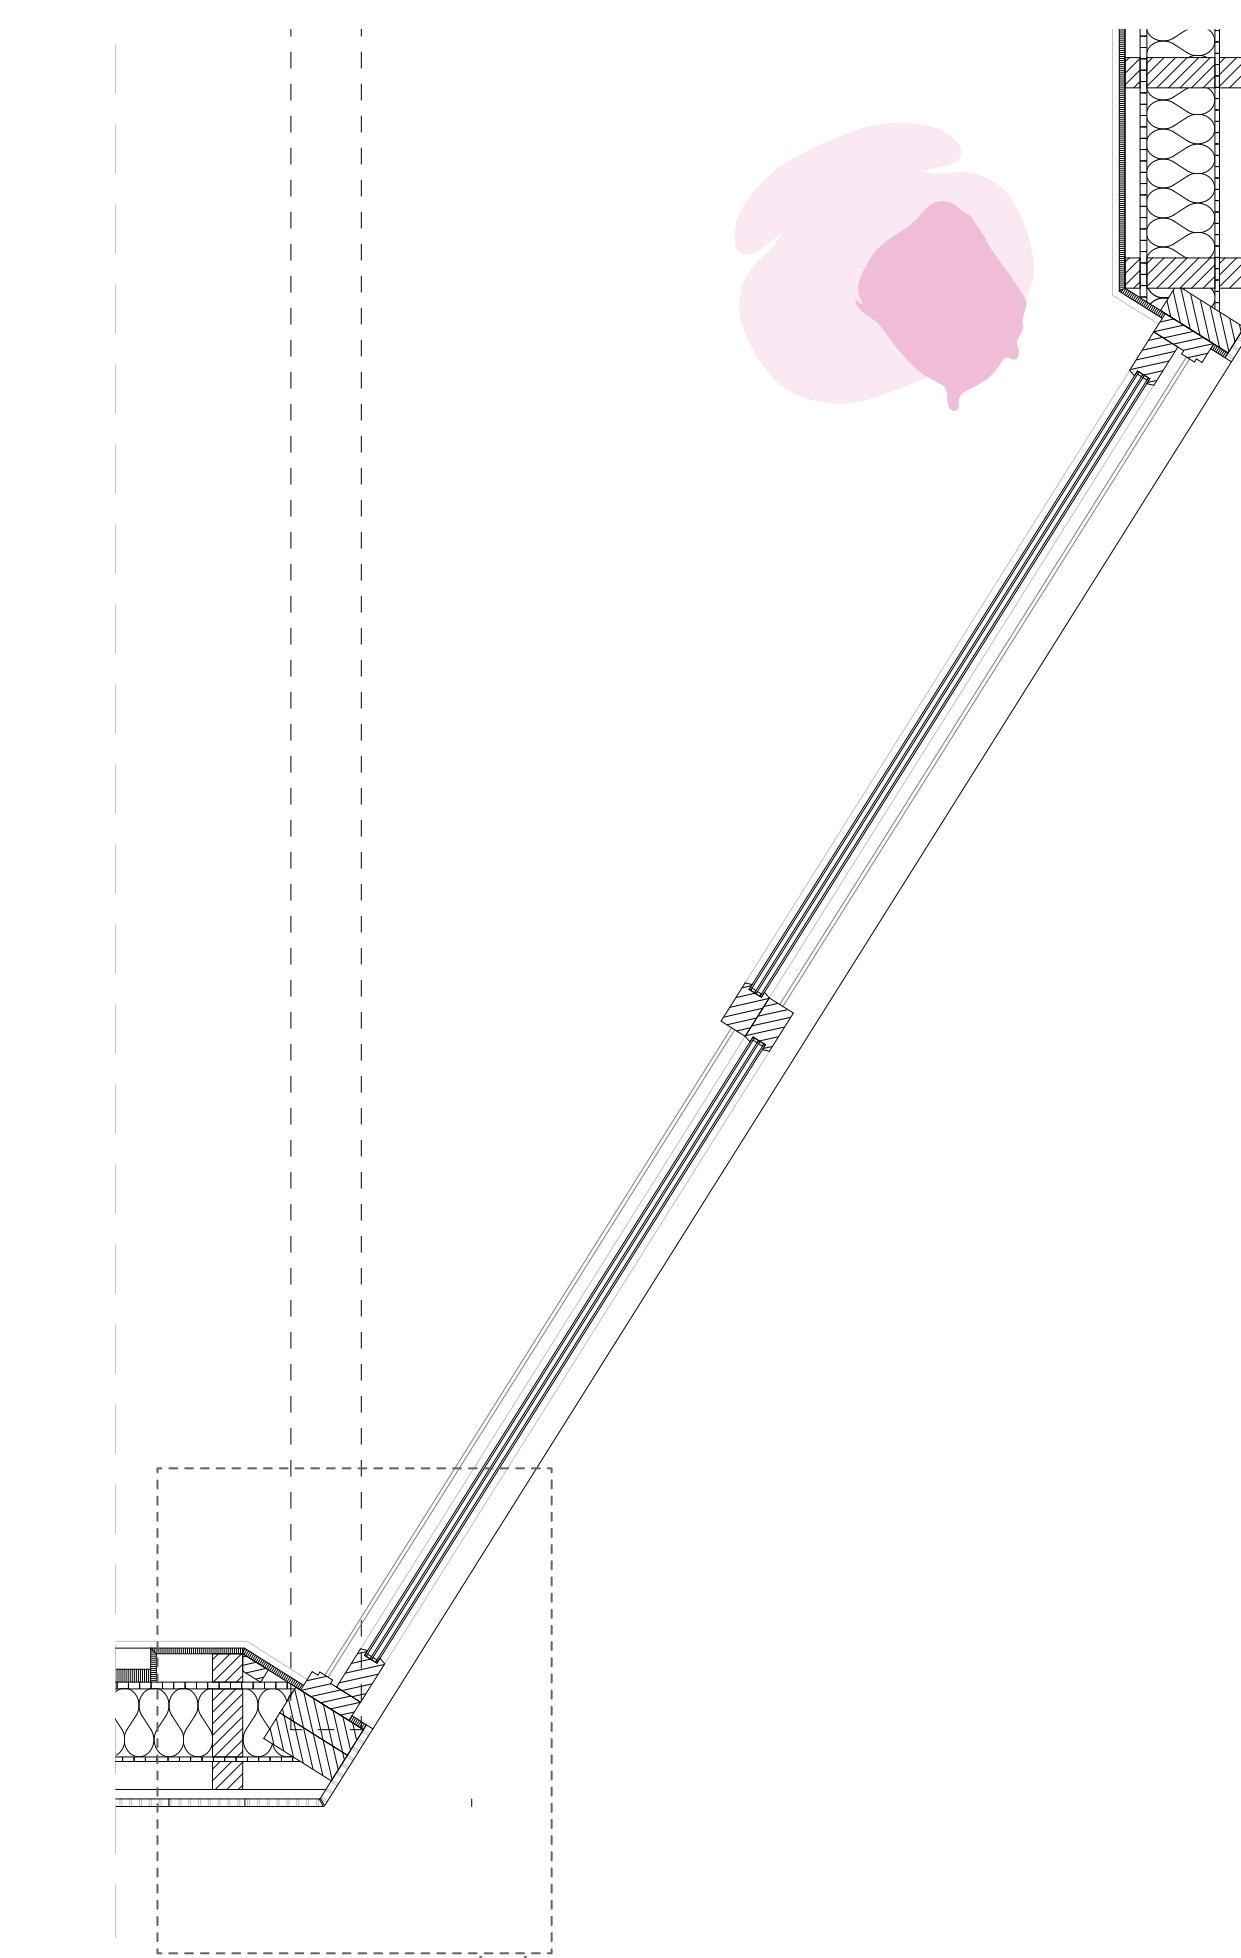
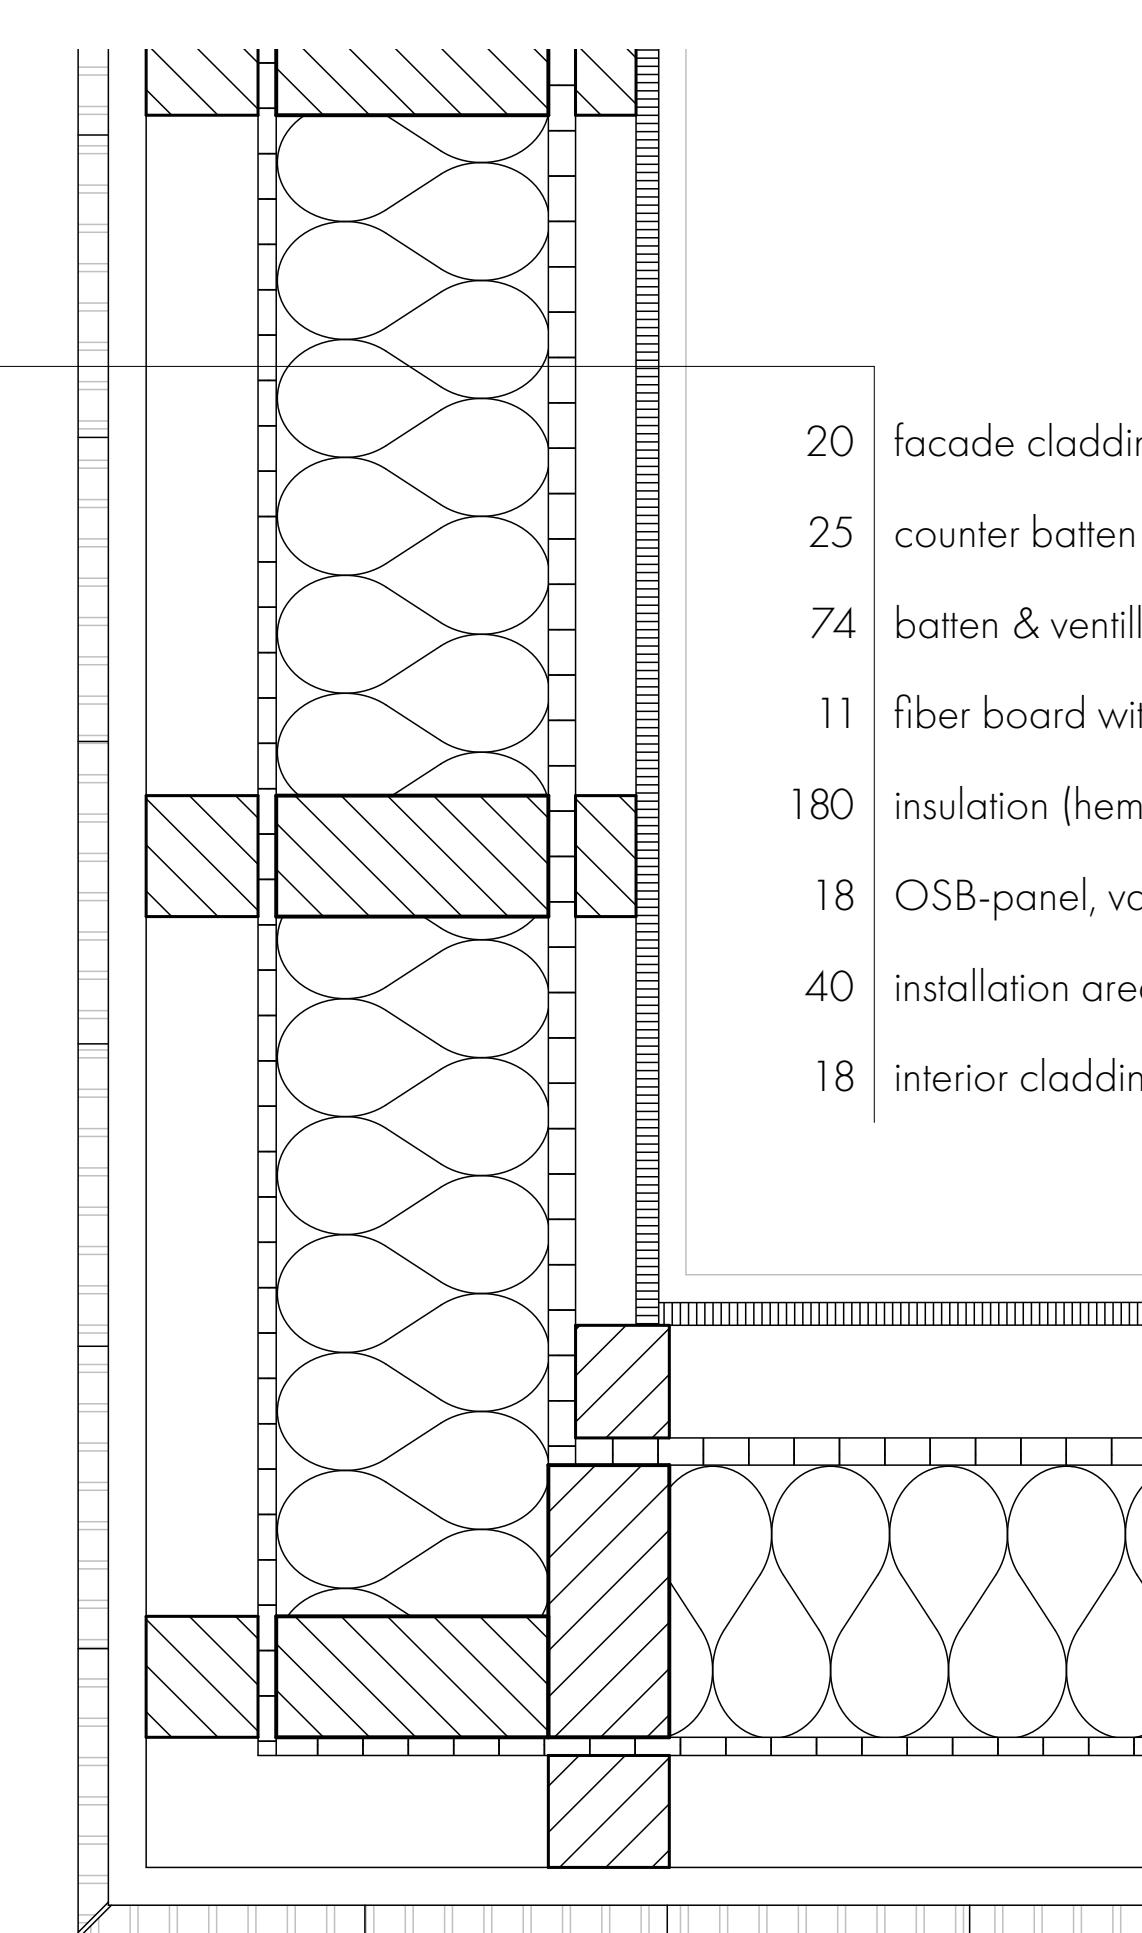
detail 6
1:5

20 facade cladding, burned wood
25 counter batten
74 batten & ventilation cavity
11 fiber board with bitumen, wind barrier
180 insulation (hemp) in balloon frame wall
18 OSB-panel, vapour barrier
40 installation area
18 interior cladding, wood

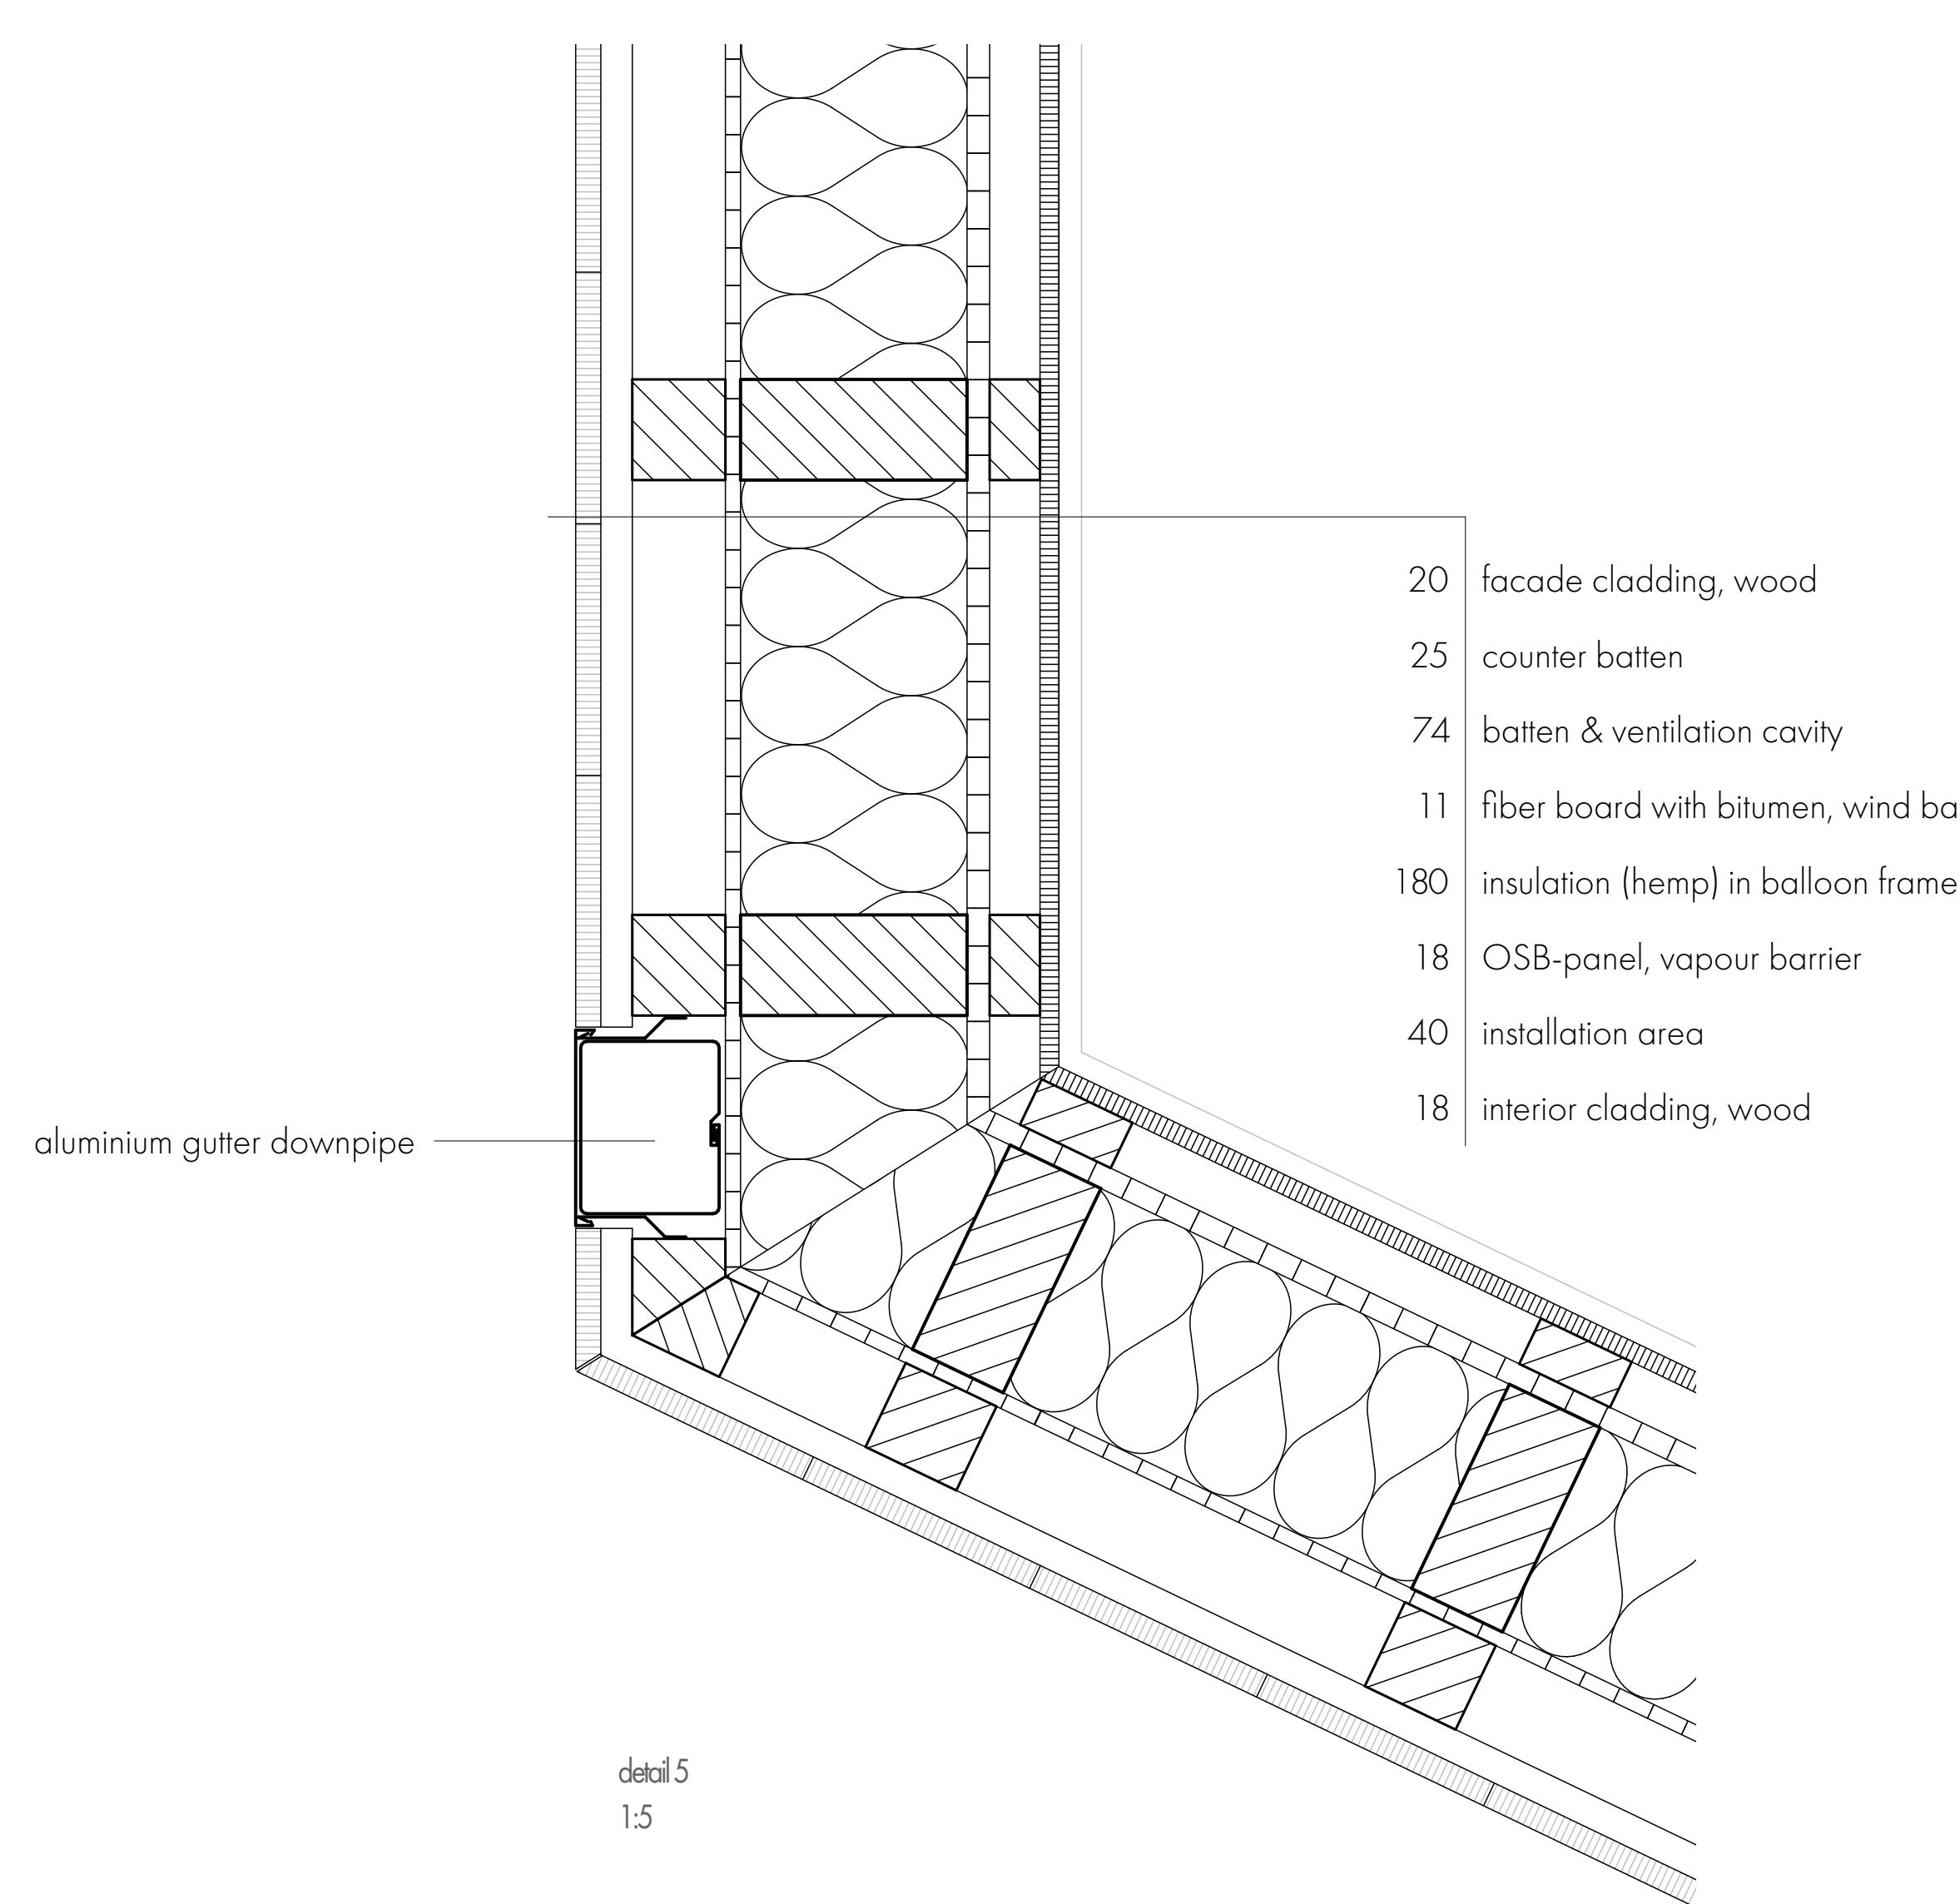
aluminum gutter downpipe

- 20 facade cladding, wood
- 25 counter batten
- 74 batten & ventilation cavity
- 11 fiber board with bitumen, wind barrier
- 180 insulation (hemp) in balloon frame wall
- 18 OSB-panel, vapour barrier
- 40 installation area
- 18 interior cladding, wood
