Post-Syrian War Residential Heritage Transformations in the Old City of Aleppo: Socio-Cultural Sustainability Aspects

Christine Kousa ^{1,2,*}, Uta Pottgiesser ^{1,2} and Barbara Lubelli ¹

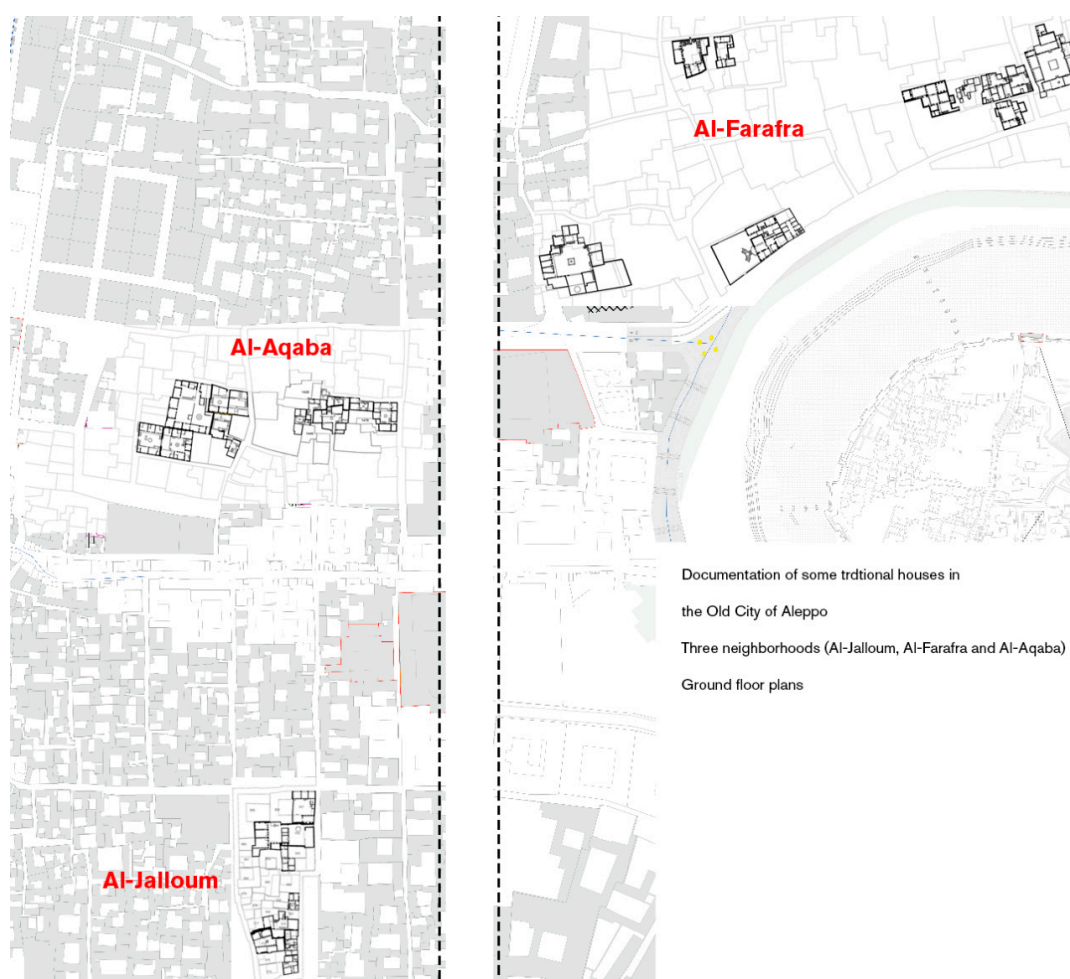
Figure 2 shows the plans of the studied houses, redrawn also thanks to manual measurement techniques, simple sketches, pictures and notes of observations made during inspections.

Figure 2. Plans of houses as documented by on-site survey and redrawn using AutoCAD software, Al-Jalloum, Al-Farafra and Al-Aqaba neighborhood, Old Aleppo, Winter 2020, Source: C. Kousa and students' work.

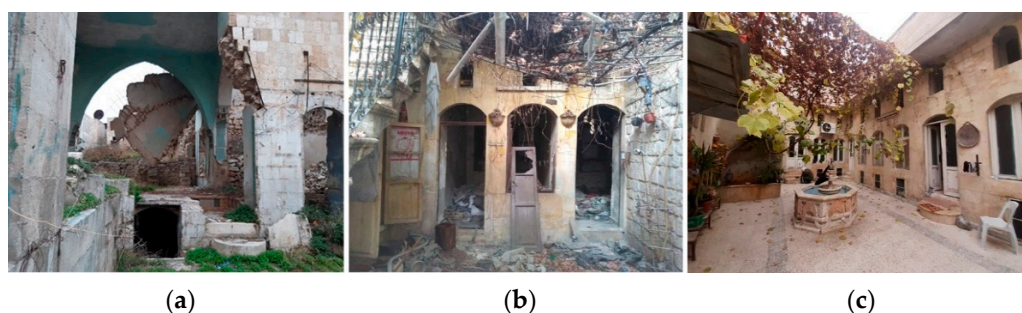
Among the 15 houses surveyed in Al-Jalloum neighborhood, 3 were classified “totally destroyed” and 1 was under reconstruction at the moment of the visit. Three houses were classified as “not affected”. Only one house was classified “partially damaged” (Figure 3).

Figure 3. A house that was completely destroyed, Cadastral number 558 (a); a house that was severely damaged, Cadastral number 568 (b); a house that was not affected, Cadastral number 576 (c); Al-Jalloum neighborhood, Old Aleppo, winter 2020, Source: C. Kousa and students' work.

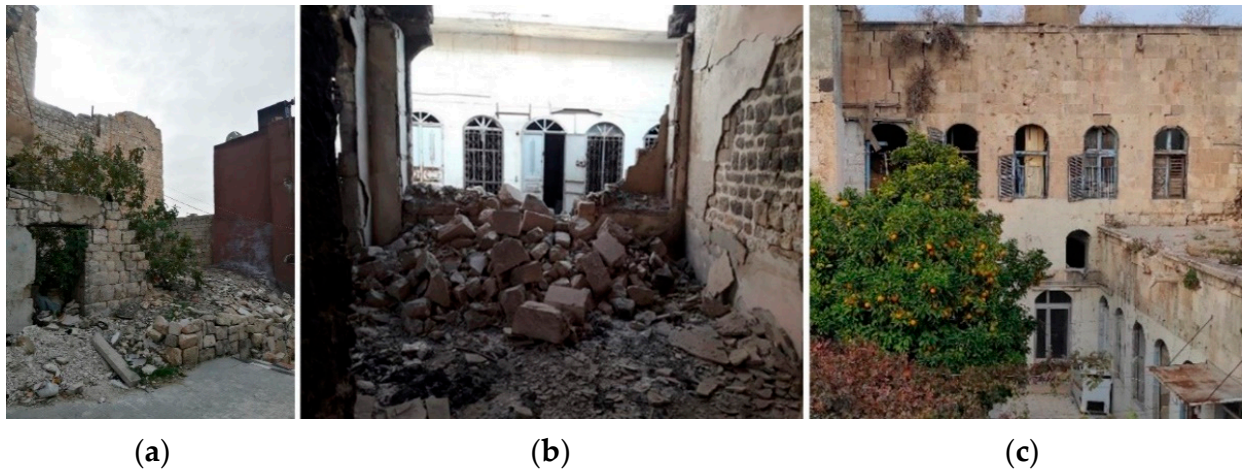
Among the 53 houses surveyed in Al-Aqaba neighborhood, 16 houses were “totally destroyed”, while 8 houses were classified “partially damaged”. The 29 remaining houses were classified as “not affected” (Figure 4).

Figure 4. A house that was completely destroyed, Cadastral number 1426 (a); a house that was severely damaged, Cadastral number 1429 (b); bullet holes from the fighting, on the façade of the house at Cadastral number 1424 (c); Al-Aqaba neighborhood, Old Aleppo, Winter 2020, Source: C. Kousa and students' work.

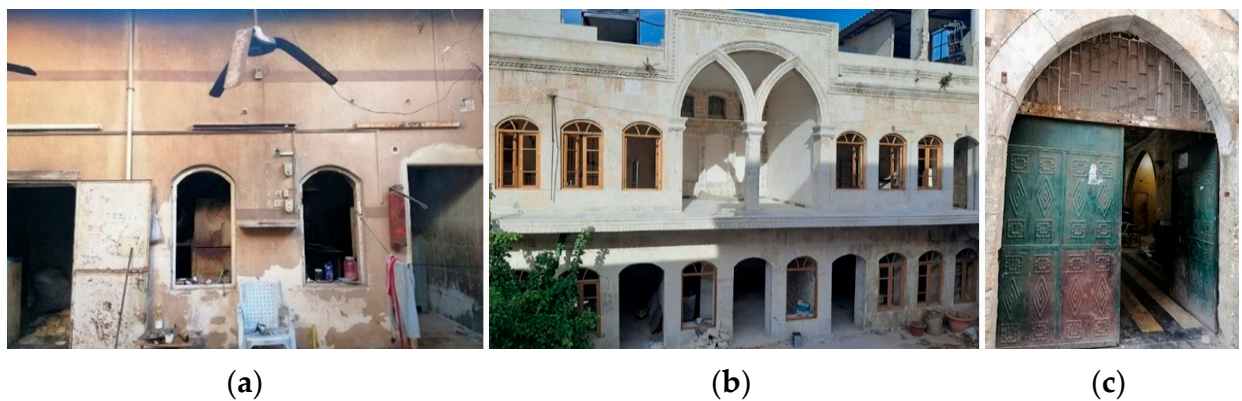
The survey showed that some of the houses had recently adopted a different function and was reused as e.g., a roastery building, a hotel, a factory, a charitable organization, a shop, etc. (Figure 5). Other houses proved to be empty (Figure 6).

Figure 5. A house that has been reused as a roastery building, Cadastral number 1479 (a); a house that has been used as a hotel, Cadastral number 1514–1515 (b); a house that has been used as a factory, Cadastral number 1427 (c); Al-Aqaba neighborhood, Old Aleppo, Winter 2020, Source: C. Kousa and students' work.

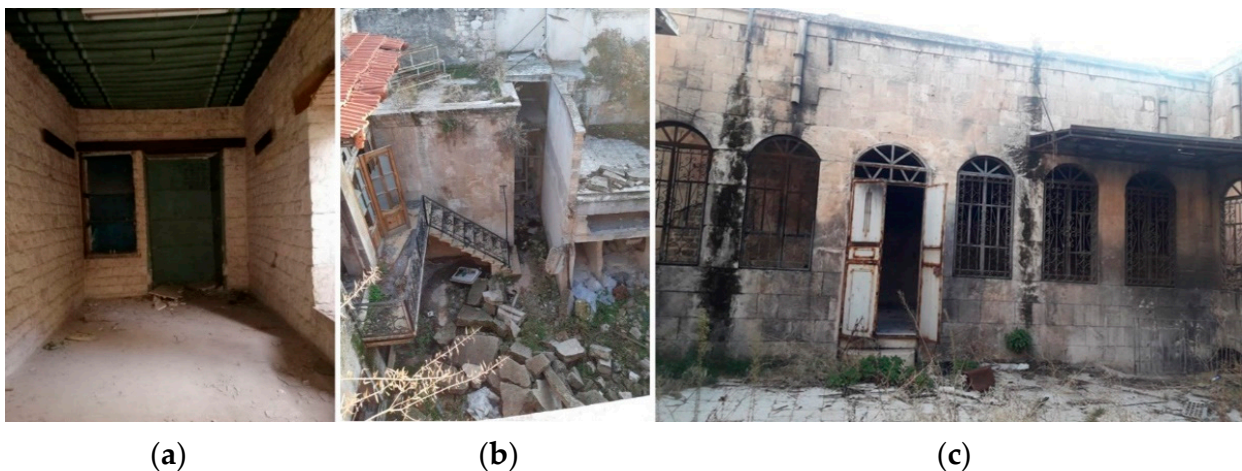
Figure 6. Examples of houses that have been abandoned: Cadastral number 1453 (a), Cadastral number 1480 (b), and Cadastral number 1429 (c); Al-Aqaba neighborhood, Old Aleppo, Winter 2020, Source: C. Kousa and students' work.

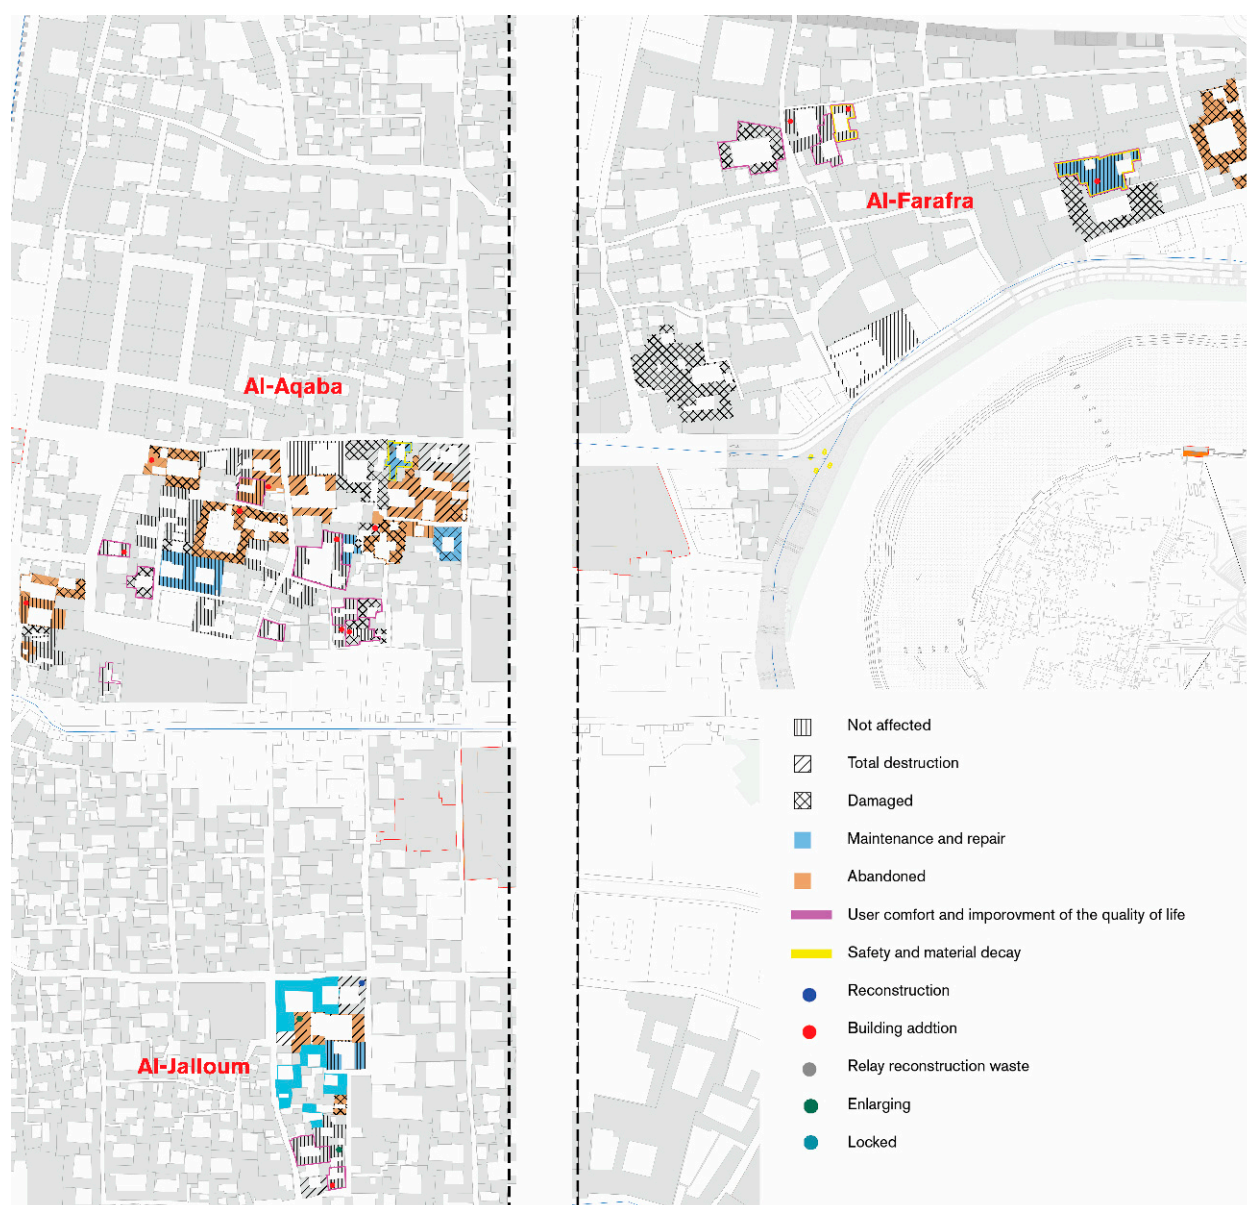
- c. Safety and severe material decay: In almost all the visited houses, some parts were reconstructed, as they were in bad structural condition. The main interventions consisted of completion and rebuilding of a demolished roof, replacing of the wooden ceiling and rebuilding of the walls after removal the affected parts.
- d. Need of maintenance and repair: In this case, interventions consisted mainly of replacing/restoration of the wooden and metal carpentry and of the stone tiles, plumbing and electrical works, and painting of walls (Figure 7).

Figure 7. Map case studies visualization in the three neighborhoods of Al-Jalloum, Al-Farafra and Al-Aqaba, Source: C. Kousa.
