## Monitoring bolt tightness of rail joints using axle box acceleration measurements

Structural Control and Health Monitoring: the bulletin of ACS

# Monitoring bolt tightness of rail joints using Axle Box Acceleration Measurements

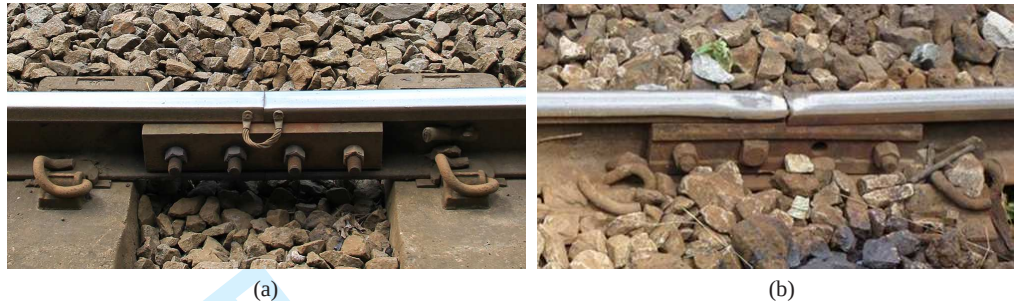
Figure 1. Two examples of rail joints: (a) invisible damage: loose bolts, and (b) visible damage: missing bolt and battered rail surface

Rail joints (RJs) are an important component in many railway networks worldwide; an example of a RJ is shown in Figure 1a. Although the use of continuously welded rail is nowadays more cost

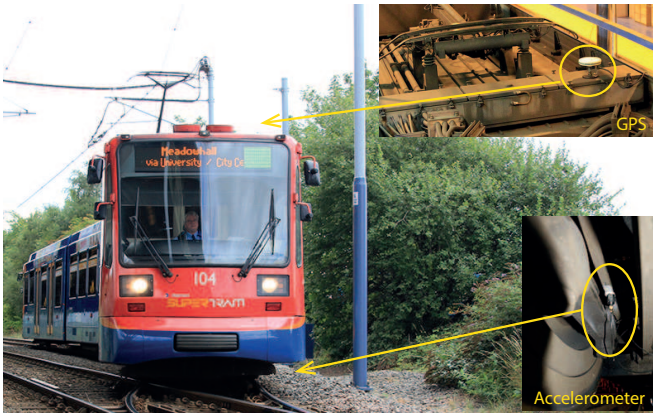
Figure 3. ABA system used with close-ups of the GPS antenna and an accelerometer

In this paper, the ABA system was mounted on a regular Supertram tram with resilient wheels in Sheffield (see Figure 3). Four accelerometers were mounted on the four axle boxes of a bogie to register acceleration measurement. The lower close-up in Figure 2 shows a sensor mounted on the Supertram bogie. The accelerometers are of piezoelectric type (MEMS), and have a range of  $\pm 100g$ , a frequency bandwidth of 30 kHz, and a sensitivity of 50 mV/g. The accelerometer chosen is suitable for railway application as a similar instrumentation has been under extensive test in The Netherlands for mainline applications (15).

The upper close-up in Figure 3 shows the location of the positioning GPS antenna on the tram roof. The speed signal was obtained from the meter cabinet of the tram. The accelerations, speed and position were recorded in a data acquisition system on-board of the Supertram test tram.
