**Damage pattern recognition for corroded beams strengthened by CFRP anchorage system based on acoustic emission techniques**

[10.1016/j.conbuildmat.2023.133474](https://doi.org/10.1016/j.conbuildmat.2023.133474)

Construction and Building Materials

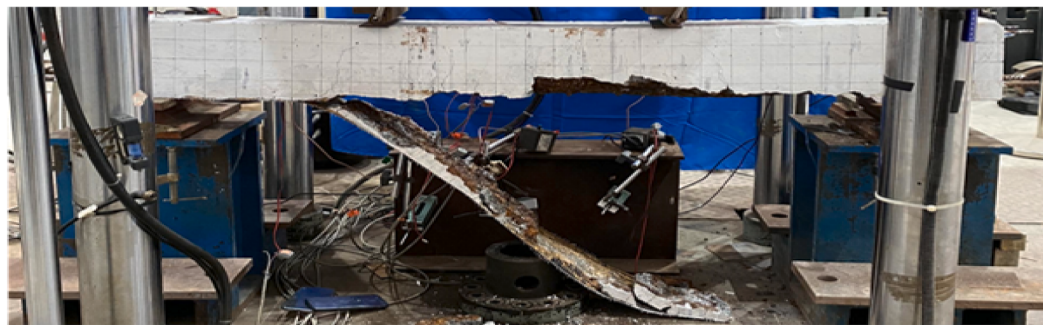
**Fig. 9.** The final failure modes of test beams.

Fig. 9 depicts the final failure modes of corroded beams strengthened by CFRP anchorage system. It can be observed that debonding, tearing, and fracture at the interface between CFRP and the beam can occur during the failure process of CFRP reinforced beams. interface can occur during the failure process of CFRP reinforced beams. When the stress on the beam surpasses the ultimate strength of CFRP, the CFRP laminate may tear and fracture, resulting in beam failure. Debonding can also occur at the interface between CFRP and the beam, decreasing the beam's strength and stiffness. Lastly, microcracks' initiation and propagation inside the beam are also observed in the damage pattern of CFRP reinforced corroded beams. Microcracks' initiation and propagation can be caused by several factors, such as corrosion, concrete cracking, and steel bar corrosion. As these microcracks extend to the surface of the beam, they form macrocracks, resulting in beam failure.
