Engineering review on the final closure of Saemangeum Dike

**Report EX 5192
Release 2.0 – Draft Final Report Version
September 2005**

Report EX 5192
September 2005

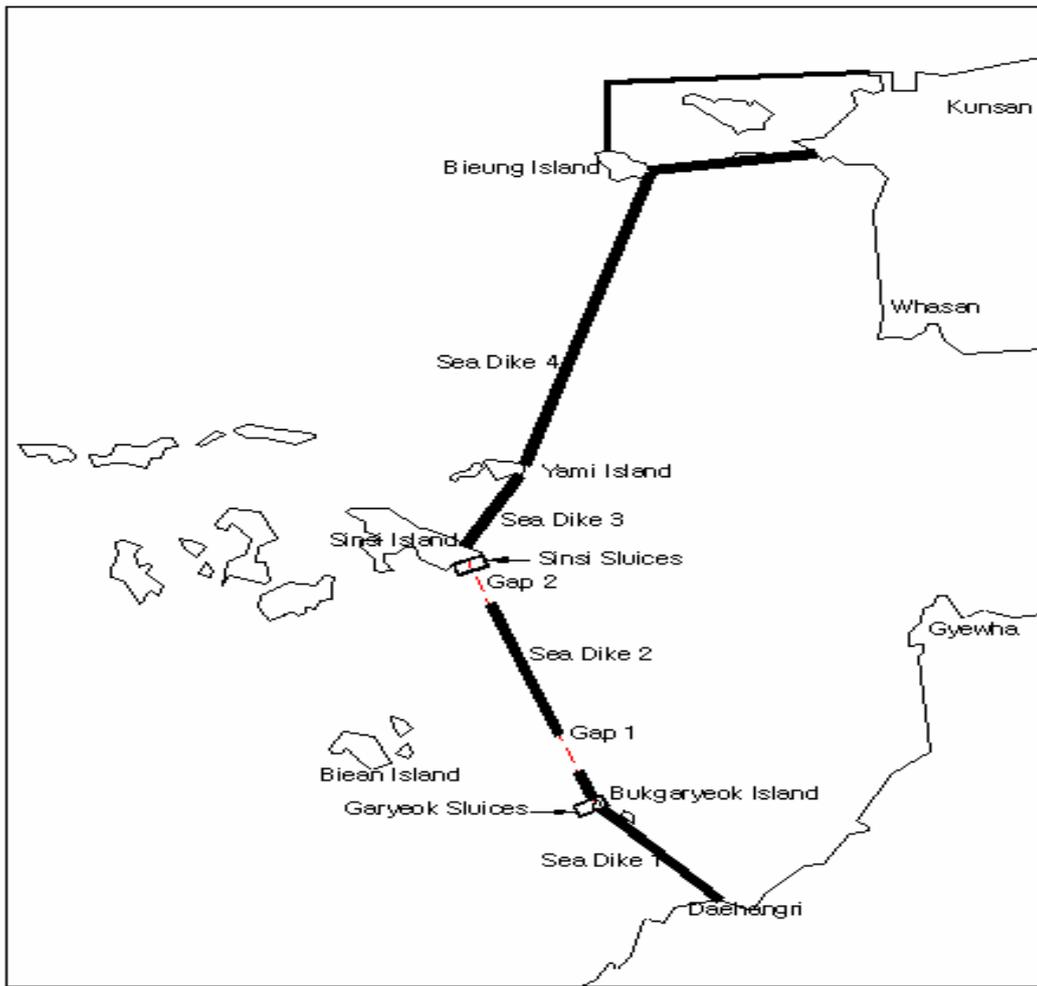
Figure 2.1 Alignment of Saemangeum Sea Dikes and Construction Stages as of March 2005

(thick lines = construction completed, dashed red lines = gaps remaining)

Survey control along the sea dikes is based on a series of stations every 100m, each dike starting with St. No.0. Thus for example Station 9 would be 900 m from St. No. 0.

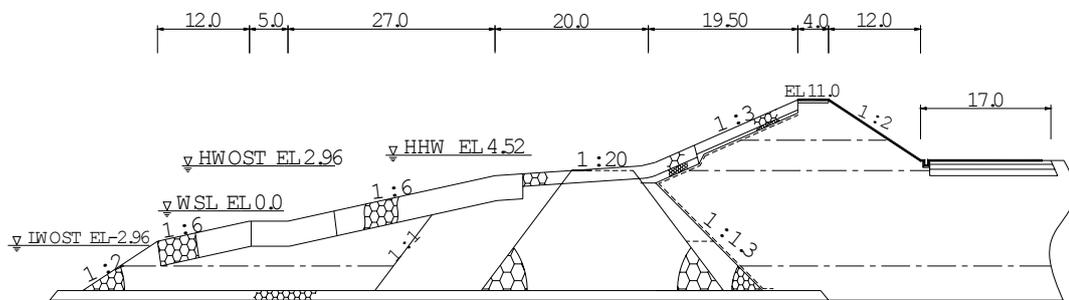
Figure 2.2 Typical seaward cross-section of Dikes

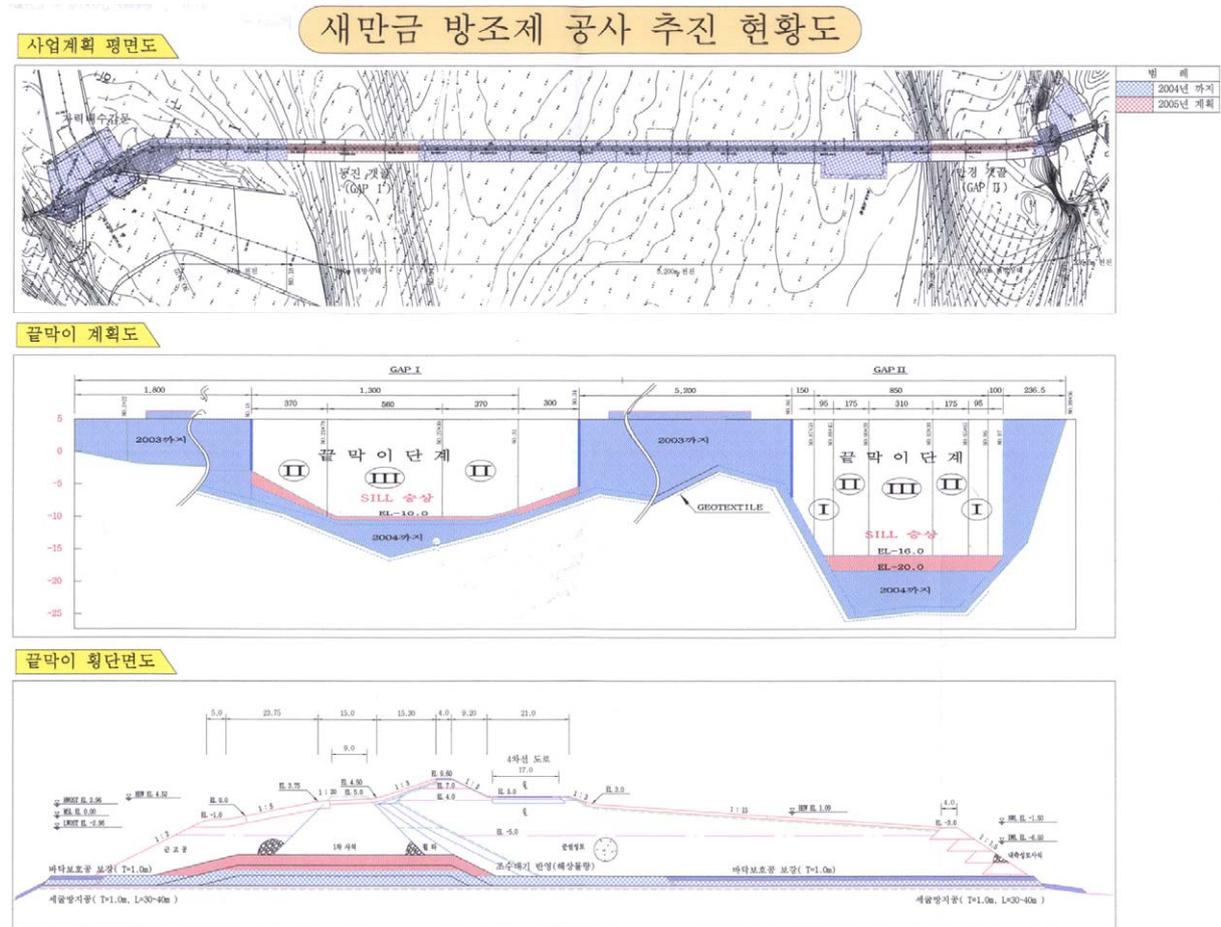
Figure 2.3 Arrangements for final closure as provided by KARICO

Figure 2.3 provided by KARICO explains the various stages in the closure process in further detail. The waiting periods have been selected to coincide with the highest spring tides when currents will be at their maximum and successful placing of stone into these currents will be difficult.

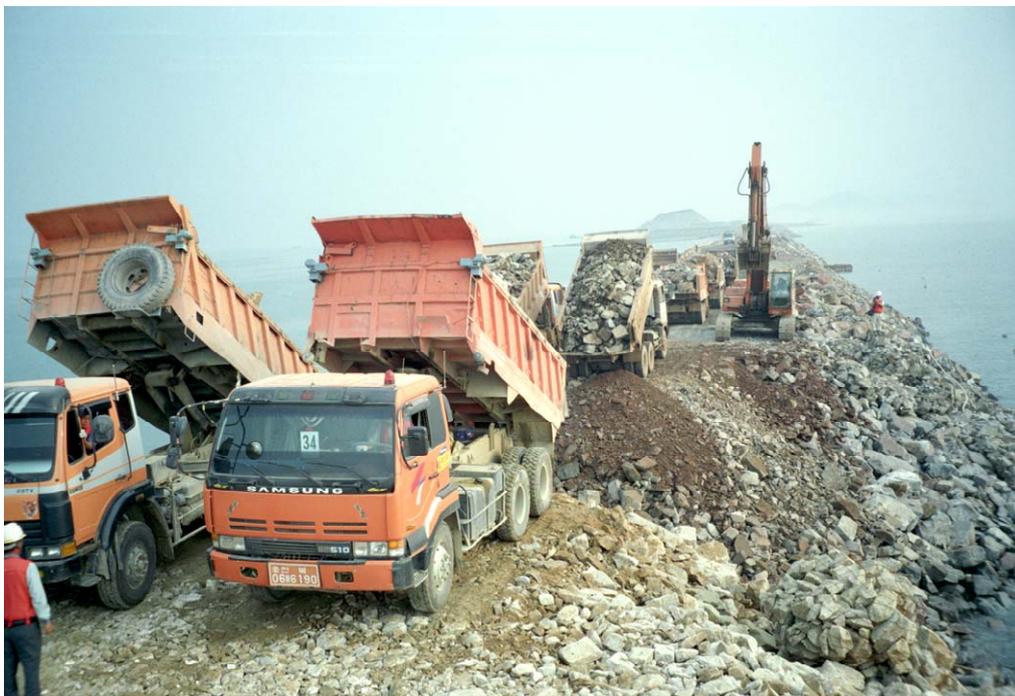
Figure 2.4 Construction plant completing final closure of Saemangeum Dike No 4

KARICO have provided photographic evidence (see for example Figures 2.4) illustrating the kind of arrangement envisaged for the end of the dikes, based on the successful closure procedures adopted for the final closure of the gap in Dike No 3 in 2003.

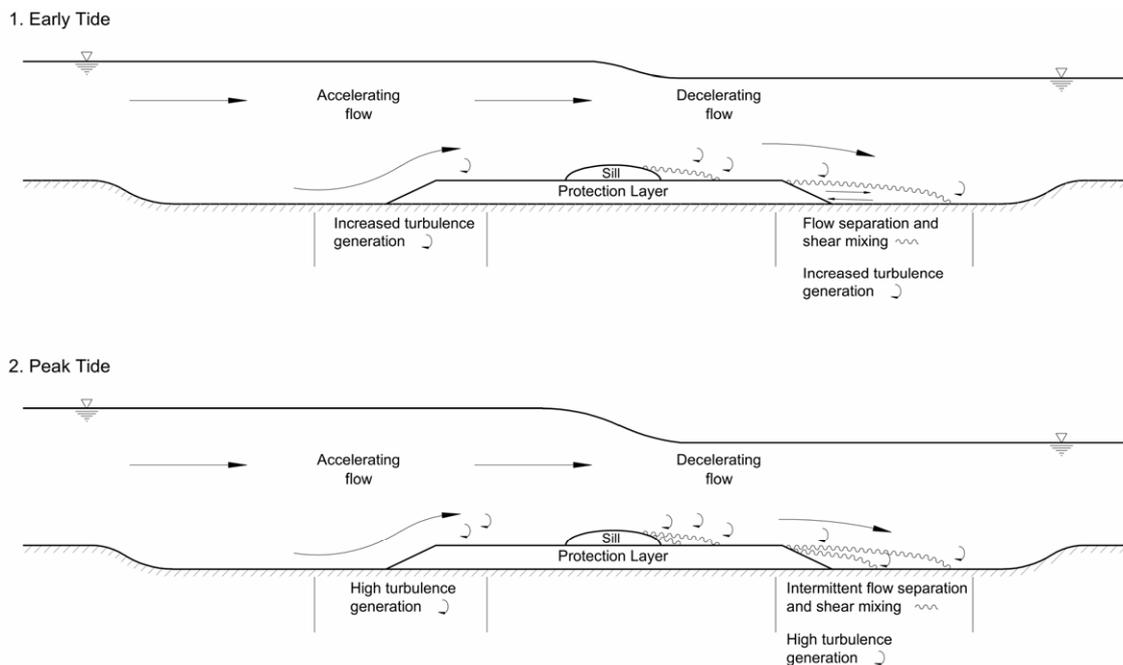
Figure 4.3 Schematic representation of vertical structure of flow field through closure gap at two stages of the tide

In a vertical plane (see Figure 4.3), the processes can be considered in 2-dimensions as follows. The flow approaches the trapezoidal cross-section of the dike gap over the open seabed which adjacent to the toe of the area covered by the bed protection mat has a slope in the range 1:8 to 1:3 (7 to 18.5 degrees). In the deepest scoured areas it can be steeper at 1:2 (26.5 degrees) and locally it can be as steep as 1:1.5 (33.7 degrees). At the transition between the shallower and steeper sloping bed there will be high levels of turbulence due to disturbance in the boundary layer. This will lead to a high local potential for sediment transport which can maintain the bed slope at this location. The flow then accelerates further as it passes up the slope and into the gap where the highest velocities are experienced extending to the downstream side where the mean flow speed is noticeably faster for at least 500m. The flow turbulence and intermittent flow separation on the downstream slope will lead also to higher sediment transport potential at this location. The faster and more turbulent flow has the potential to erode sediment from the bed upstream and downstream and to carry suspended sediment through the gap.

As the flow speed varies through the tide the detailed 2-dimensional flow pattern will change. On the downstream slope in the early stages of the tide the flow will have a tendency to separate at the sections with steeper slopes, producing a recirculation with upstream directed flow at the bed. As the flow speed increases to the maximum in the tide this will tend to produce more intermittent separation on the downstream slope with increased levels of turbulence.

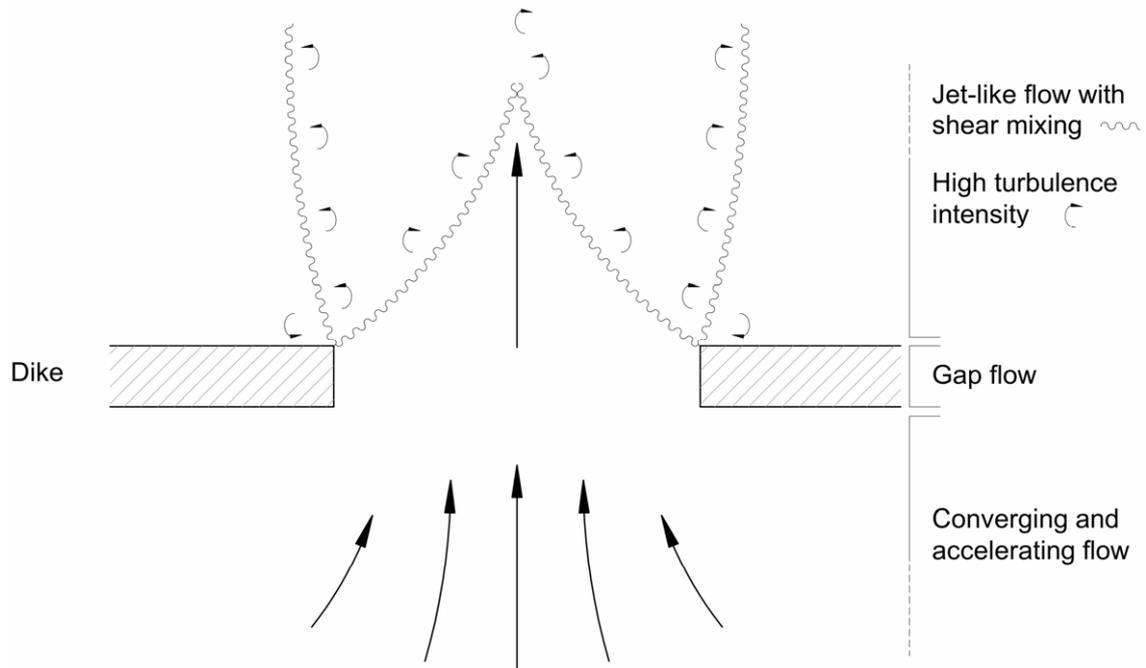
Figure 4.4 Schematic representation of horizontal structure of flow field through closure gap at peak tide.

In 2-dimensions in plan view (see Figure 4.4) the flow passes towards the gap and accelerates locally through the gap generating a zone of faster flowing water on the downstream side of the gap. Also the flow interaction with the side walls will generate shear layers at either side of the gap leading to vortex action with locally increased turbulence intensities.

It is expected that the deeper areas of scour measured at the toe of the bed protection mat on the seawards and landwards sides of the gap at both north and south ends of the gap are related to the shear layers generated from each side of the gap on flood and ebb flow directions.

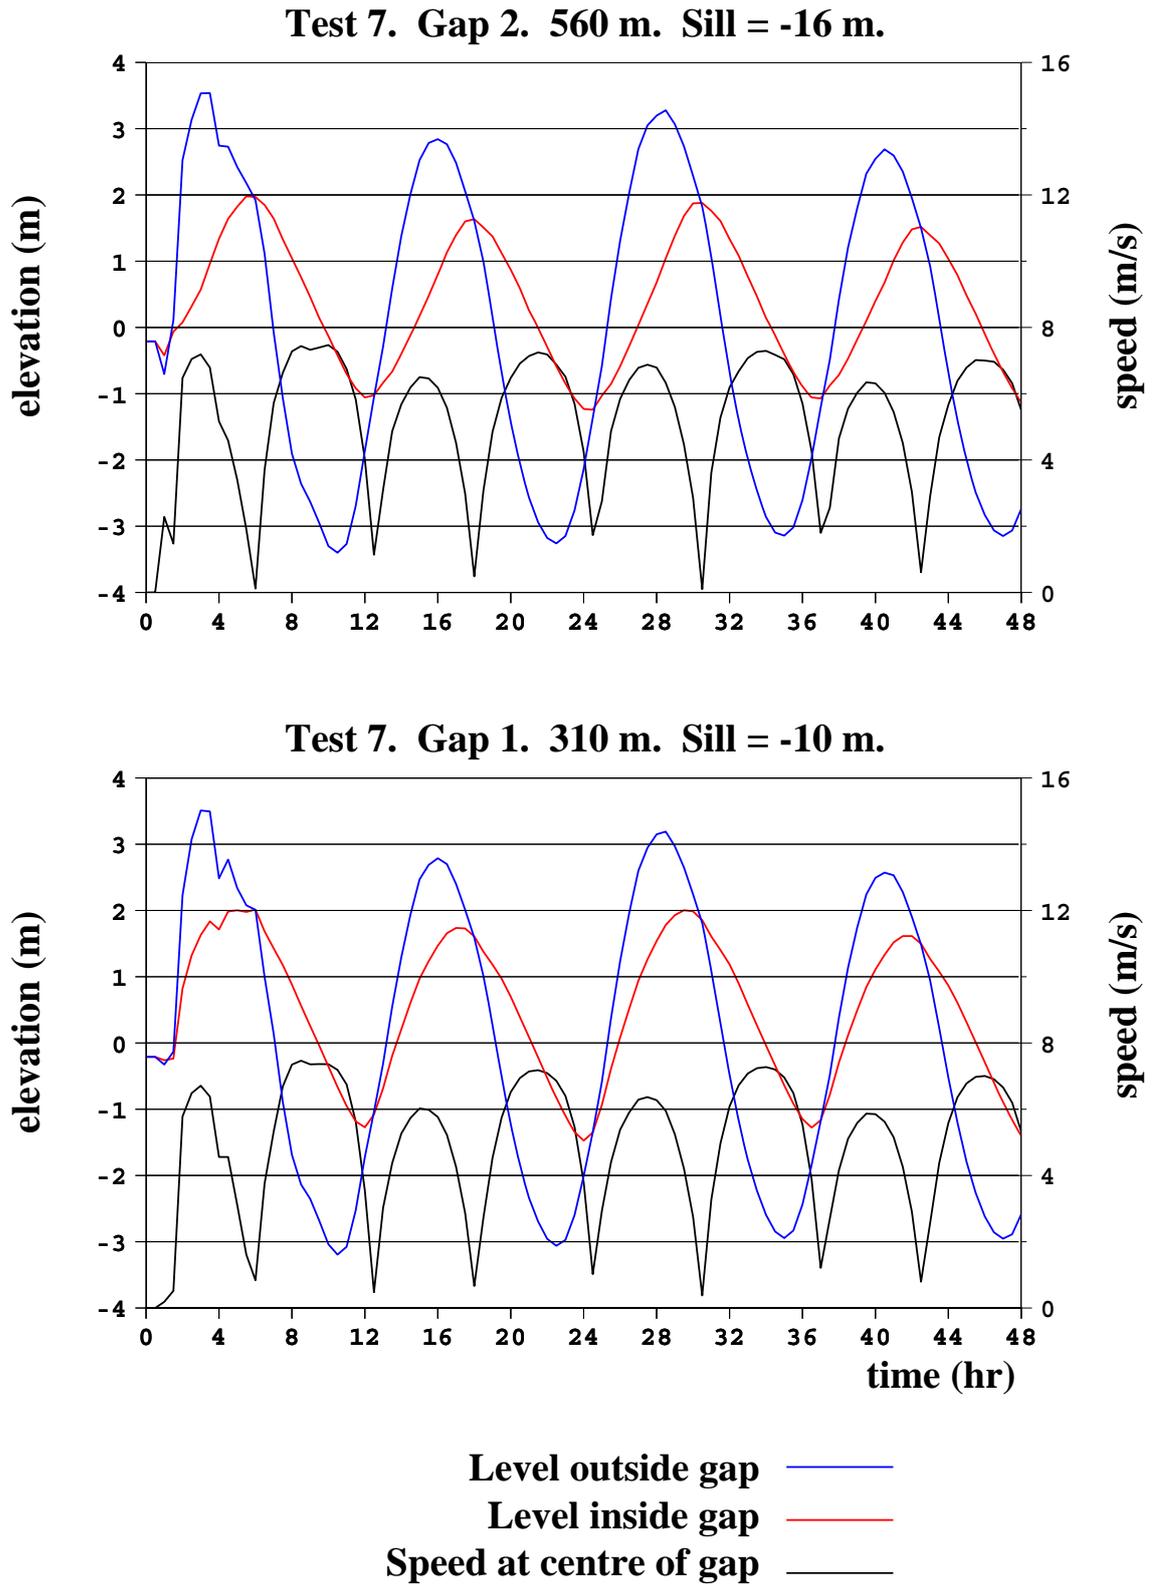
Figure 3.1 Speed at centre of gaps 1 and 2 and water level inside and outside of each gap for HRW Test 7

(Spring tide, Gap 1 = 560m, Gap 2 = 310m)

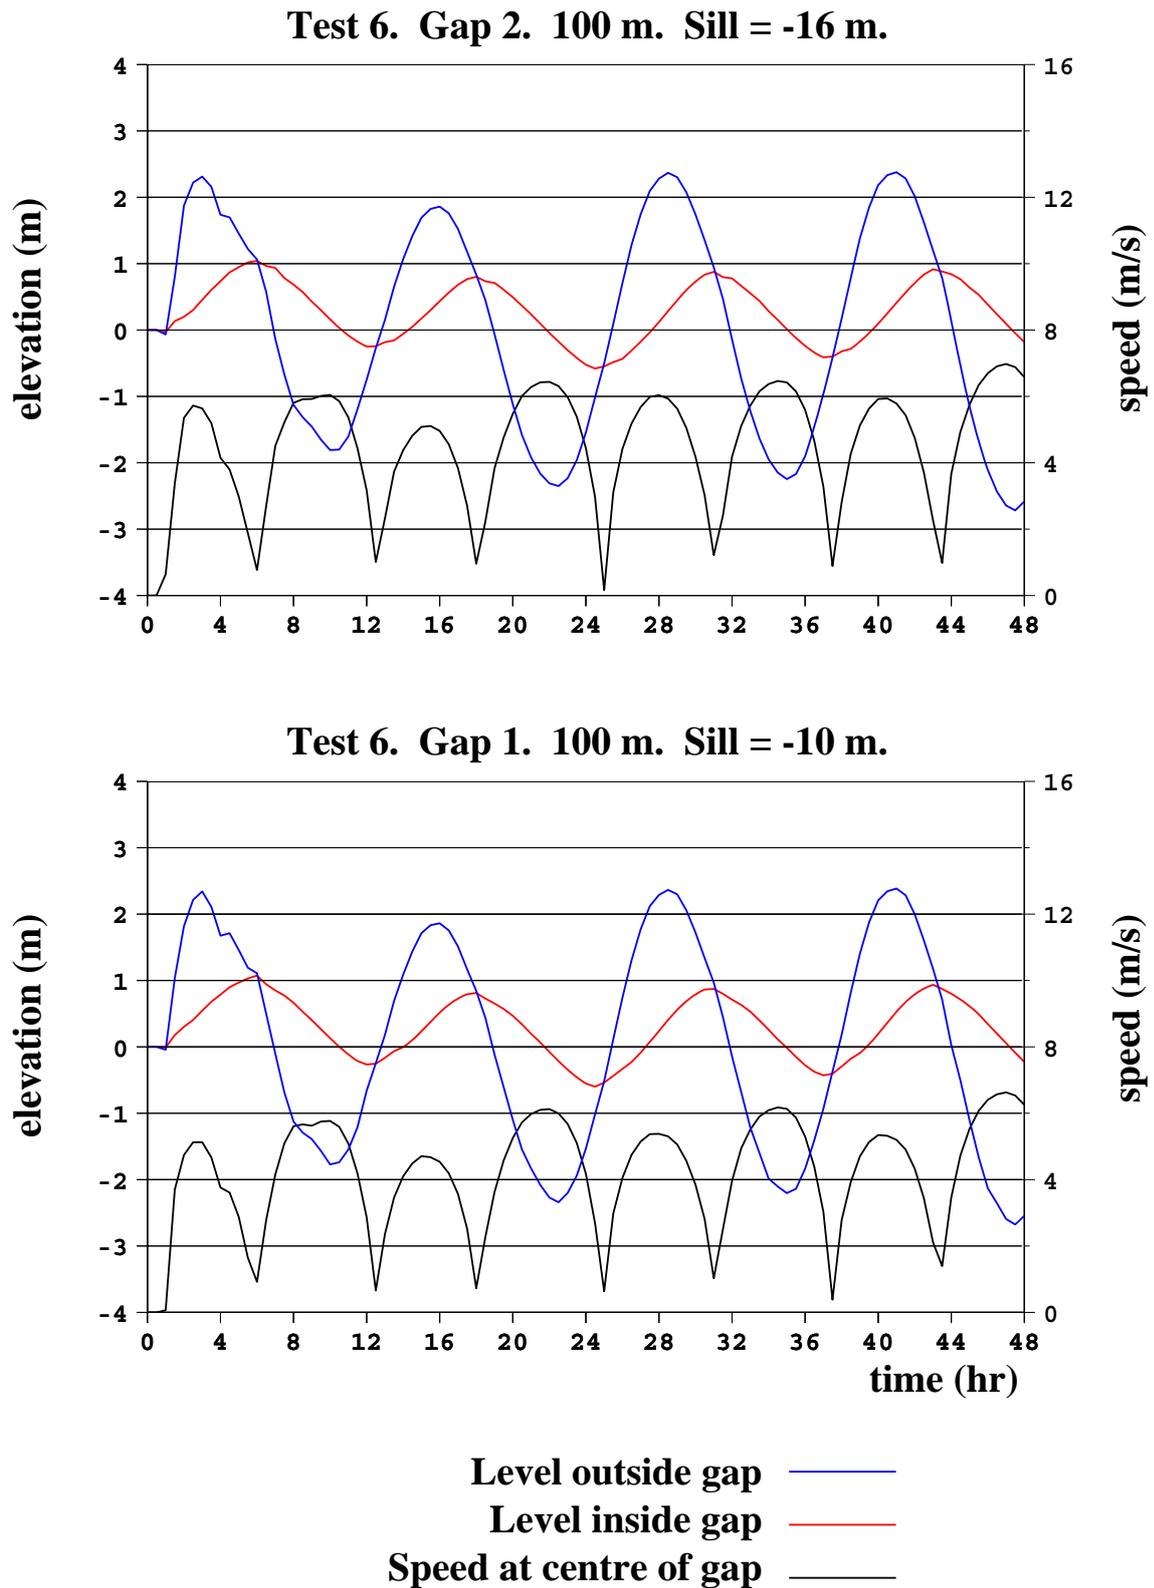
Figure 3.2 Speed at centre of gaps 1 and 2 and water level inside and outside of each gap for HRW Test 6

(Neap tide, Gap 1 = 100m, Gap 2 = 100m)

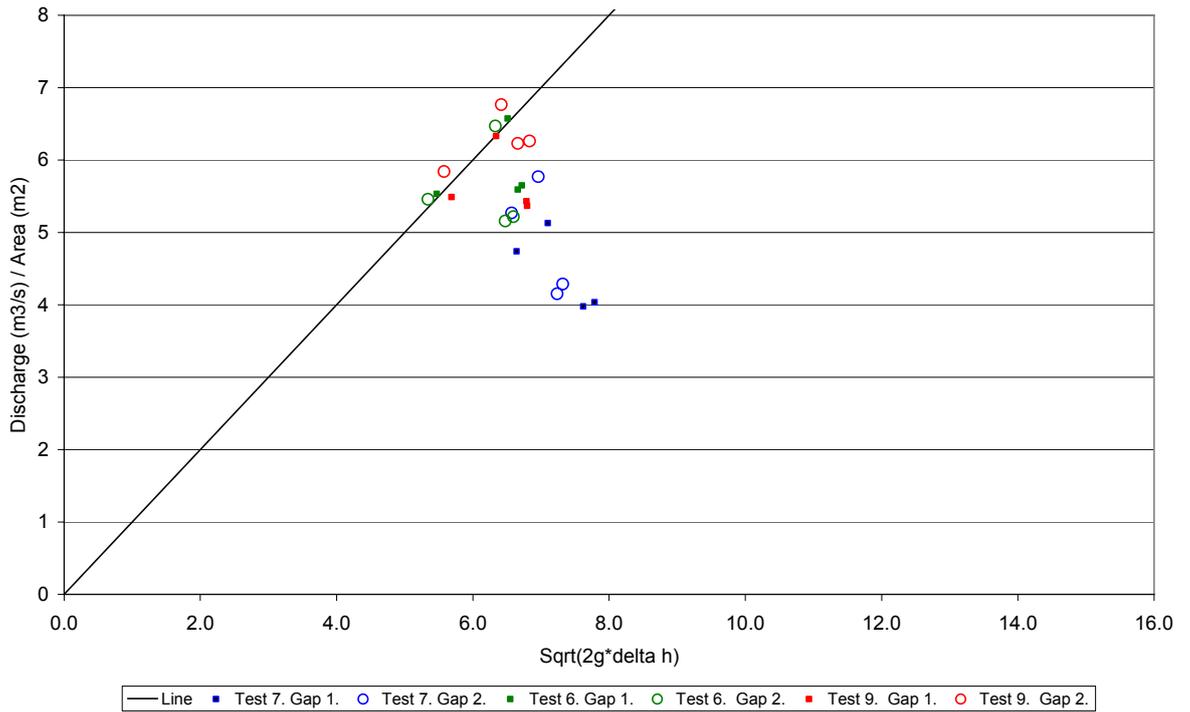
Figure 3.3 Relationship between gap centre speed and water level difference across gap, tests 6, 7 and 9

Test 9 Neap tide gap 1 50m, gap 2 50m

Angled line represents $x = y$ (analytical solution with coefficient = 1)

To investigate whether the model conforms to such a formula the results of the HR model for three stages of closure were tested for obedience to this formula. It was found (Figure 3.3) that the formula was approximately obeyed but that for a wide gap the coefficient μ was about 0.7 and it grew as the gap narrowed up to a maximum value of about 1.1. These results are as might be expected although the manual suggests that generally a coefficient μ of the order of 0.9 is appropriate. In the context of horizontal closure it is also suggested that values rising to 1.3 or so may be possible as closure proceeds.

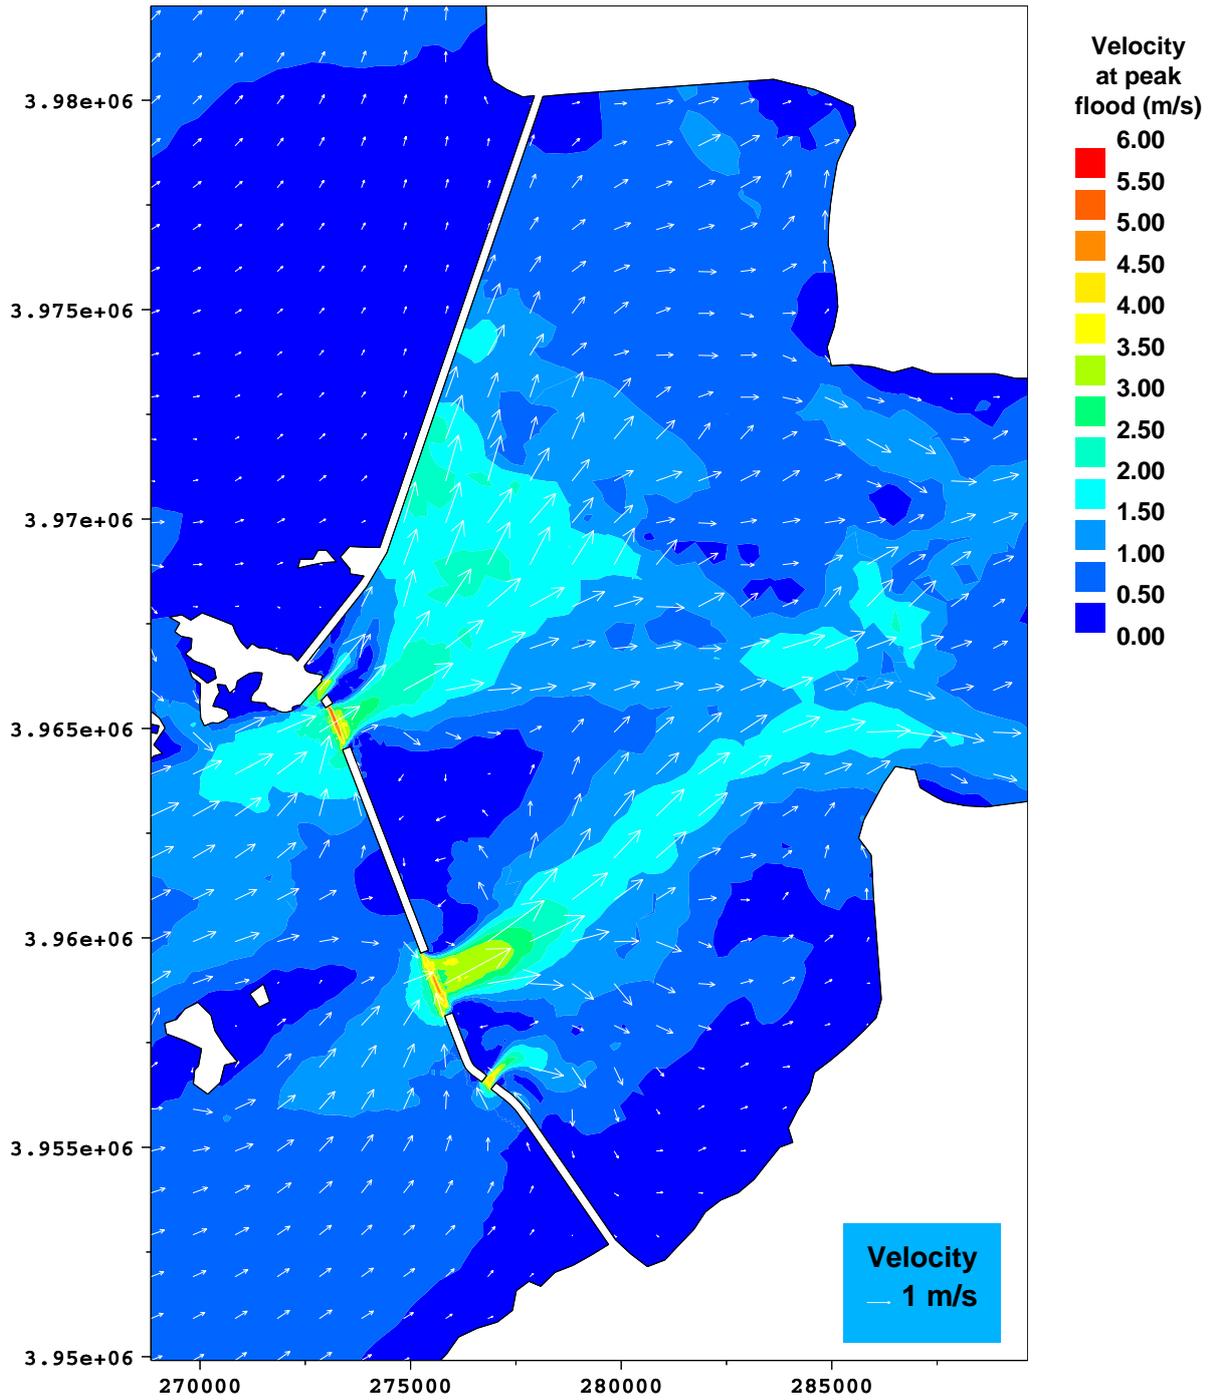
Figure 4.1 Current velocity vectors at peak flood, Test 1

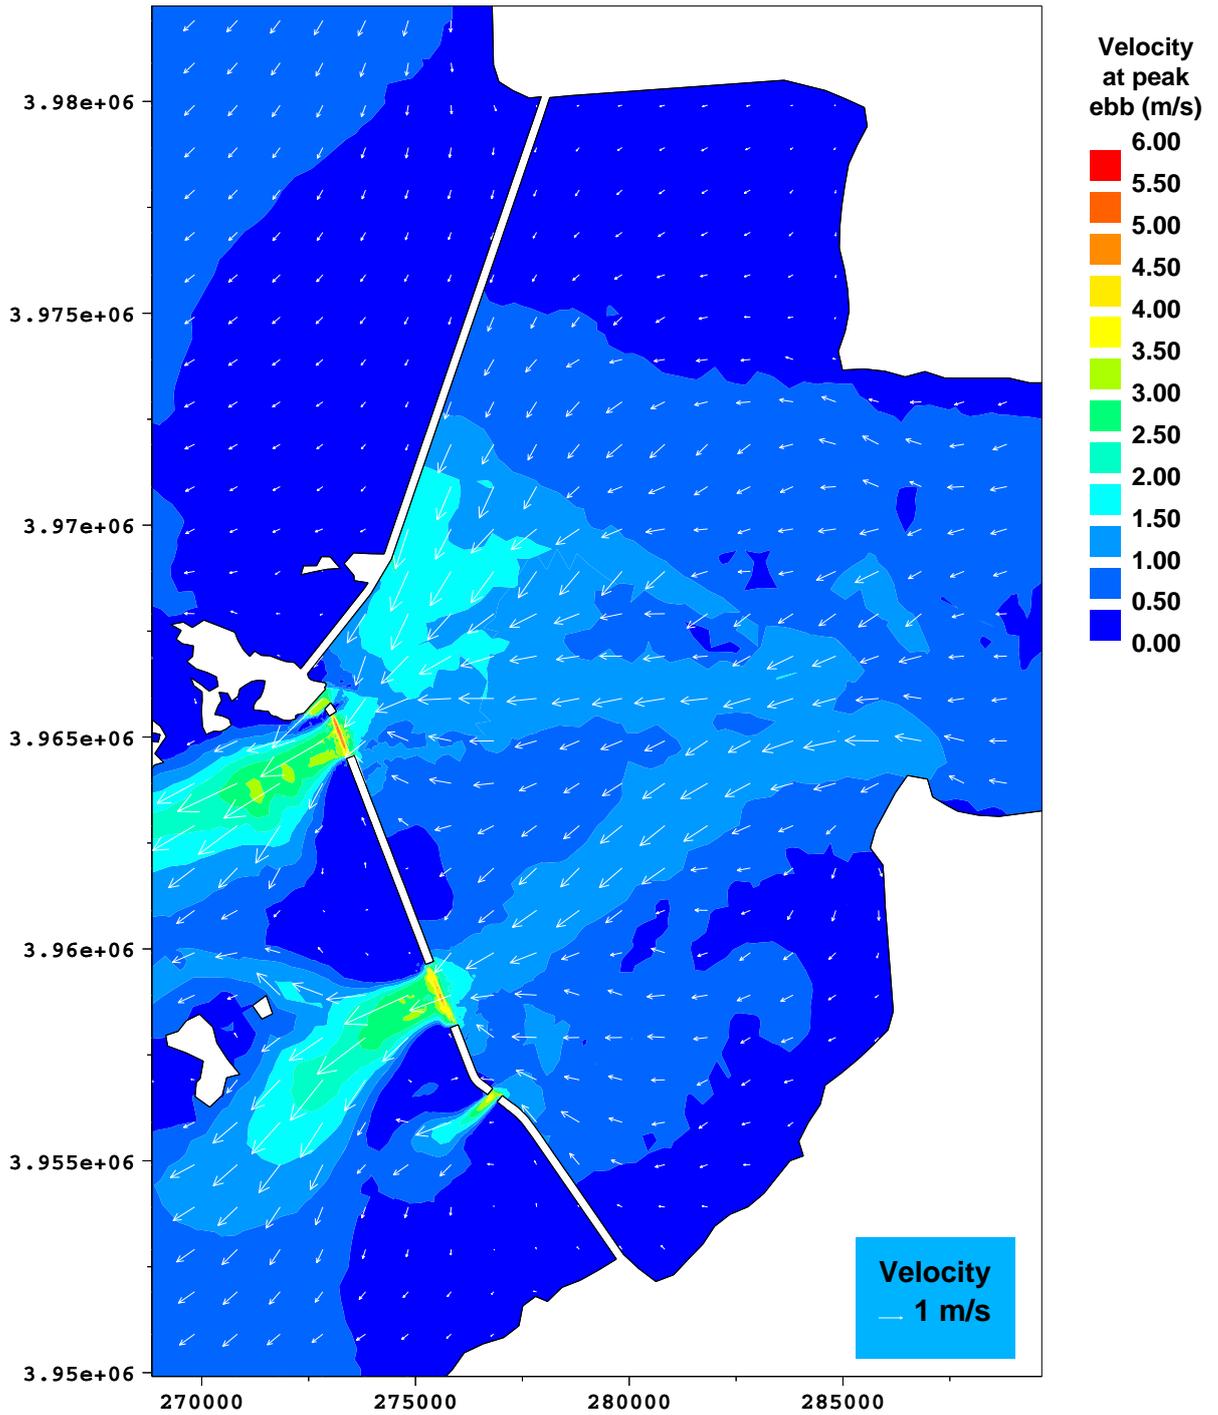
Figure 4.2 Current velocity vectors at peak ebb, Test 1

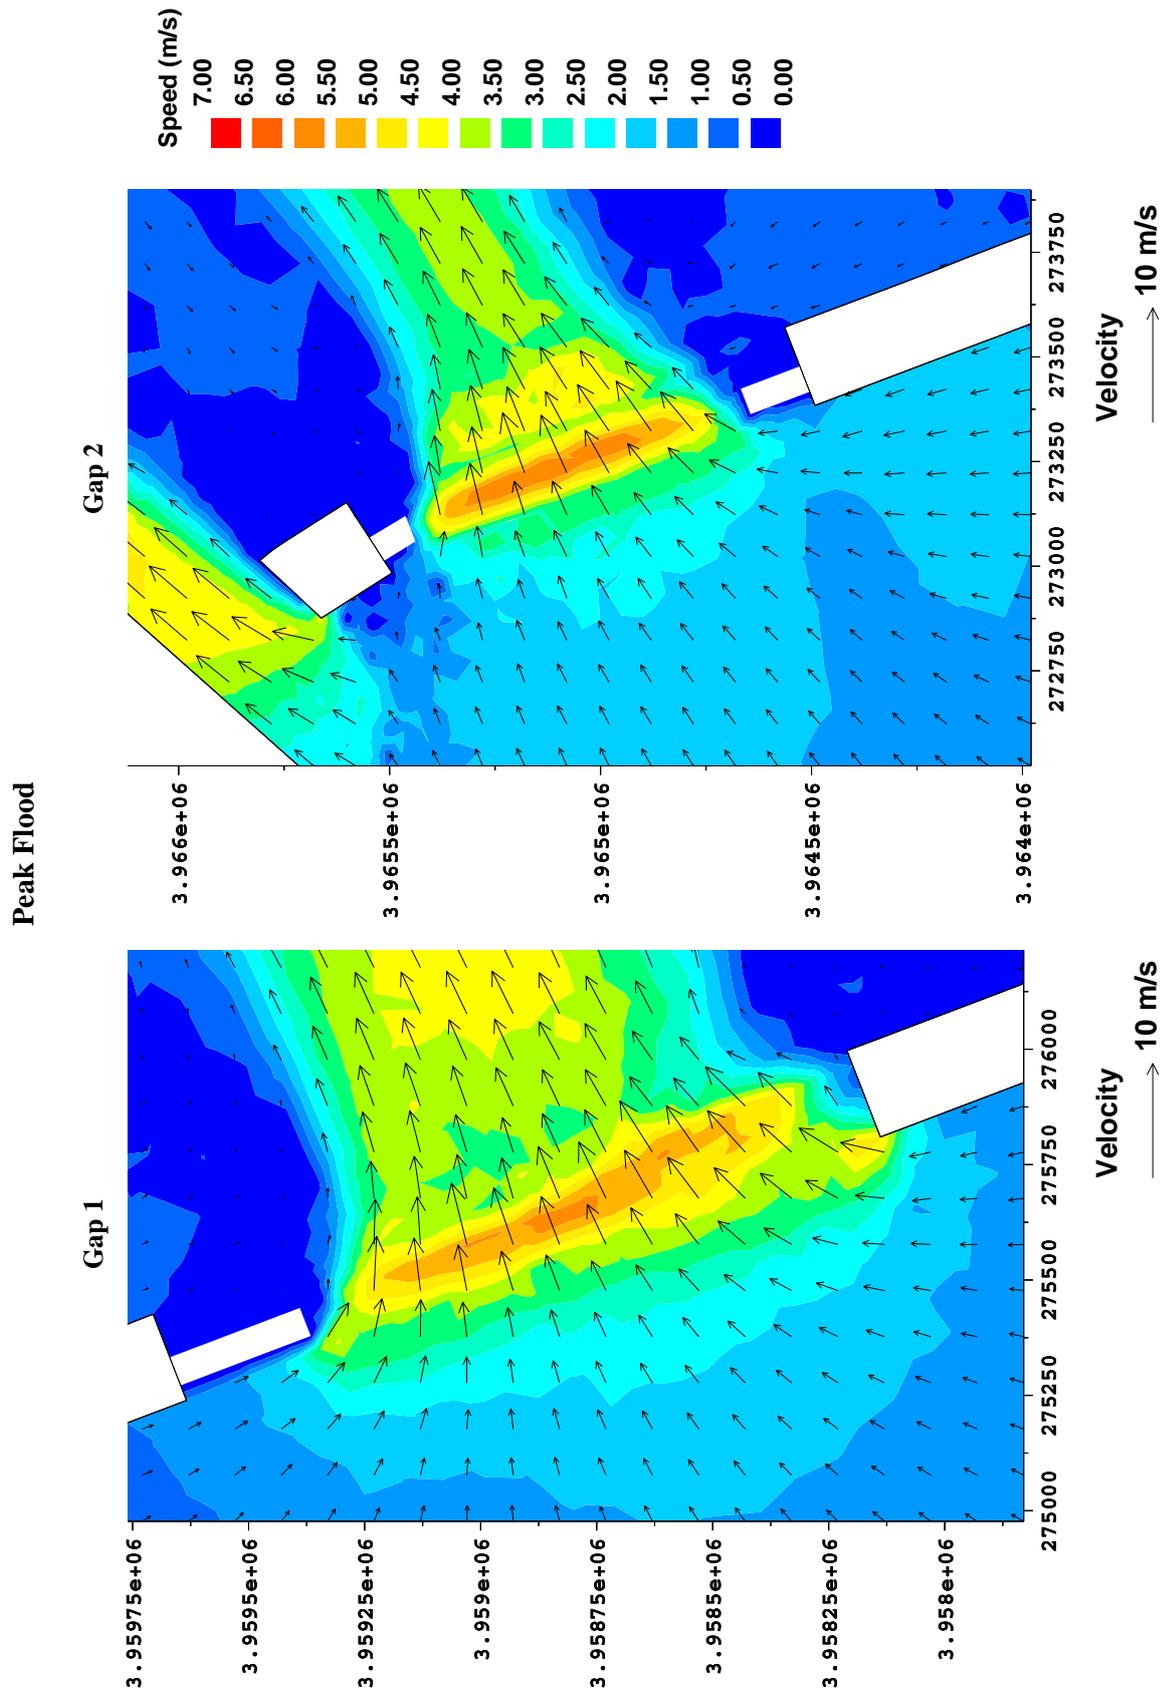
Figure 4.5 Current velocity vectors at peak flood. Spring tide. Test 3. Gap 1 : 1300 m. Gap 2 : 850 m

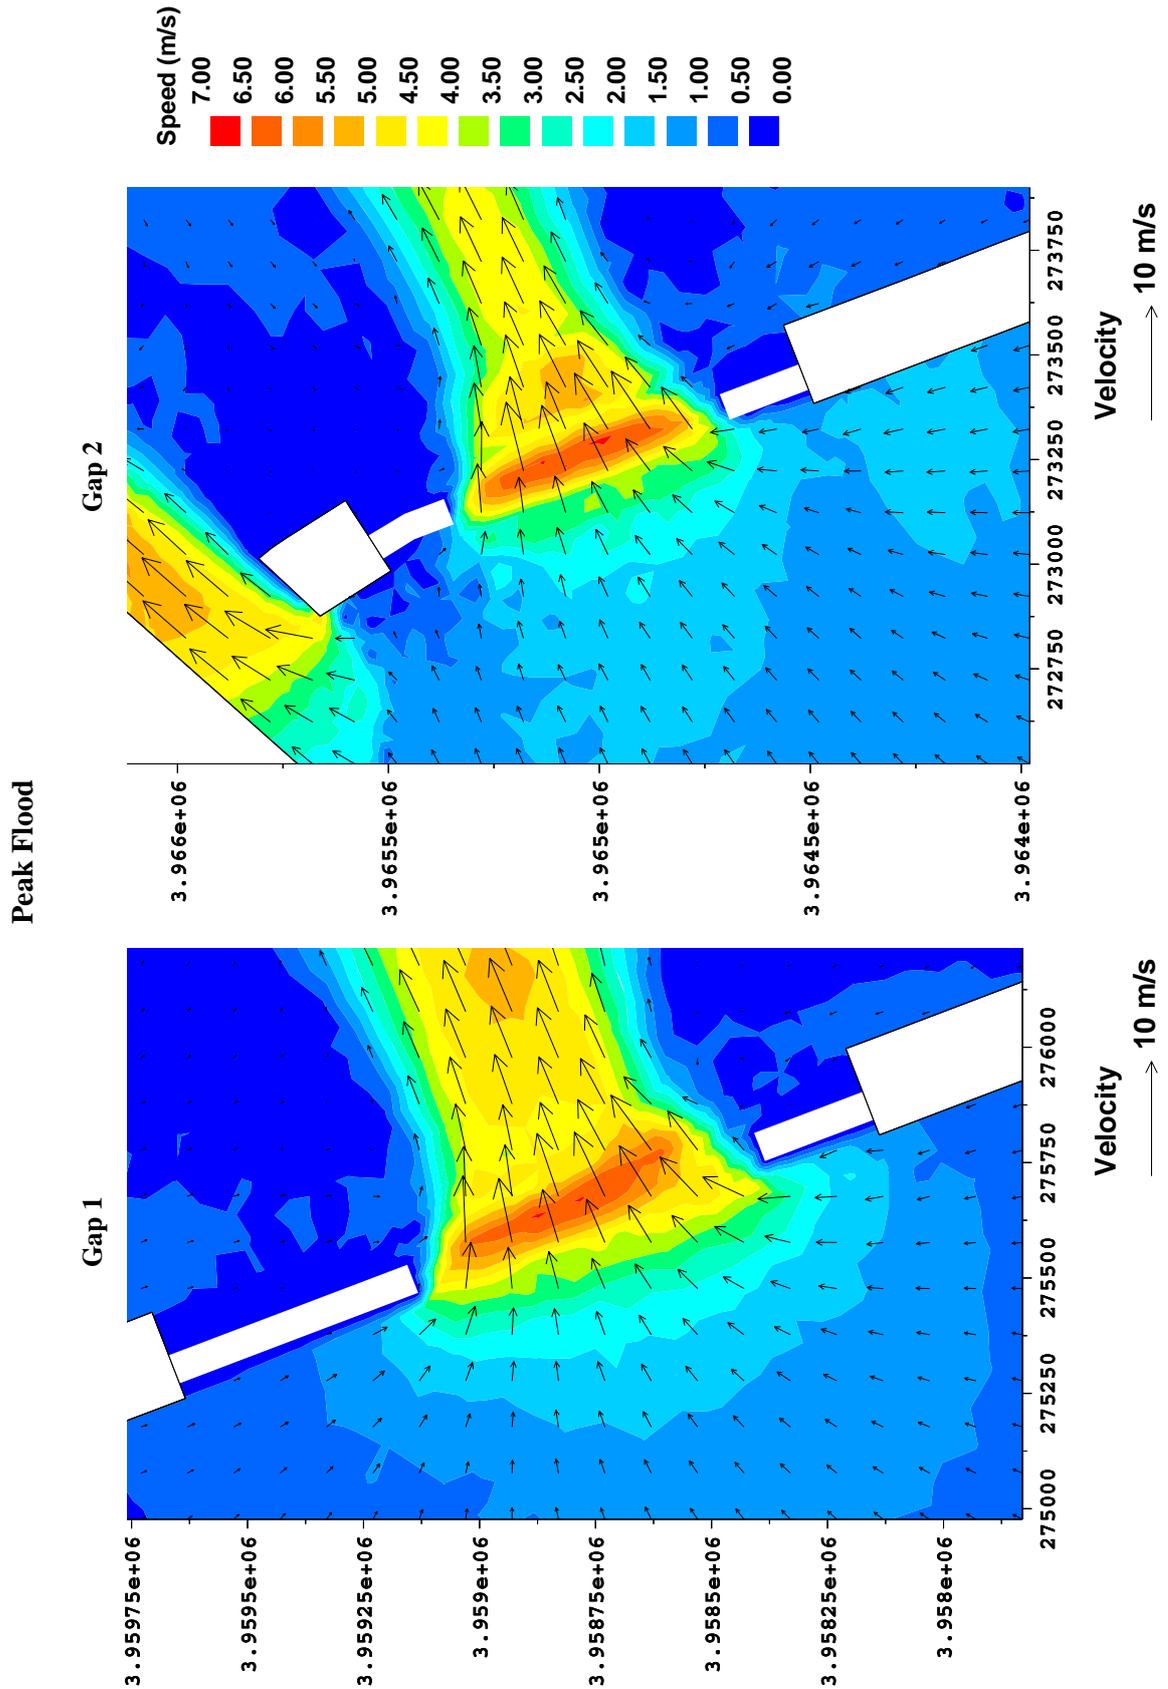
Figure 4.6 Current velocity vectors at peak flood. Spring tide. Test 4. Gap 1 : 800 m. Gap 2 : 700 m

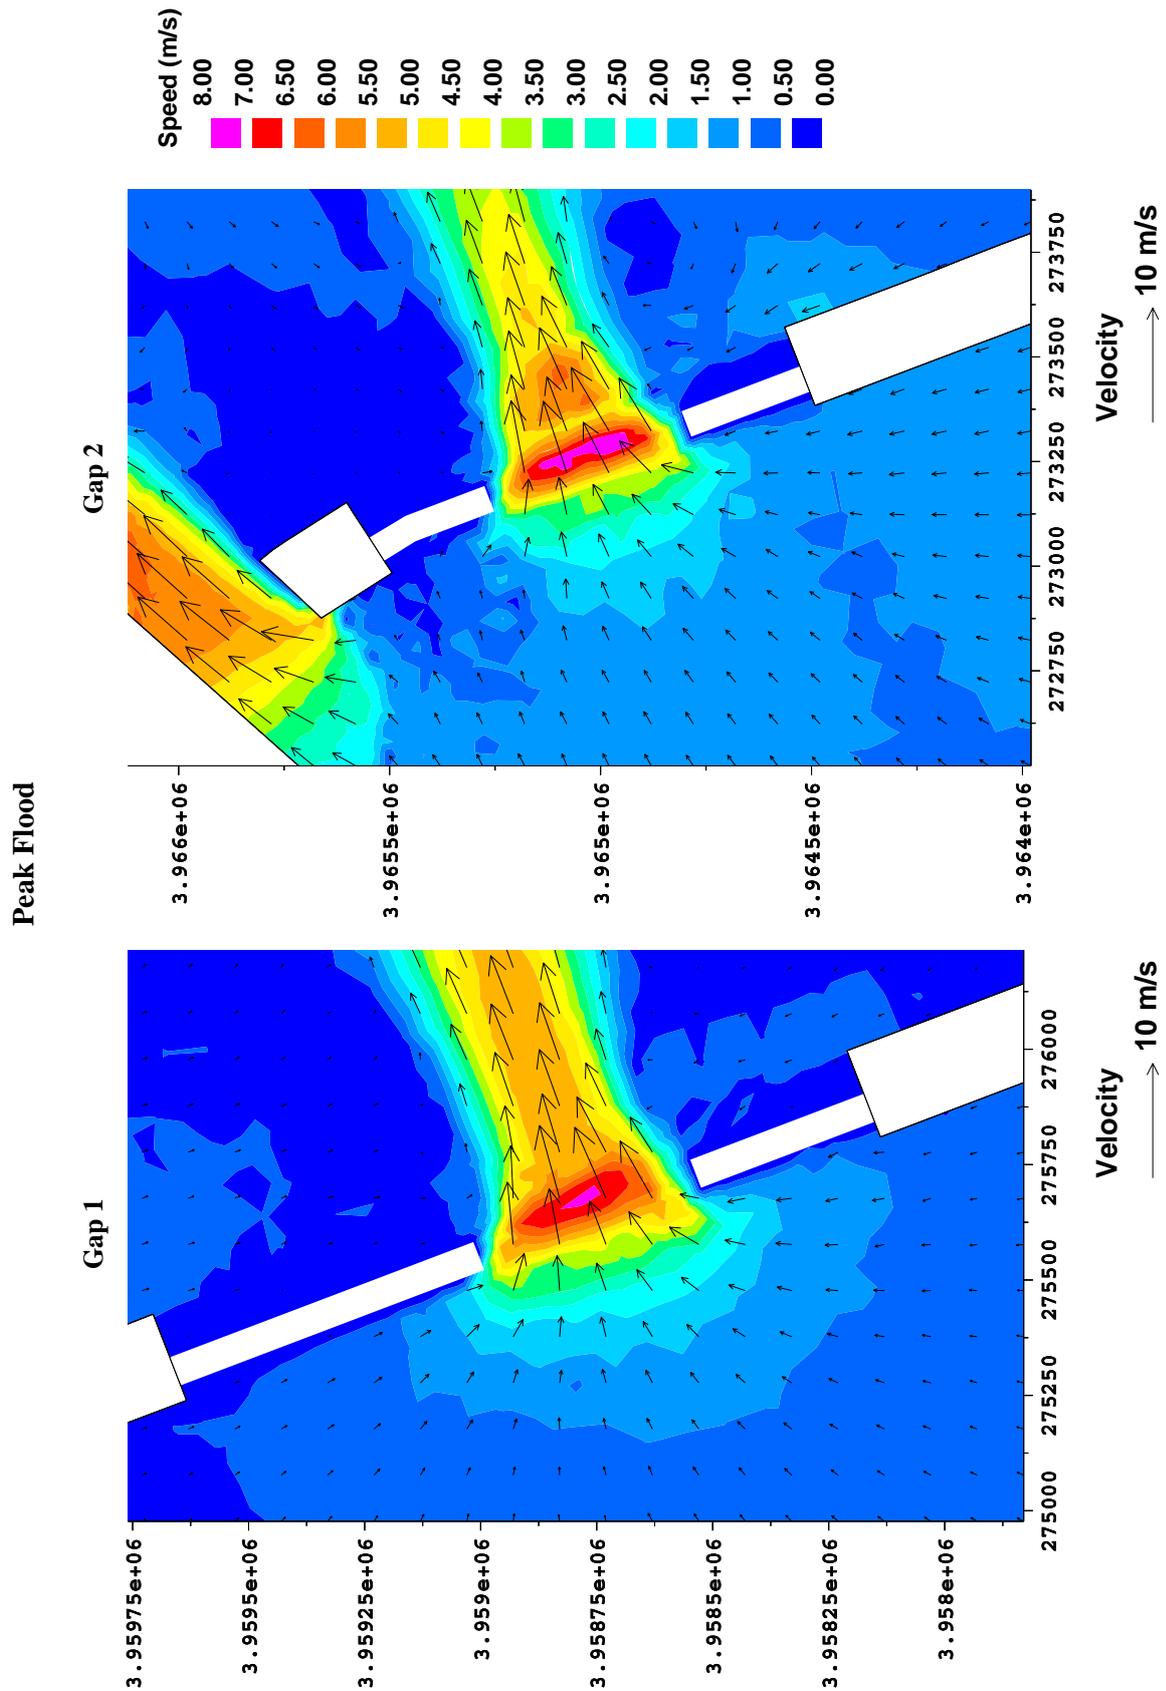
Figure 4.7 Current velocity vectors at peak flood. Spring tide. Test 5. Gap 1 : 500 m. Gap 2 : 500 m

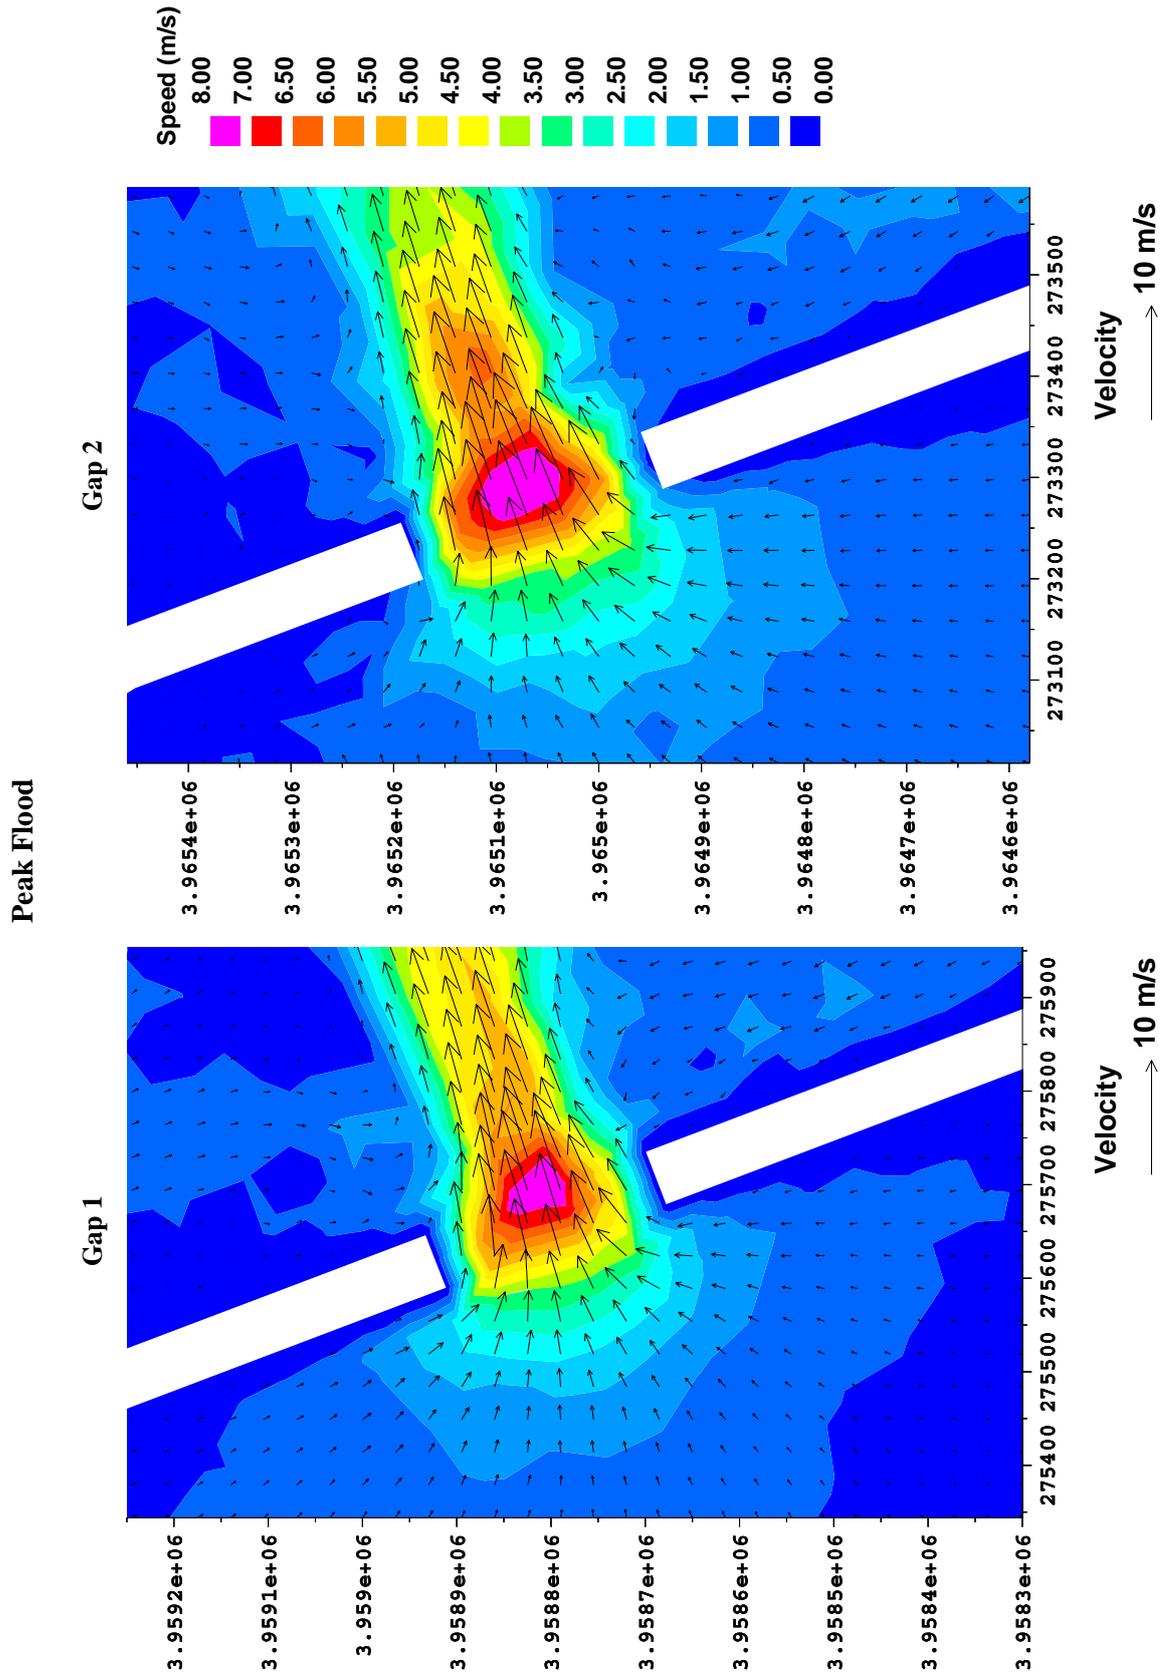
Figure 4.8 Current velocity vectors at peak flood. Spring tide. Test 8. Gap 1 : 200 m. Gap 2 : 200 m

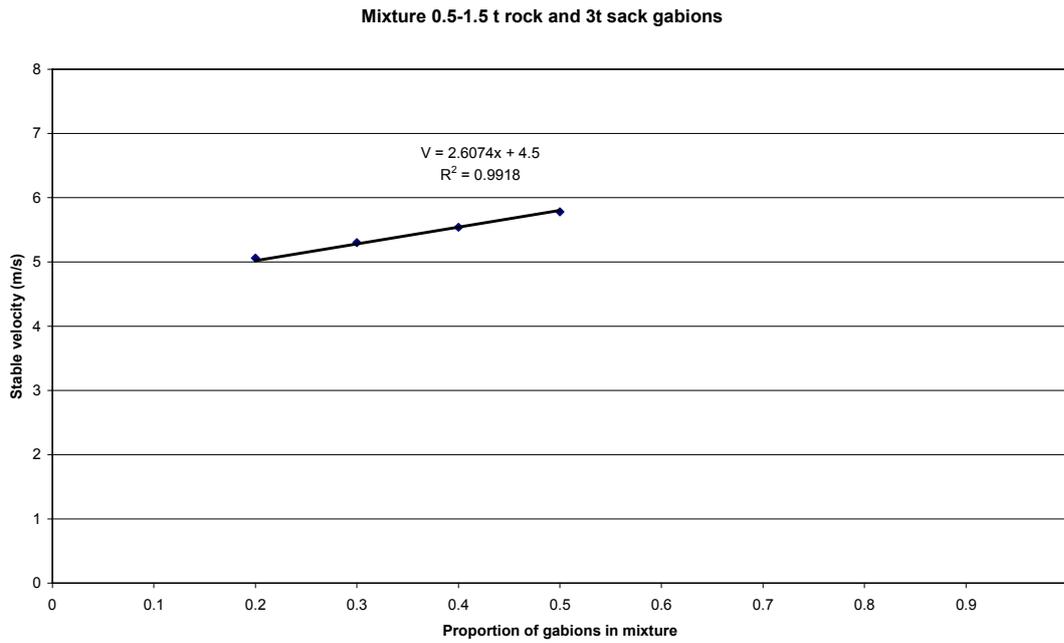
Figure 4.1 Relationship between stable velocities for mixture 0.5-1.5t rock and 3t gabions and proportion of gabions in mixture
