Engineering review on the final closure of Saemangeum Dike

**Report EX 5192
Release 2.0 – Draft Final Report Version
September 2005**

Report EX 5192
September 2005

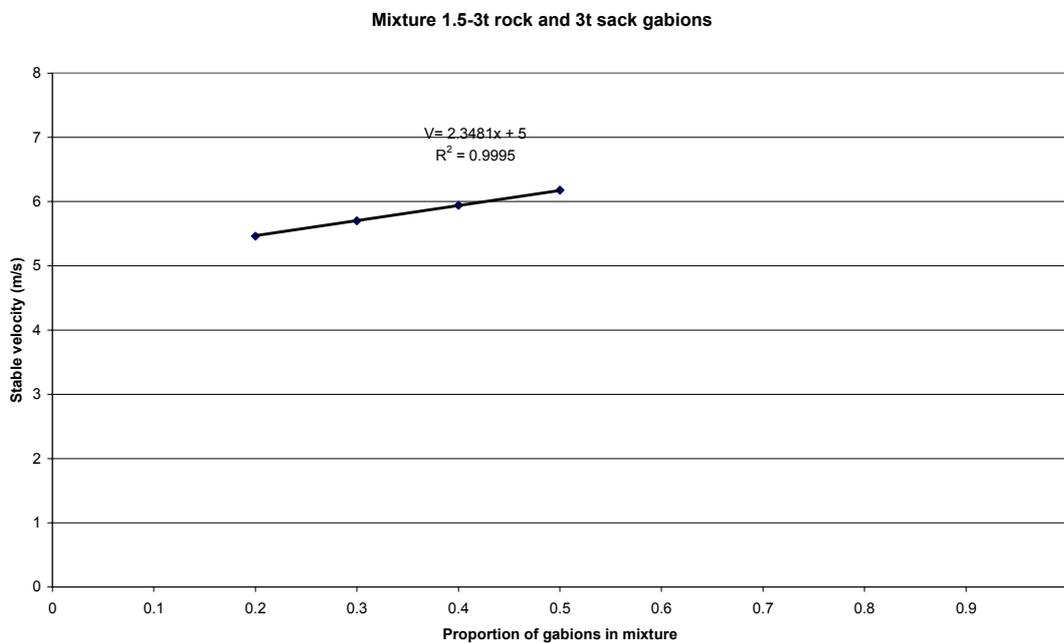
Figure 4.2 Relationship between stable velocities for mixture 1.5-3.0t rock and 3t gabions and proportion of gabions in mixture

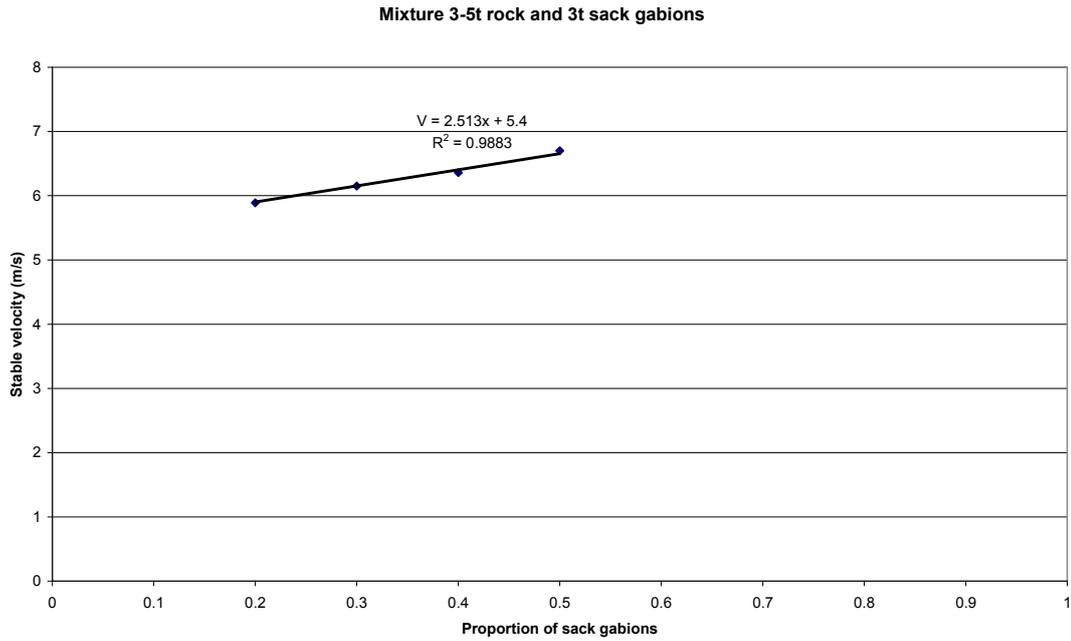
Figure 4.3 Relationship between stable velocities for mixture 3.0-5.0t rock and 3t gabions and proportion of gabions in mixture

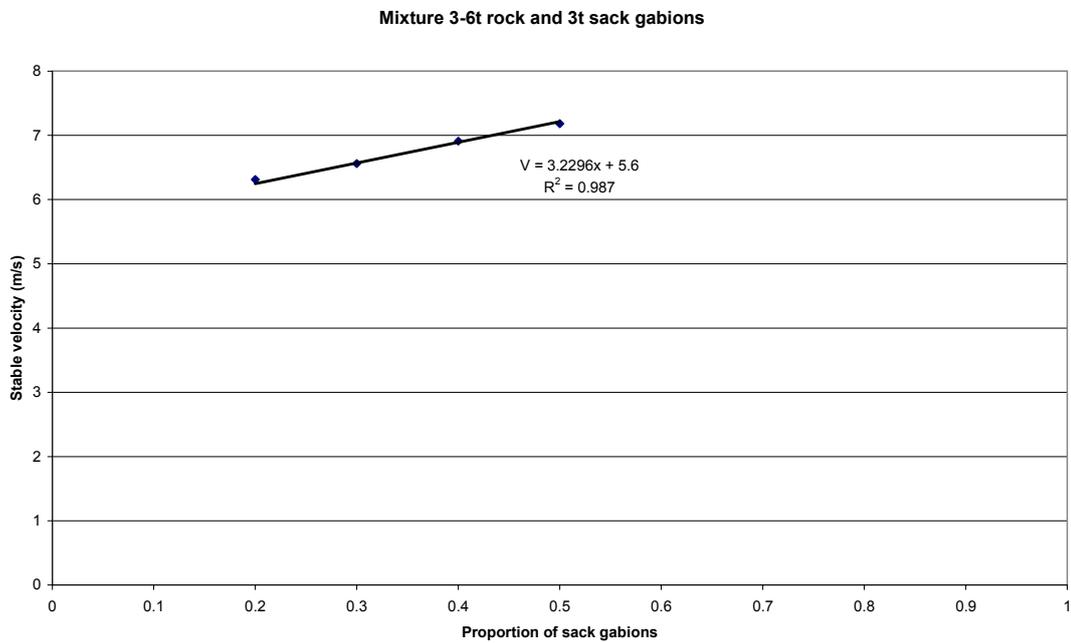
Figure 4.4 Relationship between stable velocities for mixture 3.0-6.0t rock and 3t gabions and proportion of gabions in mixture

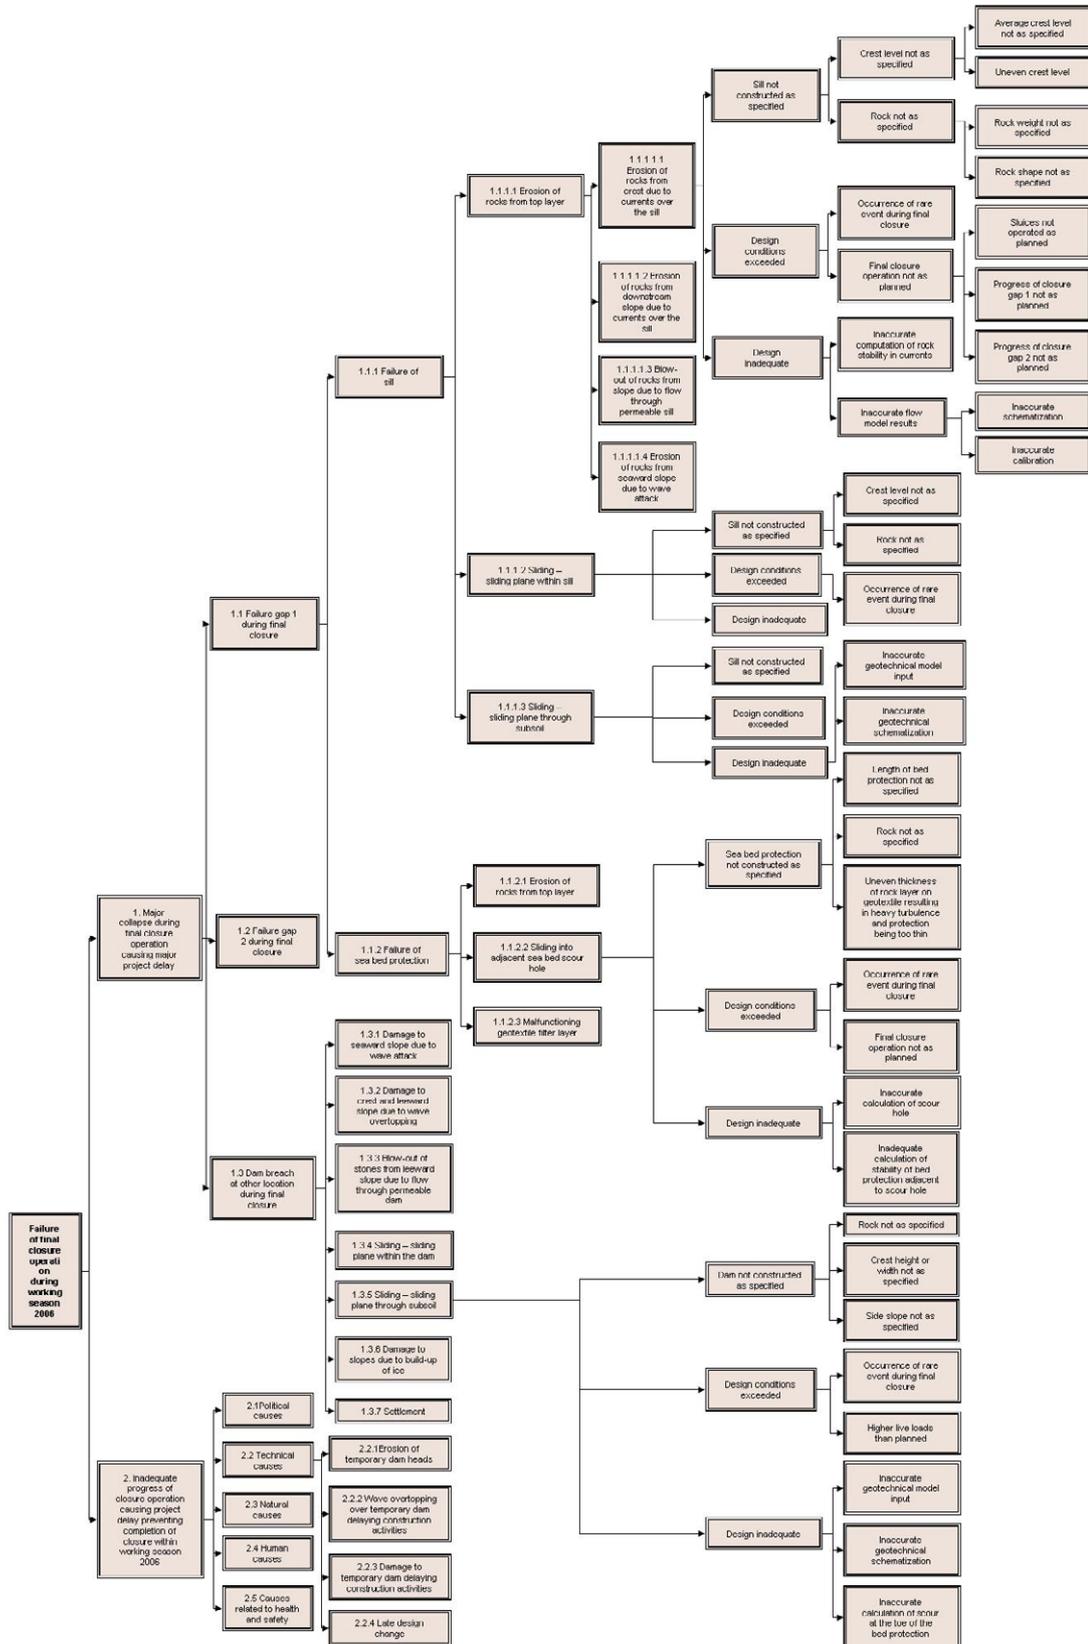
Figure 7.2 Fault tree of failure of final closure operation during working season 2006
