Ten years of bored tunnels in the Netherlands; Part II structural issues

K.J. Bakker

A. Bezuijen

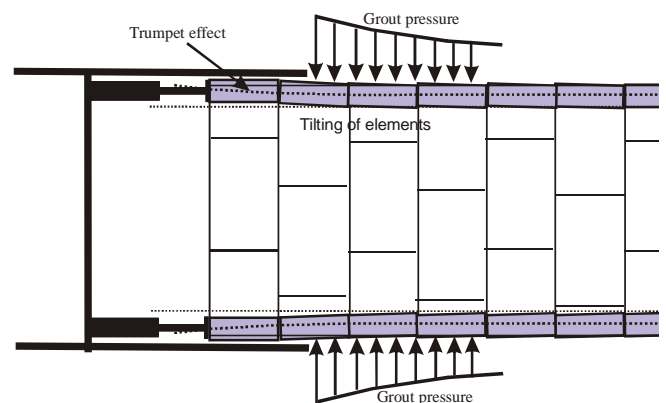
Figure 1. Trumpet effect in tunnel ring construction

The further deformation is characterised by the trumpet shape of the tubing that develops, see Fig. 1, with the inevitable related stress development in the lining. The trumpet shape and the high jacking forces lead to local stress concentrations and irregular deformations in the lining and occasional to slipping between the different tunnel elements. The

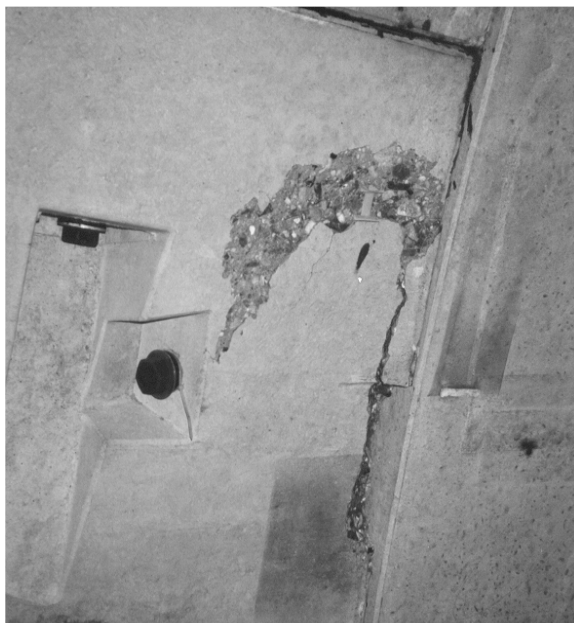
Figure 2 Damage to the Dowel and notch sockets

Characteristic to the damage was cracking and spalling of concrete near the dowel and notches see Fig. 2. Quite often the damage was combined with differential displacements between subsequent rings and with leakage. The evaluation report, see Bakker

(2000), attributed the damage to irregularities in the construction of the lining at the rear of the TBM and subsequent loading during TBM progress. Further a correlation of the damage with high jack forces was observed; these appeared to be necessary to overcome the friction in this part of the track, which prevented smooth progress.

Failure of the dowel and notch system, see Fig. 2. led to spalling and in some cases to leakage. In the cases that leakage was observed this must have been correlated to damage to the notch at the outer side of the lining, creating a shortcut to water penetrating behind the rubber sealing there.

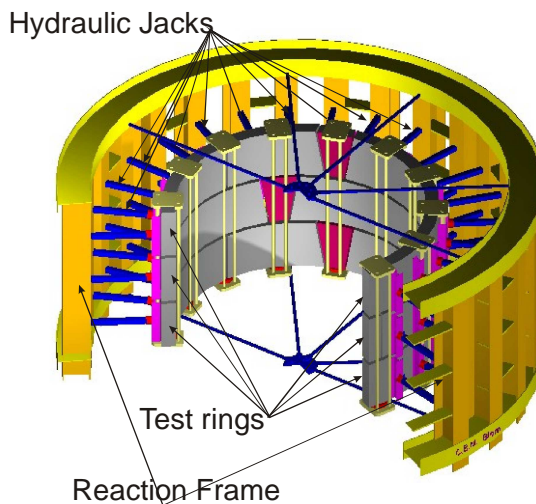
Figure 3. Large-scale tunnel ring testing in the Stevin Laboratories at Delft University (the diameter of the (gray) inner ring is 8.3 m.

With respect to the tunnel ring construction, it is difficult to erect a stress free perfect circular ring. The ring needs to be built onto the end of a former ring that already has undergone some loading and deformation from the tail void grouting while it partially has left the tail of the TBM, see Fig. 3.

Besides this technical measure, the evaluation was the trigger for the undertaking of fundamental research into lining design that included large scale physical testing of tunnel tubing at Delft University see Fig. 4. In this project that was a combined effort of physical and numerical testing, the details of assembling tunnel segments into subsequent tunnel rings and these into a tube were investigated. Amongst others the main results of the project were reported by Blom (2002), and Uijl et al (2003). Based on this research it was decided to omit the dowel and notches for the Green Hart tunnel; which led to a nearly damage free tunnel lining.

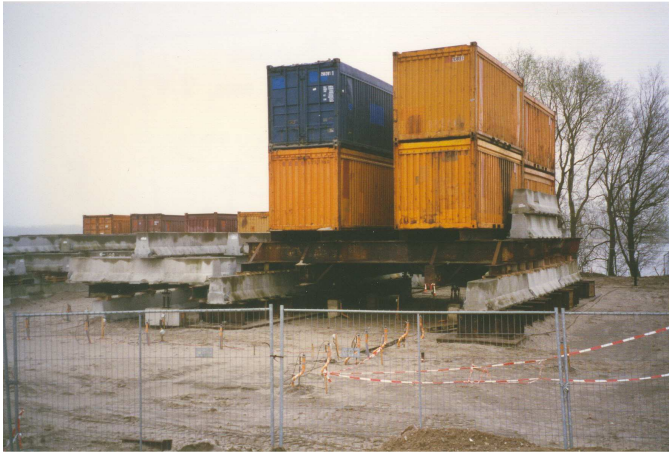
Figure 4 Test site for the Pile-tunnel interaction test

A trial field with loaded piles and pile configurations was installed in the area near and above the track of the TBM, see Fig. 4. One of the main concerns was that due to an increase in pore pressure the effective stresses around the pile tip might be affected and that a release in isotropic stresses might trigger a drop in pile bearing capacity.

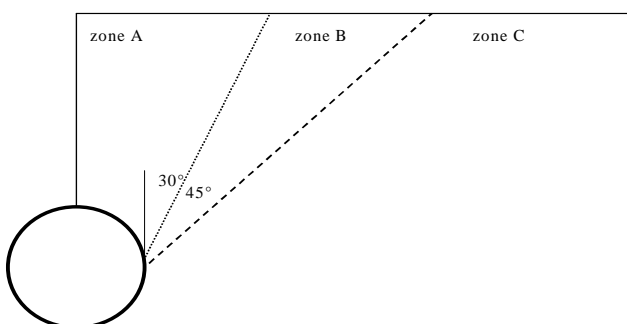
Figure 5 Zones that indicate different effects on piles foundations

However, reasoning and analysis is one thing; measuring and validation is another; based on the field measurements and physical model research in Delft and Cambridge Kaalberg et al. (2005), proposed a zoning as shown in Fig. 5, with the following indicators; a zone 'A' above the tunnel where the settlement of a pile is expected to be larger than the soil displacements. A zone 'B' adjacent to the tunnel, with an inclined influence line, where the pile will follow the soil deformation at the tip of the pile, and further a zone 'C', outside Zone B, where at soil surface level the settlement of the pile will be less than that of the soil surface. This zoning proposal more or less coincides with the main results as published by Selemetas (2005) that were mainly based of physical testing in a

- 4) No proof was found that tunnel driving, in normal operation, might give cause to loss of bearing capacity of piles. Settlements in general are related to the settlement of the ground and the position of the pile toe with respect to the zones indicated in fig. 5.

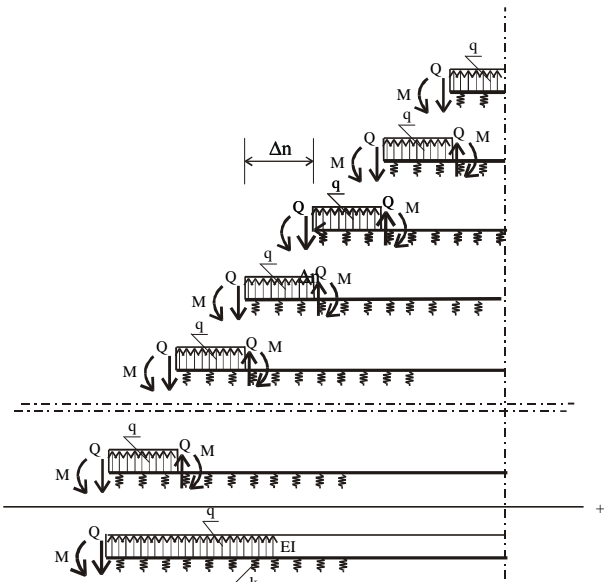
Figure 6 Conceptual model for the analysis of beam effects in the tube of a bored tunnel by Boogaards (1999)

beam with an elastic bedding and a series summation, such as developed by Boogaards & Bakker (1999), see Fig 6. and later on applied by Hoefsloot (2002). See Fig. 7 for a comparison between model outcome and measurements from the 2nd Heinenoord tunnel.

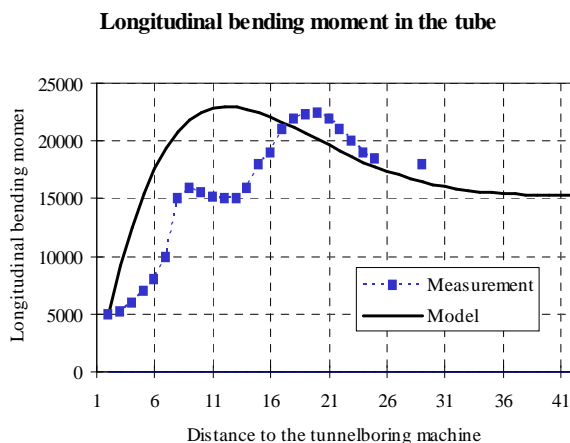
Figure 7 Longitudinal bending moment due to the construction forces measured and calculated acc. to Bogaards model

However, using generally accepted parameters, the measured deformations are much higher than according to these models. Recently, Talmon et al. (2008) have presented results that may explain the lower stiffness that are found in the measurements (the lining stiffness can be lower due to only local contact between the elements and the soil stiffness reduces due to unloading of the soil around the tunnel), but these are not yet generally accepted.
