VISUALISATION ENTRANCE „BAUTEIL BÖRSE“

DEMOUNTING DDR PLATTENBAU

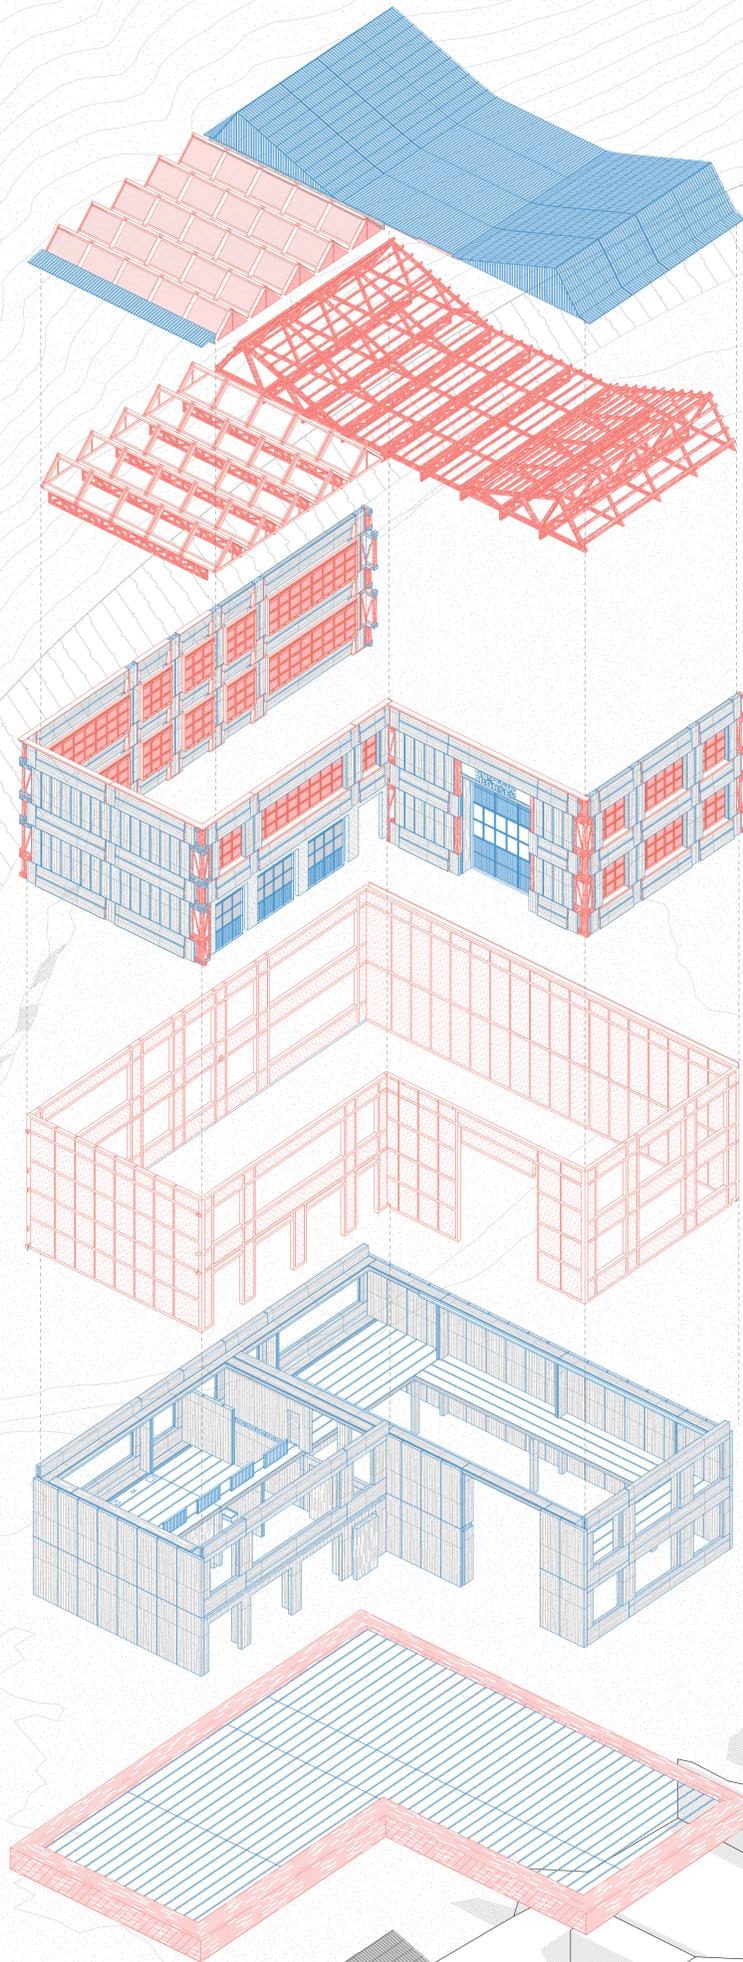
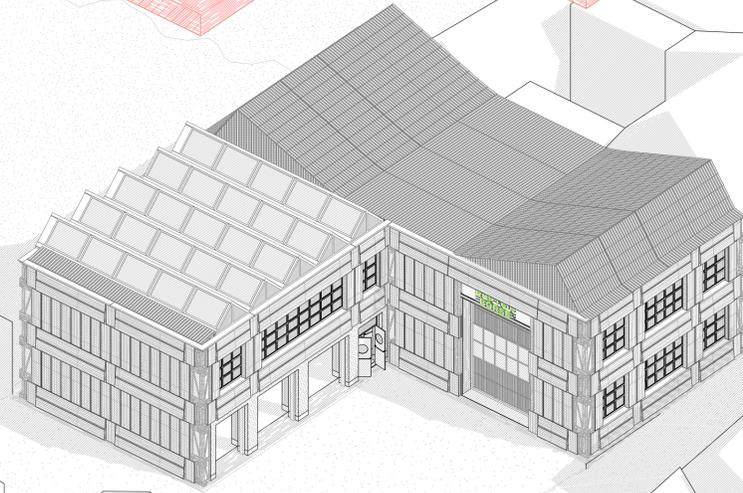
6. Roof cladding
Re-used corrugated sheets

5. Roof structure
Wood construction based on trusses

4. Facade
Re-used and appropriated outer protection layer

3. Insulation layer
Bio-based insulation + timber sub-construction

2. Shell construction
Re-used „Plattenbau“ panels

1. Foundation:
New strip foundation +
Re-used ceiling panels

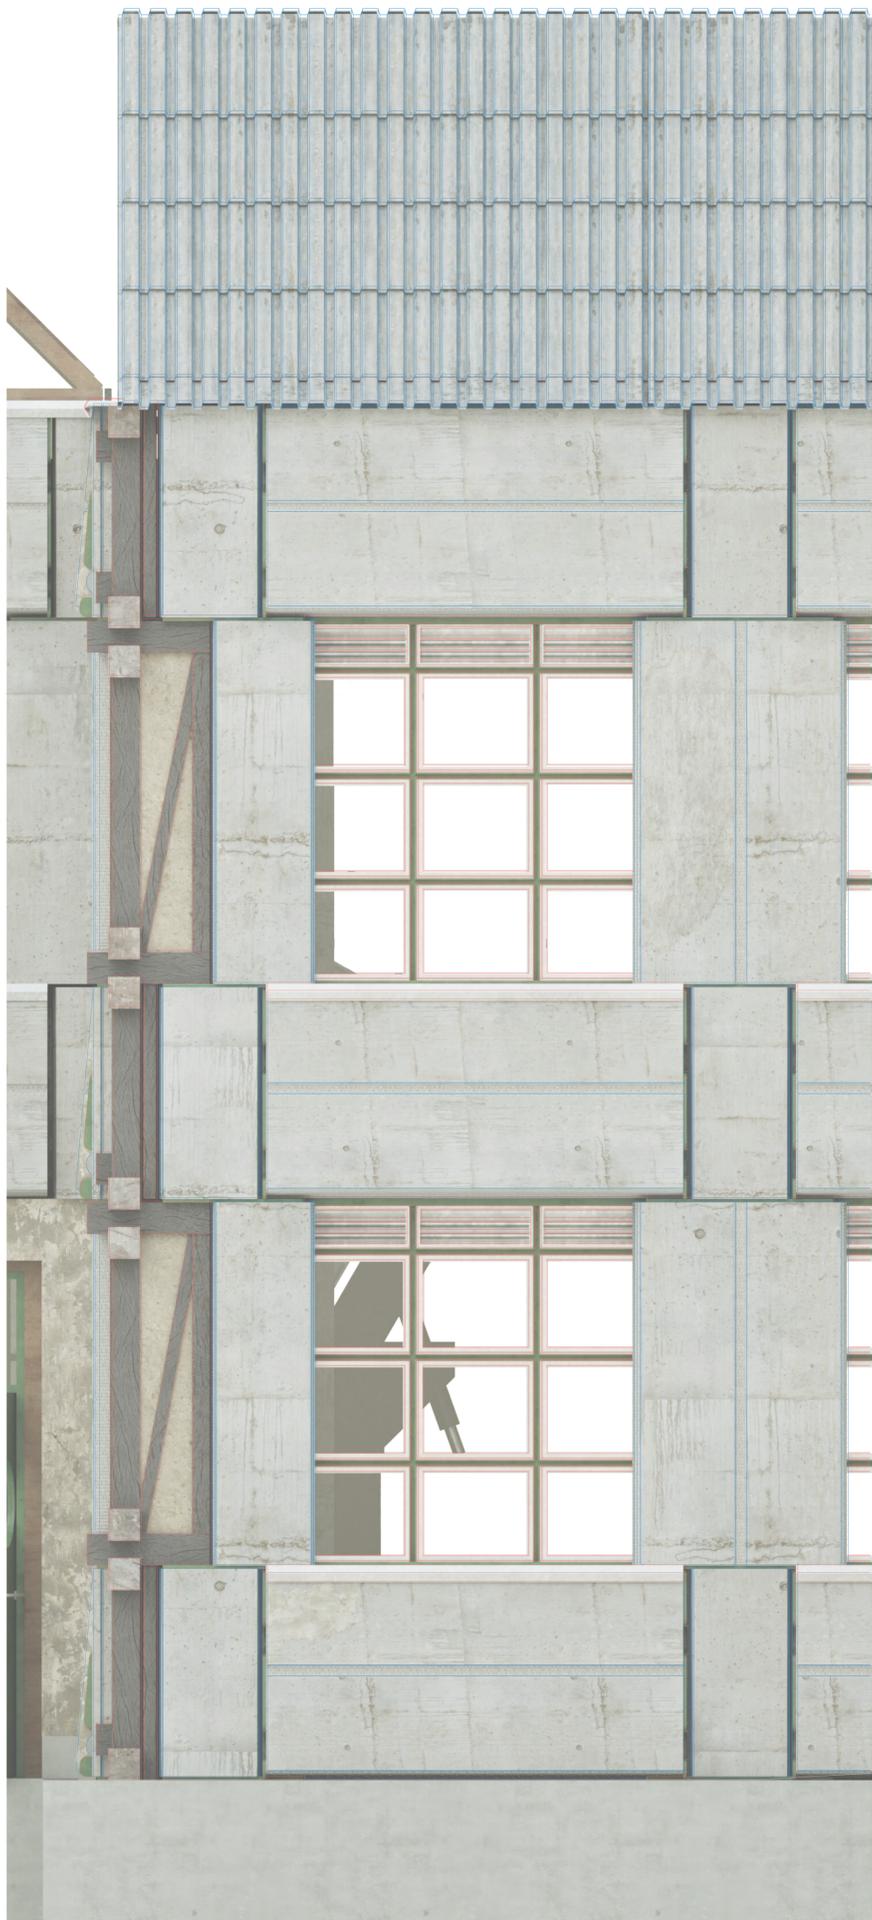
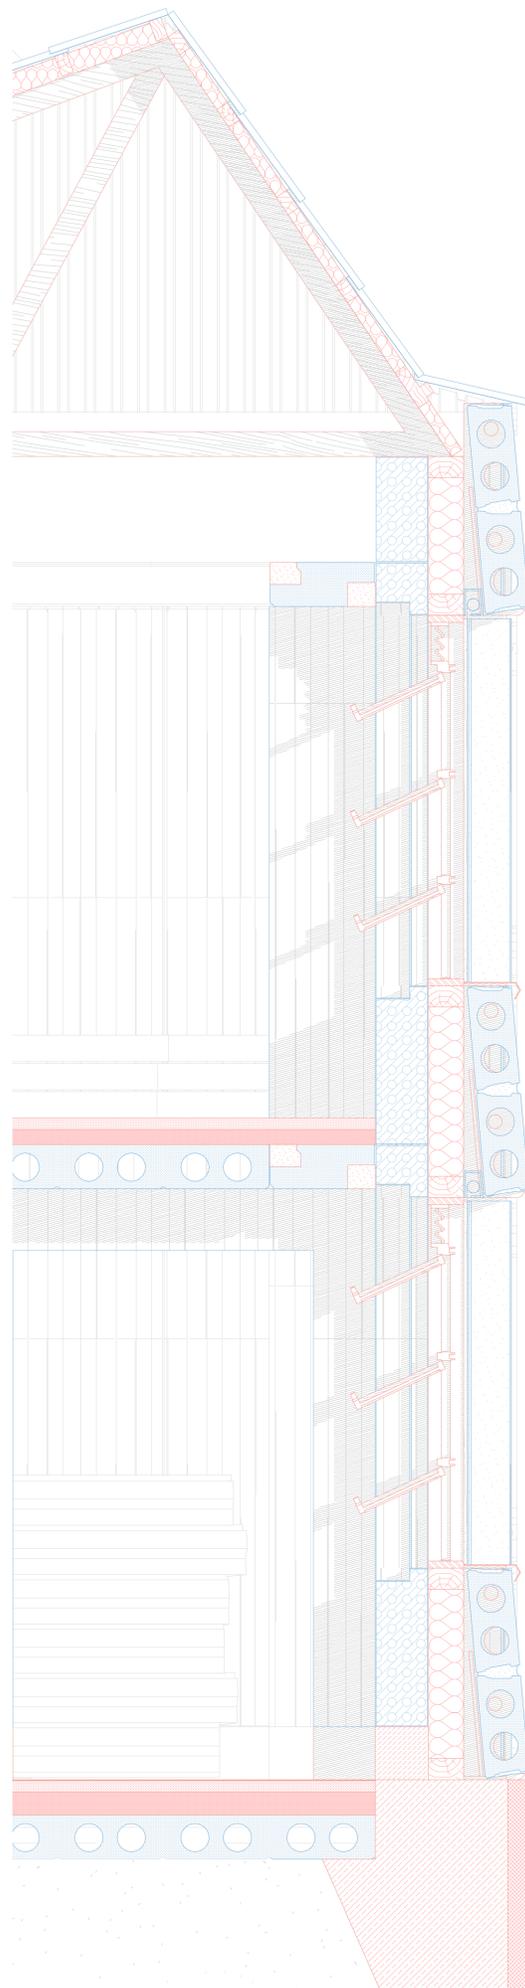
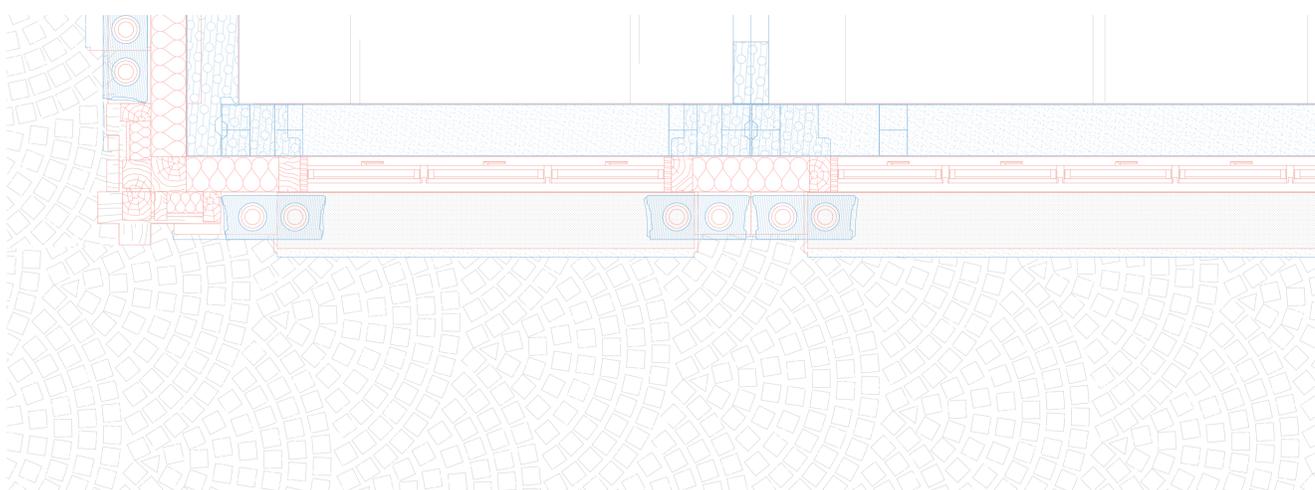
FRAGMENT DETAILS 1:20

- 30 mm** ROOF
- 5 mm** Reused corrugated metal sheets
- 8 mm** Wooden slat subconstruction
- 7 mm** Wood wool insulation
- 10 mm** Wooden truss

- Facade**
- 250 mm** Re-used concrete ceiling panels
- 2 mm** Stainless steel console
- 200 mm** Timber Insulation

- 450 mm** FLOOR
- 5 mm** Concrete Screed
- 15 mm** Acoustic Insulation
- 250 mm** Re-used ceiling-elements

- Foundation**
- 250 mm** Re-use ceiling elements
- 750 mm** Concrete strip foundation
- 300 mm** Perimeter insulation

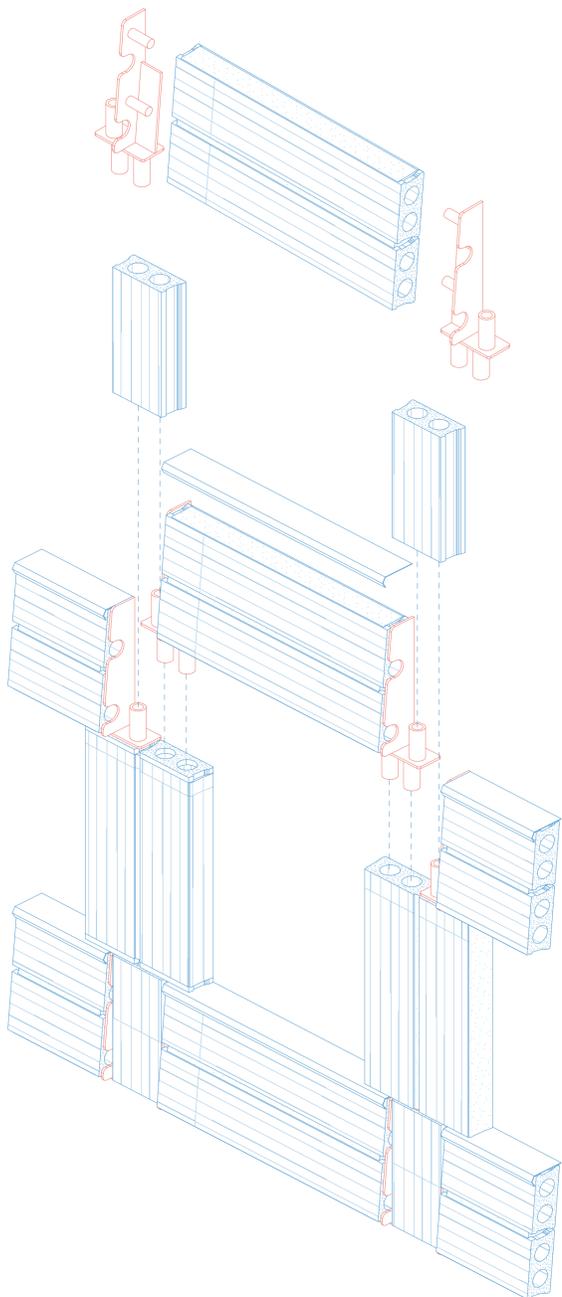
CONSTRUCTION PRINCIPLE EXTERIOR FACADE
