Volumetric Pothole Detection from UAV-Based Imagery

Chen, Siyuan; Laefer, Debra F.; Zeng, Xiangding; Truong-Hong, Linh; Mangina, Eleni

Journal of Surveying Engineering

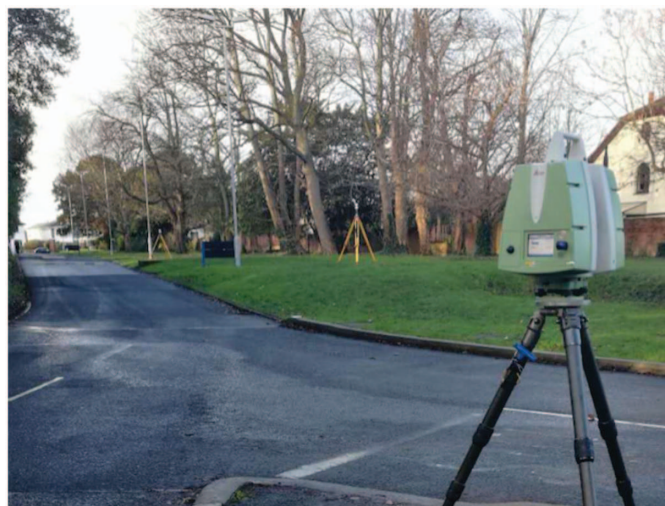
Fig. 9. (Color) Leica P20 Scan Station at the data collection site.

To estimate the accuracy of the proposed UAV-SfM data capturing method and related damage-extraction algorithm, TLS data were collected for benchmarking. These data were collected with a Leica P20 Scan Station (Wetzlar, Germany) and postprocessed with Leica's proprietary software Cyclone (V9.1). Potholes were manually extracted from the TLS data as a reference set to compare the performance of the algorithm on both the TLS data set and UAV-SfM data set.

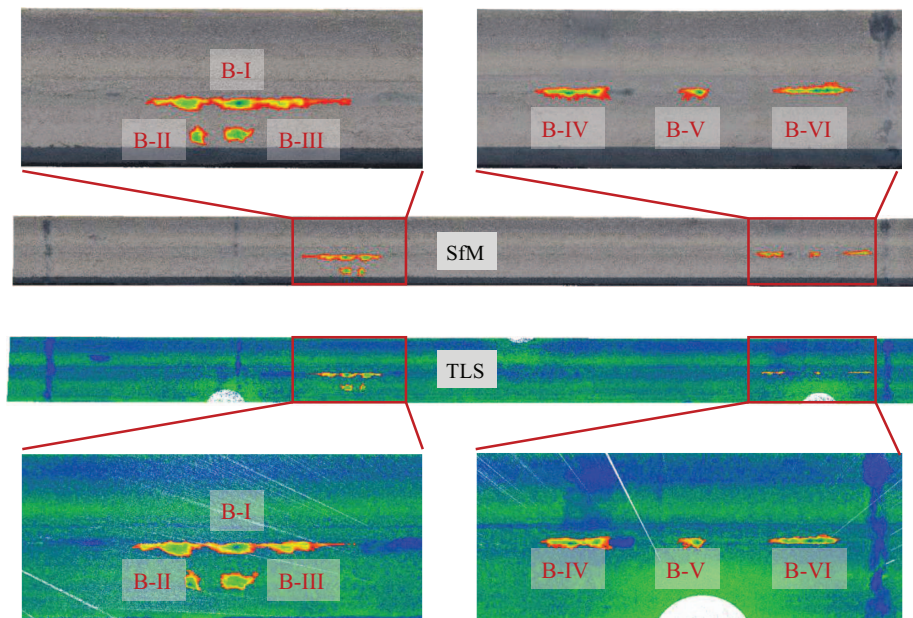
Fig. 12. (Color) Location of target potholes in SfM and TLS bridge data sets.

The second field trial was of an asphalt bridge deck located in County Wicklow in south Dublin. At this site, there were no obstacles around the bridge and no objects casting shadows. At 150 m long and 4.8 m wide, the pavement size was similar to that in Field trial 1. The Field trial 1 flight path was repeated, resulting in 91 aerial images in 12 min (60 from 10 m above and 31 from 20 m above). A total of 4 images containing vehicles were manually removed. The remaining 87 images were used as the input for the 3D reconstruction, resulting in a point cloud of 43 million points. The accompanying TLS data set had 270 million points and was collected in 180 min from 10 scan stations. The resolution setting was 5 mm at 10 m. From both data sets, six potholes were manually extracted (shown as B-I to B-VI in Fig. 12).

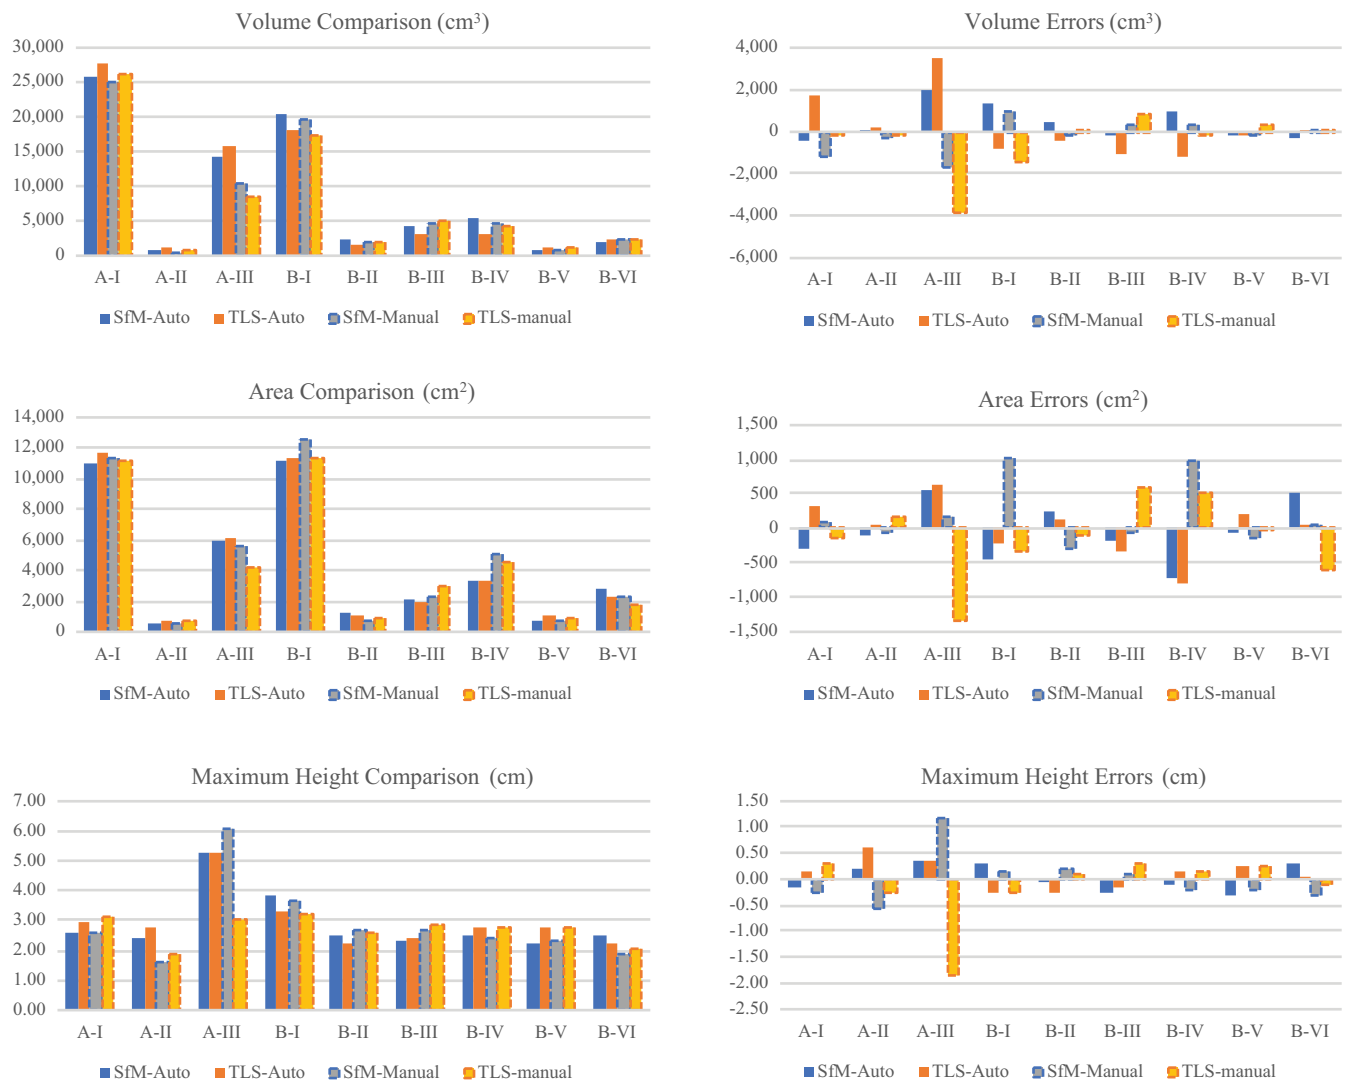
Fig. 13. (Color) Error analysis.

Automatic pothole extraction was applied in both the SfM and TLS point clouds. The manual extraction results of each data set are also presented (Tables 1–6 and Fig. 13). By comparing each result with the average result, the maximum discrepancy in the two data sets was found to occur in Pothole A-III in the UCD road study. A possible reason is that previous repairs posed a challenge for the curve fitting because the final road surface was neither flat nor sloped in a consistent manner. Specifically, Fig. 14 shows the three repaired patches (marked with A, B, and C) causing a different and uneven

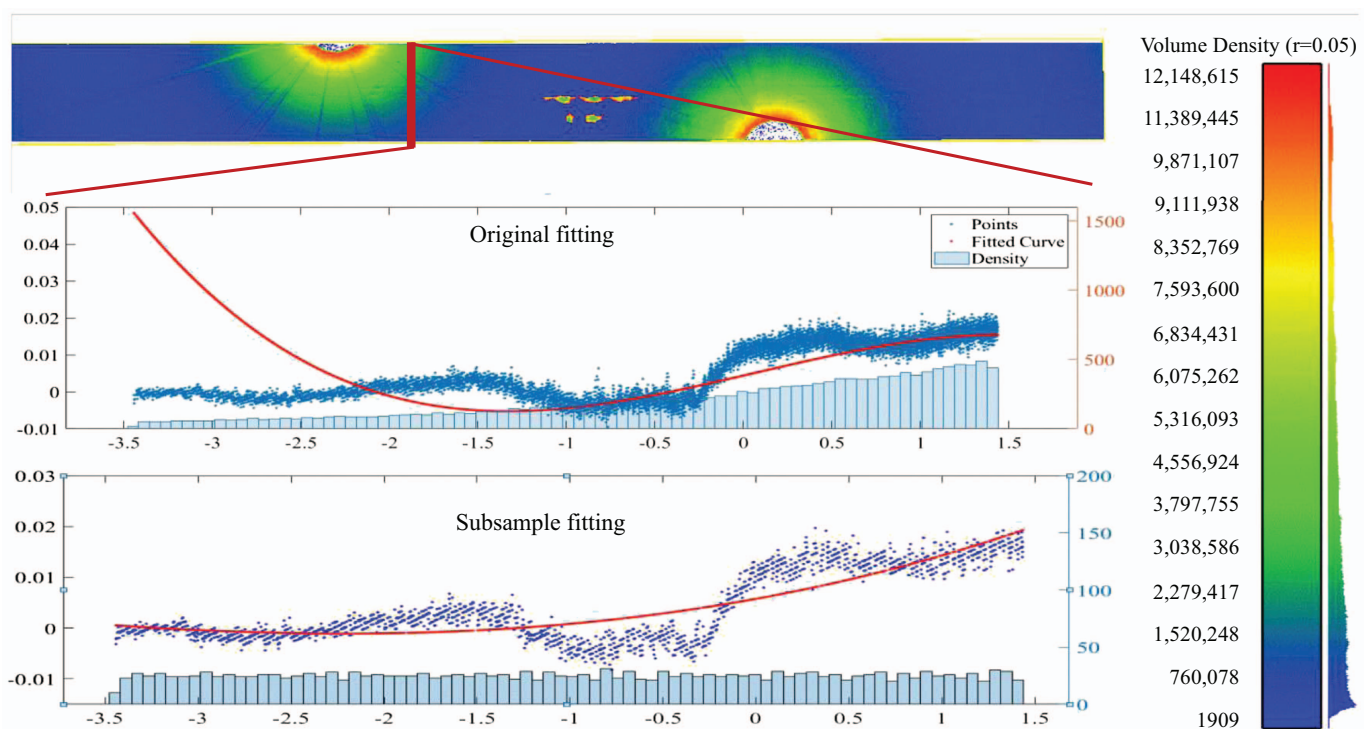
**Fig. 16.** (Color) Effect of nonuniform distribution.

sets have serious radial distribution biases. Thus, data collection from one side of the road have much denser points than the other side, which introduces errors in the curve-fitting process proposed herein. For the cross section shown in Fig. 16, the fitted curve will be skewed to the right side surface, whereas points on the left will be ignored due to the much higher density on the right. In this case, it causes a problem for the pothole extraction in TLS data set. Additionally, due to the points density drops and radial distribution, the TLS data set contains some empty gaps, which look like white strips (Fig. 17). The missing points along these strips will cause subsequent problems for detailed extraction and mesh generation. The SfM data set does not have this kind of problem.
