## **Semi-selective demolition: Current demolition practices in Flanders**

### **Abstract**

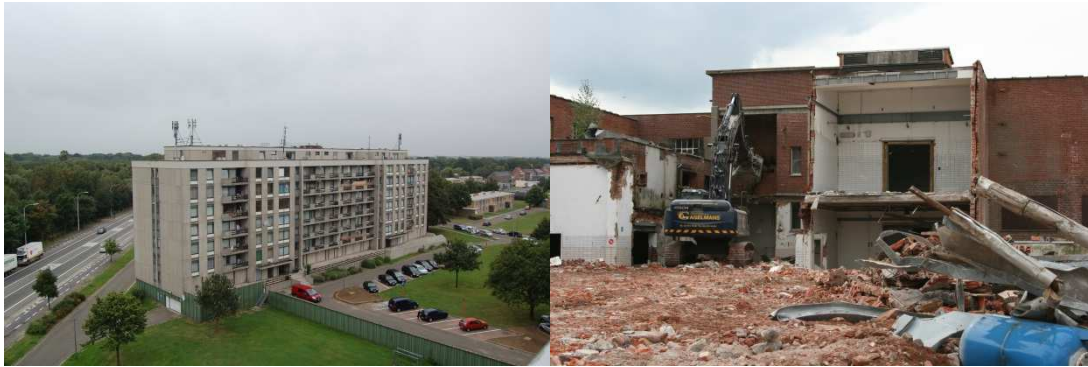
**Figure 1.** BAU case studies (left: apartment complex, right: old milk factory).

In 2 case studies, the demolition works were documented without interfering in the process in order to assess the Flemish business-as-usual (BAU) demolition practices. We selected a complex with 20 apartments and an old milk factory for this task (Figure 1).

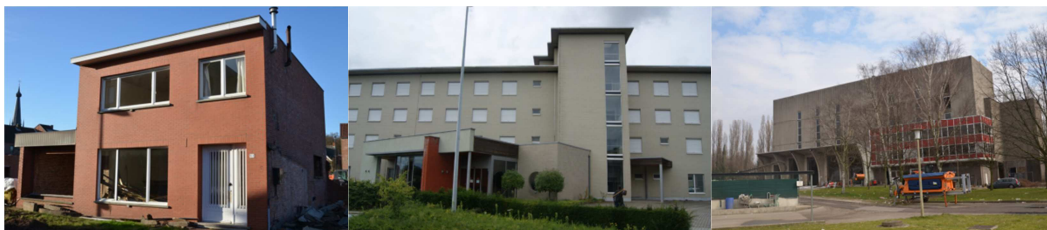
**Figure 2.** Case studies for the testing of the monitoring system (left: single family house, middle: residential care center, right: incineration plant).

Furthermore, a new quality management and traceability system, developed by the Flemish construction confederation VCB, was tested in 3 case studies. This monitoring system aims at the certification and quality assurance of waste streams that originate from selective demolition. We selected the following buildings: a single family house, a residential care center and part of an incineration plant (Figure 2).

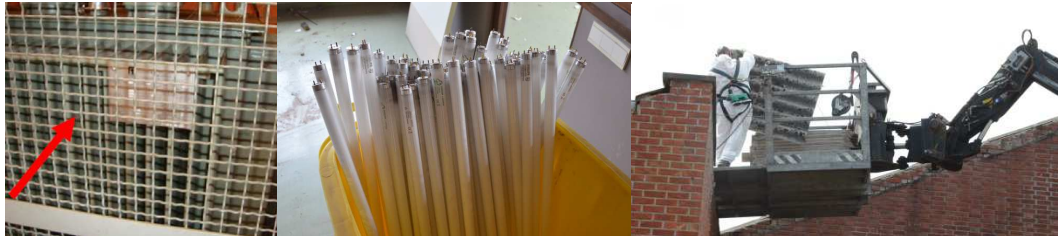
**Figure 2.** Hazardous materials (left: PCB-containing transformer, middle: mercury-containing lamps, right: asbestos).

In a first stage of a BAU demolition project, the hazardous substances (e.g. asbestos, mercury-containing lamps, PCB-containing equipment) that are present in the buildings are removed (decontamination). The performance of this decontamination step mainly depends on legislation and law enforcement.

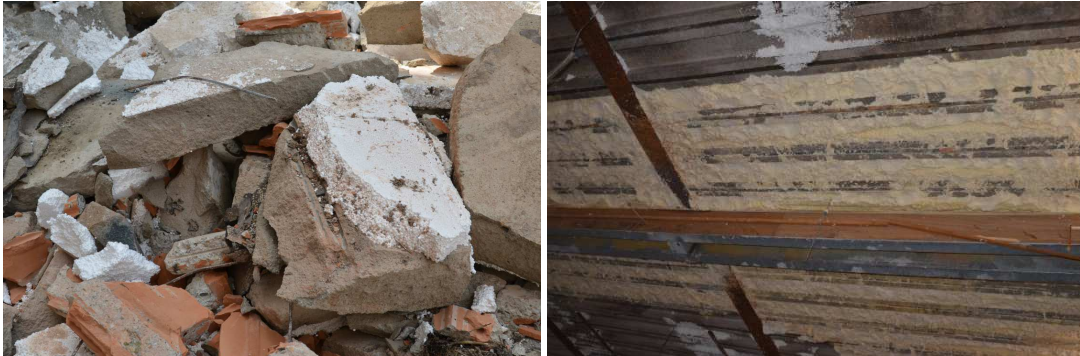
**Figure 3.** Examples of complex insulation materials that are difficult to dismantle (left: expanded polystyrene, right: polyurethane foam).

- **A lack of cost efficient techniques for the selective deconstruction and removal of “complex” materials.** In several studied case studies, this was the case for the removal of gypsum plaster. The presence of gypsum plaster in the stony fraction hampers high-grade recycling but selective removal is labor-intensive. A similar problem arised with the removal of organic insulation materials (e.g. PUR foam) (Figure 3). The presence of the latter is expected to be higher in the demolition projects of the future. It is important to continue to invest in research to efficiently remove these complex materials and design construction products that are easier to dismantle.
