## Fatigue behavior of impacted carbon fiber reinforced plastics

Biagini, D.

Biagini, D. (2024). *Fatigue behavior of impacted carbon fiber reinforced plastics*. [Dissertation (TU Delft), Delft University of Technology]. <https://doi.org/10.4233/uuid:09ac860d-dbf7-4d02-a750-8267afbdb26a>

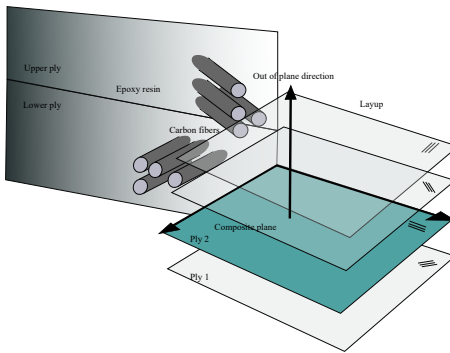
Figure 1.1: A simplified scheme of CFRP, showing plies having different fiber orientations stacked one on top of each other to form a layup

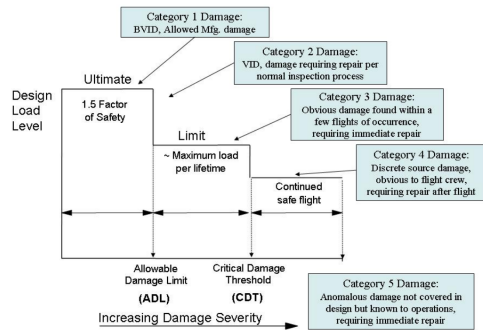
Figure 1.2: Damage tolerance guidelines for CFRP dictated by the EASA [8] the FAA [7]

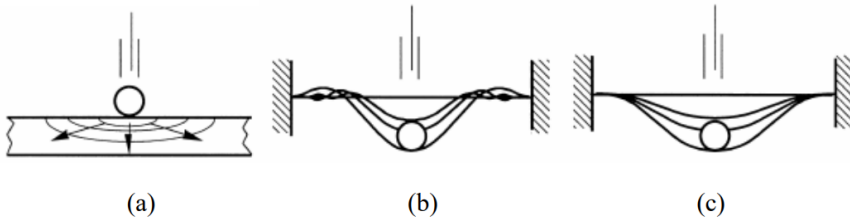
Figure 1.3: Impact response classification: a) short b) medium c) long impact time [11]

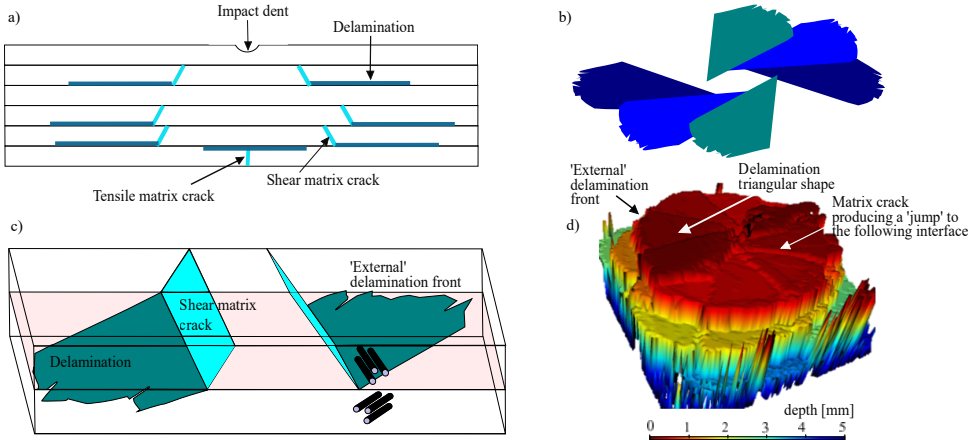
Figure 1.4: BVID in a quasi-isotropic laminate with 45deg angle mismatch between plies a) side view representation b) representation of delaminations (top view) in different interfaces showing the double-triangular shape c) representation of a single interface between two plies showing delamination originating from shear matrix crack d) ultrasound scan of actual impact damage showing the 3d delamination envelope

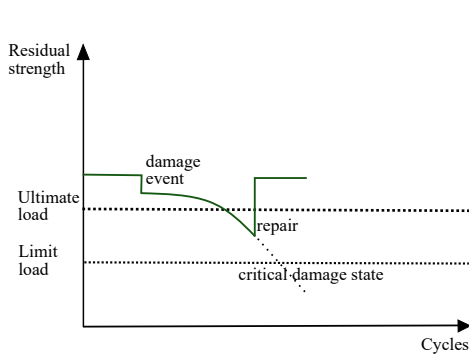
Figure 1.5: Slow growth procedure

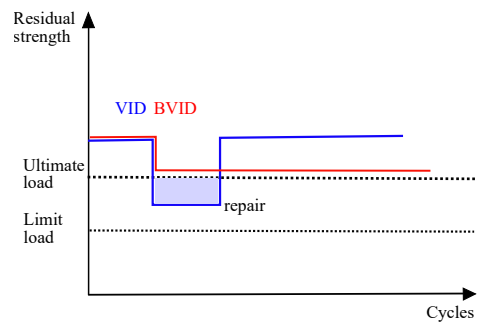
Figure 1.6: No growth procedure for BVID and VID

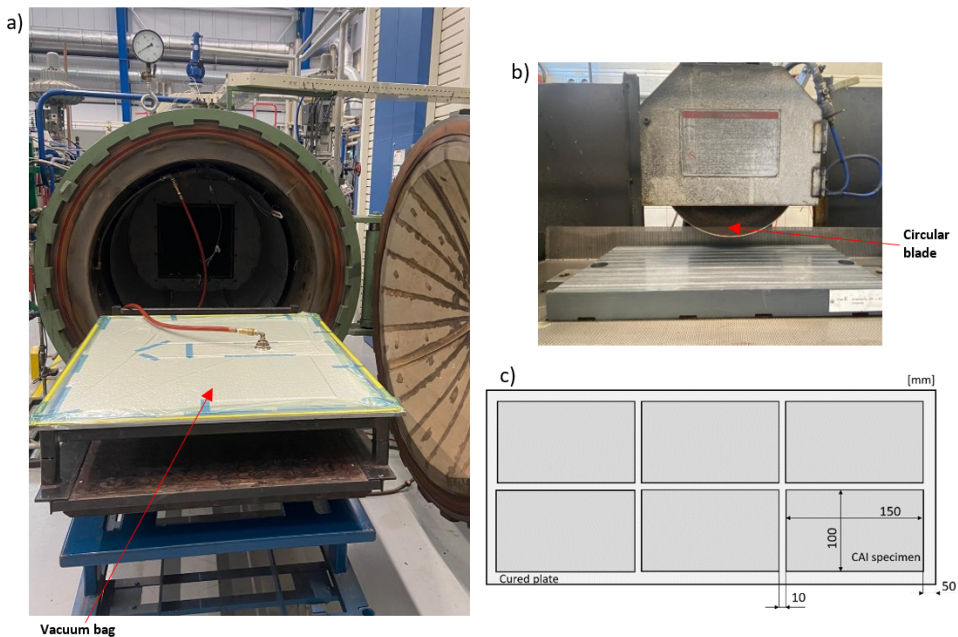
Figure 2.1: Images from the manufacturing of the laminate showing a) the autoclave and the vacuum bag containing CFRP plates, b) the diamond saw used to cut the specimens, c) the scheme of the cuts.

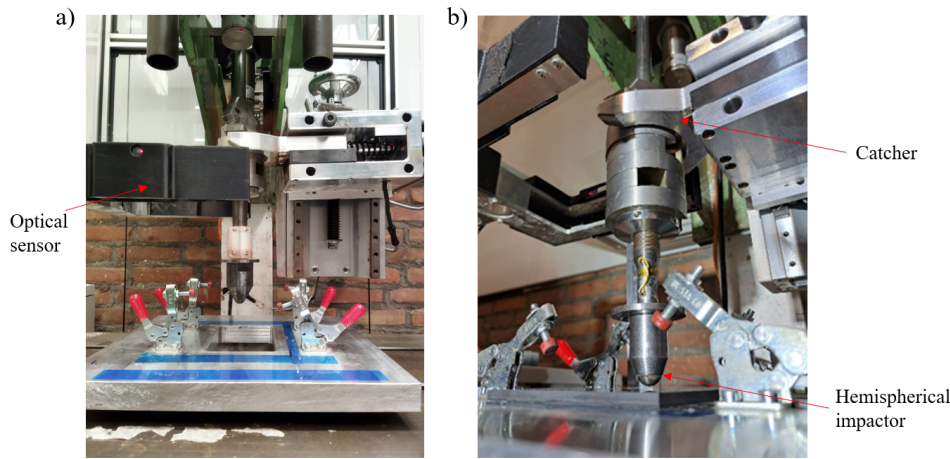
Figure 2.2: Fixture of LVI test showing the hemispherical impactor, the catcher to avoid bounce back triggered by optical sensor

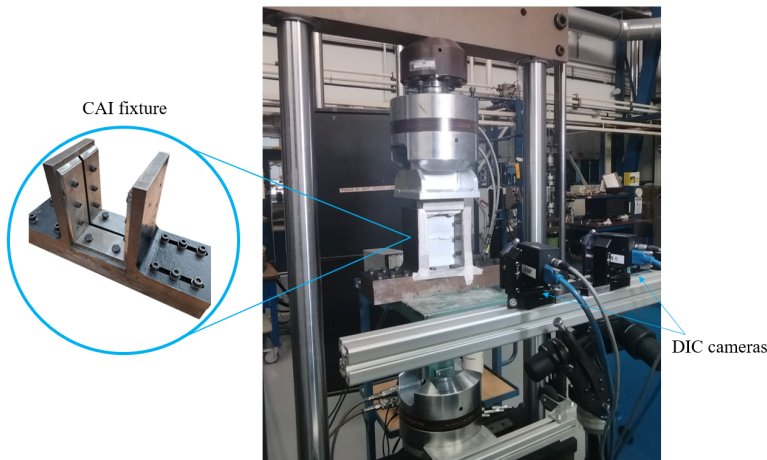
Figure 2.3: CAI fixture with DIC cameras

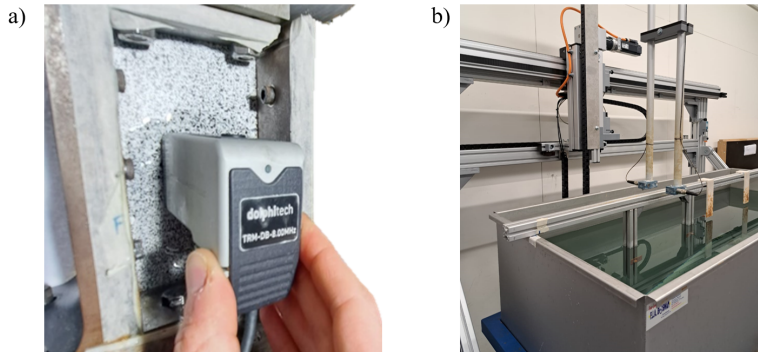
Figure 2.4: Images of the ultrasonic inspections performed showing a) pulse-echo system scanning probe, b) through thickness attenuation water tank

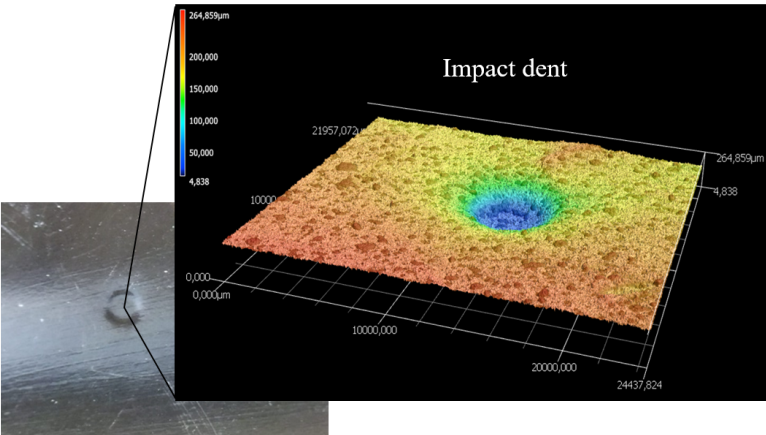
Figure 2.5: Impact dent photo and profile of the dent obtained with optical microscopy showing a dent depth < 0.3 mm

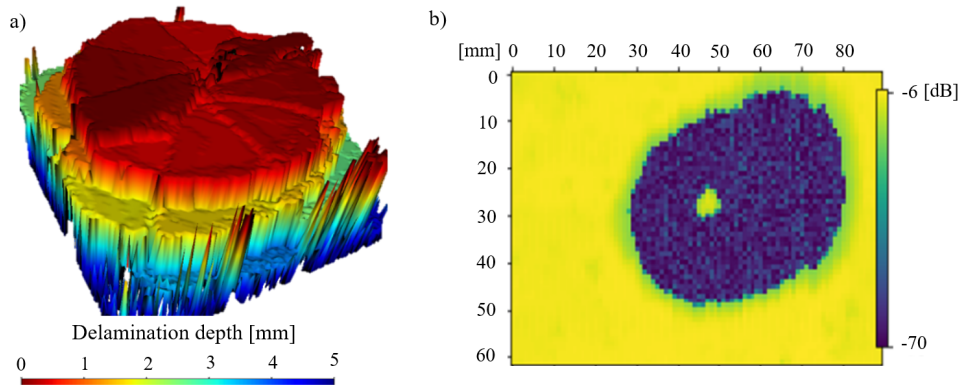
Figure 2.6: Impact damage ultrasound scan obtained with a) pulse-echo and b) through thickness attenuation system

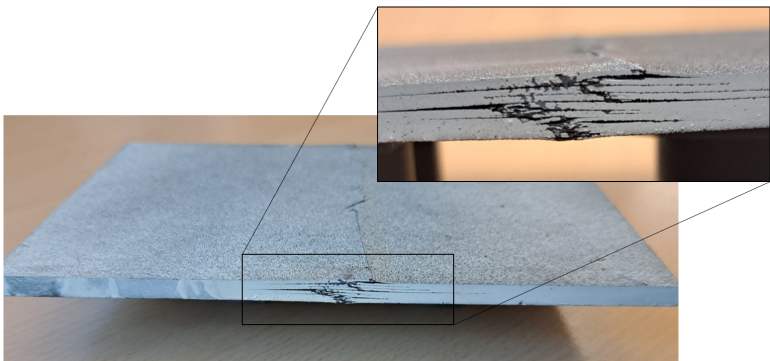
Figure 2.7: Failed specimen in compression fatigue after impact test showing signs of delamination, sublaminates buckling and fiber kinking

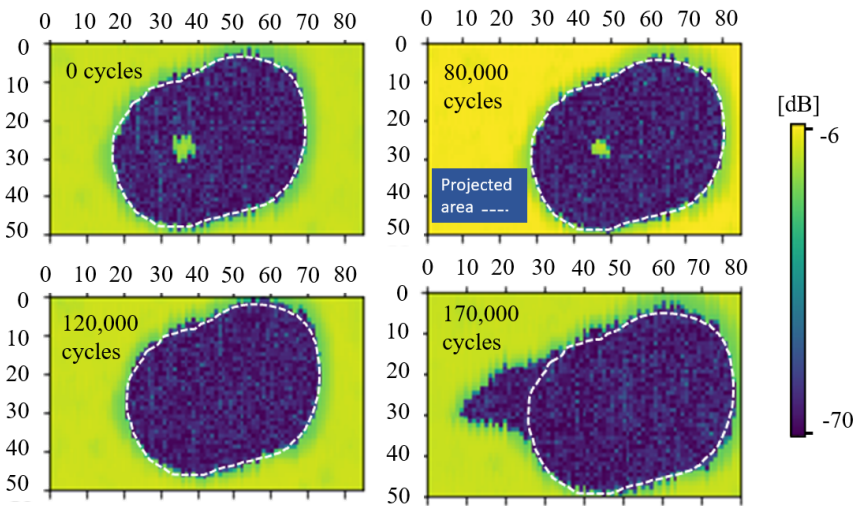
Figure 2.8: through transmission scan monitoring showing growth in the central impact area happening before delamination growth outside of the projected area

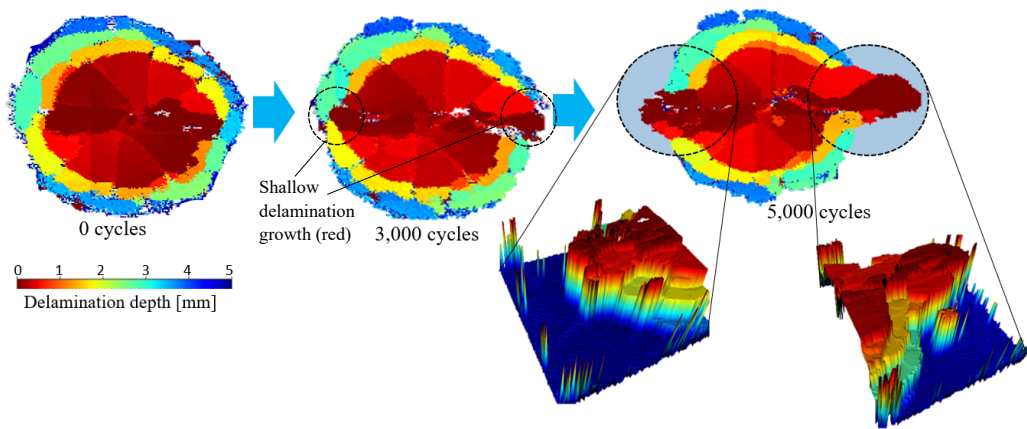
Figure 2.9: Pulse-echo scan monitoring of specimen s4 showing the preferential growth of shorter delamination (in width) happening before the onset of growth outside of the projected area. Initial growth affects mostly shallow delaminations i.e. situated at small depth with respect to the impacted face

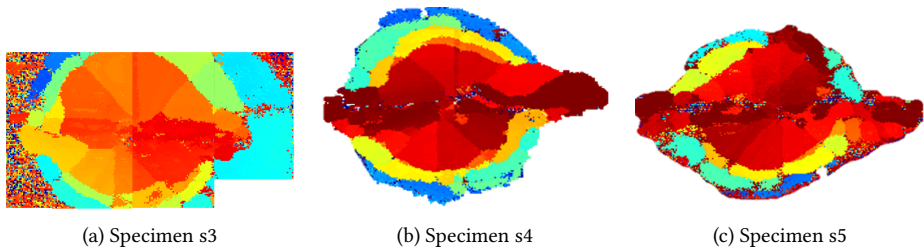
Figure 2.10: Comparison of pulse-echo scans prior to failure (> 90 % of fatigue life) in different specimens with different loads applied and different fatigue lives. Image shows a similar damage envelope before failure, with the extensive growth of delamination of small depths (red colors) in the perpendicular to the loading direction

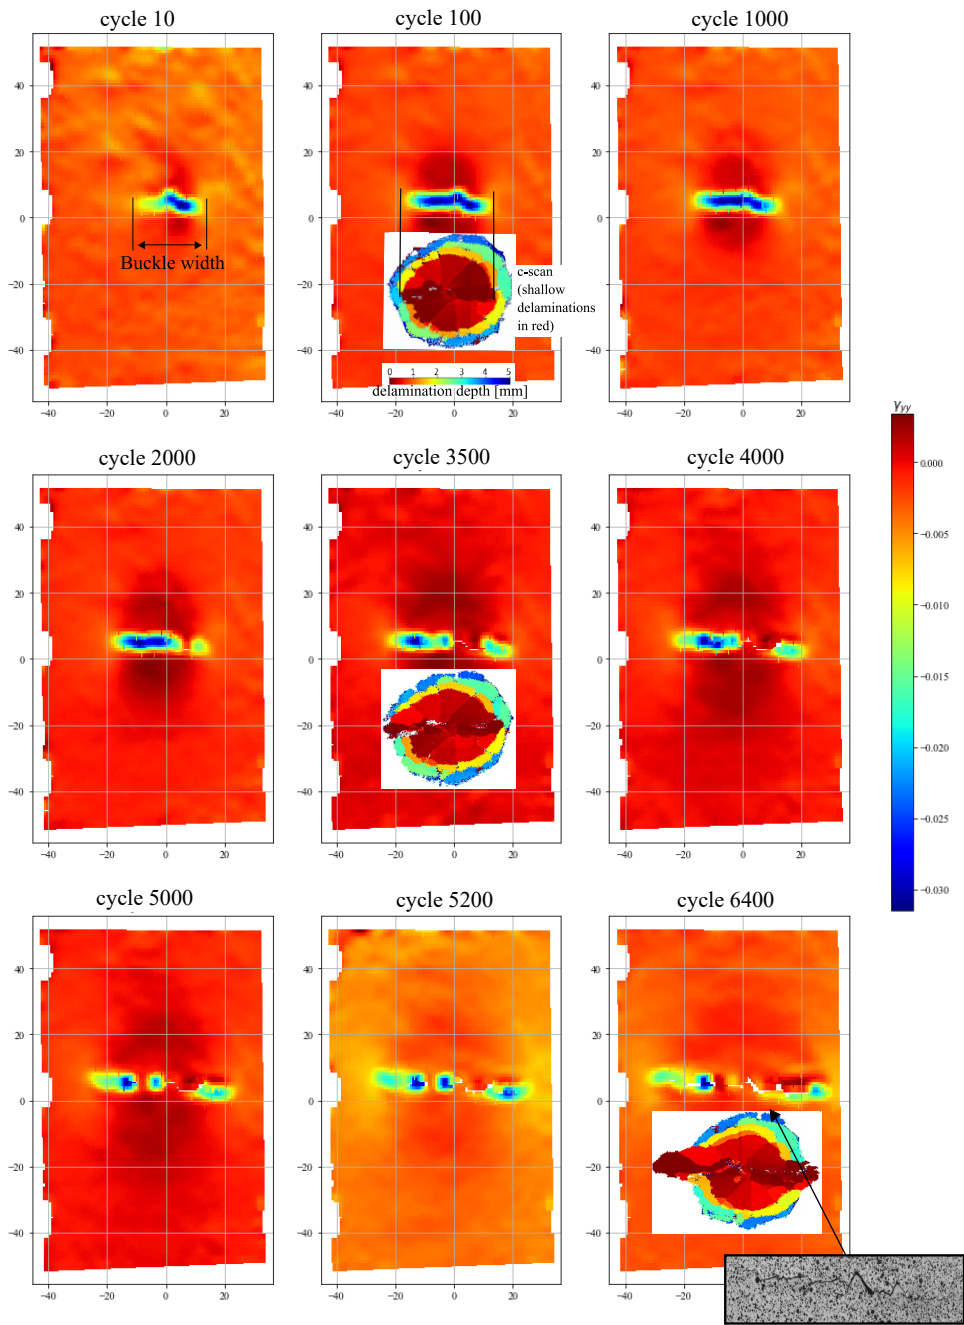
Figure 2.11: DIC results of fatigue propagation showing the  $\gamma_{yy}$  engineering strain in specimen s4. The image on top-center shows how the local buckling width in the perpendicular to the loading direction matches the shallow delamination (red colors in the ultrasounds) and not the larger delaminations

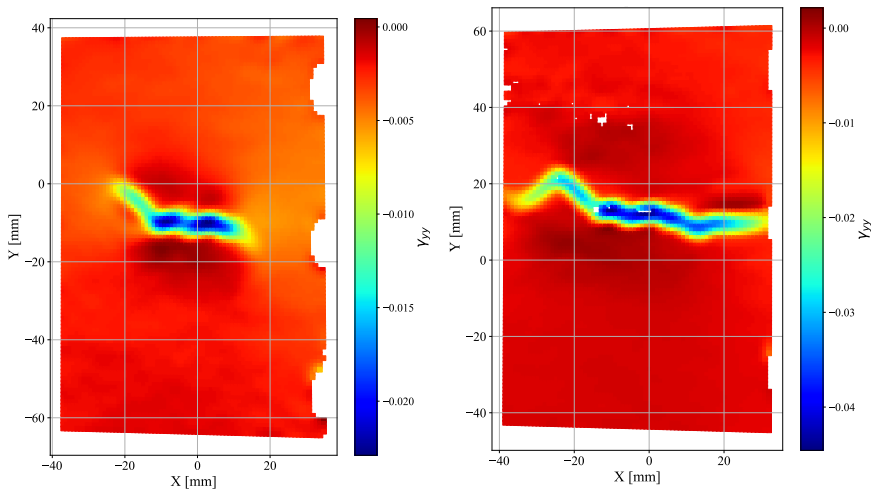
(a) sp 1 at 0% and 90% of fatigue life. Initial projected delamination width (x-direction) = 50 mm

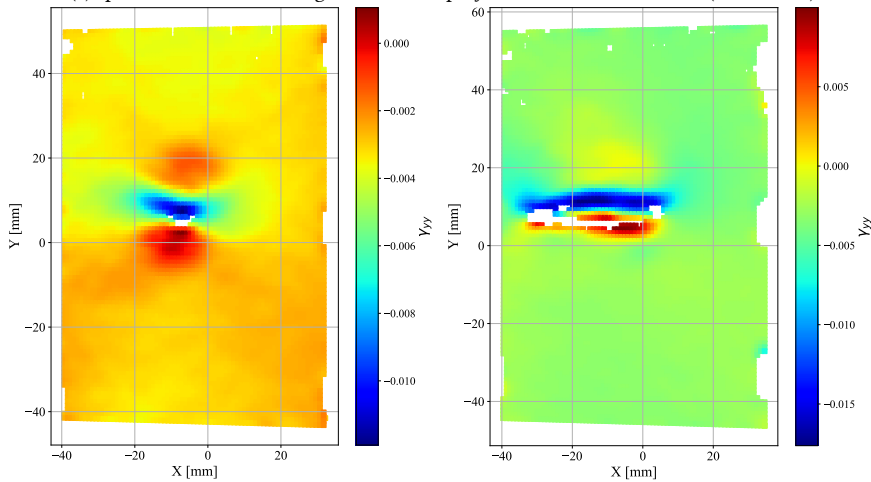
(b) sp 2 at 0% and 90% of fatigue life. Initial projected delamination width (x-direction) = 50 mm

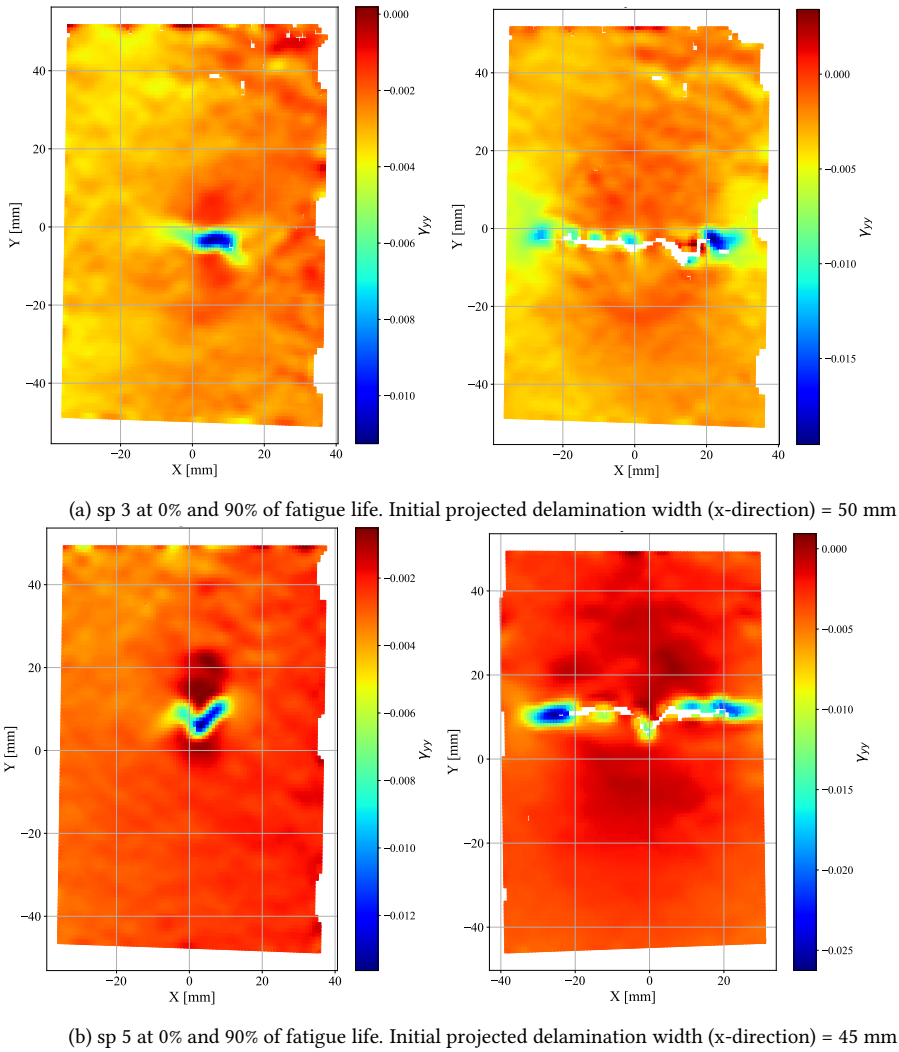
Figure 2.13: Comparison of strain fields at different specimens at the beginning and close to the end of fatigue life. The results show growth of local buckling in the perpendicular to width directions, starting from an initial size smaller than the overall projected width of delamination (in the x-axis direction).

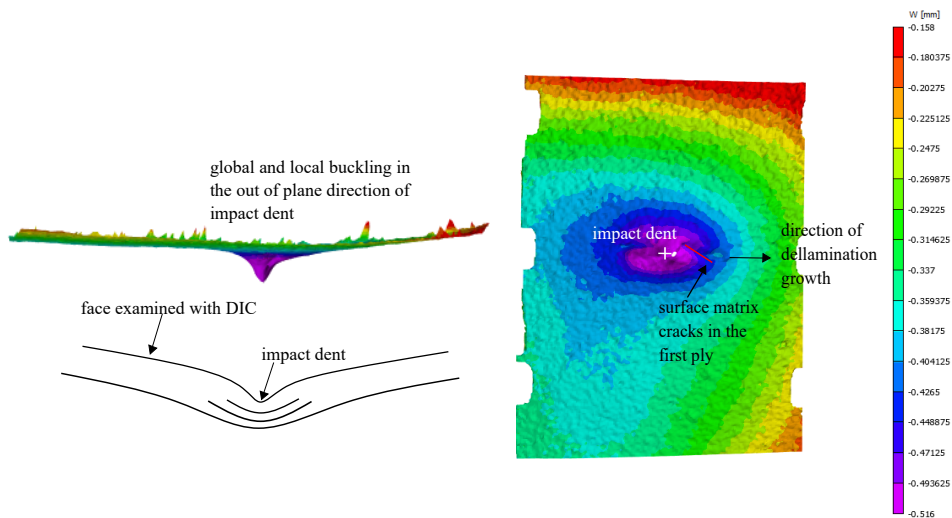
Figure 2.14: Out of plane displacement of loaded specimen s4 derived with DIC analysis. The plot shows the direction of buckling compared to the impact dent. The delamination growth direction and the position of surface cracks is also shown

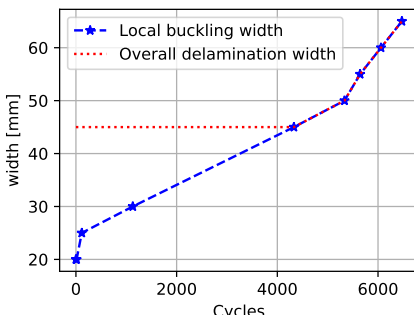
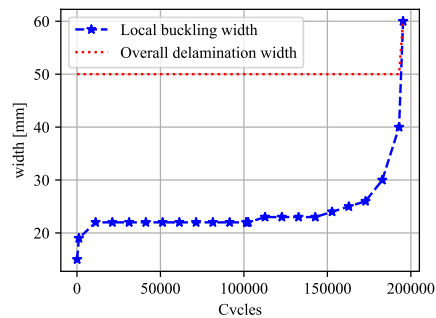
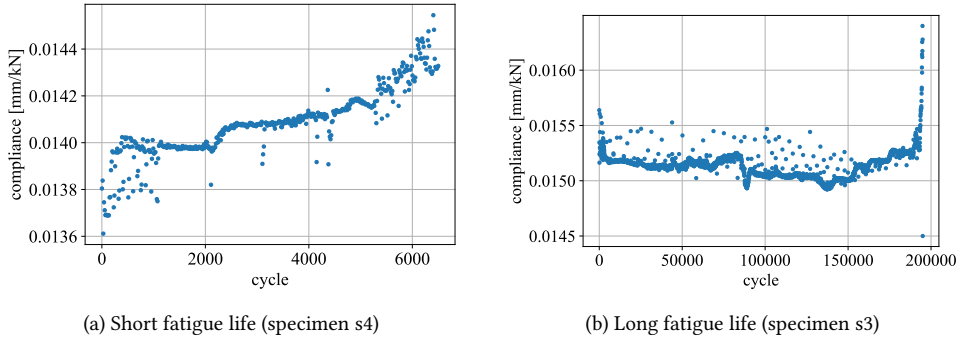
(a) Short fatigue life (specimen s4)

(b) Long fatigue life (specimen s3)

Figure 2.16: Degradation of stiffness in (a) short and (b) long fatigue lives

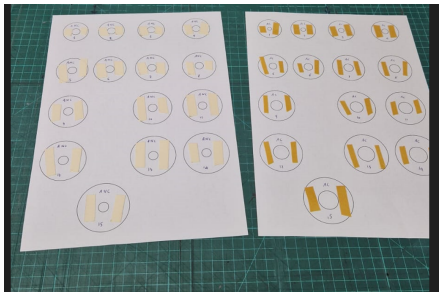
(a) PTFE rings (in figure placed on a sheet of paper) before being located in the prepreg, one per each interface

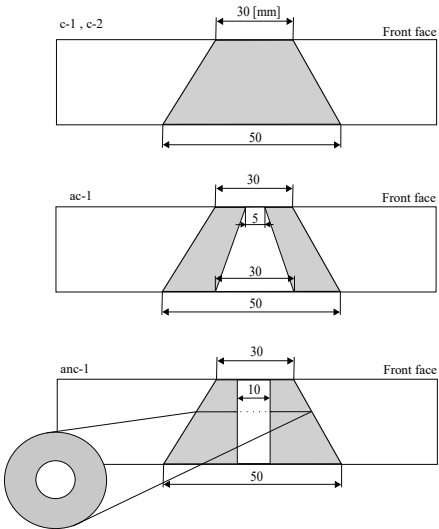
(b) Schematic of the section of the specimens. The grey areas indicate where the PTFE circular or annular inclusions are situated

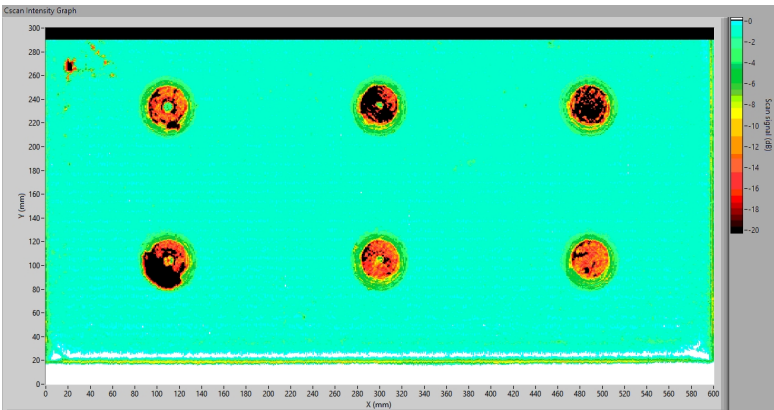
(c) Ultrasound scan of the manufactured plate

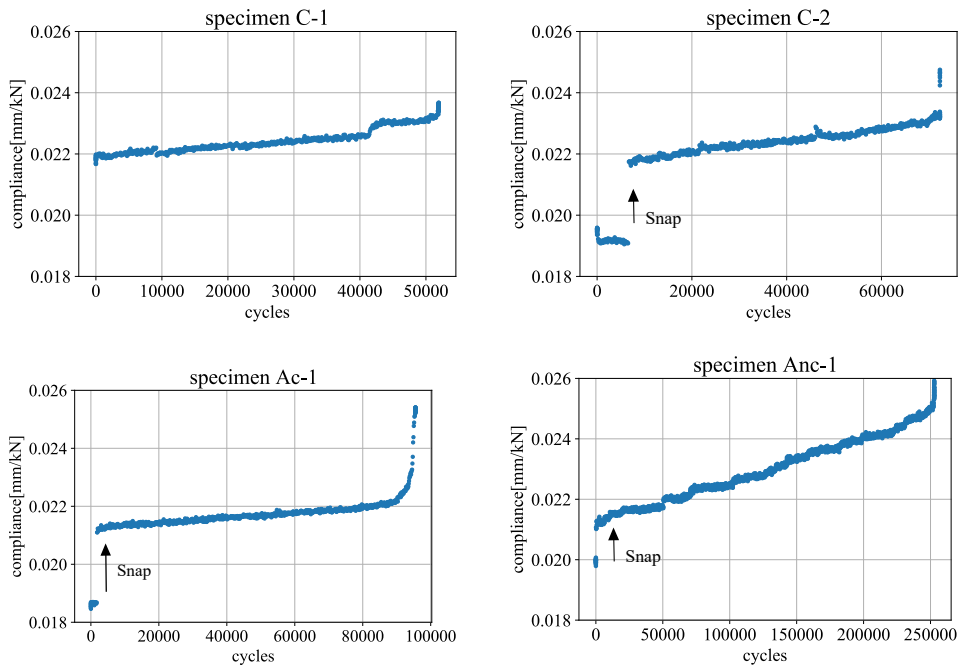
Figure 3.2: Stiffness degradation illustrated through compliance increase in different specimens

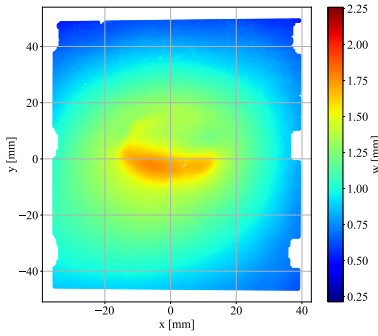
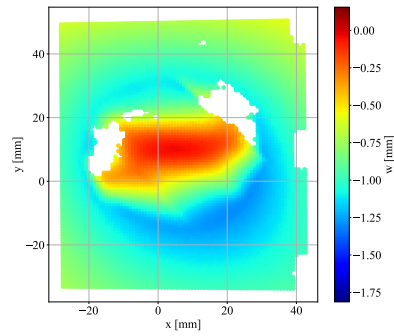
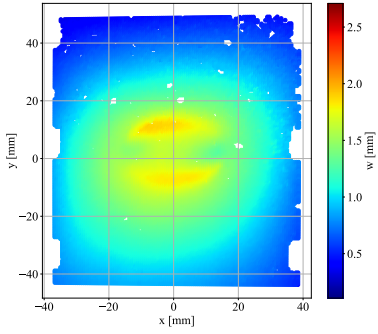
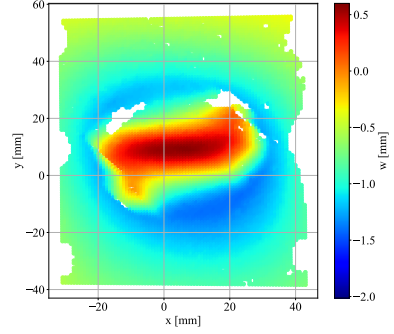
(a) Specimen C-1 front face

(b) Specimen C-1 back face

(c) Specimen C-2 front face

(d) Specimen C-2 back face

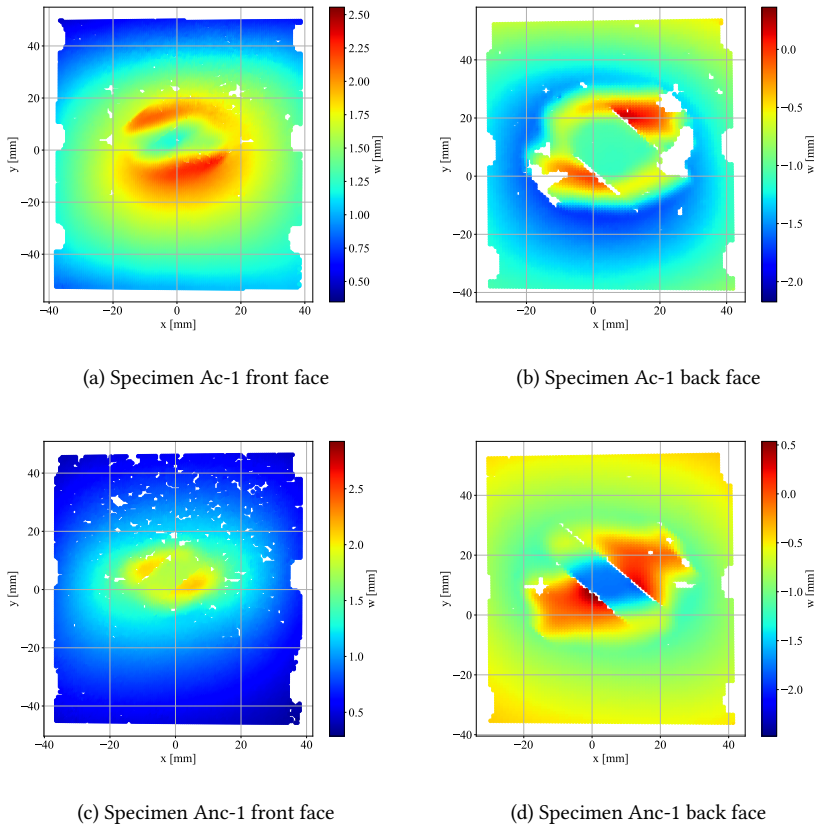
Figure 3.4: Out of plane displacement in specimens Ac-1 and Anc-1 derived with DIC. In the back face (right side figures) a positive out-of-plane displacement (in red) area surrounded by a negative displacement area (in blue) denotes the presence of local buckling having opposite out-of-plane displacement compared to the global buckling. A double/shape local buckling can be seen in both cases, caused by the presence of a central non-delaminated zone.

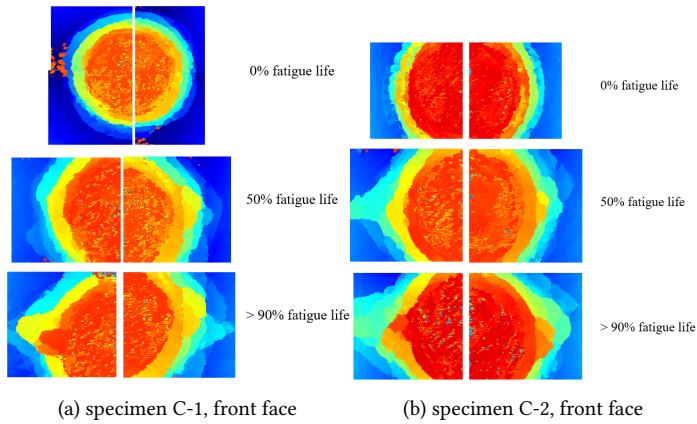
Figure 3.5: Ultrasound scan at different stages of fatigue life in specimen C-1 and C-2. The results show the propagation of several delaminations at multiple depth locations, all in the perpendicular to the loading direction

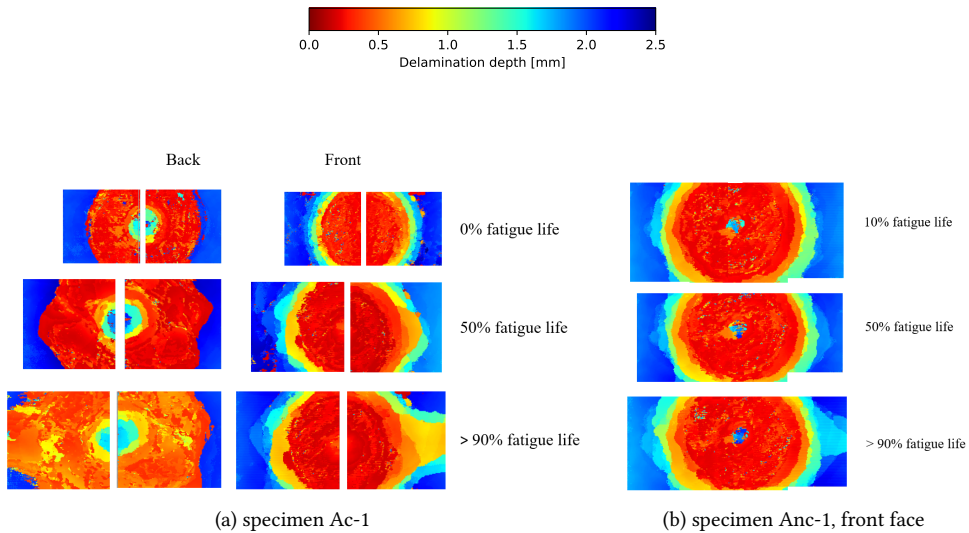
Figure 3.6: Ultrasound scan at different stages of fatigue life in specimen Ac-1 and Anc-1. The results show the propagation of several delaminations at multiple depth locations in the case of specimen Ac-1 and the propagation of delaminations close to the back face in specimen Anc-1. Growth happened in the perpendicular to the loading direction.

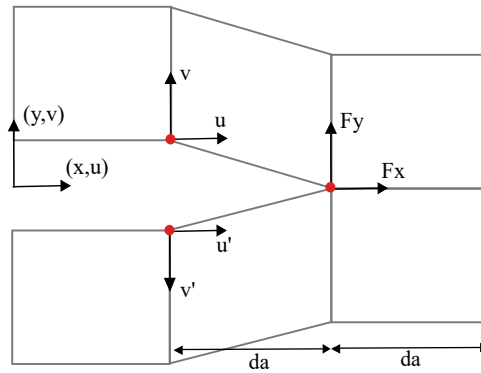
Figure 4.2: The VCCT technique schematic

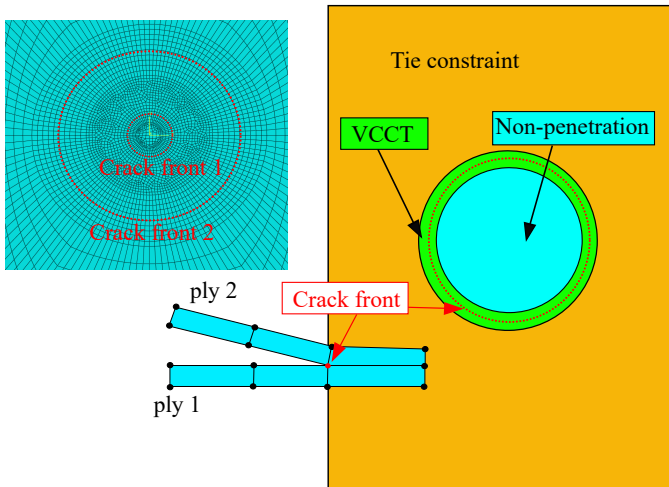
Figure 4.3: Scheme of the modeling approach adopted for the interfaces between plies and mesh in case of circular and annular delamination

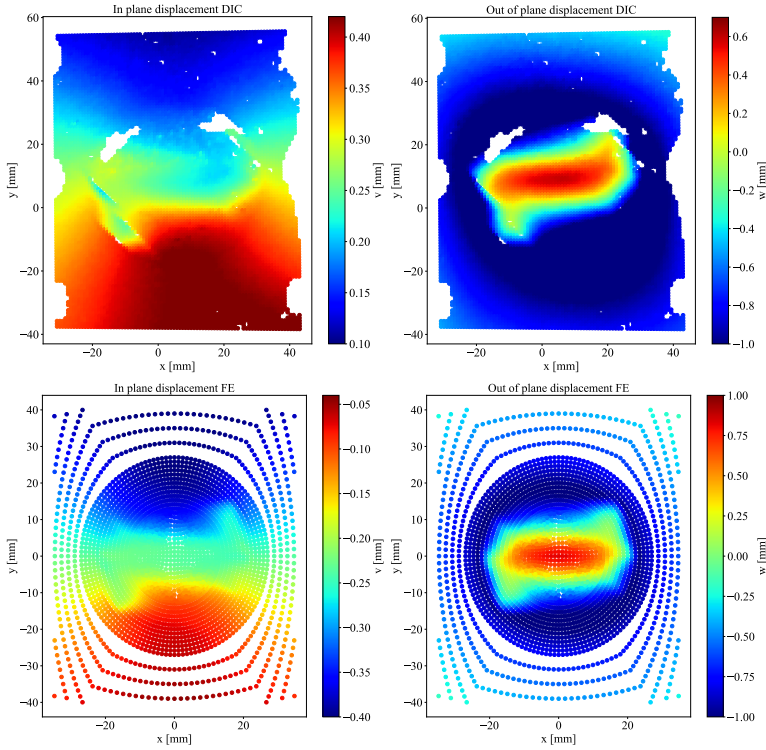
Figure 4.4: Comparison of DIC surface displacement in specimen c-2 (top images) and FE simulations (bottom images). Left side of the figure compares in-plane displacement while right side of the image compares out of plane displacements.

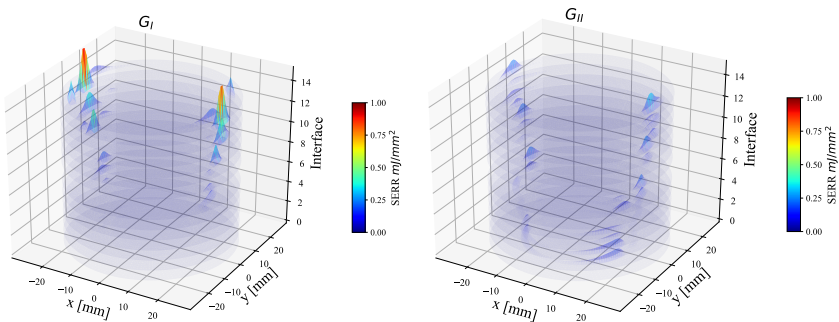
Figure 4.5: Distribution of strain energy release rates  $G_{max}$  across various interfaces within the layup. Each circular surface in transparent blue, represents a VCCT interaction zone (Figure 4.3) modelling one interface. The x and y coordinates of the plot align with the specimen axis, where  $x = 0$  and  $y = 0$  represent the central coordinates of the specimen, and the y-axis indicates the loading direction. The interfaces are superimposed on each other, with the back face of the laminate (where larger delaminations are) placed at the top for enhanced visibility.

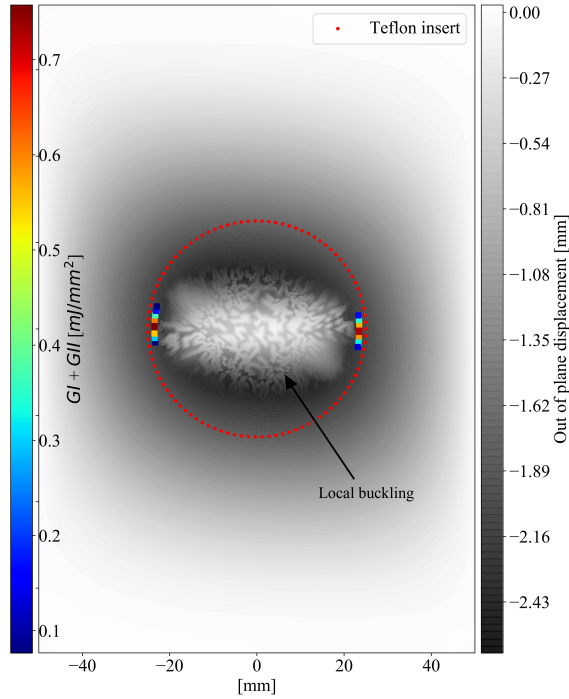
Figure 4.6: Buckling area matching SERR profiles. In color, the maximum SERR  $G_{max}$  values in the penultimate interface (where the higher values were observed). In the gray scale, the magnitude of out of plane displacement of the upper ply to this specific interface shows an elliptical local buckle.

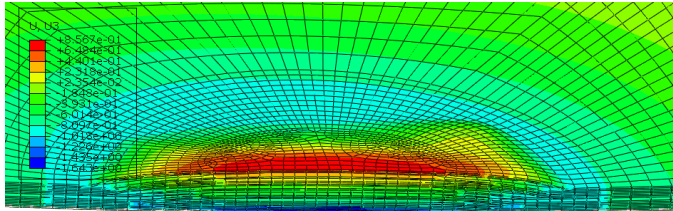
Figure 4.7: A cut section of the deformed laminate is shown. The section is cut in the x direction (perpendicular to loading) from the center point. It shows the sub laminates opening in the out of plane direction. The back face is placed on top in the figure to better show the larger delaminations.

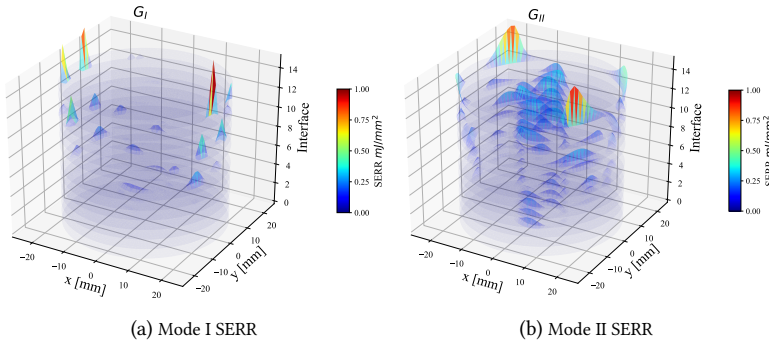
Figure 4.10:  $G_{max}$  profile in case internal non-delaminated area radius = 7 mm. Each circular surface in transparent blue represents a VCCT interaction zone (Figure 4.3) modeling one interface. The x and y coordinates of the plot align with the specimen axis, where x = 0 and y = 0 represent the central coordinates of the specimen, and the y-axis indicates the loading direction. The side with larger delamination is placed on top for enhanced visibility.

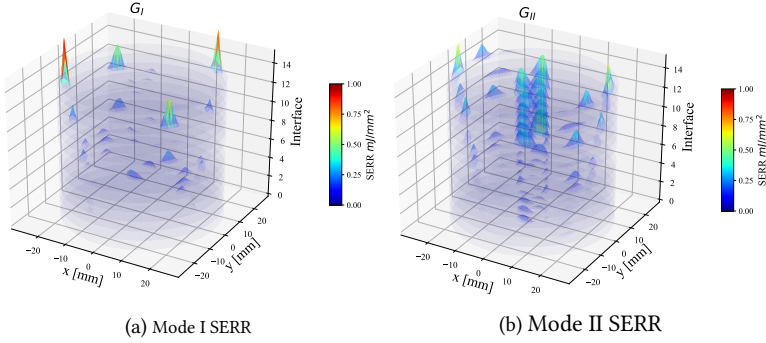
Figure 4.11:  $G_{max}$  profile in case internal non-delaminated area radius = 5 mm. Each circular surface in transparent blue represents a VCCT interaction zone (Figure 4.3) modeling one interface. The x and y coordinates of the plot align with the specimen axis, where x = 0 and y = 0 represent the central coordinates of the specimen, and the y-axis indicates the loading direction. The side with larger delamination is placed on top for enhanced visibility.

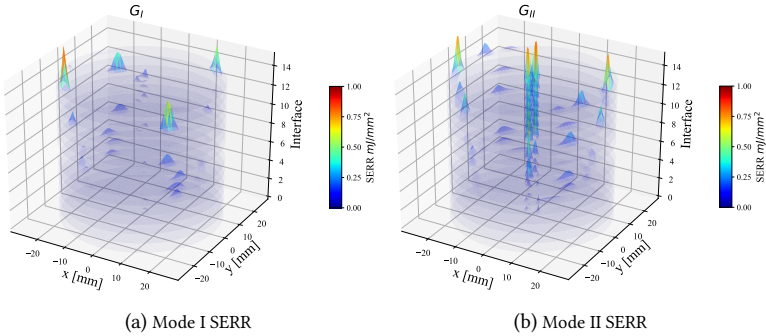
Figure 4.12:  $G_{max}$  profile in case internal non-delaminated area radius = 2 mm. Each circular surface in transparent blue represents a VCCT interaction zone (Figure 4.3) modeling one interface. The x and y coordinates of the plot align with the specimen axis, where x = 0 and y = 0 represent the central coordinates of the specimen, and the y-axis indicates the loading direction. The side with larger delamination is placed on top for enhanced visibility.

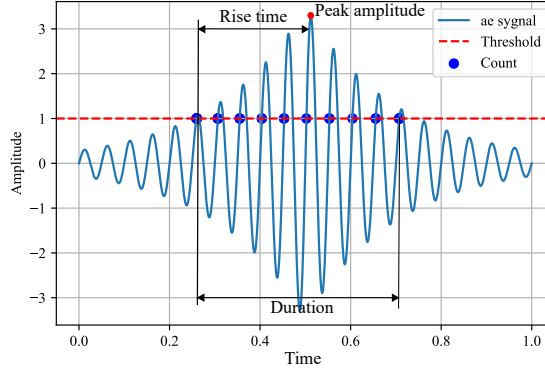
Figure 5.1: Schematic of acoustic emission waveform and some time-domain descriptors

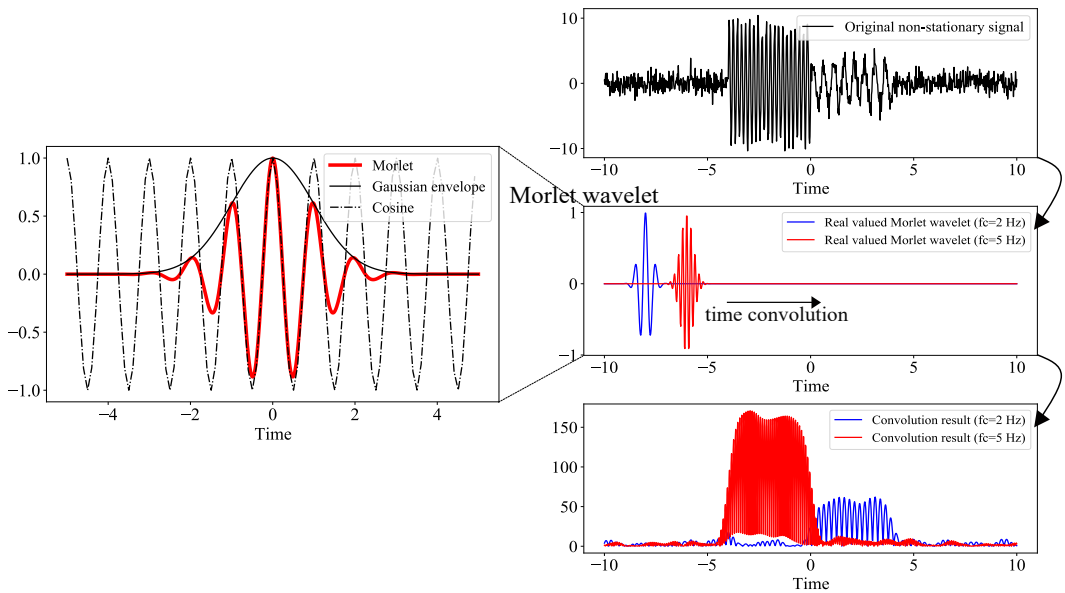
Figure 5.2: Morlet wavelets convolution visually explained

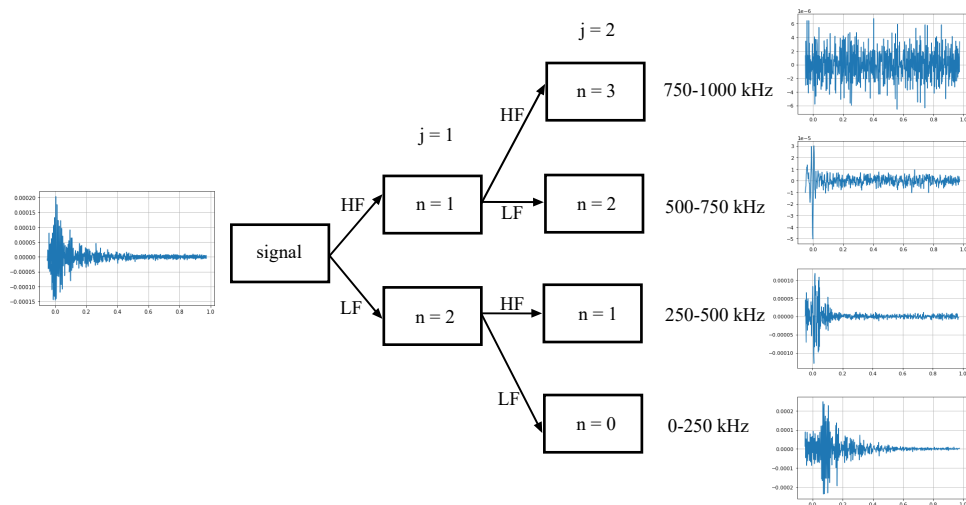
Figure 5.3: Wavelet packet level 2 decomposition tree of an acoustic emission waveform.

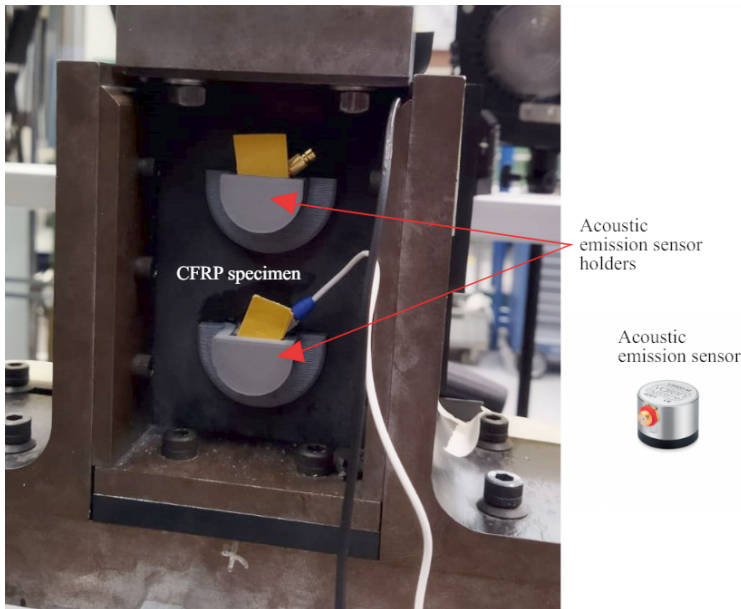
Figure 5.4: CAI fatigue setup showing the AE sensors located inside the 3d printed sensor holders, which are glued to the surface of the CFRP rectangular specimen

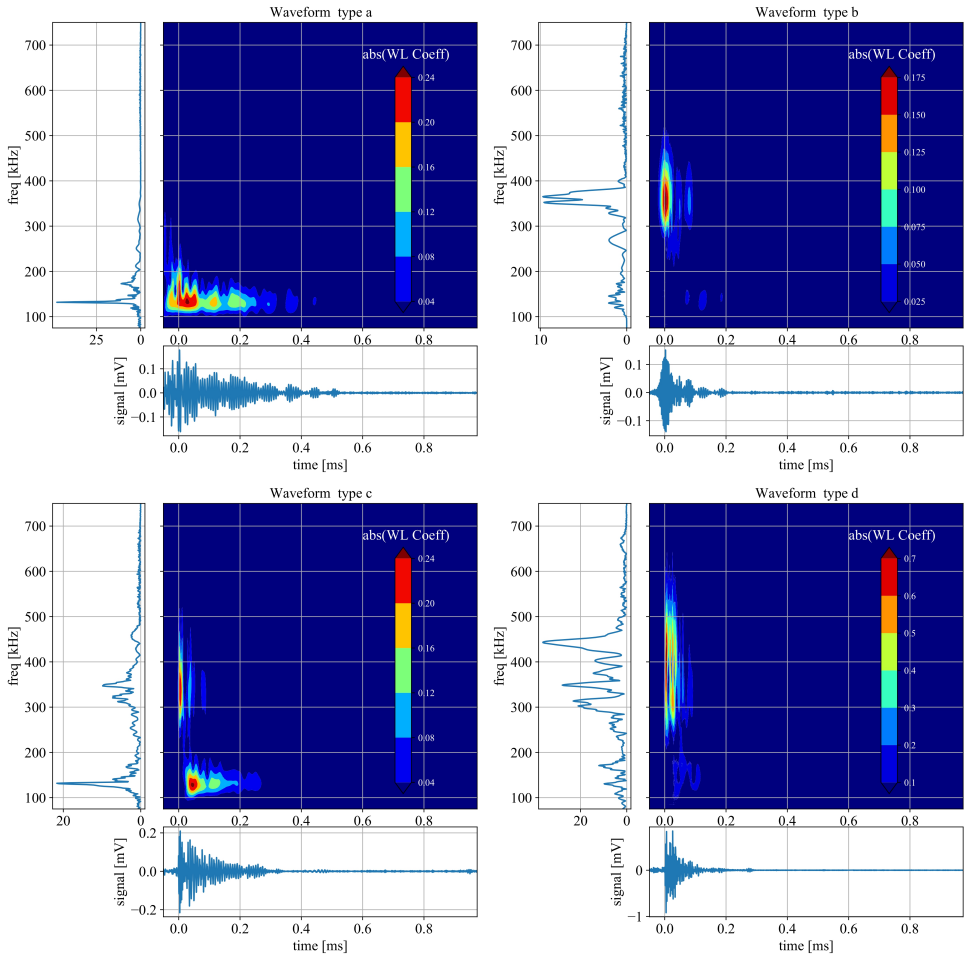
Figure 5.5: Wavelet transform of the different types of waveforms. The color plot represents the coefficient derived from the Morlet wavelet transform. The vertical subplots show the frequency spectrum derived from the Fourier transform. The horizontal subplots show the original signal

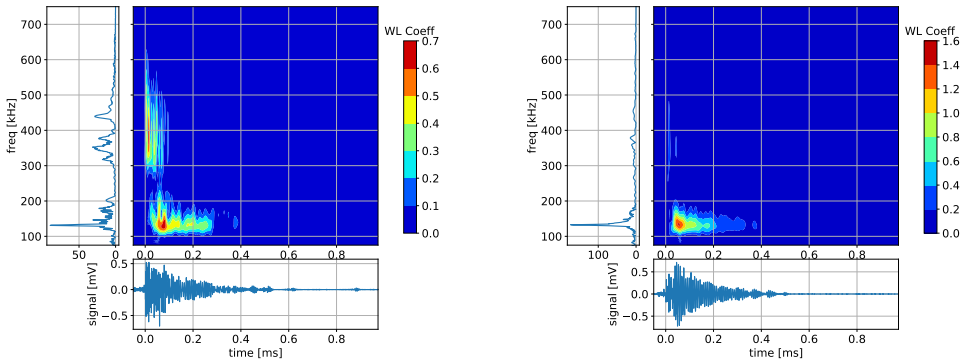
Figure 5.6: The scalogram derived with Morlet wavelets is plotted in two signals located in the proximity of the same cluster centroid with the clustering based on time-domain descriptors. Although the signals in the time domain appear similar (horizontal subplots) large differences can be found in The frequency domain (vertical subplots) and in the wavelet coefficient.

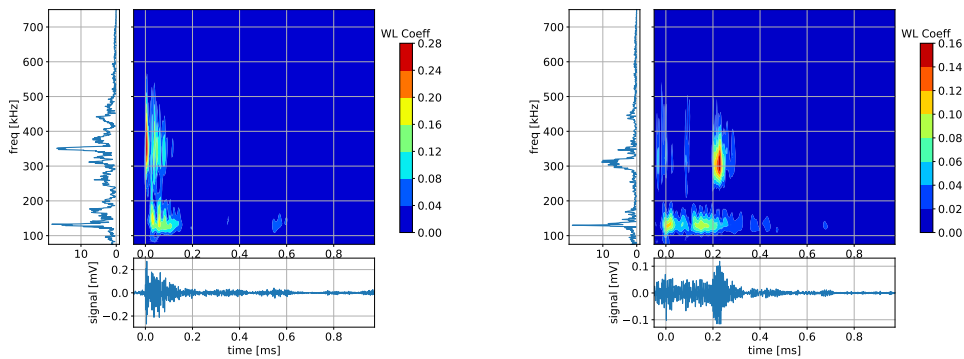
Figure 5.7: The scalogram derived with Morlet wavelets is plotted in two signals located in the proximity of the same cluster centroid with the clustering based on frequency-domain descriptors. Although the frequency spectrum is similar (vertical plots on the left), the wavelet plot reveals that in the second signal, a higher frequency event reaches the sensor after low frequency.

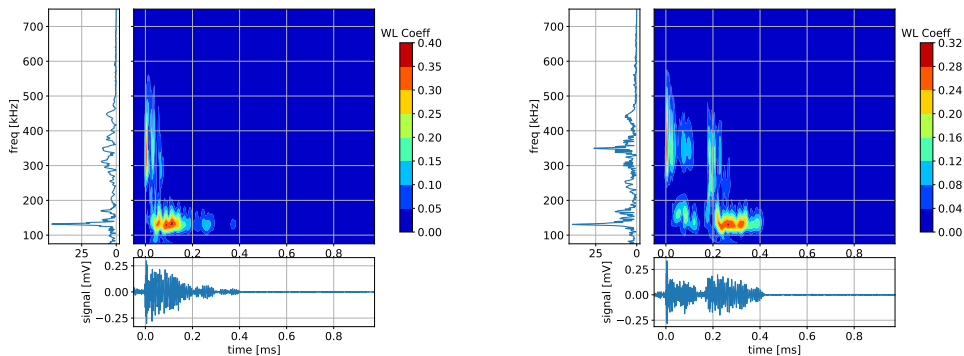
Figure 5.8: The scalogram derived with Morlet wavelets is plotted in two signals located in the proximity of the same cluster centroid with the clustering based on time-frequency domain descriptors. The frequency spectrum is similar (vertical subplots), and descriptors in the time domain (horizontal subplots) like rise time, peak amplitude, and duration are similar. However, wavelet plots show largely different scalograms.

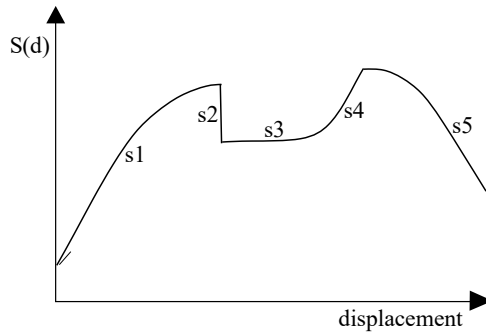
Figure 6.1: Sentry function/displacement plot. The possible trends that can be found in actual tests are shown

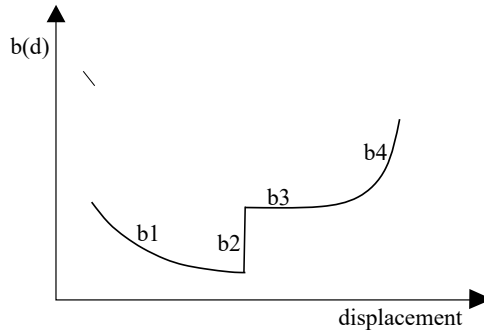
Figure 6.2: b-value/displacement plot. The possible trends that can be found in actual tests are shown

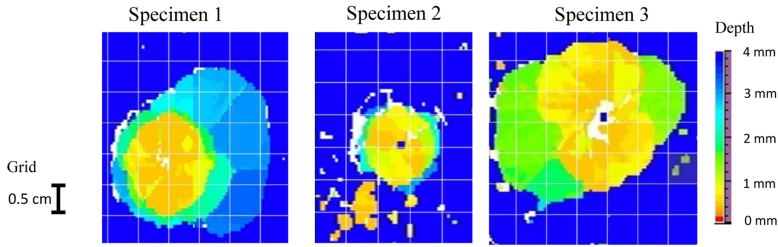
Figure 6.3: Close-up C-scan images of the impacted specimens, showing multiple delaminations at different depths. The images are cropped to show the full delamination; the impact contact point was always in the center of the specimen
