## Fatigue behavior of impacted carbon fiber reinforced plastics

Biagini, D.

Biagini, D. (2024). *Fatigue behavior of impacted carbon fiber reinforced plastics*. [Dissertation (TU Delft), Delft University of Technology]. <https://doi.org/10.4233/uuid:09ac860d-dbf7-4d02-a750-8267afbdb26a>

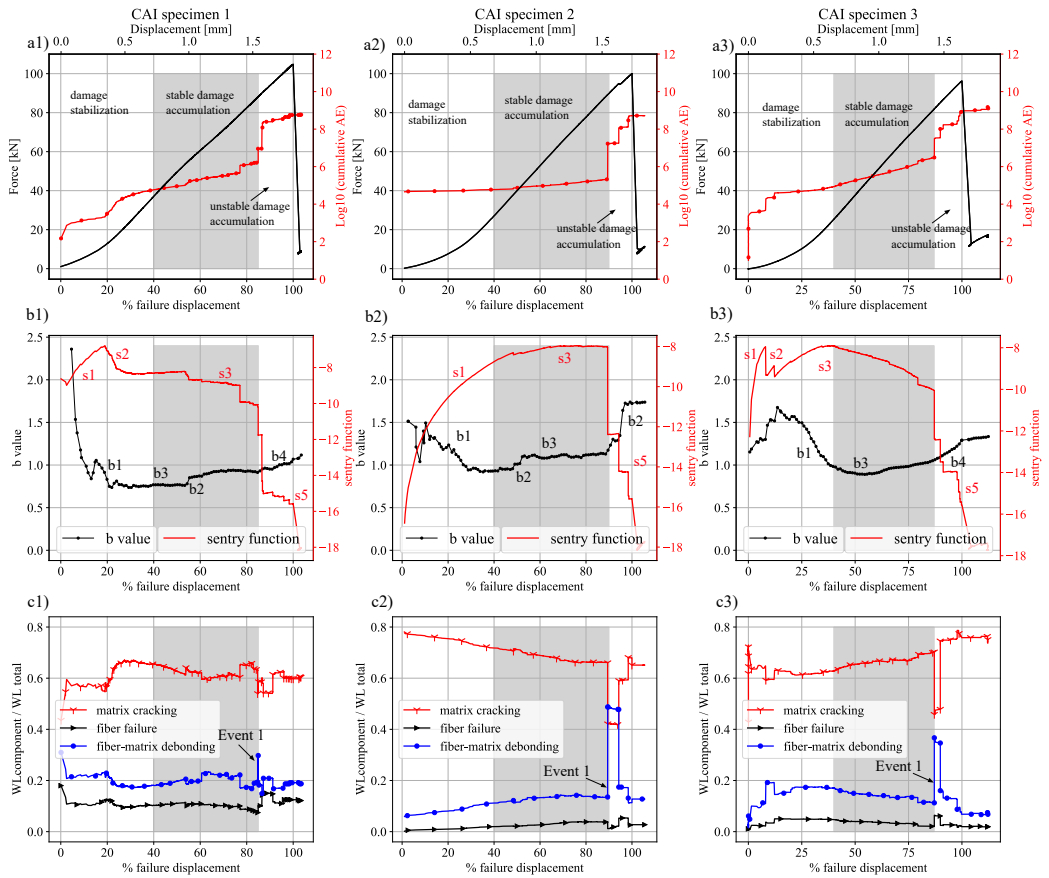
Figure 6.4: damage accumulation study in the three CAI quasi-static tests, each column of plots representing one specimen. In the first row of plots, the force-displacement and the acoustic emission cumulative signal energy (Table 5.2) are plotted. The three phases of damage accumulation are also labeled in the first row of plots. In the second row, the b value and sentry function are shown, pointing out the different trends in the b value (as described in Section 6.3.2 and Figure 6.2) and in the Sentry function (as described in Section 6.3.1 and Figure 6.1). In the third row the wavelet components ratio representing the different damage modes are plotted, and 'event 1' determining the inset of the final propagation phase, is labelled.

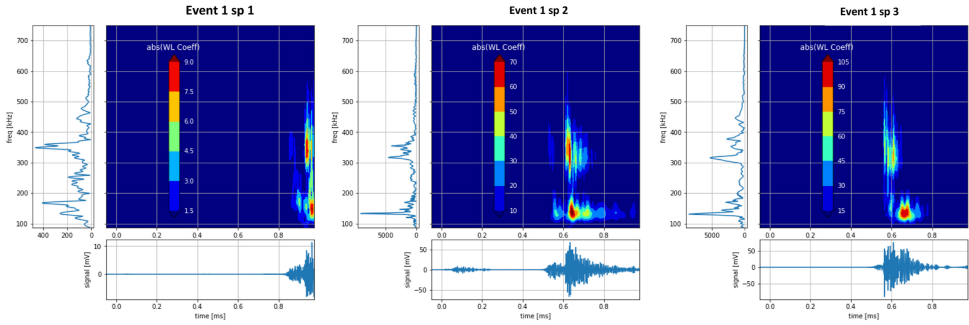
Figure 6.5: Acoustic event preceding the onset of unstable damage propagation in the three tests. The continuum Morlet wavelet scalogram is reported in the three events.

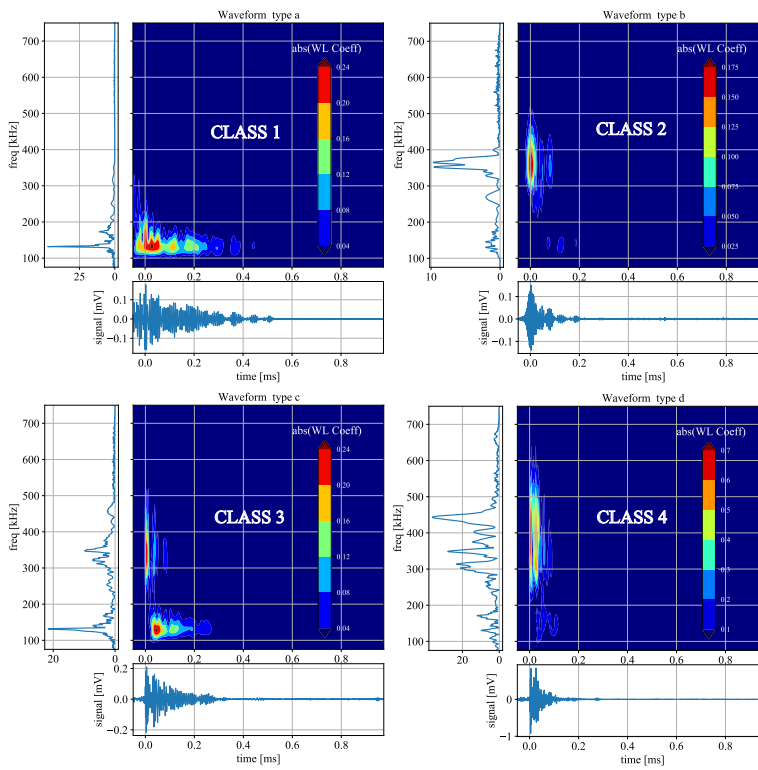
Figure 7.1: Typical scalogram of the four classes assigned to the different damage modes in the preliminary test of Chapter 5

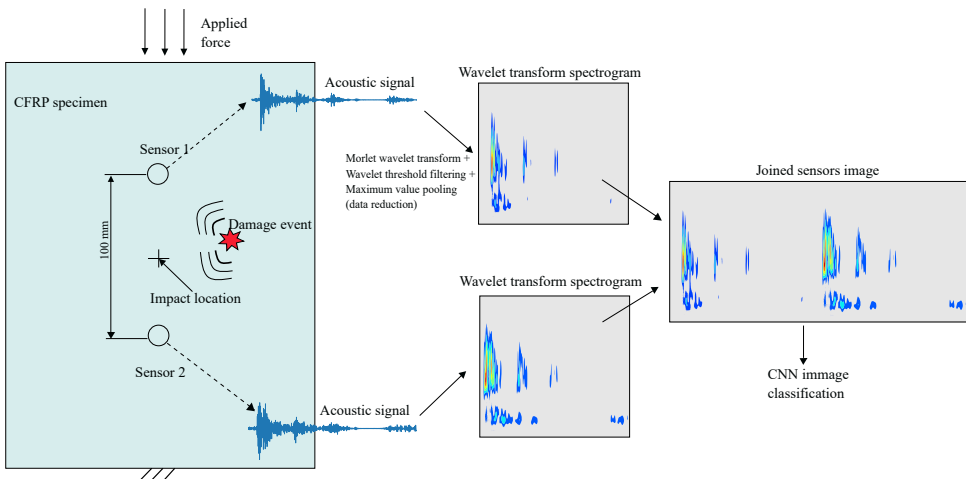
Figure 7.2: Data processing from sensor data to input of the CNN. Continuum Morlet waveform transform is applied to the acoustic signal in the two sensors. Then the two scalograms are joined to form a single image.

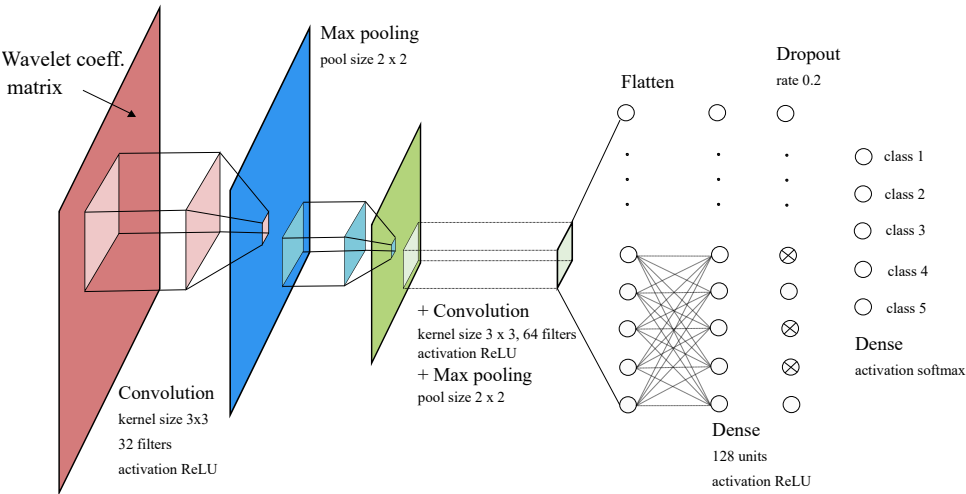
Figure 7.3: Structure of the CNN algorithm. The original images pass through a series of convolution and max pooling layers. Then a dense layer and a dropout are present. Finally dense layer with soft-max activation allows to compute the probability of each class

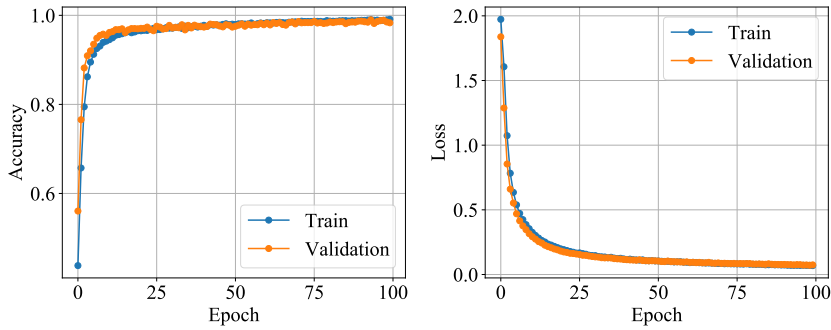
Figure 7.4: Performance of the training. The accuracy and the loss progression in the training and validation set are shown over the epochs. A good convergence is reached at 100 epochs.

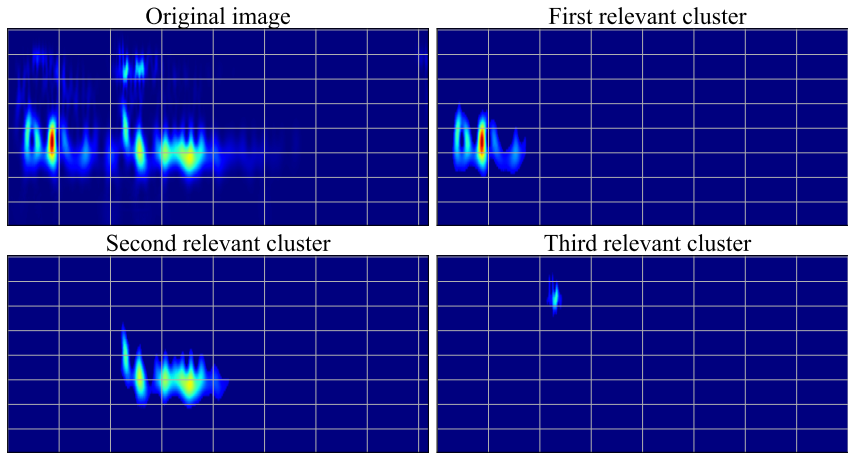
Figure 7.5: Thanks to the segmentation algorithm it is possible to divide complex scalograms with events superposition in sub-images to be handled separately

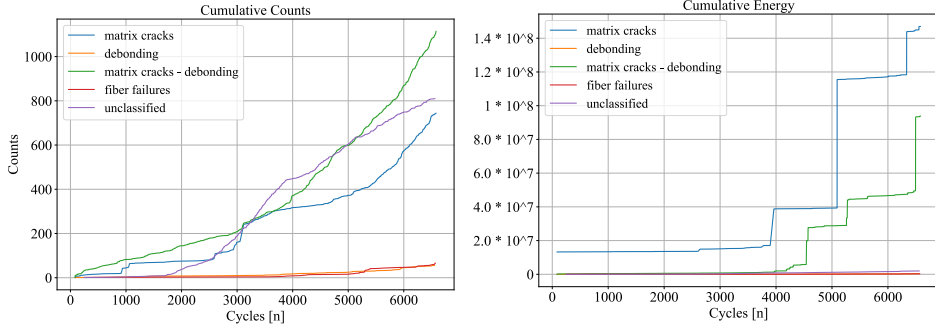
Figure 7.6: Damage modes repartition plots in specimen s4 (short life). In the left plot, the progression of cumulative count in fatigue life is shown for every damage mode. On the right, the cumulative ae signal energy is shown (defined in Table 5.2).

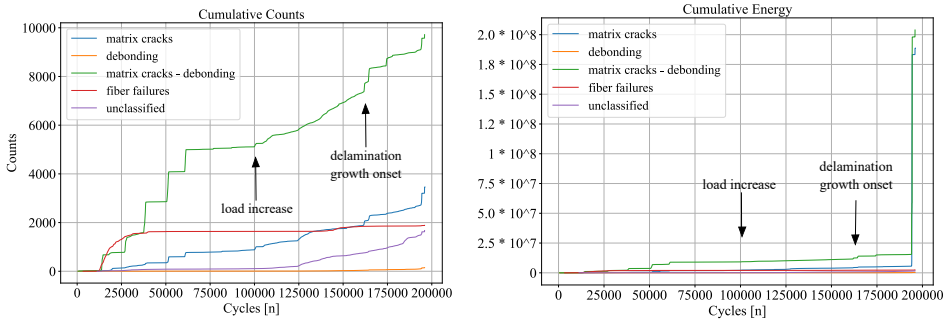
Figure 7.7: Damage modes repartition plots in specimen s3 (long life). In the left plot, the progression of cumulative count in fatigue life is shown for every damage mode. On the right the cumulative signal energy (defined in Table 5.2) is shown for every damage mode.

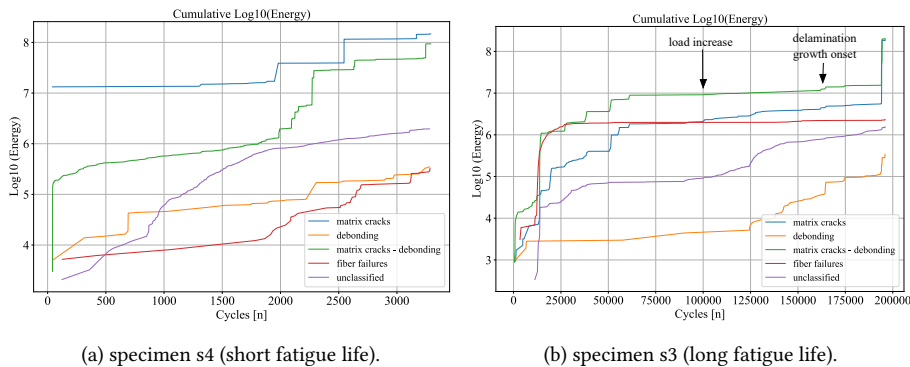
Figure 7.8: Cumulative signal energy plot in logarithmic scale

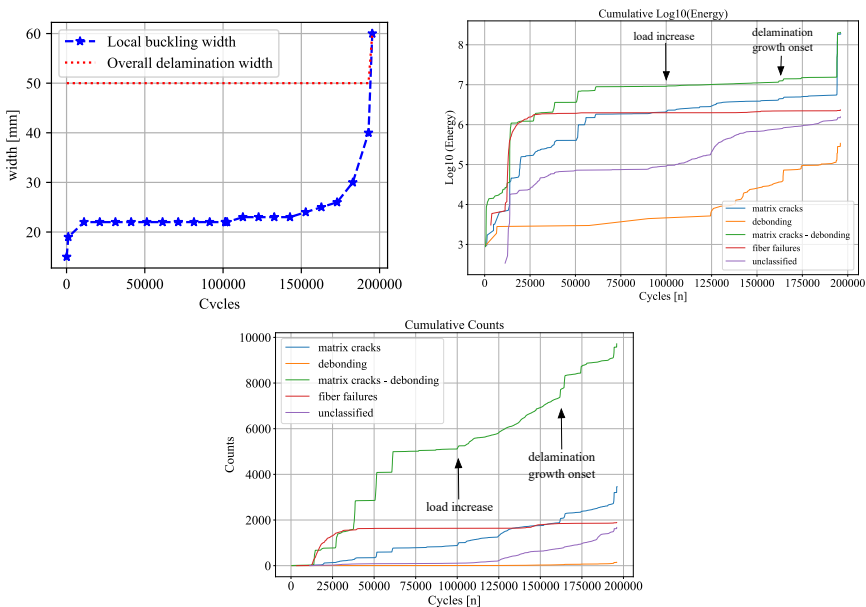
Figure 7.9: Specimen s3 delamination propagation evaluated indirectly with DIC buckle size on the left (Chapter 2), the logarithmic plot of the acoustic signal energy released by the different damage modes, and the cumulative sum of events associated to the different damage modes
